Highway Accident Report - Multiple Vehicle
Collisions and Fires Under Limited Visibility
Conditions, Interstate Route 75 at
Ocala, Florida, February 28, 1983

(U.S.) National Transportation Safety Board
Washington, DC

18 Oct 83

**MULTIPLE-VEHICLE COLLISIONS AND FIRES
UNDER LIMITED VISIBILITY CONDITIONS,
INTERSTATE ROUTE 75 AT OCALA, FLORIDA
FEBRUARY 28, 1983**

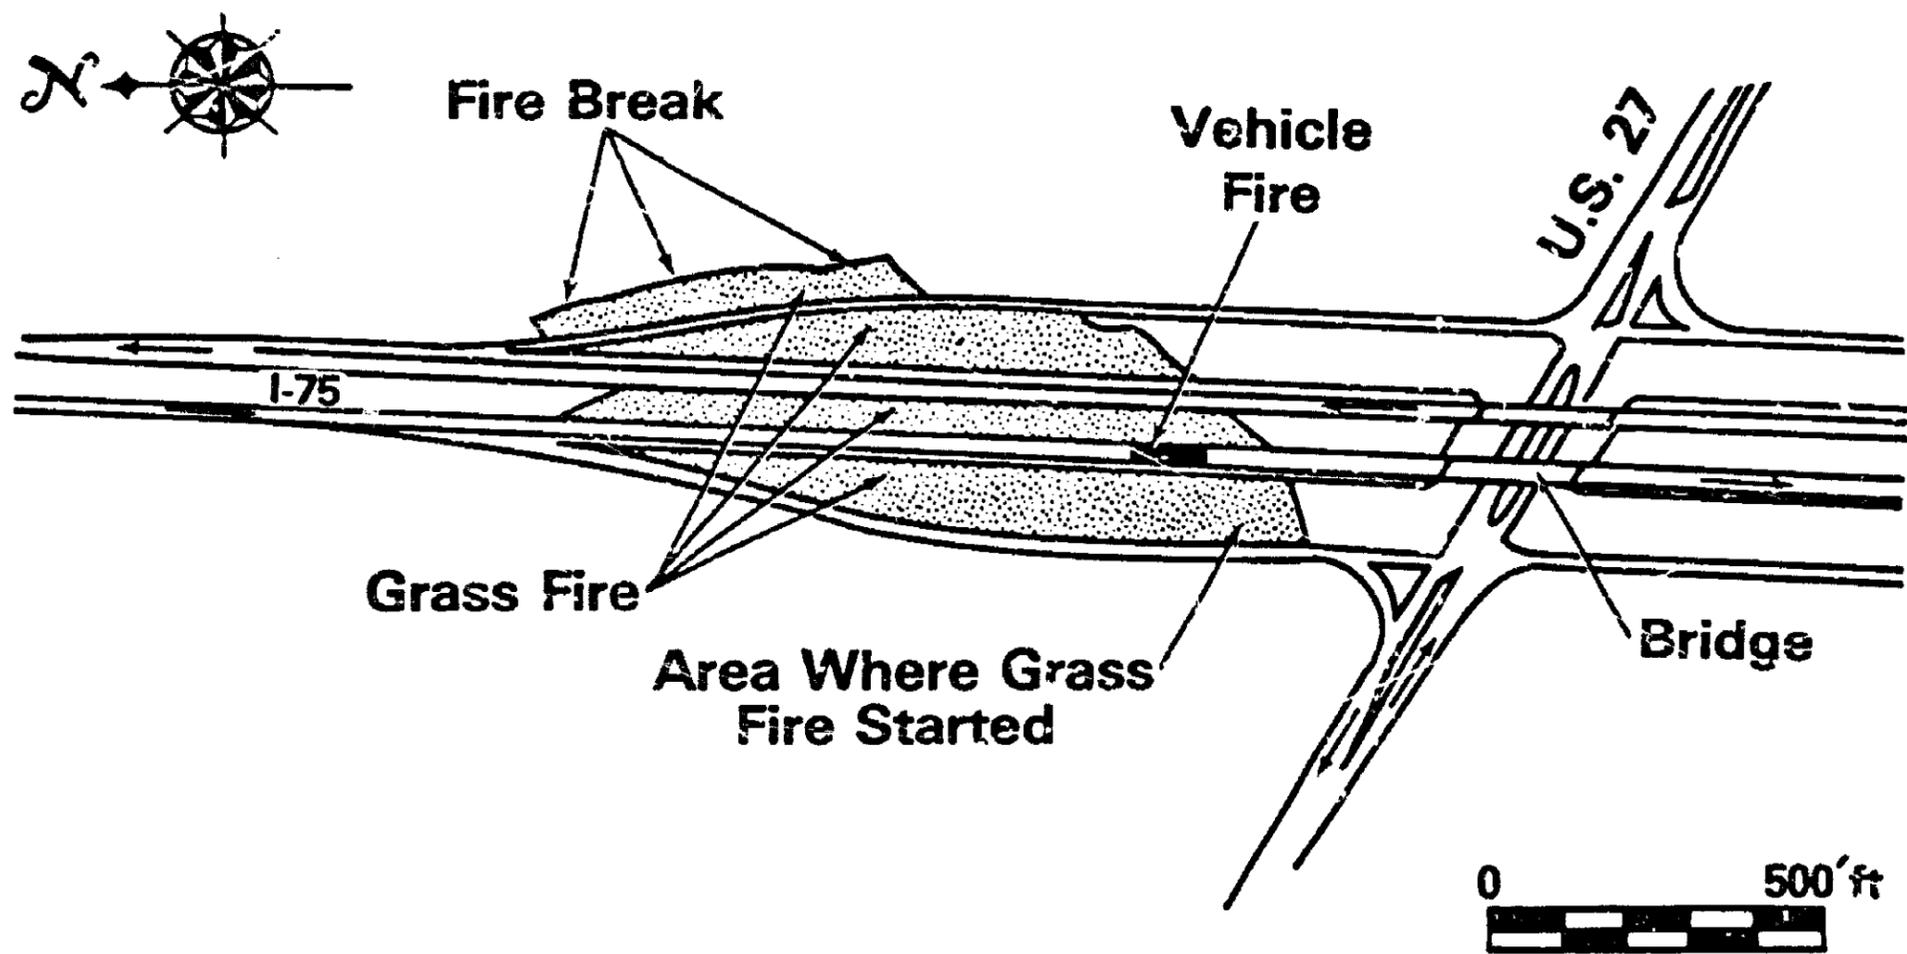
Figure 6.—Interchange and burn area.

Shortly after the accident, a vehicle fire was ignited. Witnesses placed the fire at the resting site of vehicles Nos. 17 and 20. (The fuel systems on both the pickup truck and the Chevrolet were breached.) The fire spread rapidly and eventually involved 14 of the vehicles in the accident area; 10 of these were totally burned. All combustible materials and materials with low melting points, except for some lumber on vehicle No. 10, including the 3 combination vehicles, were consumed by fire. Four other vehicles were partially burned. A grass fire, ignited by vehicle fires, burned across the median, bypassed the northbound traffic lanes, and continued to burn the grass east of the highway until it was interrupted by a fire break which had been constructed before the accident. (See figure 6.)

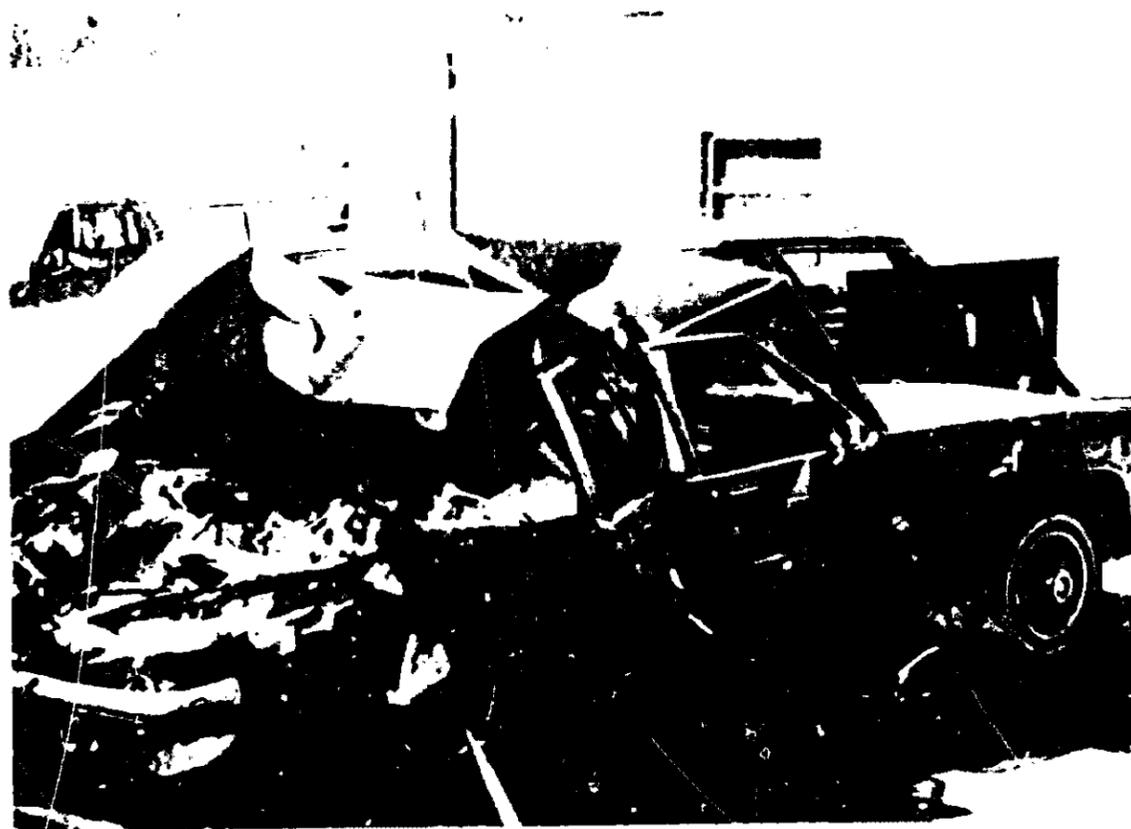
Figure 9.—Vehicle No. 8. (Note rear override damage.)

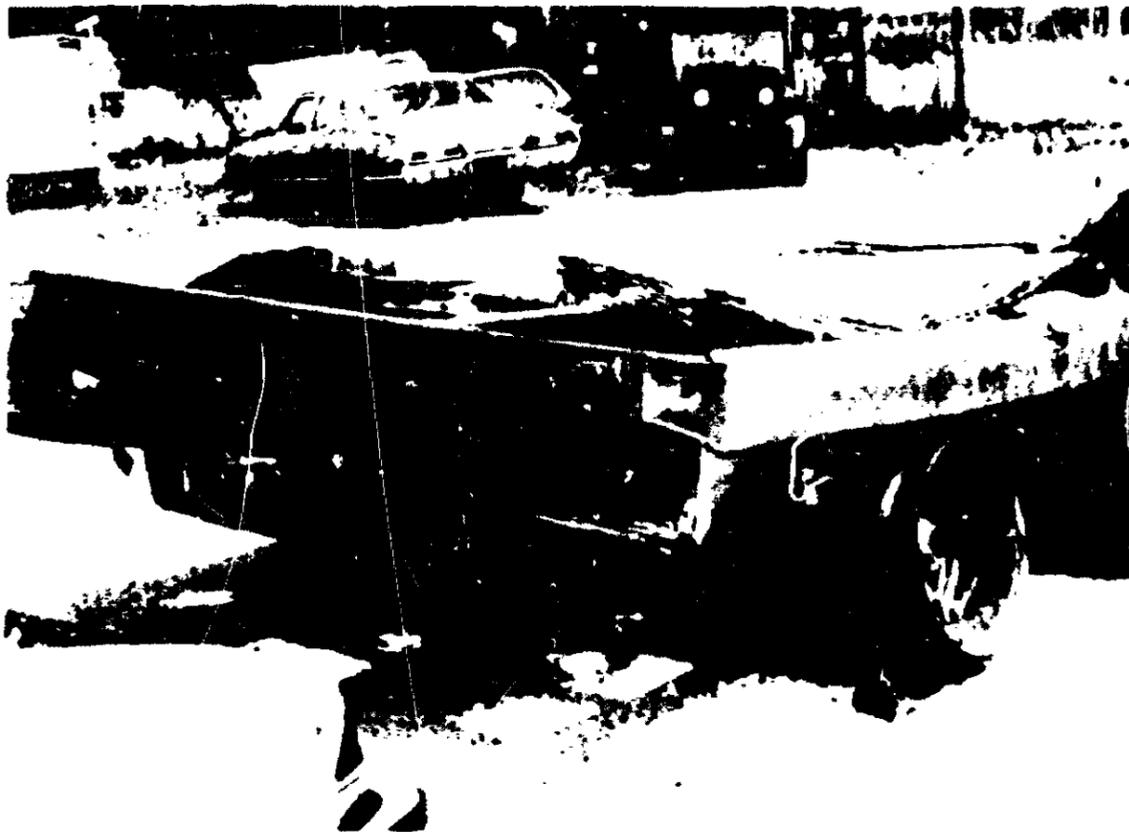
The underride protection device installed on the rear of vehicle No. 10 (the semitrailer) was damaged. The lower 6 inches of the device was rotated about 60° to 80° forward; however, the device prevented serious underride by those vehicles which struck the rear of the semitrailer.

The front bumper was buckled and the leading ends of the chassis rails were skewed to the left. All glass was missing. The rear plate on the semitrailer was buckled and the lower 8 inches of the underride protection device (from the braces downward) was rotated 60° to 80° forward. The right side rail of the semitrailer was bowed downward. The cargo apparently remained secured throughout the crash sequence and was removed from the semitrailer into the highway median to facilitate firefighting efforts. The tractor and semitrailer were both destroyed by fire. The tractor's fuel tanks maintained their integrity. Fuel lines in the engine compartment were either damaged or destroyed by fire. (See figure 11.)

Figure 11.--Rear of semitrailer (vehicle No. 10).
(Note damage to the rear underride protection device.)
