**HIGHWAY ACCIDENT REPORT**

**SAMUAL CORALUZZO COMPANY, INC.,  
TRACTOR CARGO TANK SEMITRAILER  
MECHANICAL FAILURE, OVERTURN, AND FIRE  
INTERSTATE 76 (SCHUYLKILL EXPRESSWAY)  
PHILADELPHIA, PENNSYLVANIA  
OCTOBER 7, 1983**

NTSB/HAR-84/02

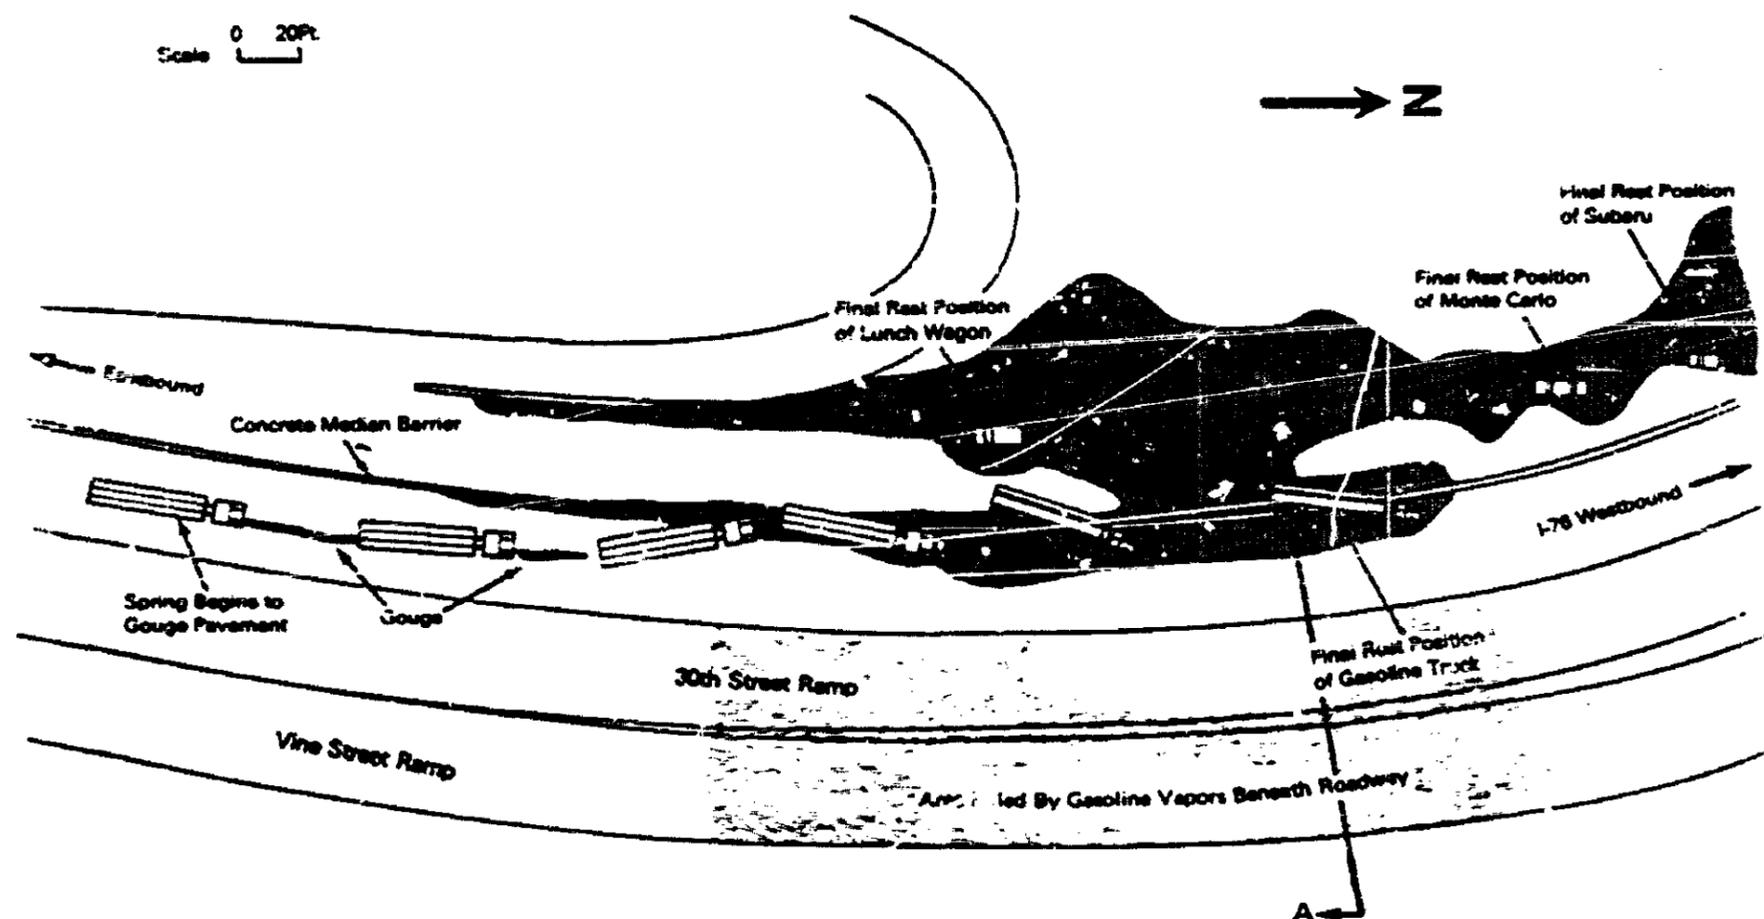
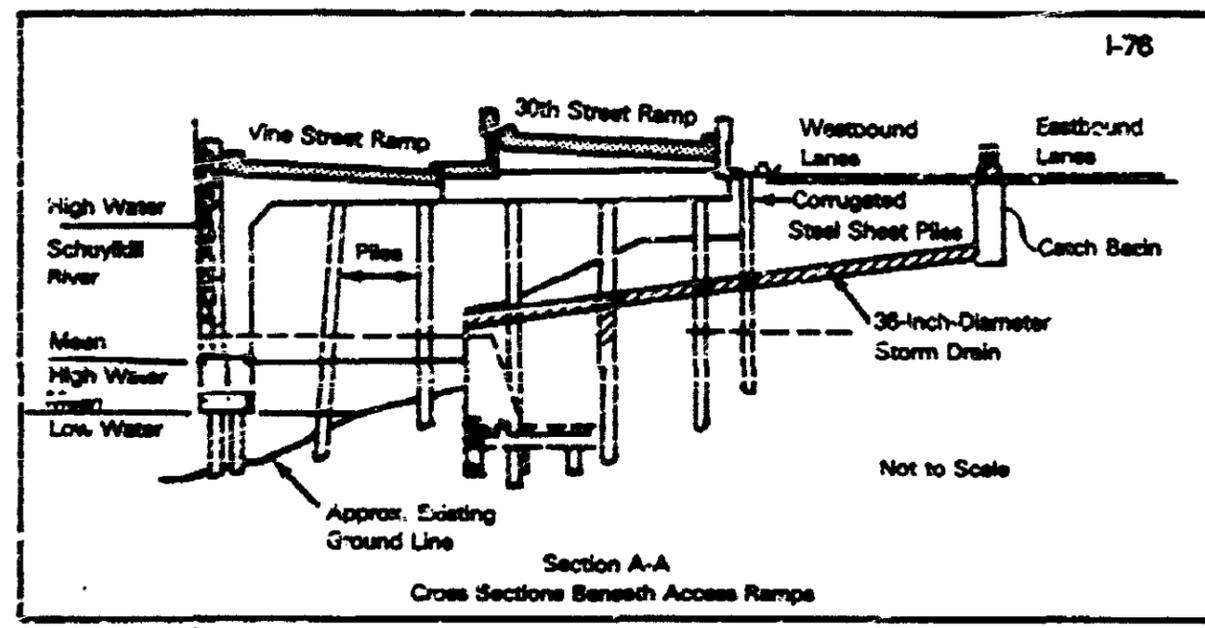
Figure 1.—Overall scene diagram of accident sequence.

About 11:35 a.m., e.s.t. on October 7, 1983, 1/ a tractor-cargo tank semitrailer (combination vehicle 2/) was traveling westbound in the right lane of Interstate 76 (Schuylkill Expressway) in Philadelphia, Pennsylvania. It veered into the inside traffic lane, struck the concrete median barrier and overturned onto its left side. (See figure 1.) The weather was clear and the pavement was dry.

All of the catch basins at the scene of the accident drained into a large cavernous area <sup>3/</sup> beneath the westbound access ramps adjacent to the I-76 expressway. (See figure 1.) The burning gasoline entered the drains for the eastbound lanes, flowed eastward into the cavernous area, and exploded. A concrete sidewalk adjacent to the westbound lanes and several expansion joints in the adjacent expressway ramps were destroyed during the explosion.

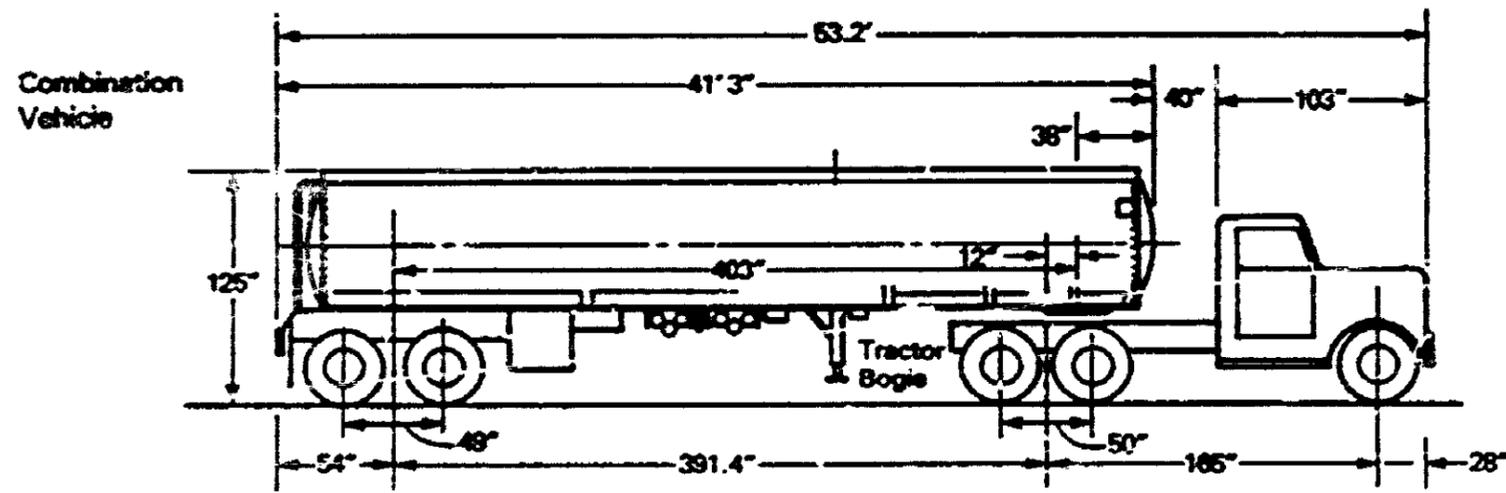
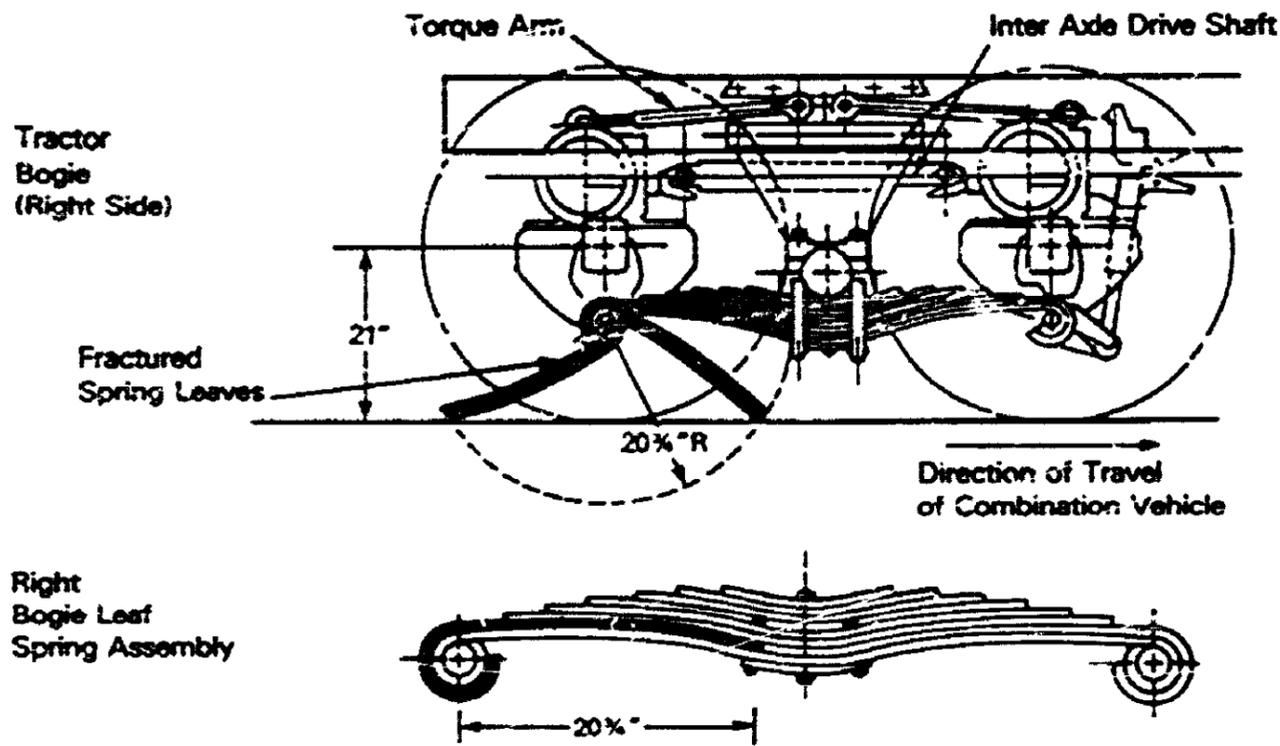
Figure 2.—Detail view of right side of tractor bogie and leaf spring assemblies.

The combination vehicle was destroyed by fire after it came to rest on its left side. The cab roof of the tractor was deformed downward 40 inches on the left side, and the tractor frame was displaced downward and leftward 22 and 13 inches, respectively. The tractor fifth wheel remained attached to the semitrailer during the collision and fire. A detailed inspection of the tractor revealed that two 4-inch-wide main spring leaves on the bottom of the right bogie 4/ leaf spring 5/ assembly were completely separated, and the rear bogie axle had rotated rearward about 6 1/2 inches on the right side. (See figure 2.) Representatives of Samuel Coraluzzo Company, Inc., indicated that the fractured spring leaves were obtained from an after-market supplier 6/ rather than the original equipment manufacturer, Mack Truck, Inc. The leaves had been installed on the tractor 9 months (60,394 service miles) before the October 7, 1983, accident.

A metallurgical examination of the fractured parts at the Safety Board's laboratory in Washington, D.C., revealed that the two main spring leaves from the right bogie leaf spring assembly contained preexisting fatigue cracks which had initiated along the tension surfaces of the leaves. The outer surface hardness of the fractured spring leaves was below the requirements specified by Mack Truck, Inc. The spring leaves did not conform to the material requirements specified on the engineering drawing for chemistry and final surface finish (shot peening 7/ followed by an aluminum coating).

Issue an "On Guard" bulletin reporting the circumstances of the accident on October 7, 1983, in Philadelphia, Pennsylvania, and warn commercial motor vehicle operators that the use of after-market parts as replacements for critical suspension components can be a dangerous practice since the parts may not meet original equipment standards. Motor carriers should be advised to physically inspect all leaf spring suspension components, directing particular attention to the tension side of all after-market leaves in the spring clip area. (Class II, Priority Action) (H-84-28)

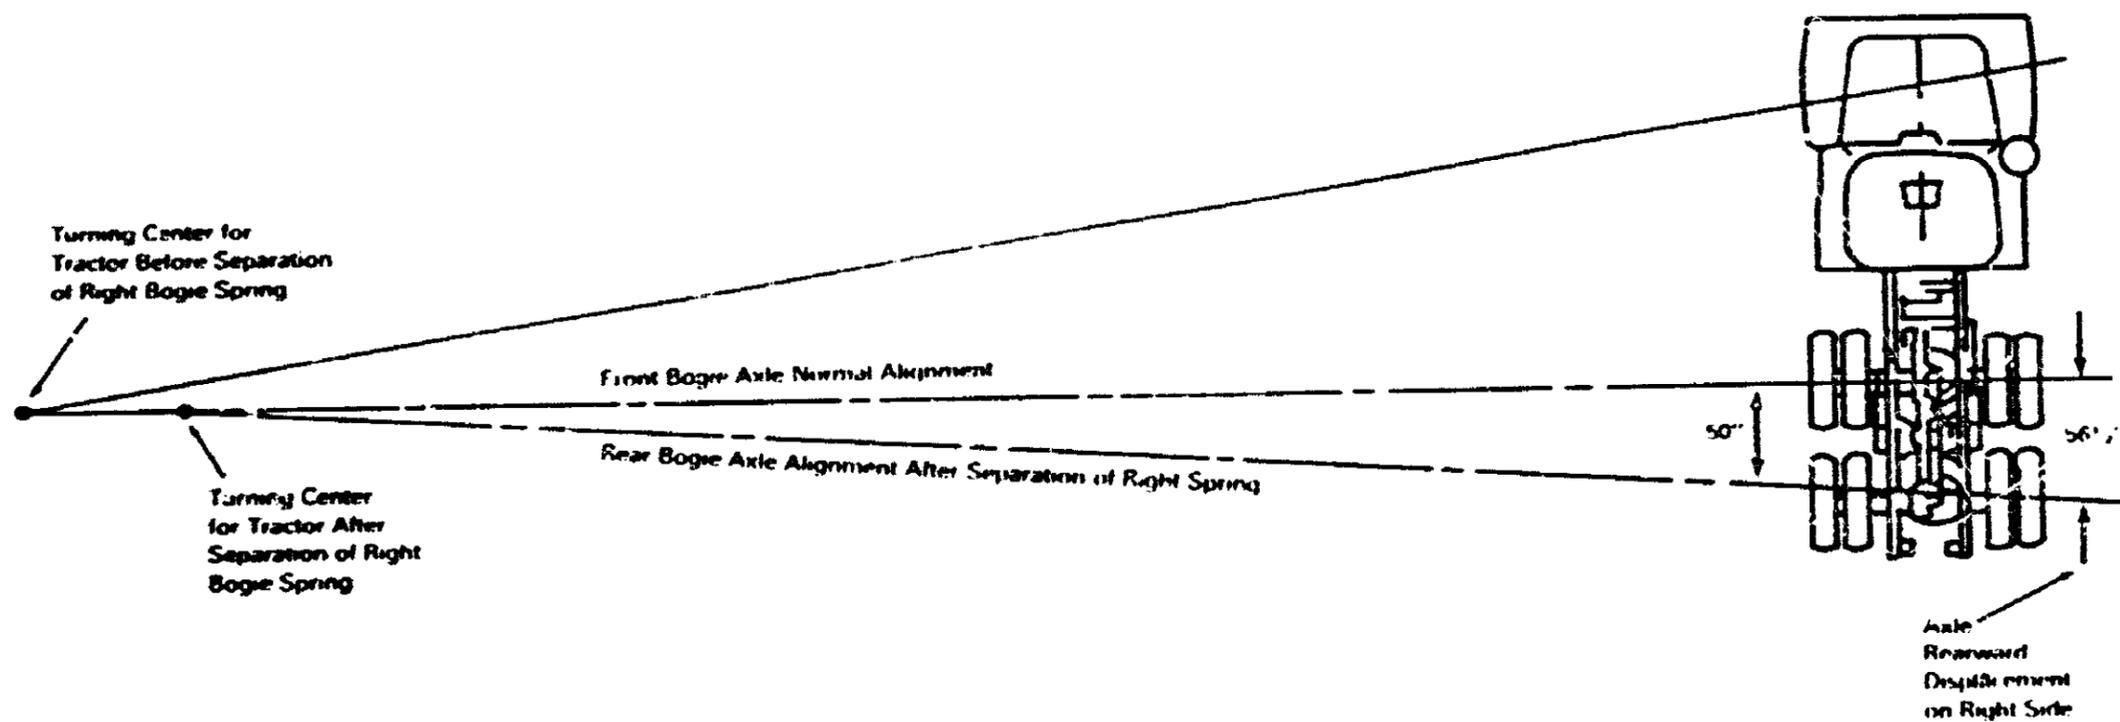
Figure 3.—Turning center for combination vehicle.

The separation of the main spring leaves permitted the rear bogie axle to rotate rearward approximately 6 1/2 inches on the right side, altered the steering alignment of the bogie axles (see figure 3), and caused the combination vehicle to veer leftward, impact the concrete median barrier, and overturn onto its left side about 120 feet west of the initial point of impact. Normally, tractor bogie axles are in a fixed position parallel to each other, provide little or no input into the vehicle steering, and track in the directional path established by the front steering axle. However, the rearward rotation of the right side of the rear bogie axle caused the rear axle to lose its alignment integrity and induced a leftward steering moment on the combination vehicle.

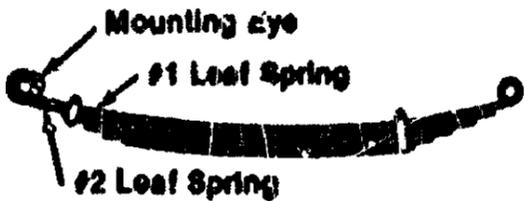
On August 11, 1981, while crossing an overpass the left steering axle suspension broke. The truck-tractor swerved left out of control, climbed a concrete bridge wall and fell 22 feet below onto another highway. Fire ensued. The truck driver was burned beyond recognition and property damage amounted to \$185,000.

Post examination of the left steering axle suspension system on the truck-tractor disclosed the top leaf spring, number one, had a lateral three-inch crack across the surface of its four-inch width, and the second spring leaf from the top was cracked the entire width. Rust deposits were conspicuous in the cracked areas.

The failure of a motor carrier to systematically inspect, repair and maintain the vehicle subject to its control contributed to this accident. Pre-trip inspection by the responsible truck driver would have revealed the visible cracks in both the leaf springs.

The purpose of issuing this bulletin is to re-emphasize to motor carriers, its drivers and maintenance personnel, the need to consistently comply with Federal and State standards of inspection and maintenance of motor vehicles. This systematic inspection is intended to minimize the operation of mechanically unsafe motor vehicles on the Nation's highways.
