Highway Accident Report - Collapse of a  
Suspended Span of Interstate Route 95  
Highway Bridge over the Mianus River  
Greenwich, Connecticut, June 28, 1983

(U.S.) National Transportation Safety Board  
Washington, DC

19 Jul 84

1. Report No. NTSB/HAR-84/03		2. Government Accession No. PB84-916203		3. Recipient's Catalog No.	
4. Title and Subtitle Highway Accident Report— Collapse of a Suspended Span of Interstate Route 95 Highway Bridge Over the Mianus River, Greenwich, Connecticut, June 28, 1983				5. Report Date July 19, 1984

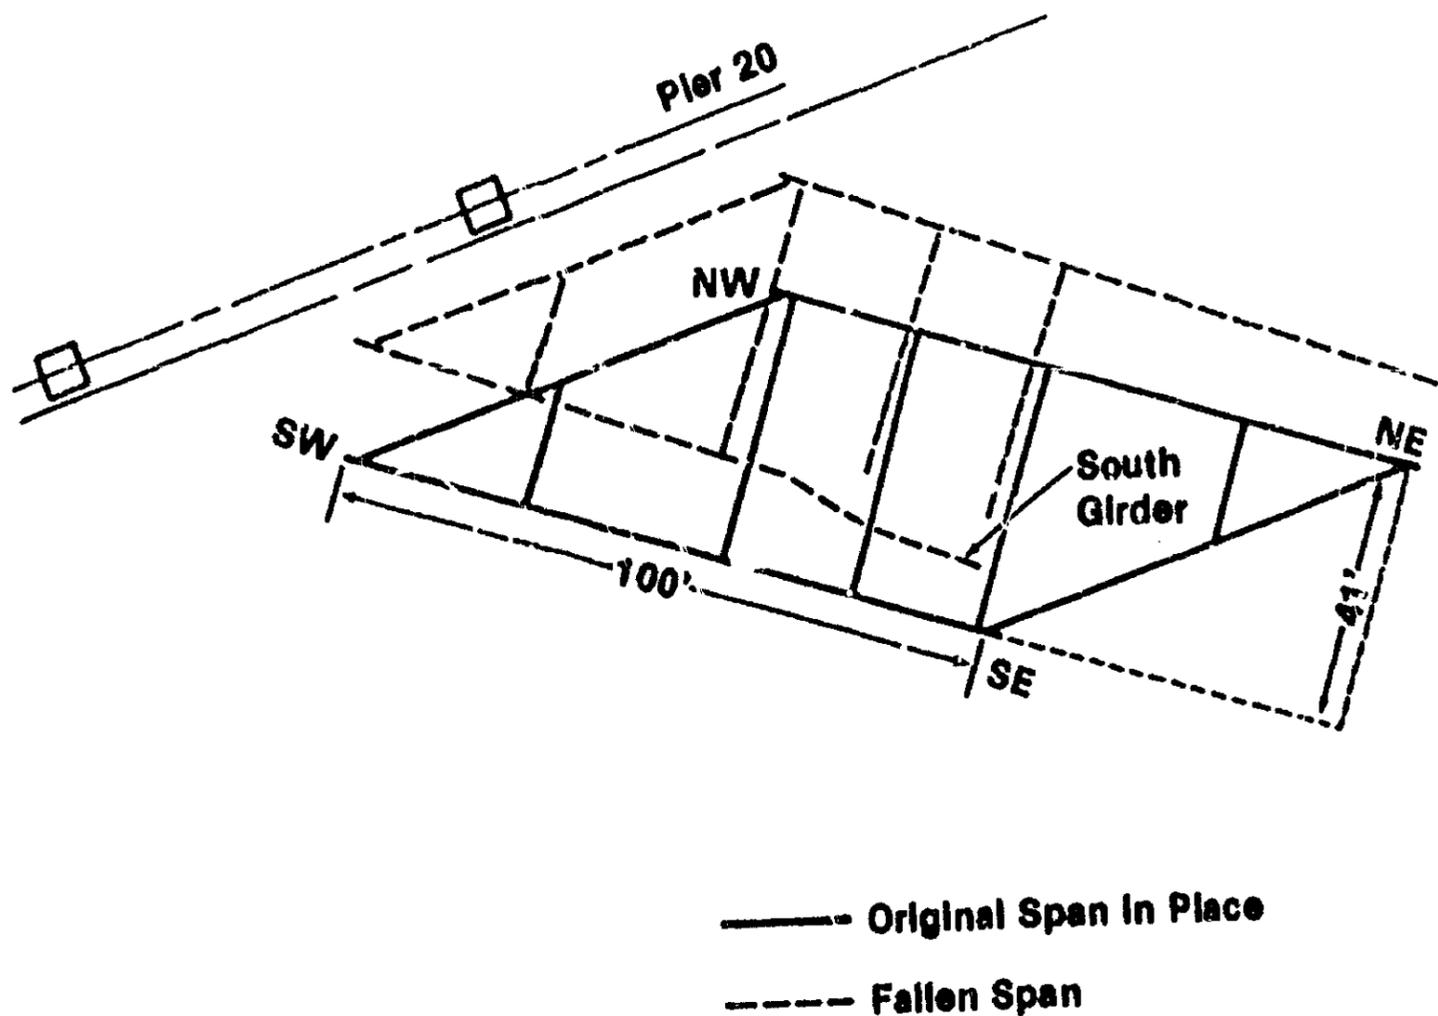
Figure 7.--Location of the steel superstructure of the suspended span in place and after collapse.

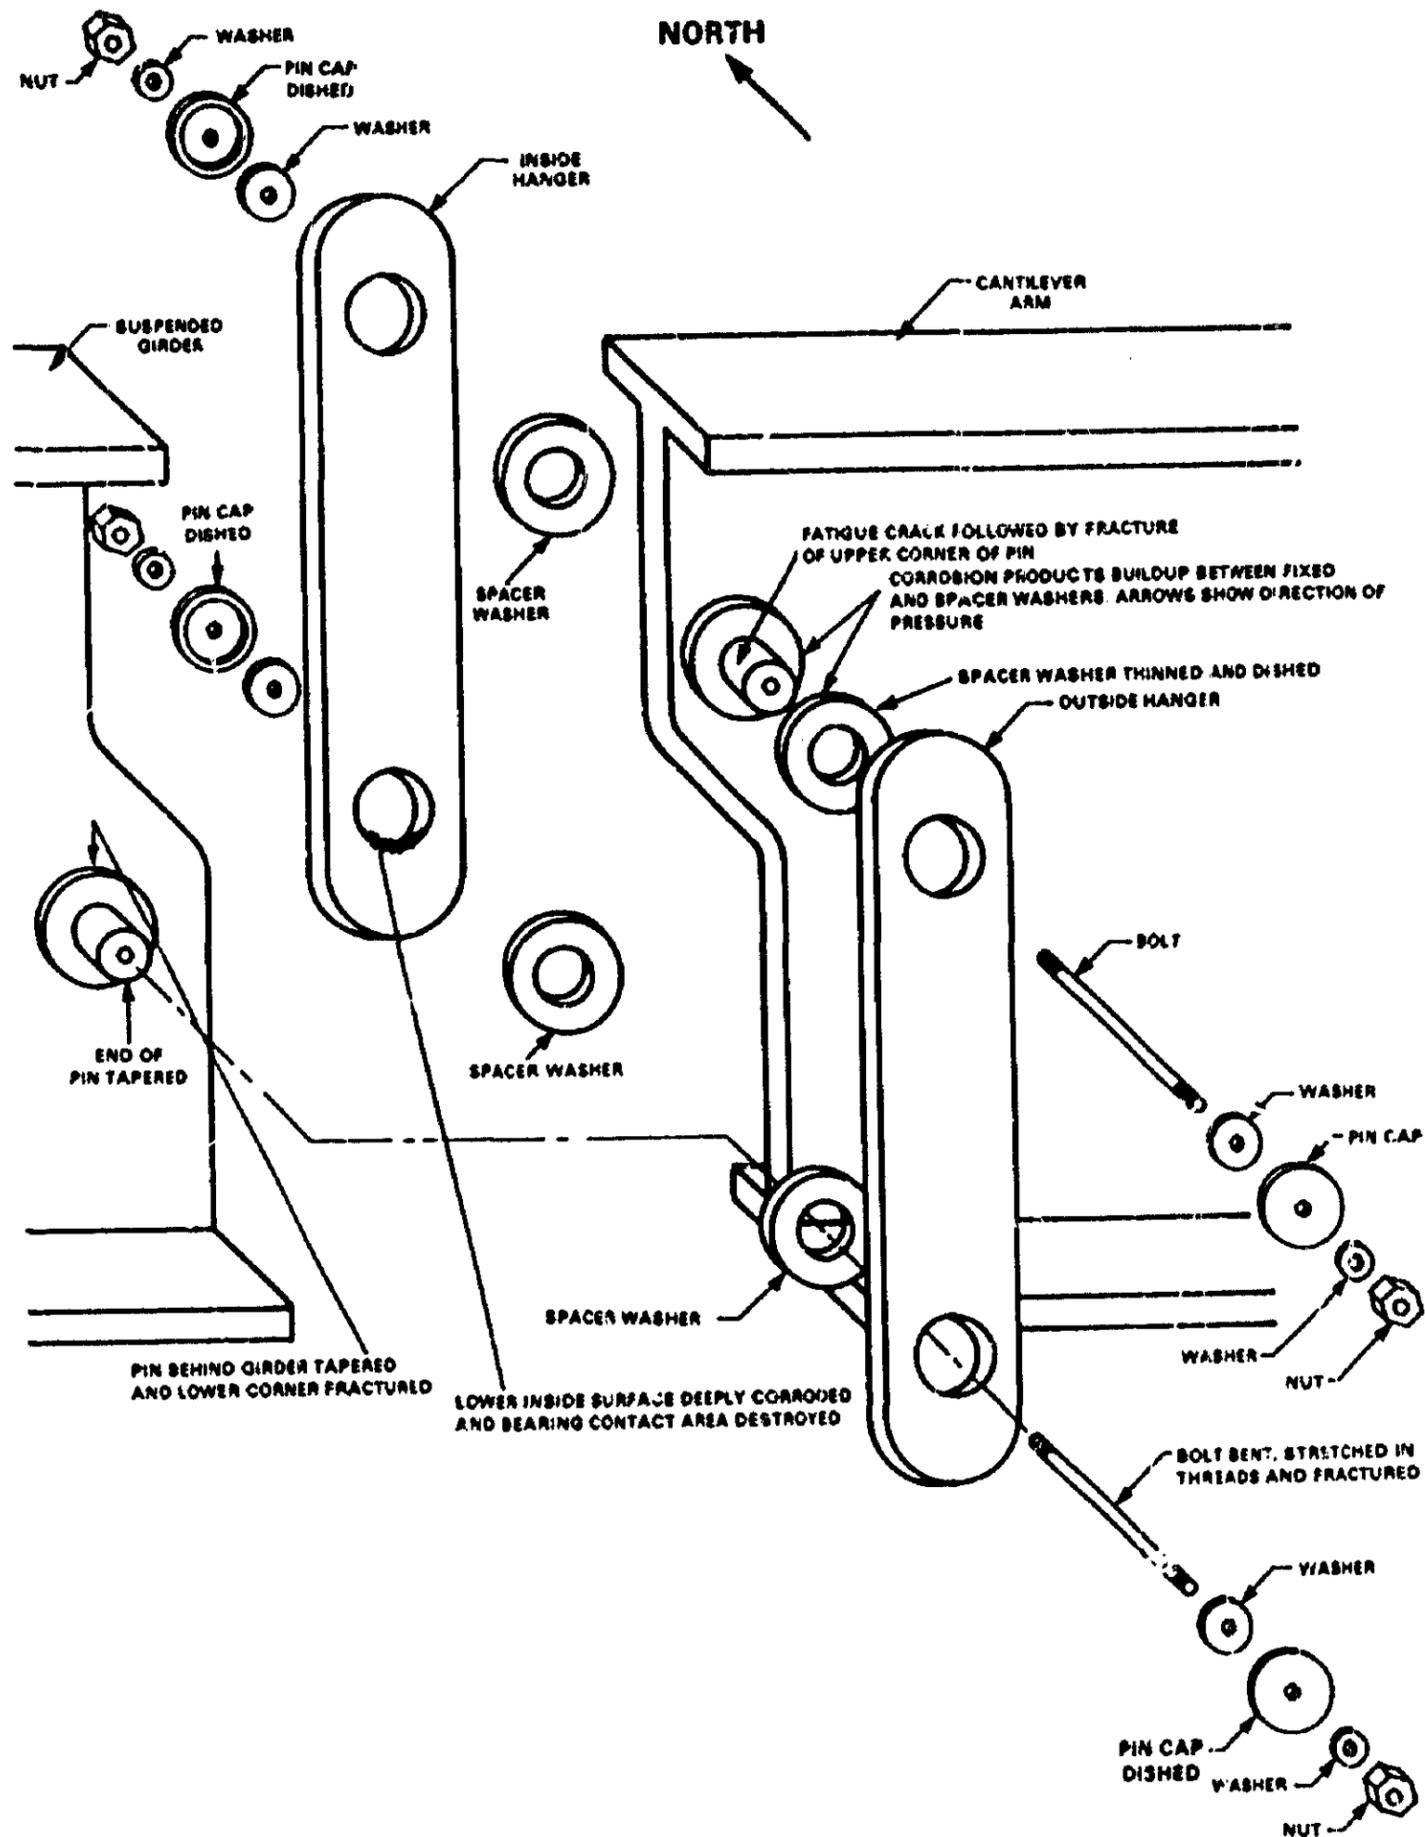
When the inside hanger at the southeast corner moved laterally and separated from the lower pin, the horizontal alignment of the span changed and the windlock parts came into contact. The off-center wear pattern of the windlock of the fallen span shows that the span was not aligned laterally with the cantilever arm for a lengthy time. The fact that the wear pattern on the female part of the windlock connection was wider than the male part of the windlock connection indicates that the male part of the windlock, while misaligned, moved downward, stayed in the center long enough to cause some wear, and then moved laterally to widen the wear pattern. Such movement and misalignment also was evidenced by the rust marks on the sides of the fingers of the expansion joint. Moreover, the same lateral shift at the expansion fingers and sag at the deck level was found in two of the other suspended spans on the bridge.

When the separation of the inside hanger from the lower pin occurred, the full load at the southeast corner would have been transferred to the outside hanger. When the outside hanger slipped off the upper pin because of the fracture of a segment on the top of the outer end of the upper pin, the span collapsed relatively quickly. The unstable span, now supported primarily at three corners, acted to rotate and pry itself from its northeast connection. About the same time, the connection at the southwest corner separated, overloading the northwest corner connection and fracturing off the flange on the roller, and the span fell.

Figure 13.--Sequence of failure of the pin and hanger assembly.
