# **NATIONAL TRANSPORTATION SAFETY BOARD**

**TRAILWAYS LINES, INC., BUS/  
E. A. HOLDER, INC., TRUCK,  
REAR END COLLISION AND  
BUS RUN-OFF-BRIDGE, U. S. ROUTE 59,  
NEAR LIVINGSTON, TEXAS  
NOVEMBER 30, 1983**

NTSB/HAR-84/04

**TRAILWAYS LINES, INC., BUS/E.A. HOLDER, INC., TRUCK  
REAR END COLLISION AND BUS RUN-OFF-BRIDGE  
U.S. ROUTE 59 NEAR LIVINGSTON, TEXAS  
NOVEMBER 30, 1983**

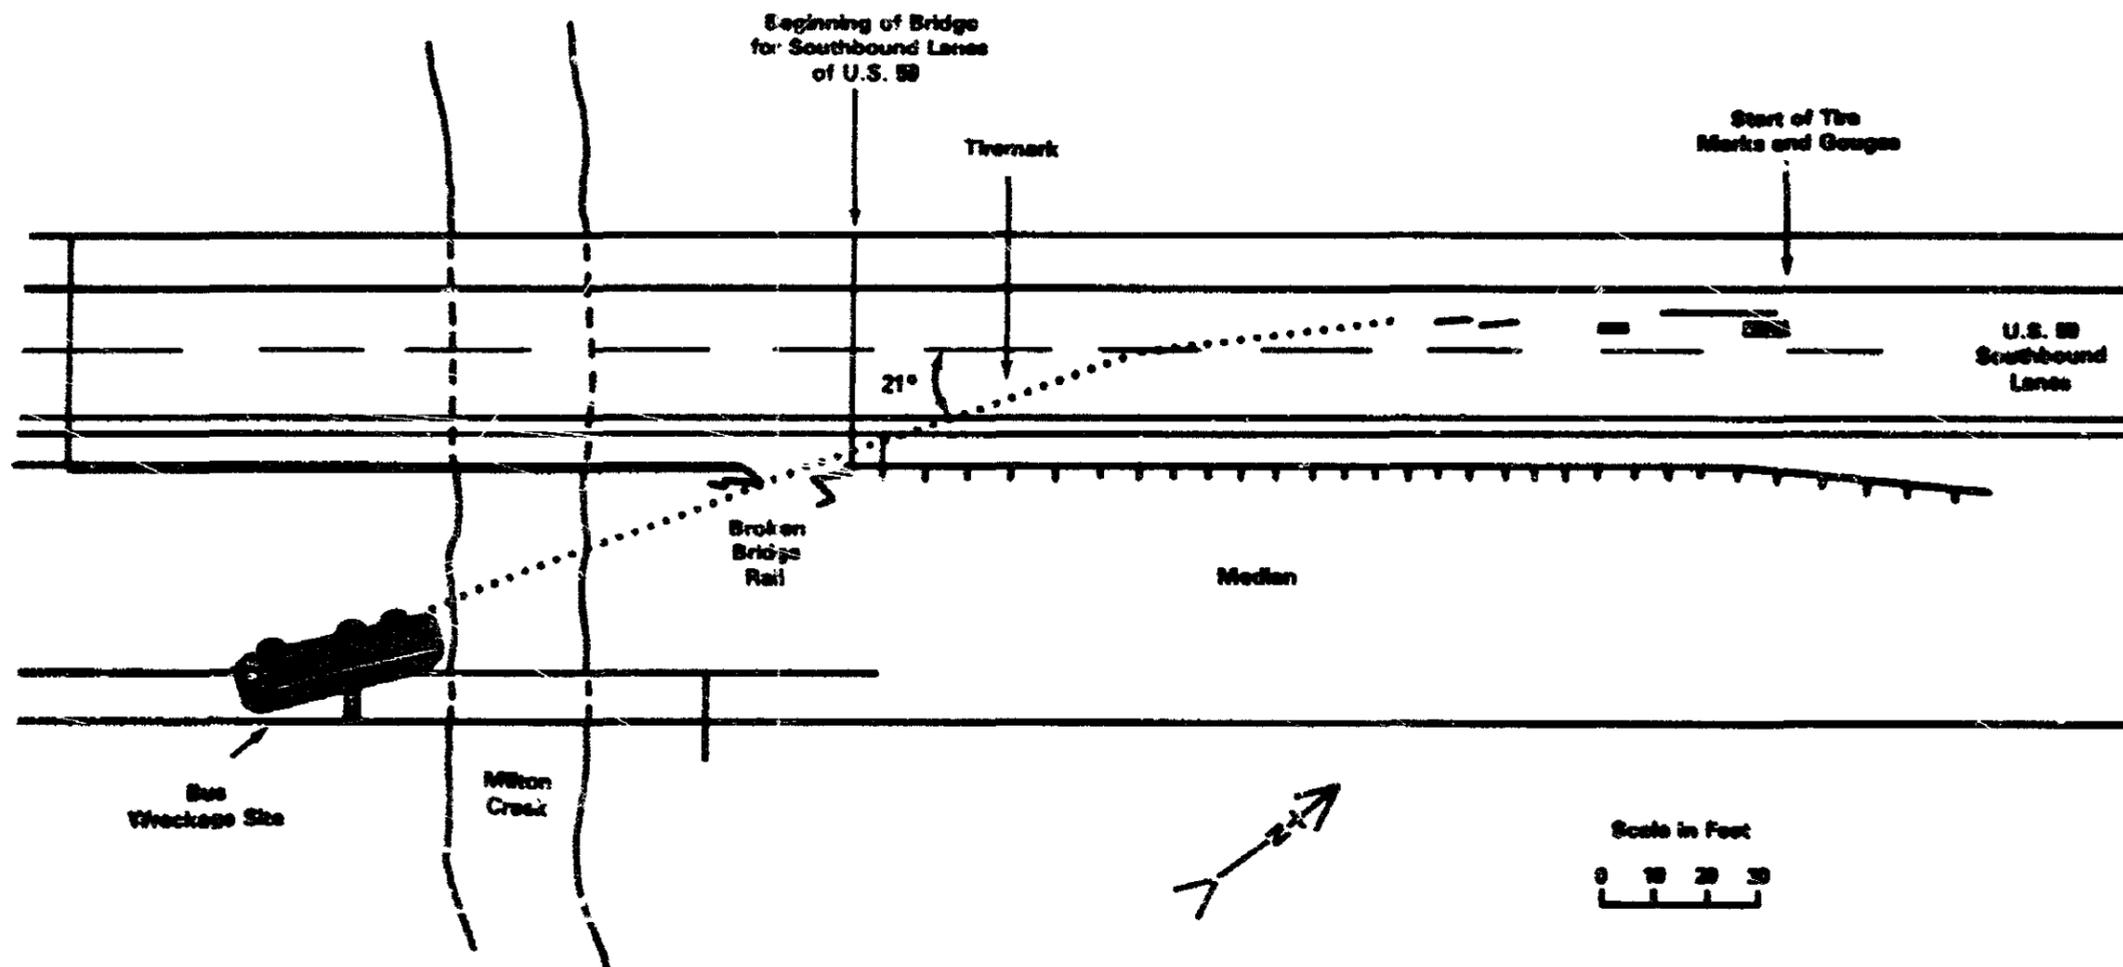
Figure 2.—Physical evidence at the scene.

The first tire marks attributed to the accident were found in the right southbound lane about 880 feet south of the intersection of U.S. 59 and Loop 116, and 170 feet before the area where the bus crashed through the bridge guardrail. (See figure 2.) South of these tire marks, another tire mark extended from the left passing lane to the edge of the bridge deck at a 21-degree angle to the centerline of the roadway.

The tiremarks in the right lane were from the left rear tires of the truck and the right front tire of the bus at the point where the vehicles collided. There were no tiremarks in the right lane prior to this point to indicate that the busdriver applied his brakes before the collision. The damage pattern on the vehicles and the path of the bus toward the guardrail indicated that the busdriver was performing a left steering maneuver just before impact. Since the bus was in the right lane at impact with the truck and then travelled at a 21-degree angle after that impact, the busdriver's steering to the left was probably a quick, last-second maneuver. Therefore, the busdriver probably saw the truck just before impact and steered sharply to the left, but reacted too late to avoid the collision.
