HIGHWAY ACCIDENT REPORT

COLLISION OF  
G & D AUTO SALES, INC.,  
TOW TRUCK TOWING AUTOMOBILE,  
BRANCH MOTOR EXPRESS COMPANY  
TRACTOR-SEMITRAILER  
TOWN OF REHOBOTH SCHOOLBUS  
REHOBOTH, MASSACHUSETTS  
JANUARY 10, 1984

NTSB/HAR-84/05

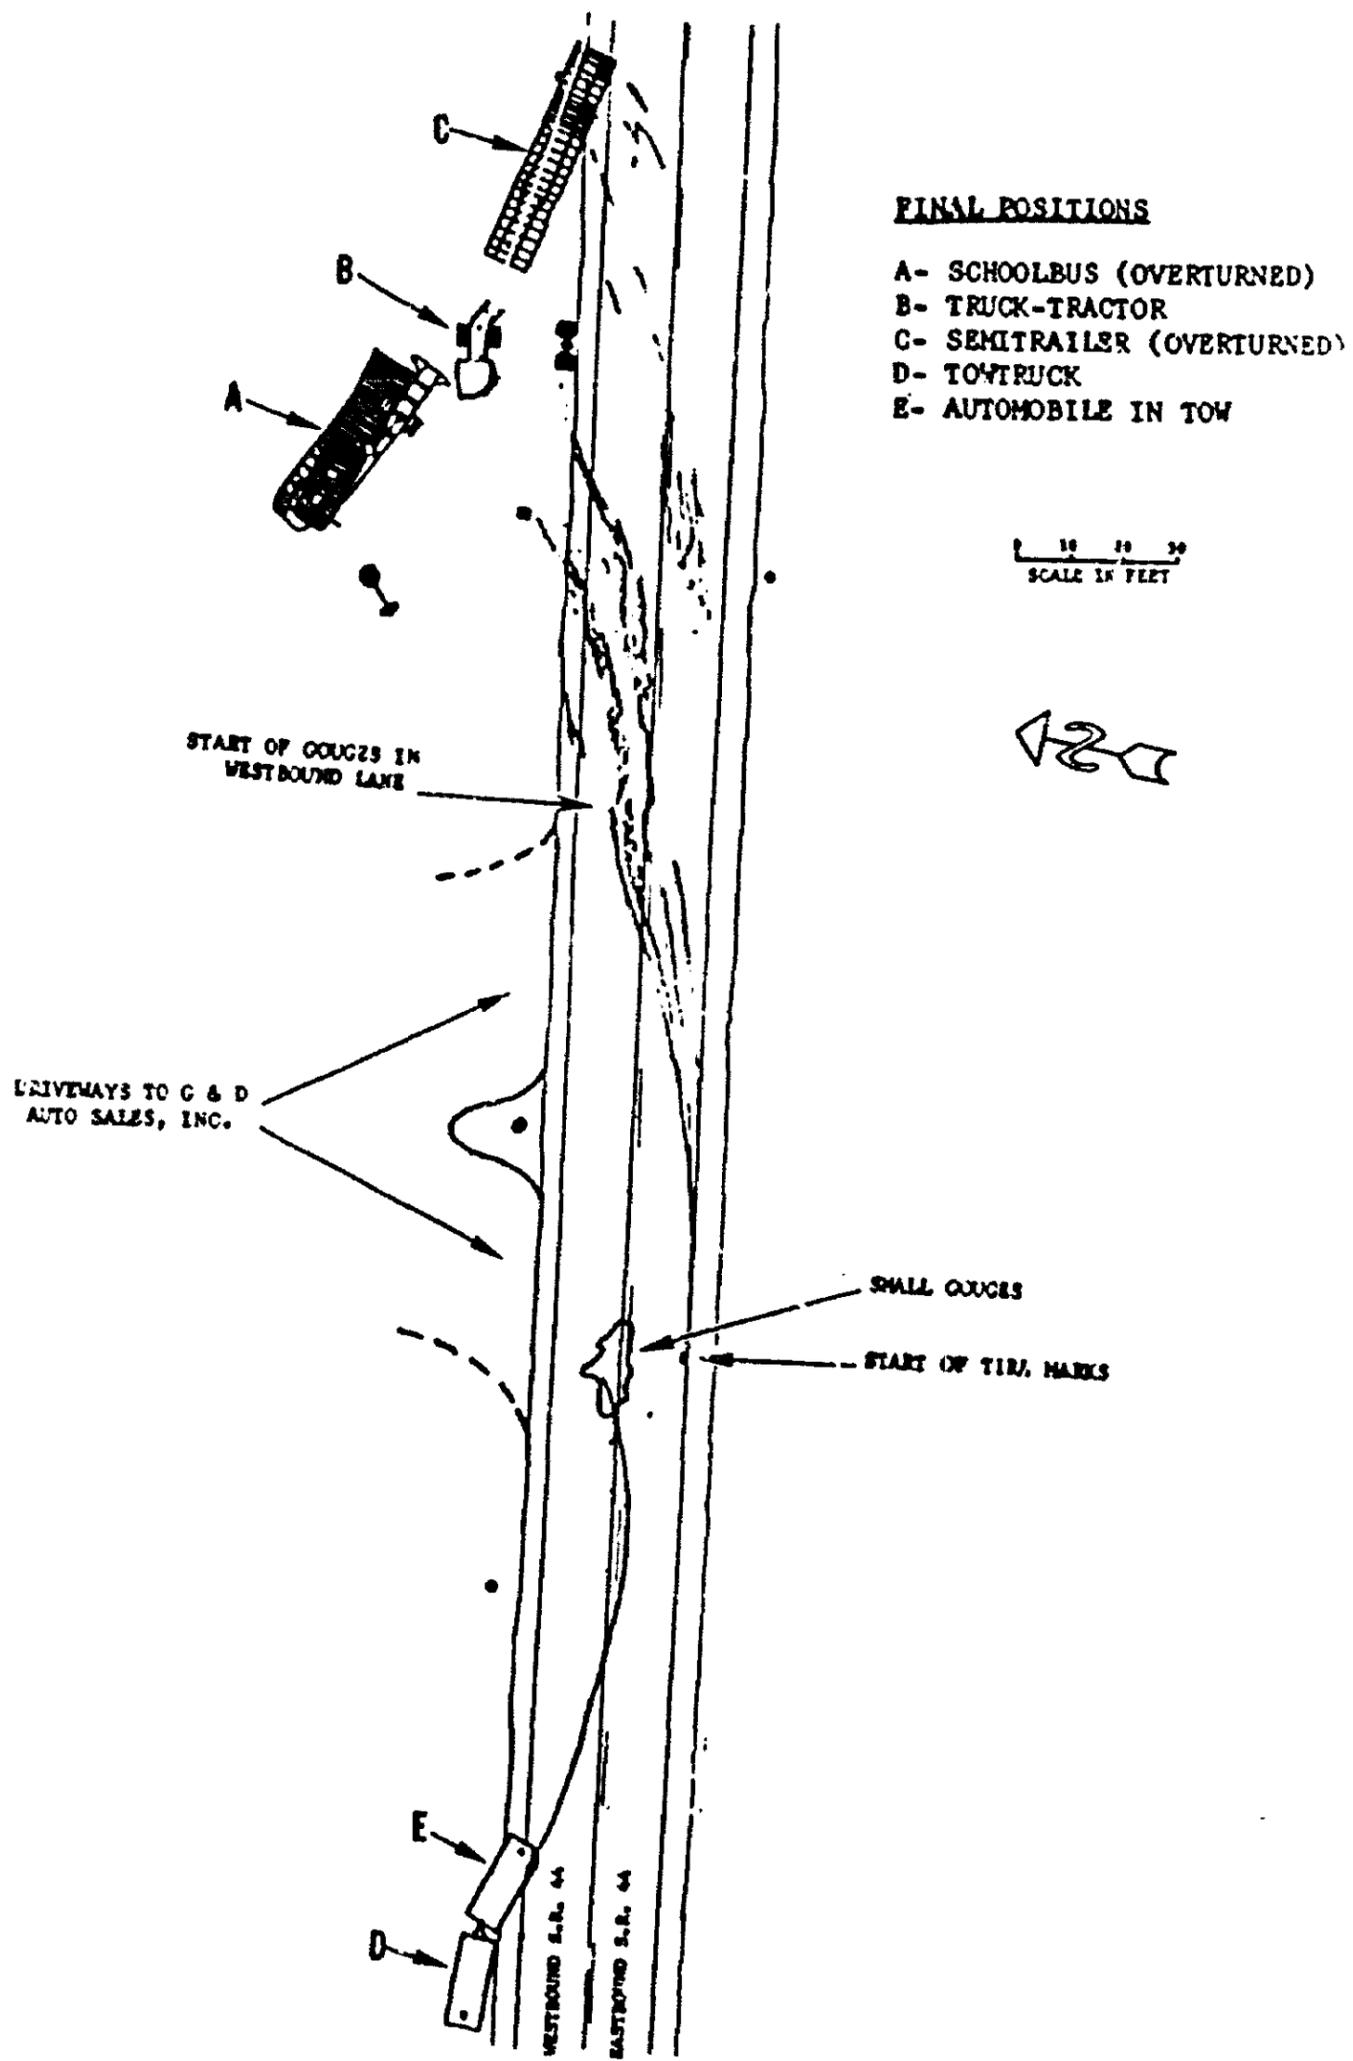
Figure 2.—Accident site.

Tire yaw marks were found beginning about 2 feet east of the gouges and within 1 foot of the eastbound white edgeline. These marks continued eastward and crossed the highway centerline at a point approximately 75 feet east of the first tiremark. There were several gouges in the center of the westbound lane approximately 110 feet east of the first tiremark, followed by tiremarks and gouges leading off the westbound lane of the highway to the final rest positions of the vehicles. (See figure 1.)

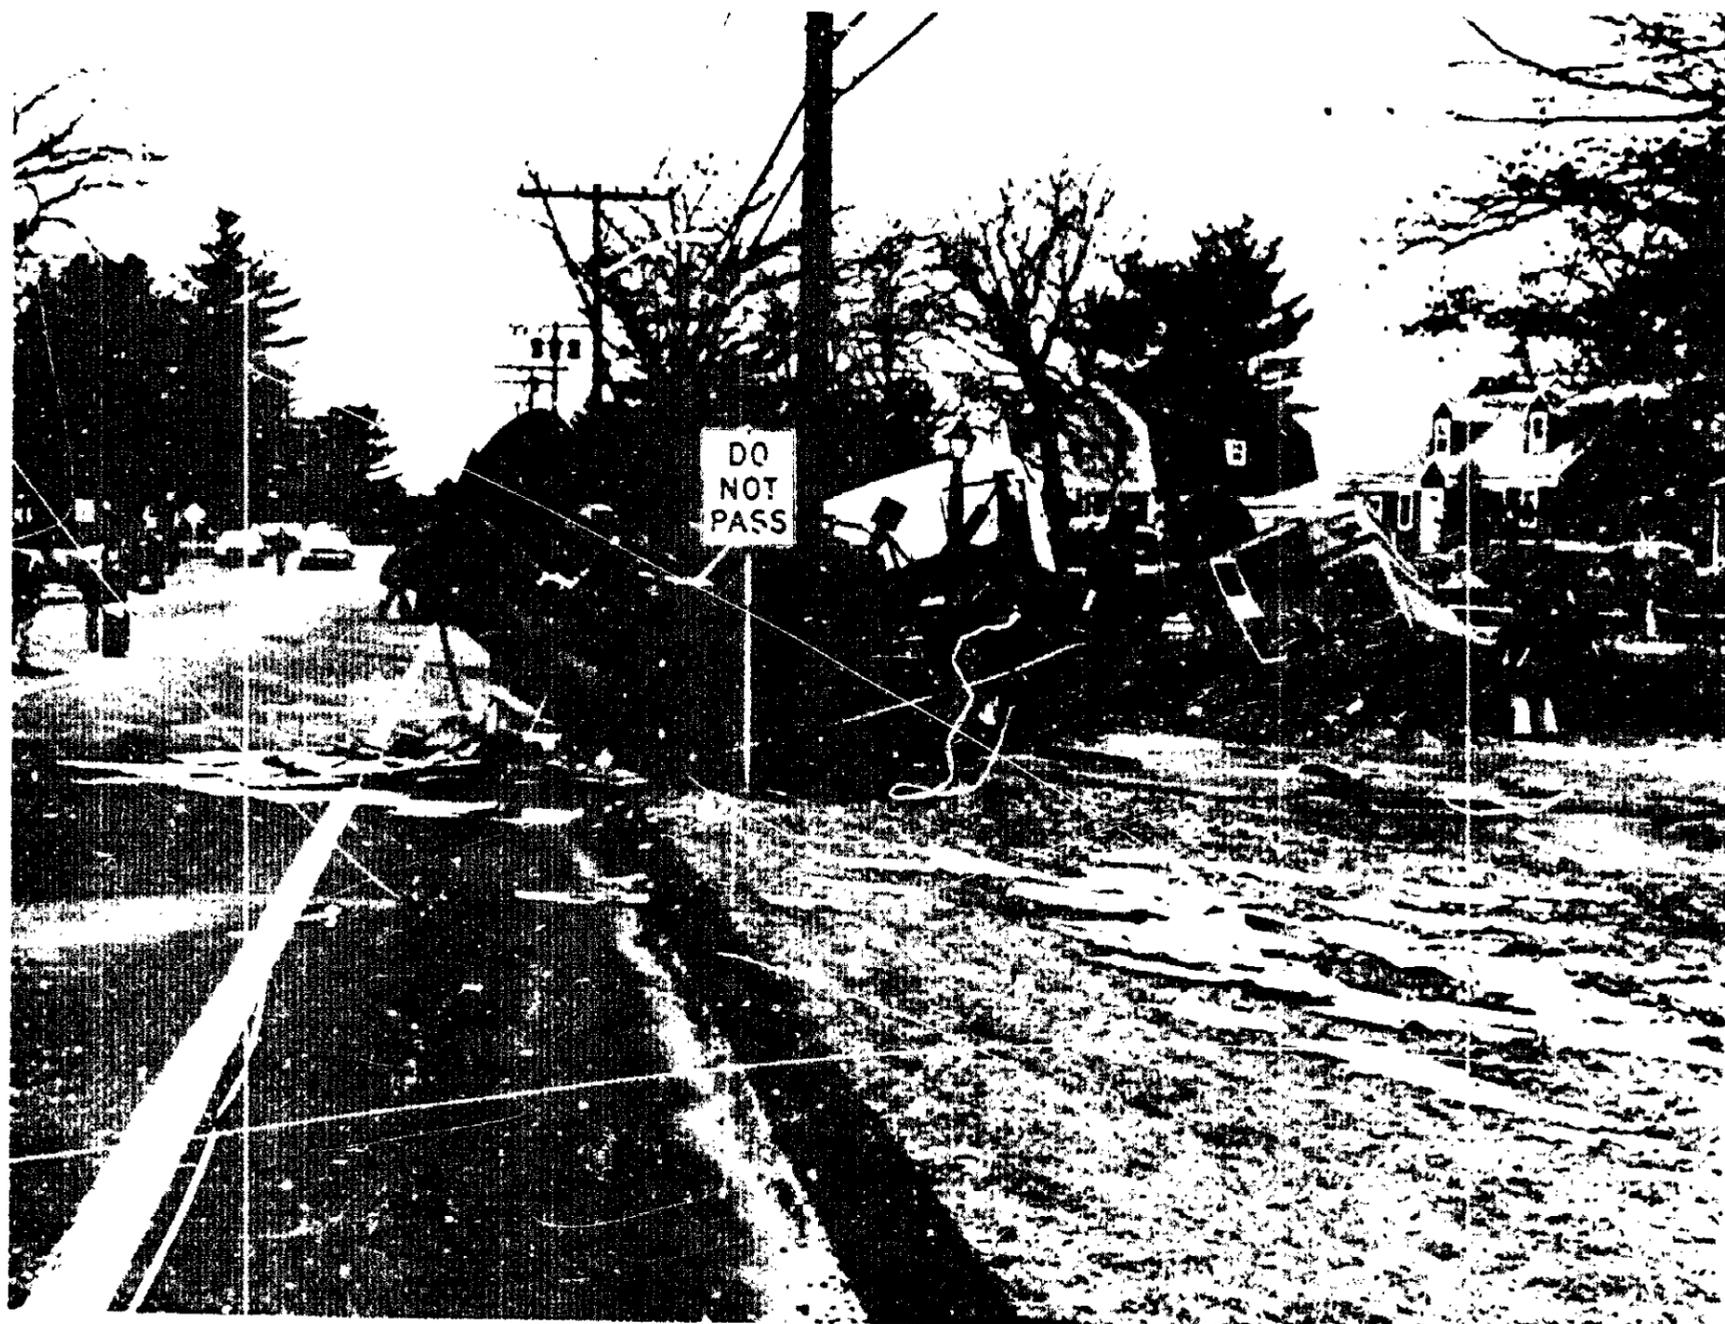
Figure 3.—View of accident scene looking west on State Route 44. Overturned semitrailer is in foreground. (Photo courtesy of Rehoboth Police Department)

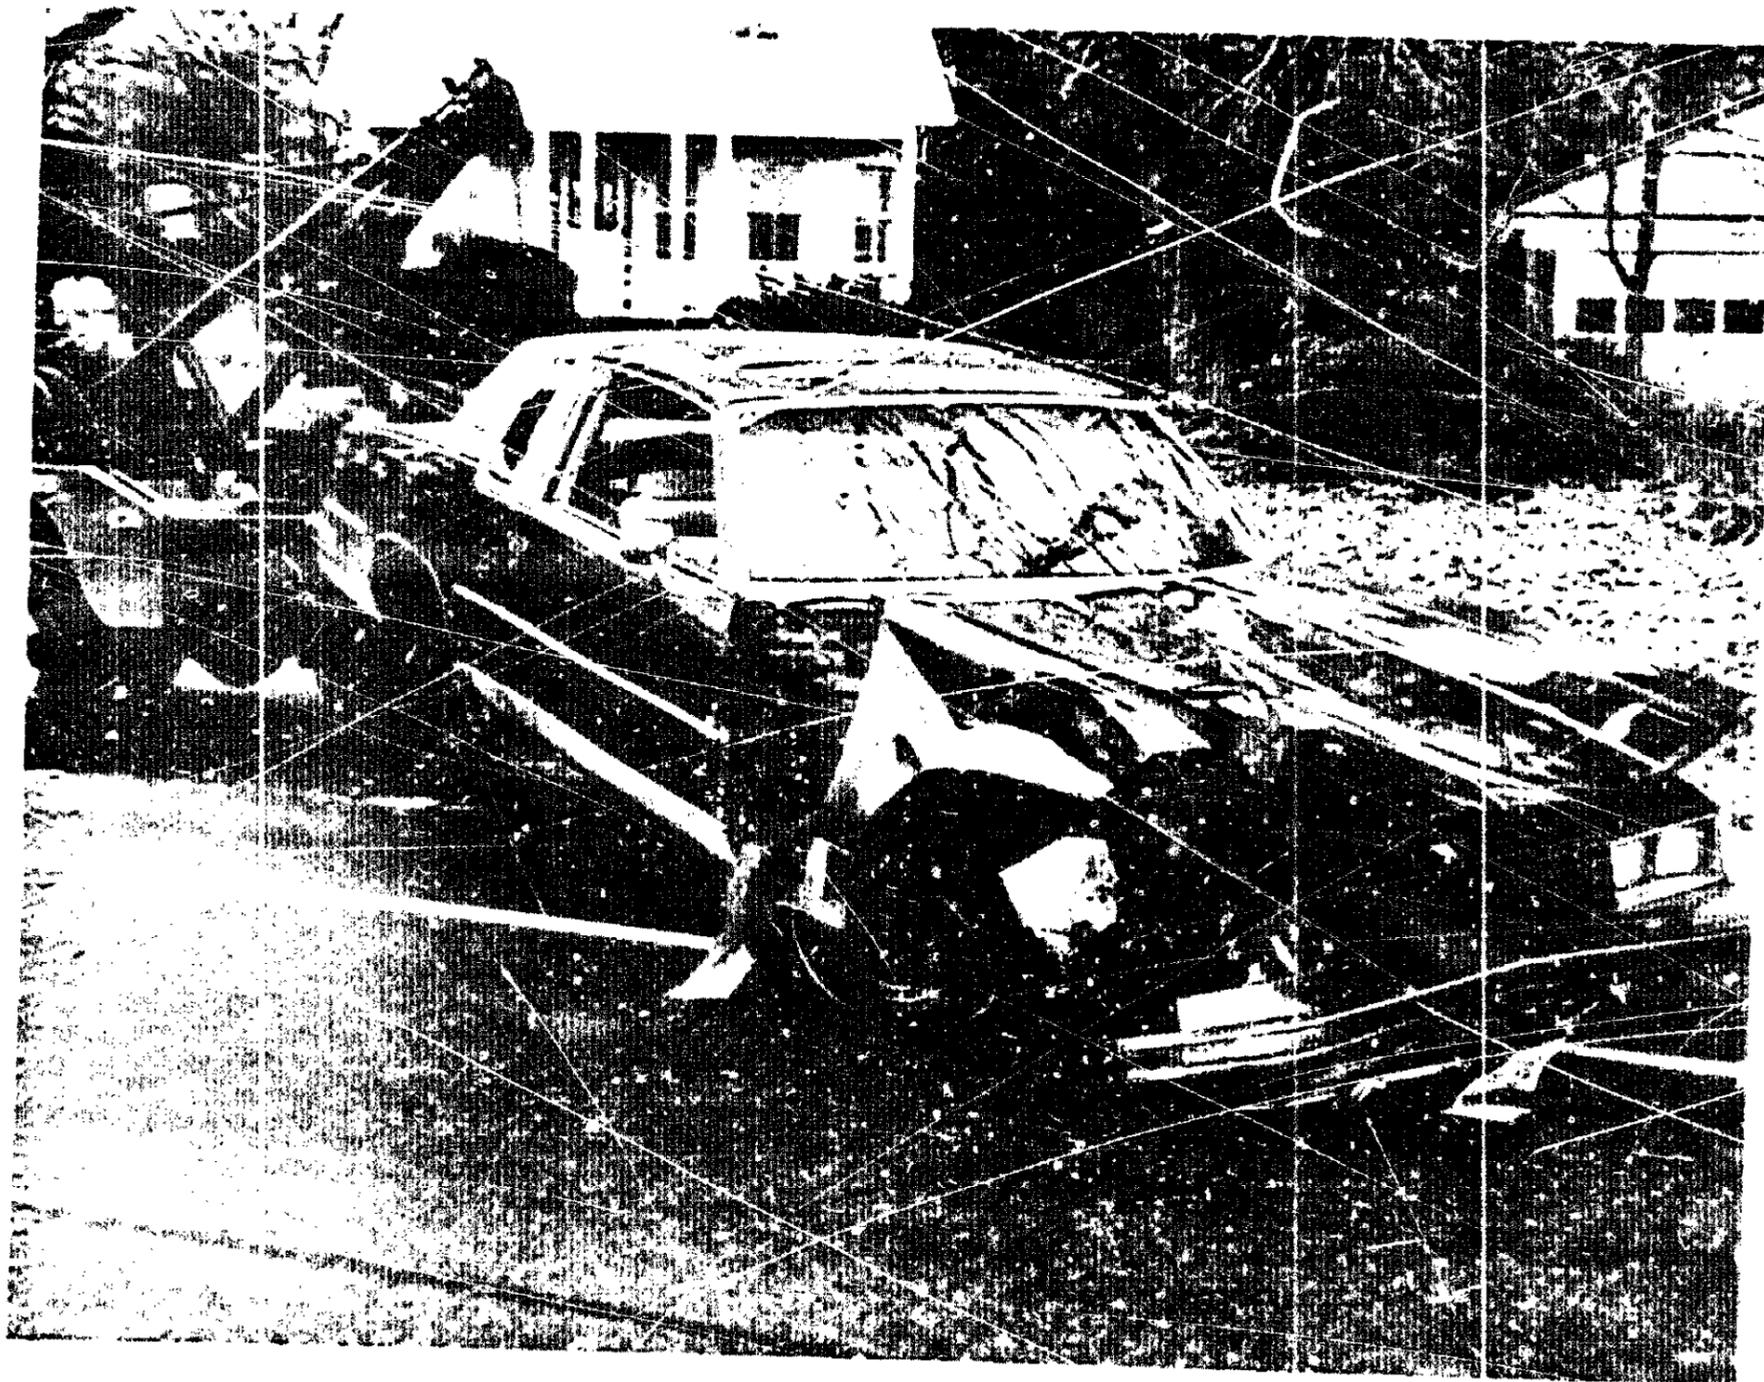
Passenger Car in Tow.—The brown 1981 Oldsmobile Cutlass was a 2-door sedan with a tan vinyl top. The right front fender suffered extensive damage. The right front tire was deflated, the bead flange of its rim was bent, and the outside sidewall and part of the tread were cut. A rectangular imprint on the right fender panel started 17 inches forward of the rear of the panel. The hood sustained minor collision damage to the right front corner, and the entire hood was displaced to the left at an angle of 26° from the car's longitudinal axis. (See figure 4.)

Figure 4.—Damage sustained by Oldsmobile in collision  
with tractor-semitrailer.  
(Photo courtesy of Massachusetts State Police)

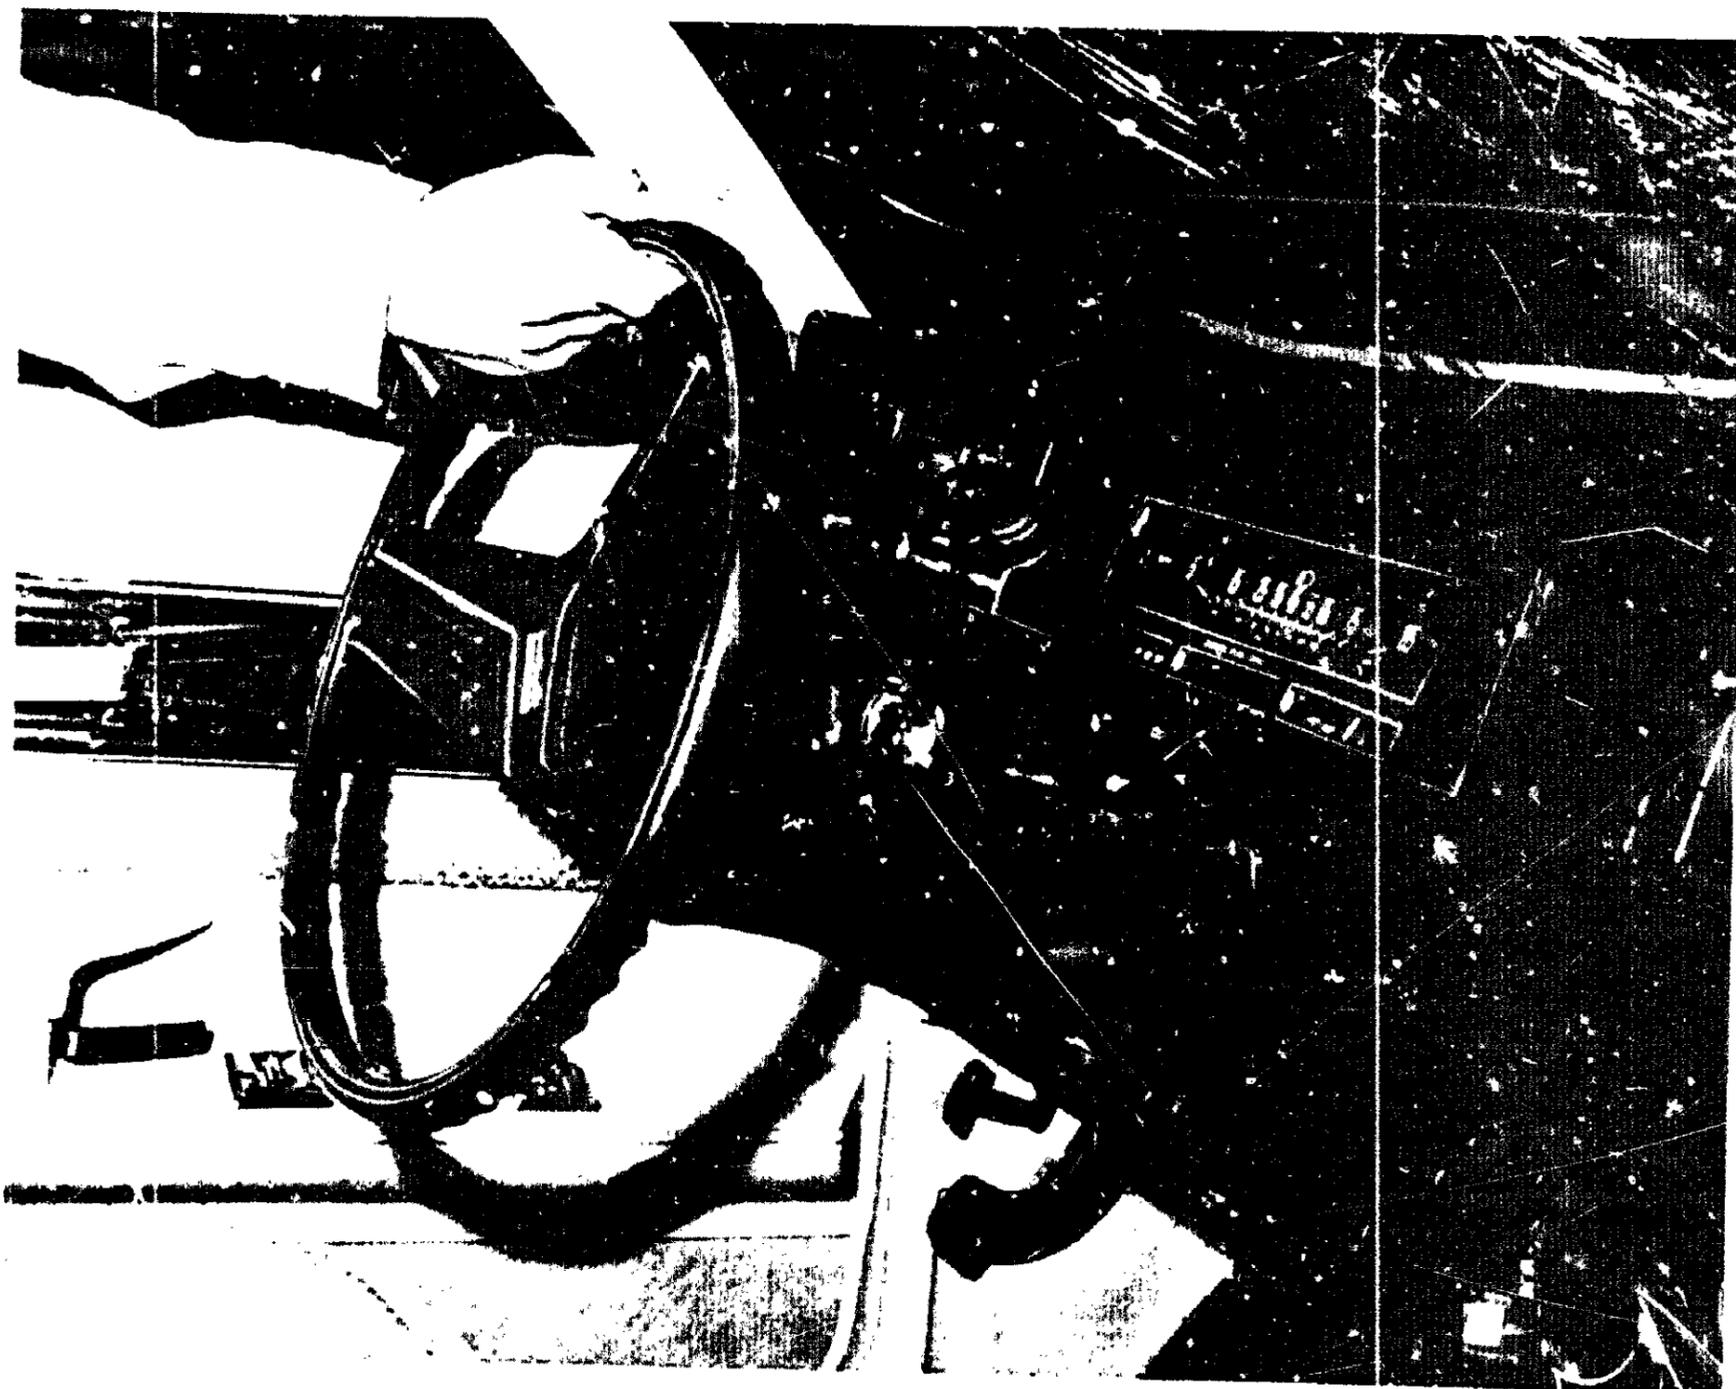
Figure 5.—View of undamaged right side of Oldsmobile's steering column and ignition switch.  
(Photo courtesy of Massachusetts State Police)

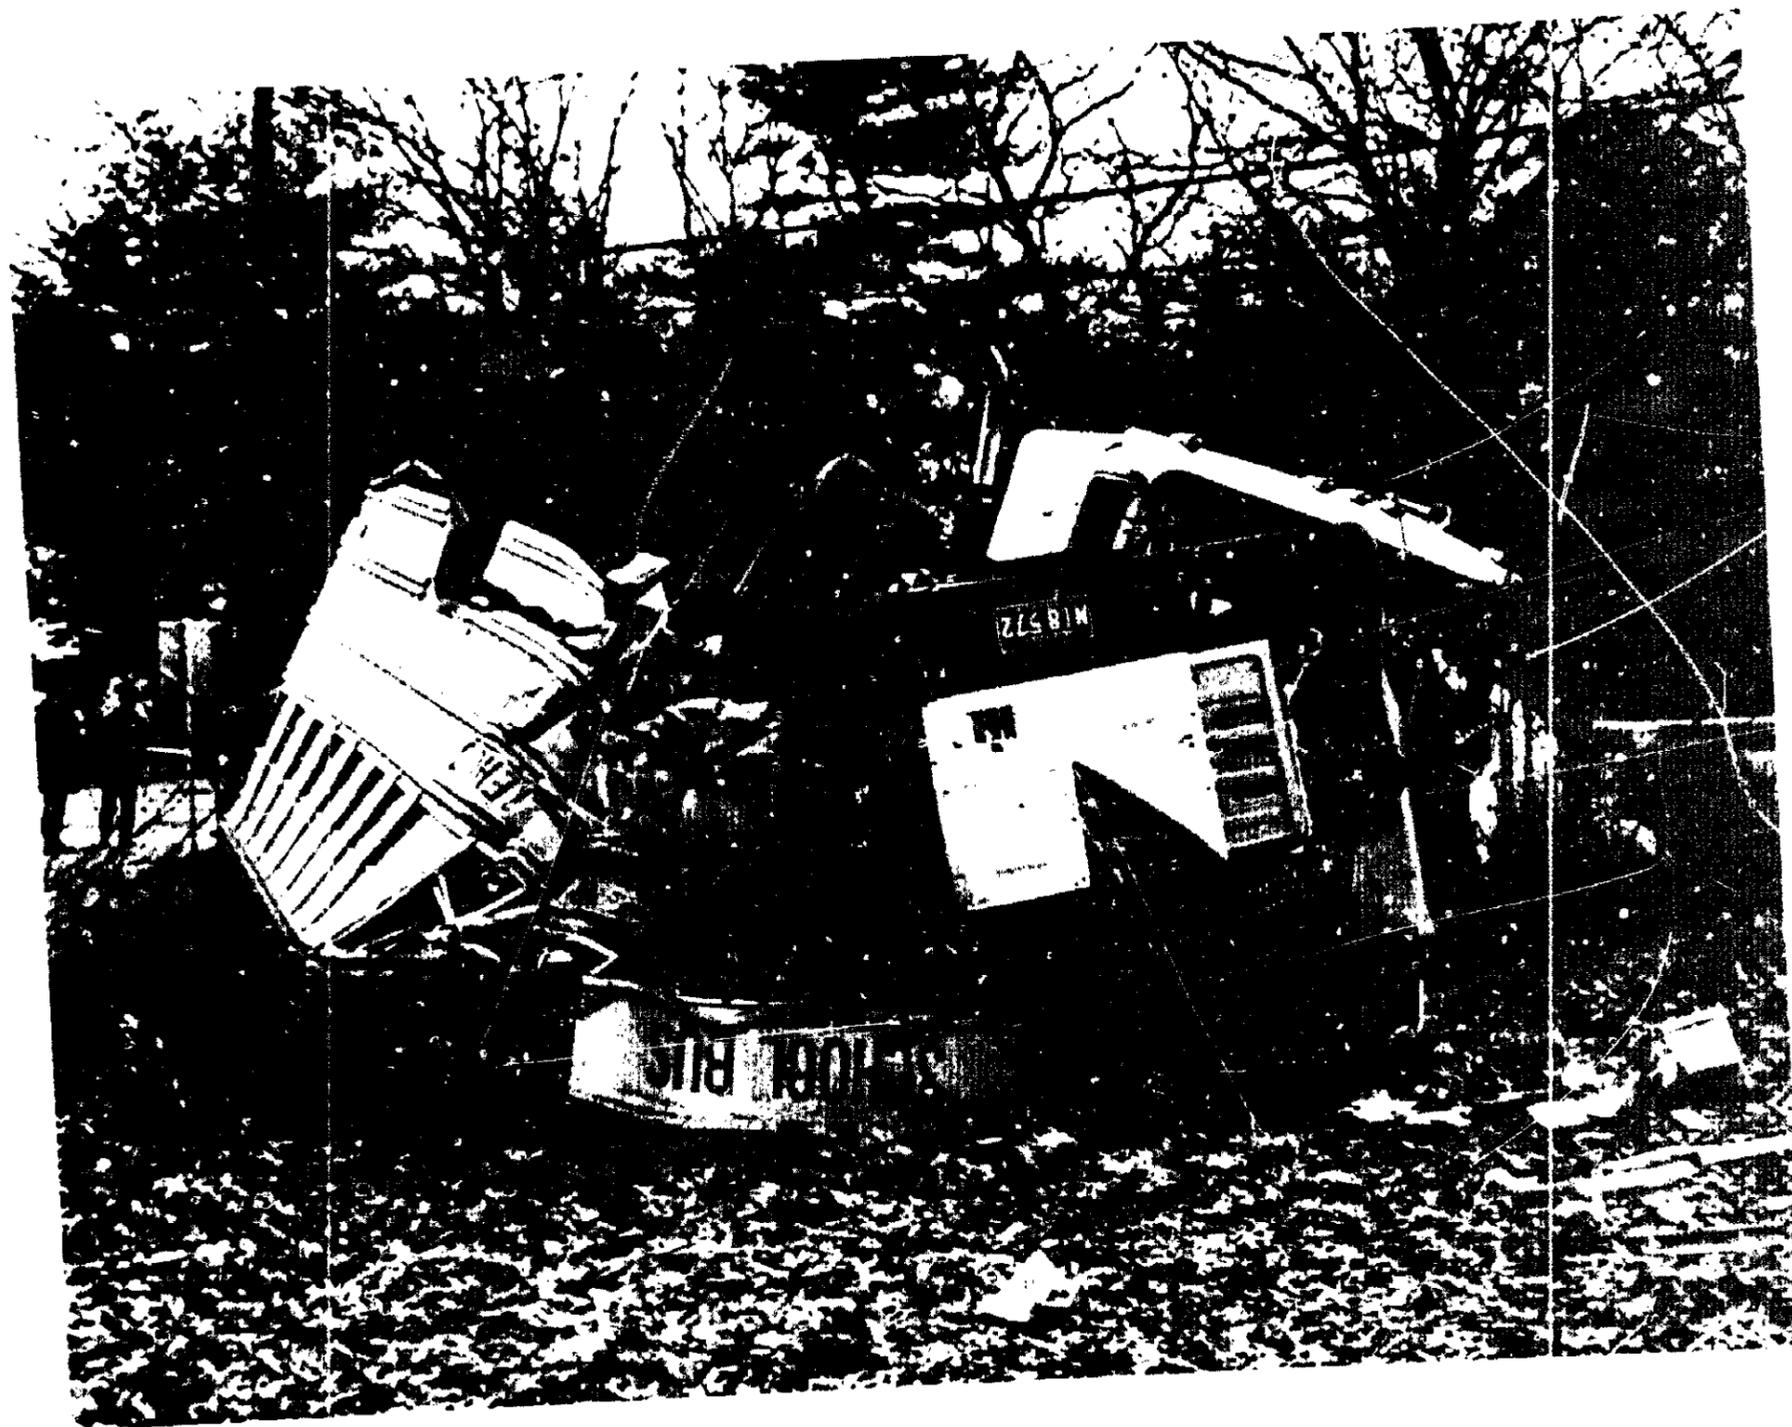
Two 22-gauge steel interior roof panels and two 20-gauge steel exterior roof panels extended the full length of the bus body. No separations were found in the roof panels, and no penetration was found in the passenger compartment from the roof. All roof fasteners were spaced on 1 1/2-inch centers. The maximum exterior roof panel deformation was 4 1/2 inches. At the rear of the bus, the undamaged floor to ceiling dimension was 72 1/2 inches; however, moving toward the front of the bus, this dimension decreased. Photographs taken at the scene showed that the front of the roof contacted the engine firewall when the bus overturned and came to rest on its roof. (See figure 6.)

The right and left front roof support pillars were displaced to the right and were broken away from the roof at the roof joint. The left front roof support pillar was displaced into the area normally occupied by the driver at an angle of approximately 45° to the longitudinal axis of the vehicle.

Figure 6.—View of schoolbus showing roof collapsed onto vehicle's firewall.  
(Photo courtesy of Massachusetts State Police)

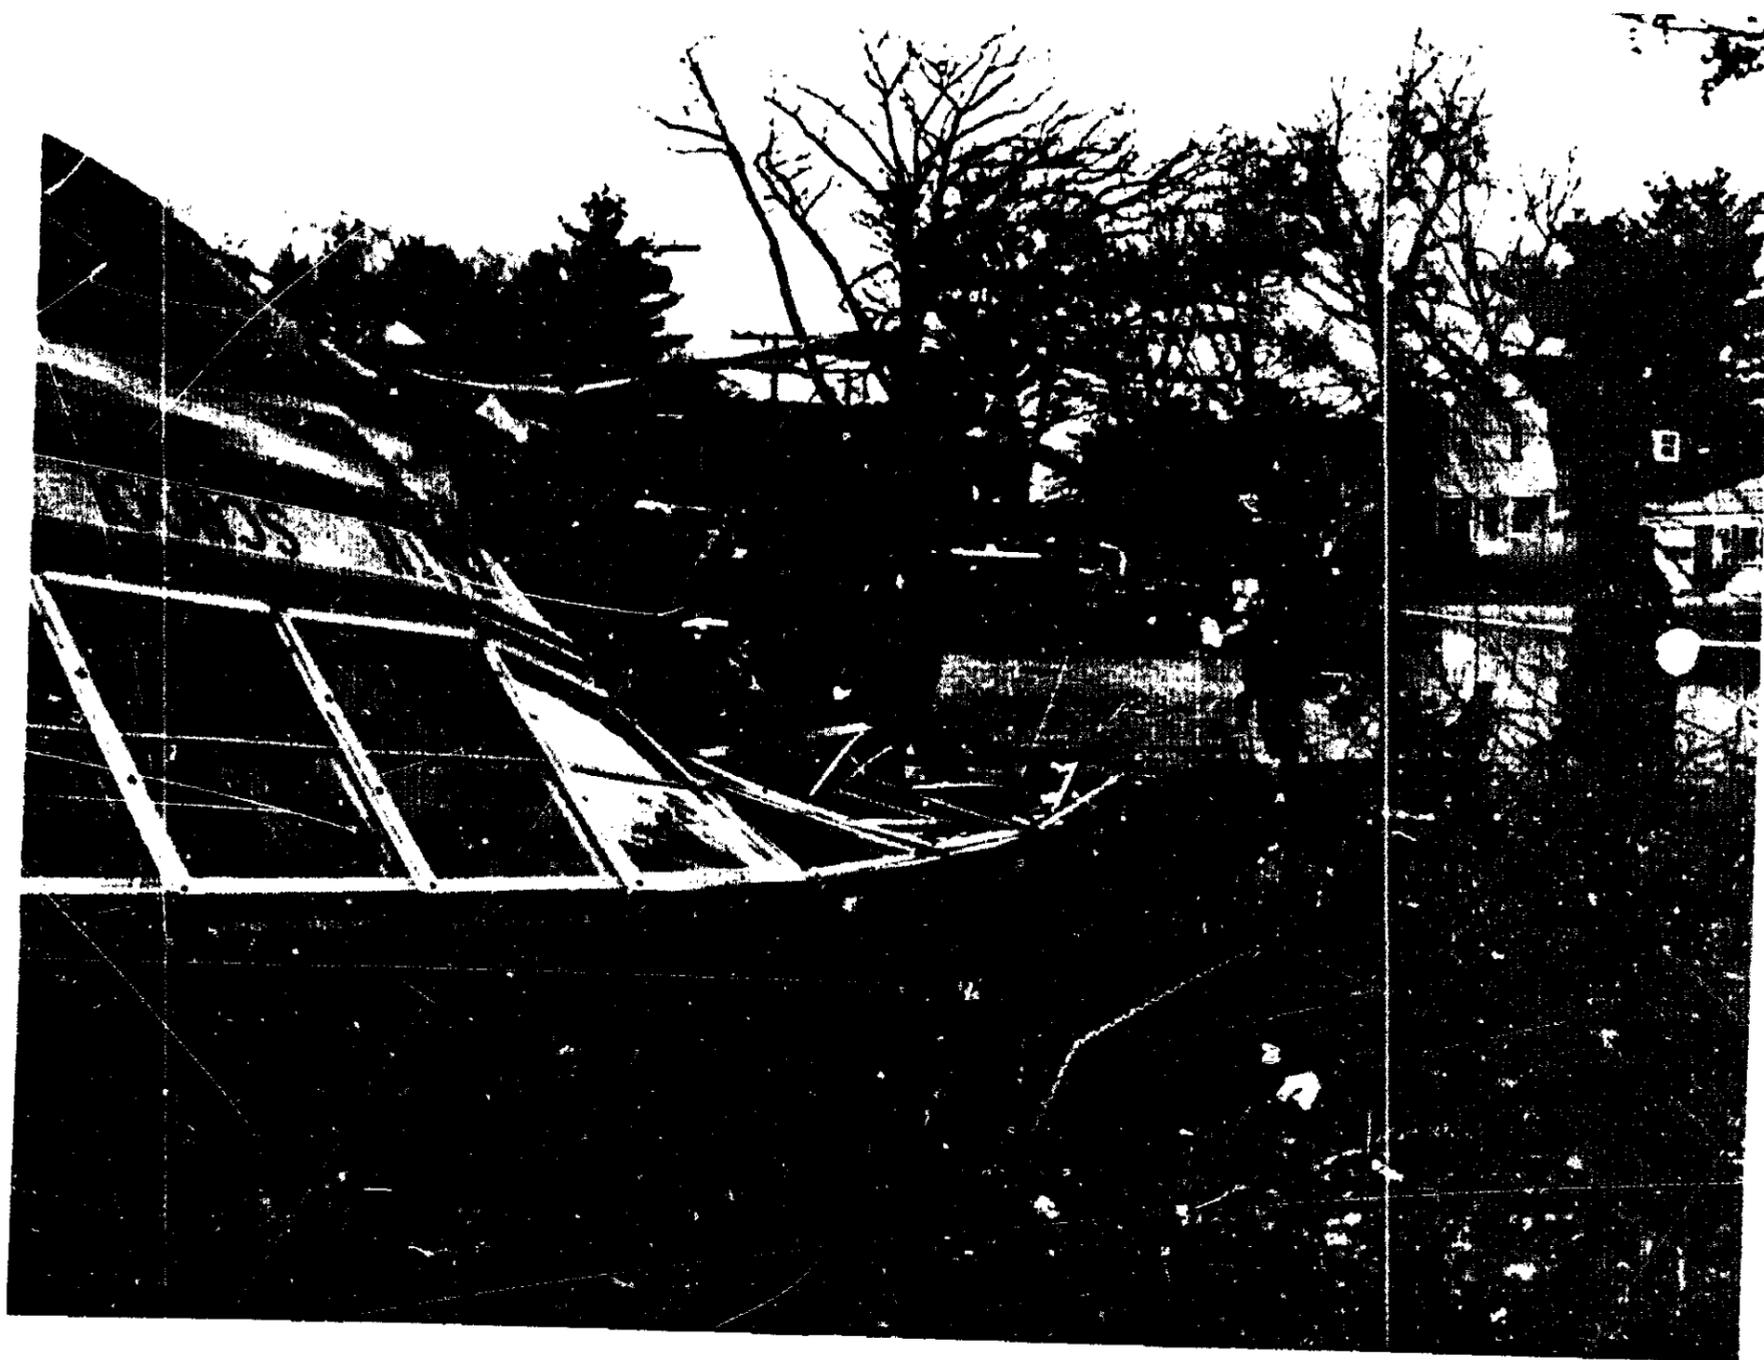
Extensive collision damage was found on the left side of the body starting immediately to the rear of the left front of the bumper and extending rearward for 16 feet. Maximum penetration into the sidewall of the schoolbus body was 18 inches at the rear of the barrier between the driver's seat and the first passenger seat on the left side. (See figure 7.)

Figure 7.—View of schoolbus in area of impact with tractor-semitrailer.  
(Photo courtesy of Massachusetts State Police)
