Highway Accident Report - Activity
Bus, Tractor-Cargo Tank Semitrailer
Collision, State Route 61 Near Devers
Texas, December 23, 1983

1. Report No. NTSB/HAR-84/06		2. Government Accession No. PB84-016206		3. Recipient's Catalog No.	
4. Title and Subtitle Highway Accident Report—Activity Bus/Tractor-Cargo Tank Semitrailer Collision on State Route 61, Near Devers, Texas, December 23, 1983.				5. Report Date September 5, 1984

ACTIVITY BUS/TRACTOR CARGO TANK SEMITRAILER COLLISION
ON STATE ROUTE 61 NEAR DEVERS, TEXAS,
DECEMBER 23, 1983

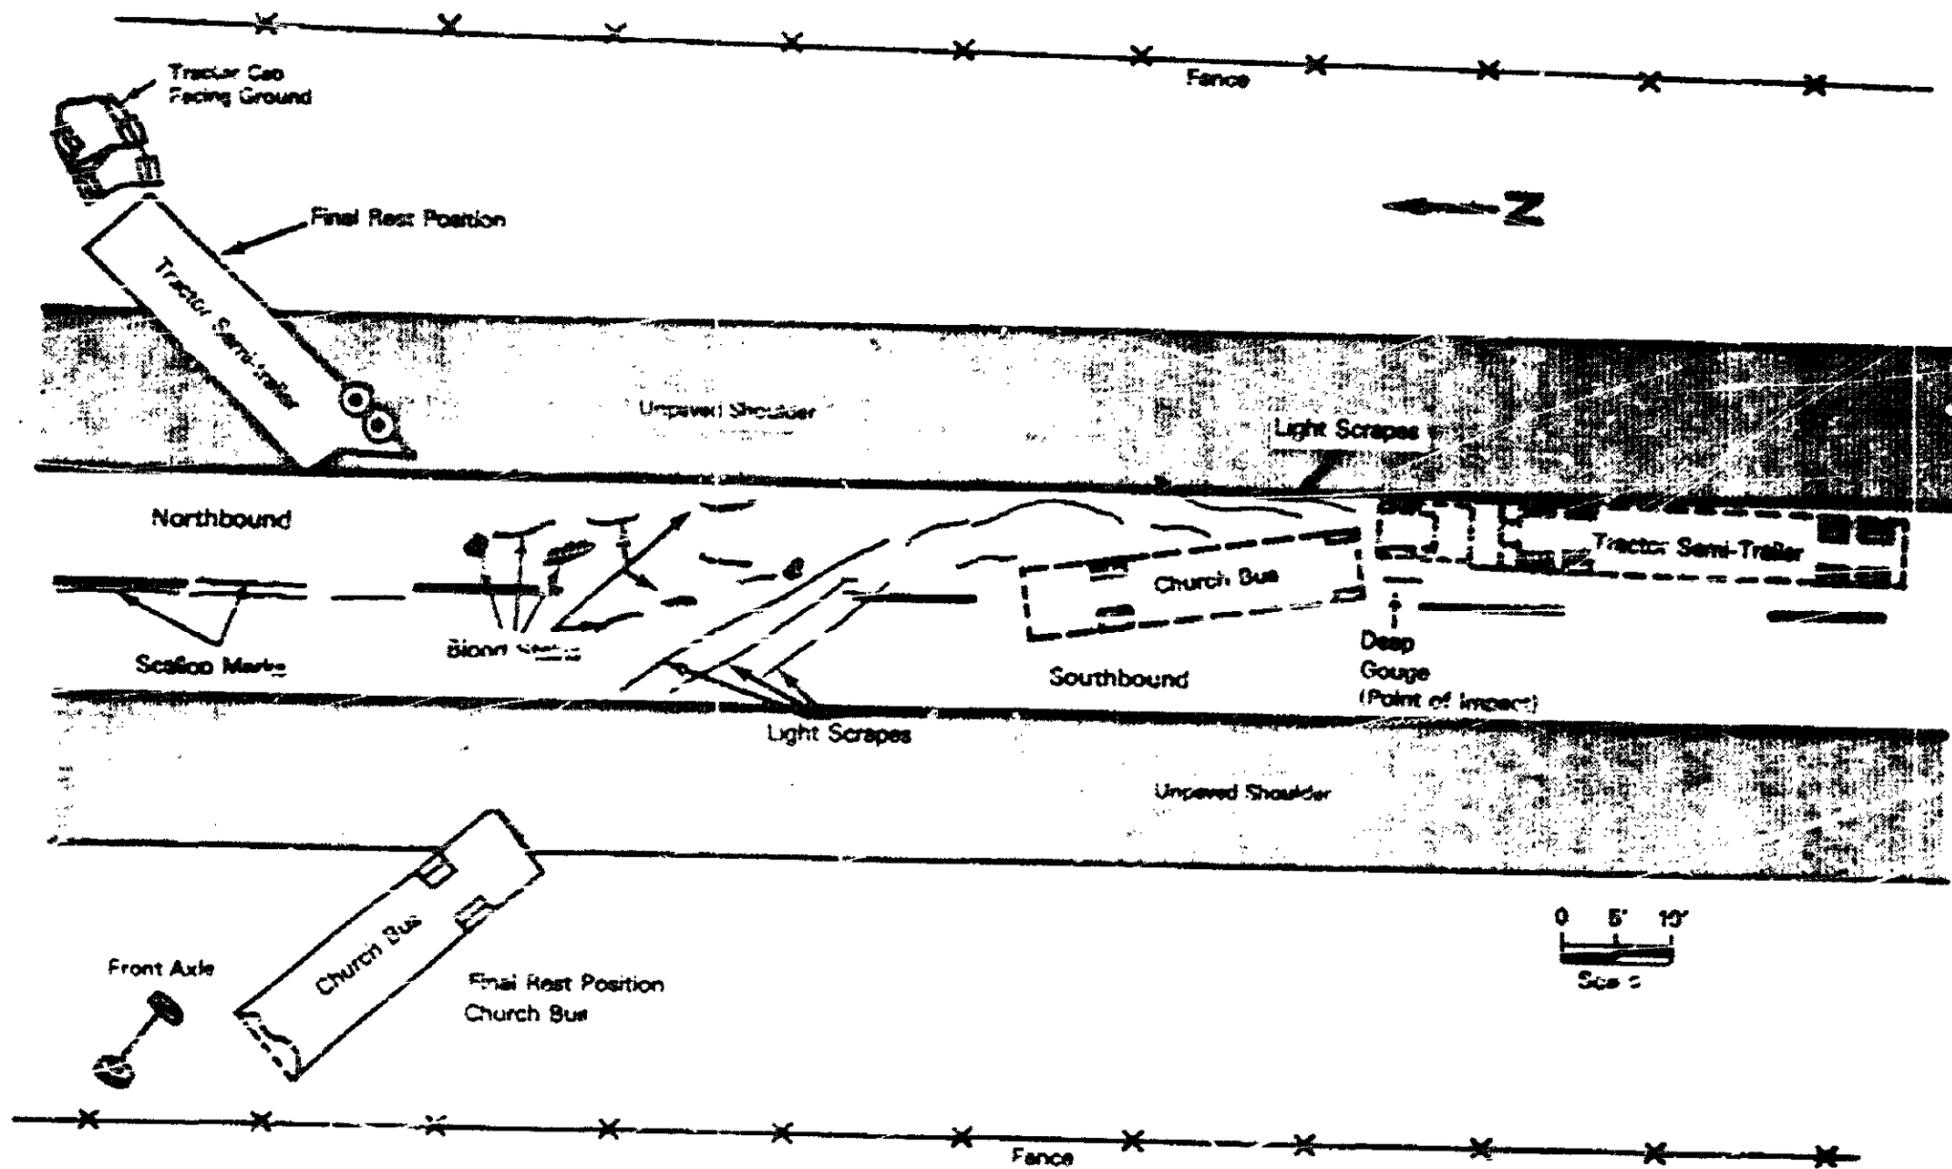
Figure 1.--Plan view of accident site (State Route 61).

At impact, the 19,175-pound bus ceased all forward motion and rotated to the left as it was pushed backward. The tractor of the 72,000-pound combination vehicle intruded into the passenger compartment. The frontal sheet metal structure of the bus was ripped open during the impact, and all of the 22 occupants were ejected through the large opening. (See figure 1.)

A gouge (1.5 inches deep by 3 feet long) was observed in the pavement surface of the northbound lane. (See figure 1.) Light scrape marks in the northbound lane extended from the gouge and across the southbound lane. Blood transfers also were noted on the pavement surface extending north toward the rest positions of the accident vehicles. Light tire scallop marks were observed near the road centerline which began about 1,252 feet from impact and ended about 102 feet from impact. The marks started in the northbound lane and extended about 350 feet, crossed over into the southbound lane, and continued for another 800 feet. The light scallop marks made a cyclic pattern that was repeated approximately every 9.34 feet, and the marks were about 7 inches apart. (See figure 7.)

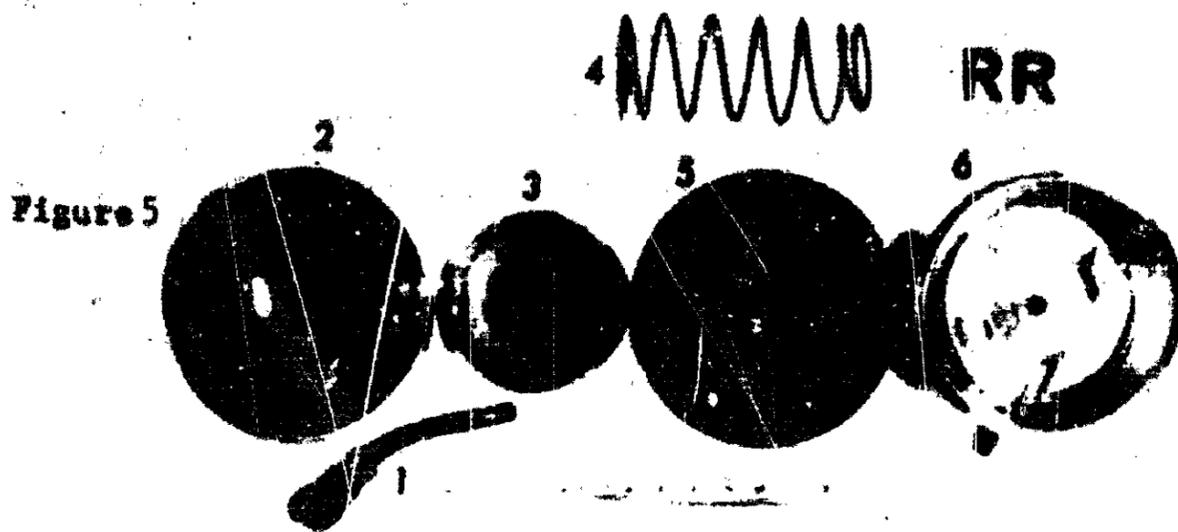
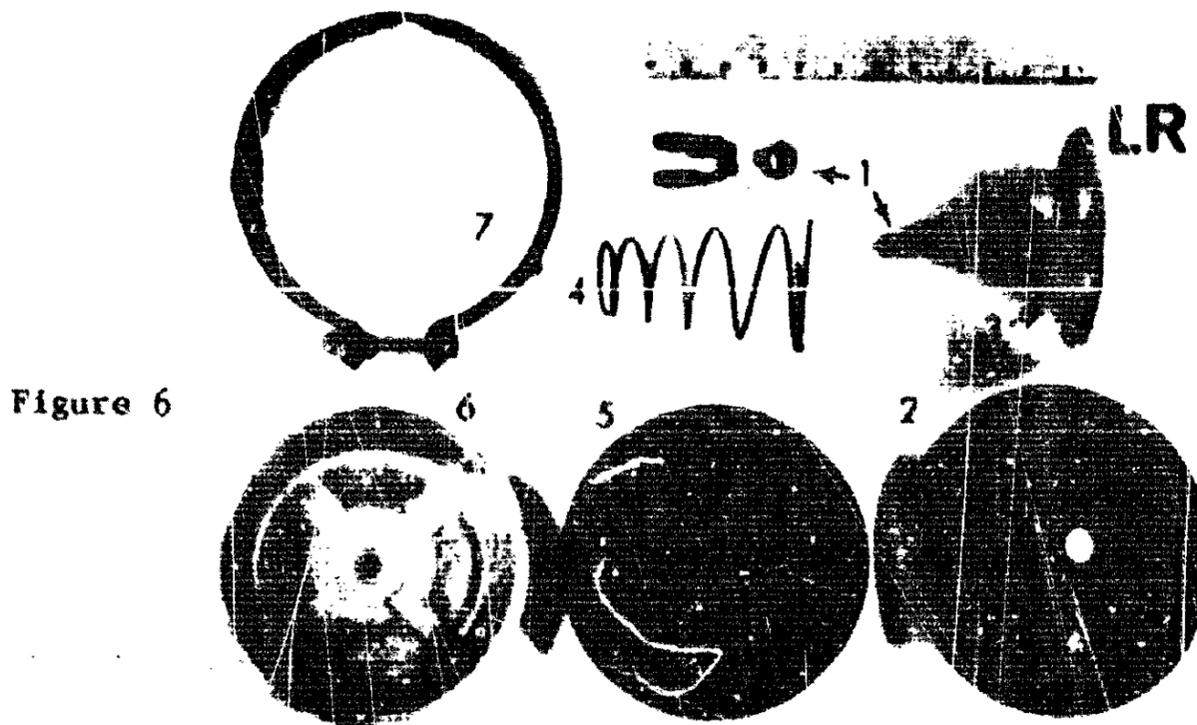
Several preexisting brake discrepancies were observed. The right front brake actuator was partially inoperative. The push rod for the brake actuator was bent about 15° and exhibited moderate cyclic scoring. The slight elongation of the push rod clearance hole at the brake actuator housing was consistent with the wear caused by sliding contact with the bent push rod over an extended period of time. (See figure 5.)

The right rear brake actuator also was partially inoperative. The brake actuator push rod had fractured and separated from its backing plate. A metallurgical examination indicated that the fractured halves were heavily damaged, corroded, and had failed due to overload. This condition existed before the accident and would have reduced the braking force generated by the actuator when the brakes are applied. (See figure 6.)

Figure 5 and 6.--Exploded views of the right rear (top) and left rear (bottom) brake actuators with components numbered (1) push rod assembly, (2) push rod housing, (3) backing plate, (4) springs, (5) flexible diaphragm, (6) pressure housing, and (7) assembly clamp.

The Safety Board encourages all activity groups to establish preventive maintenance programs for their privately owned vehicles to insure that the vehicles' brakes and tires are inspected properly and are maintained in good condition.

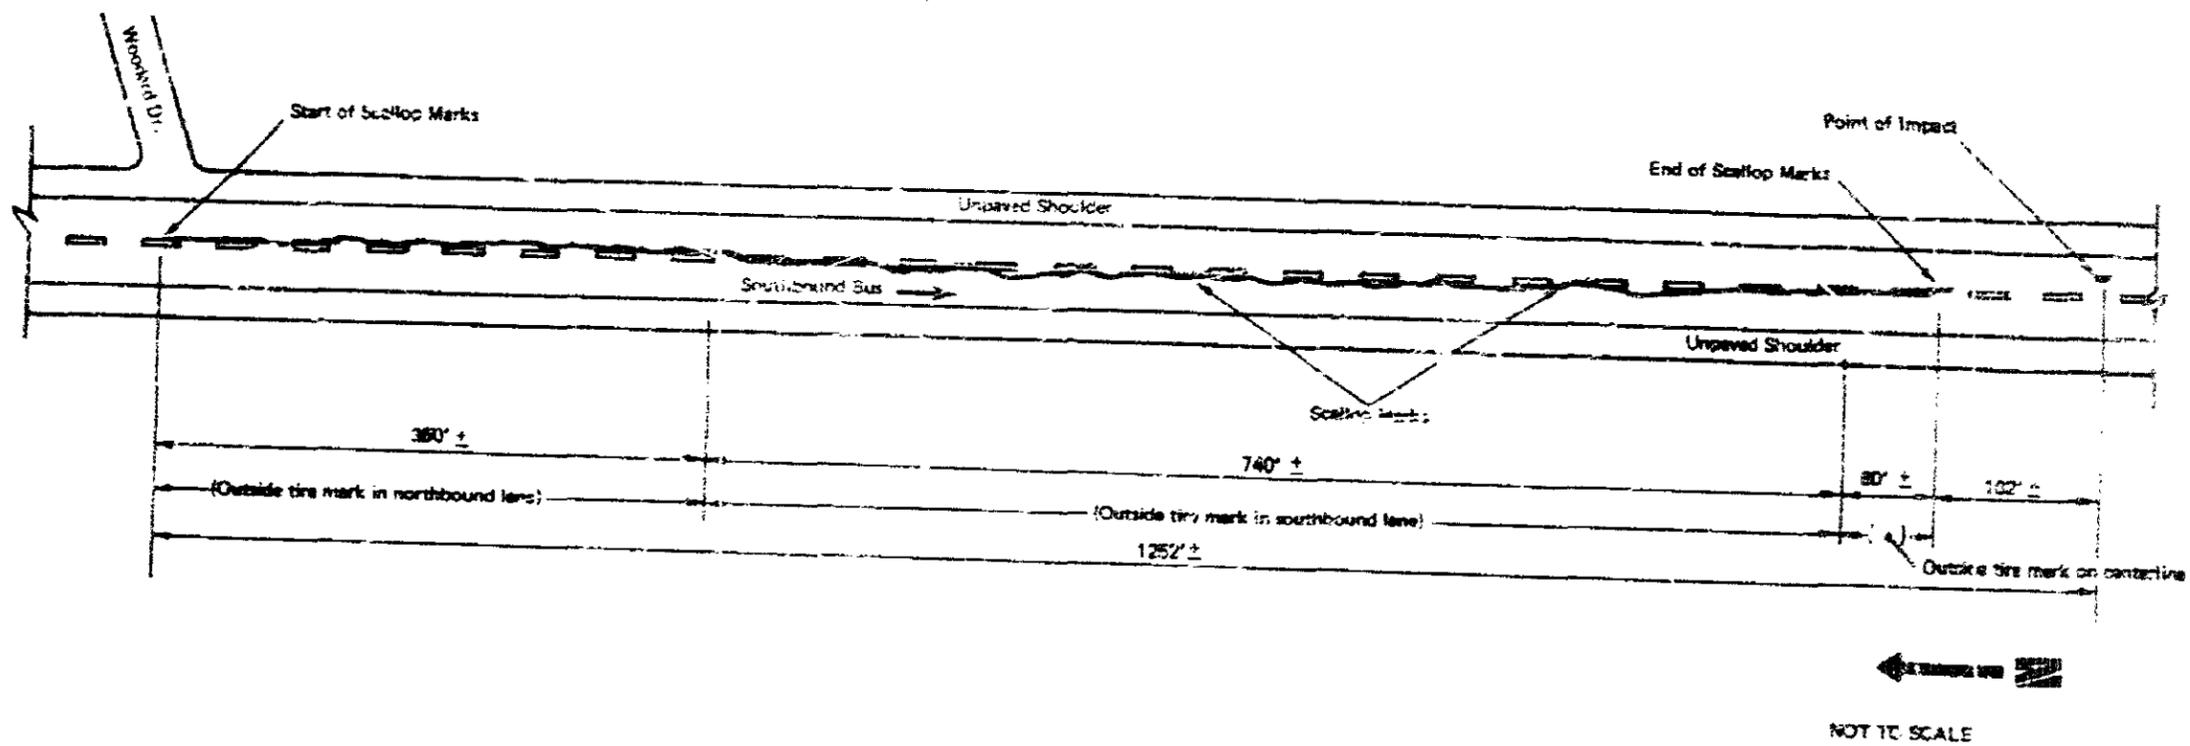
Figure 7.--Plan view of the tire scallop marks in the southbound lane.

The deflated left front tire began marking the pavement with light scallop marks about 1,252 feet from impact. The scallop marks made a repeating cyclic pattern on the pavement about every 9.34 feet which was slightly less than the circumference (9.68 feet) of the failed left front tire. The scallop marks were about 7 inches wide and matched the tread width of the left front tire within 1/2 inch. The scallop marks in the southbound lane were almost parallel to the road centerline for 800 feet.

5. The deflated left front tire began marking the pavement with light scallop marks which closely matched the circumference and width of the failed tire.

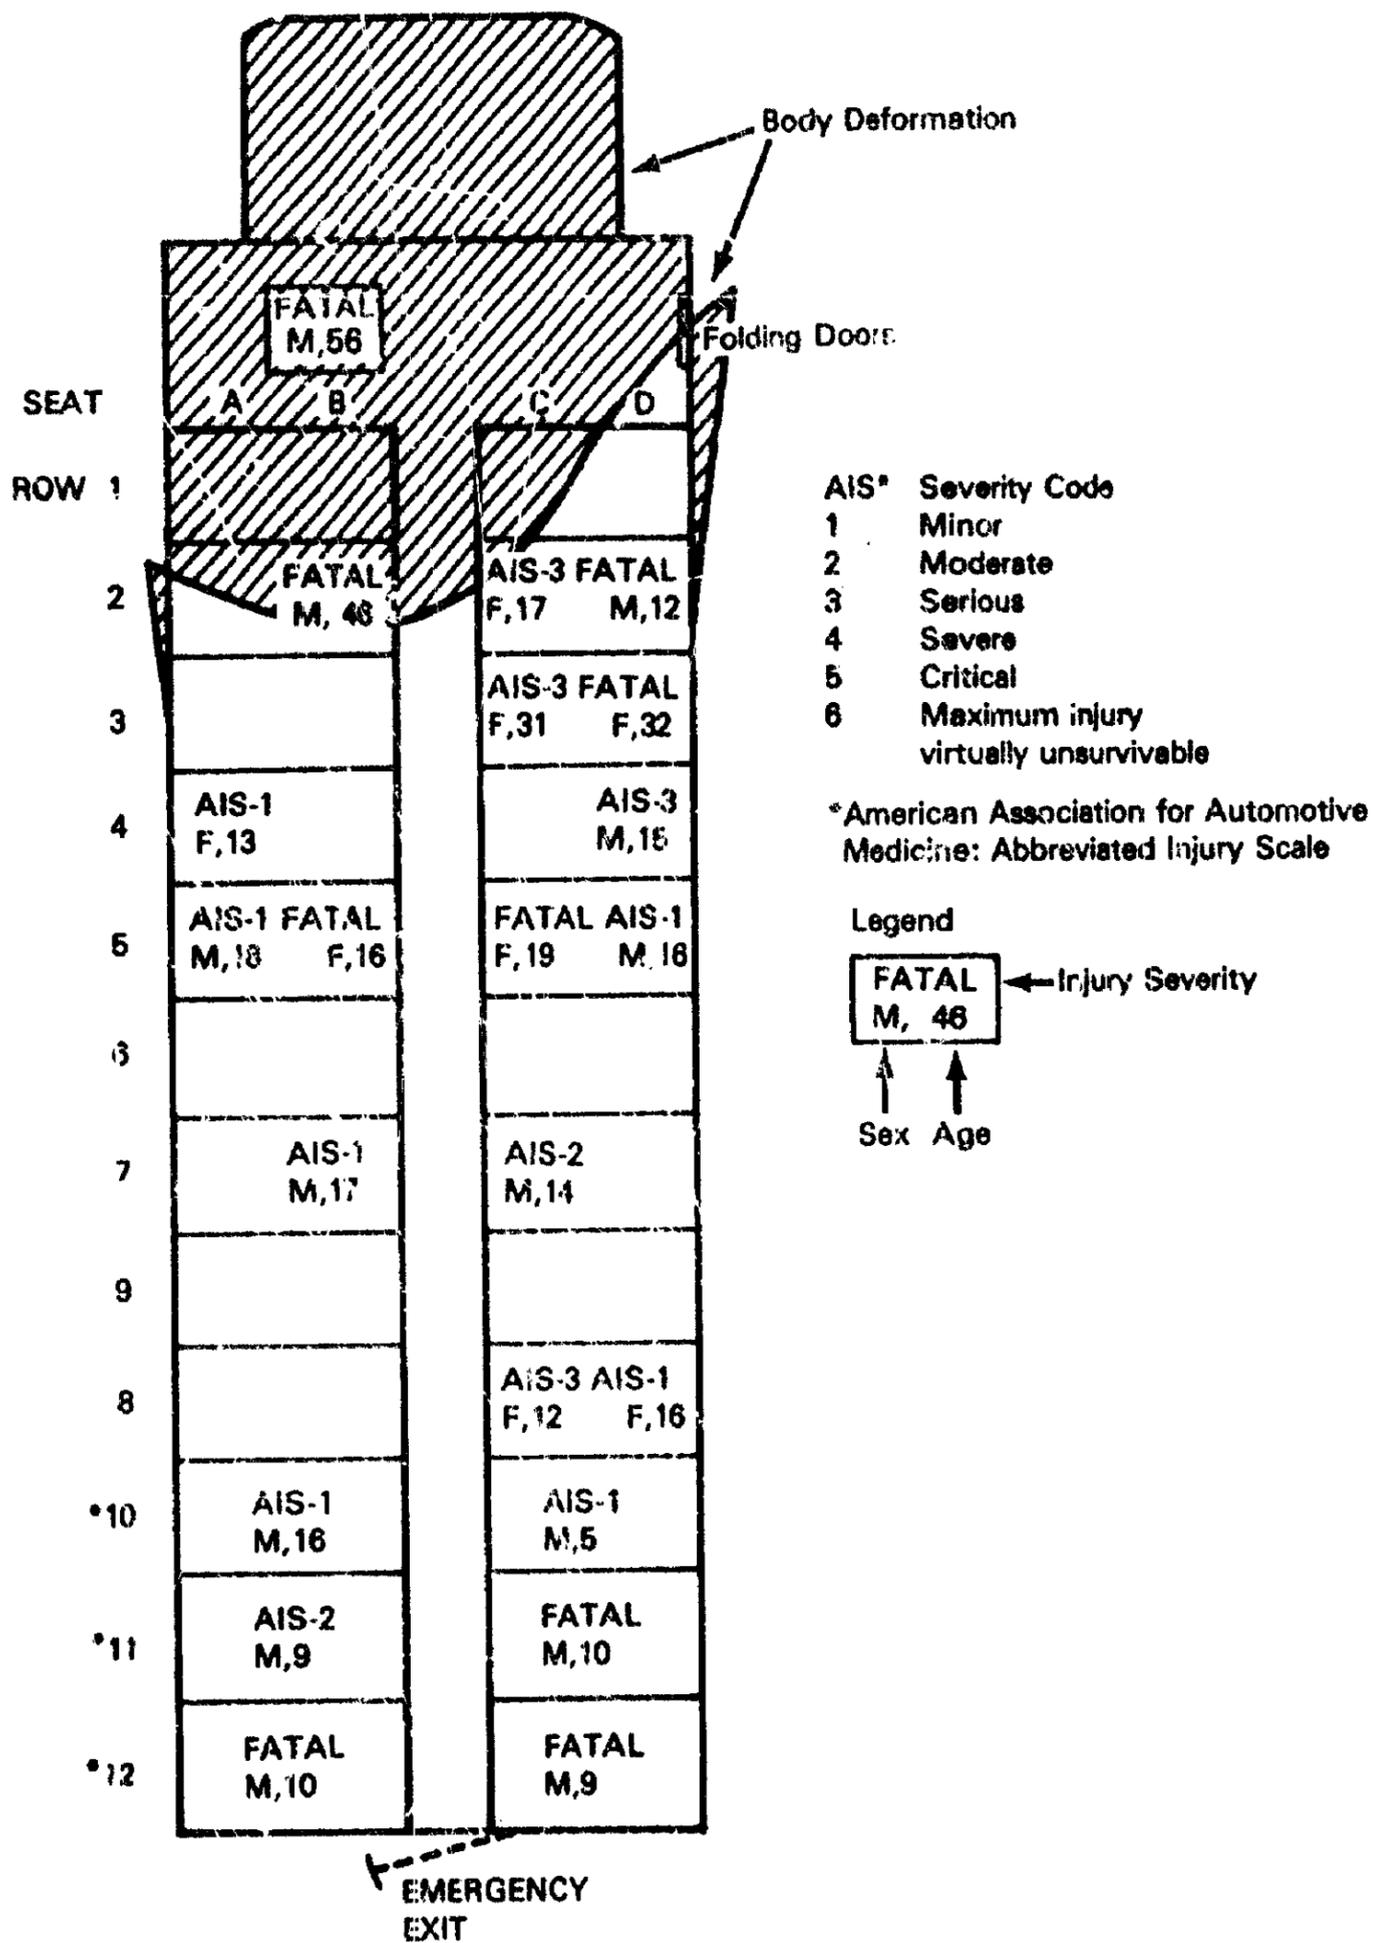
Figure 8.--Activity Bus Seating Chart Noting Occupant Age, Sex, and Injury Severity.

The driver and all 21 passengers were ejected from the bus. Their ages ranged from 5 years old to 56 years old. Figure 8 contains the reported seating position, age, sex, and injury severity of the bus occupants; appendix D describes the bus passenger injuries by abbreviated injury scale severity and seating location. The truckdriver was the only occupant in the combination vehicle, and he was killed in the collision.

Six of the nine fatally injured bus occupants had been seated in the first five rows at the front of the bus where major seat damage was noted. The remaining three fatally injured bus occupants had been located in the last two rows of seats where no seat damage was observed. Seven of the 13 surviving passengers had been seated behind row 6, where minimum seat damage was noted. Four of the seven passengers sustained minor injuries, two sustained moderate injuries, and one sustained serious injuries.
