NATIONAL TRANSPORTATION SAFETY BOARD

HIGHWAY ACCIDENT REPORT

COLLISION OF
DEQUEEN, ARKANSAS
POLICE DEPARTMENT PATROL CAR
AND TERRELL TRUCKING, INC.
TRACTOR-SEMITRAILER
U.S. ROUTE 71
ASHDOWN, ARKANSAS
JULY 5, 1984

HTSB/HAR 84/07

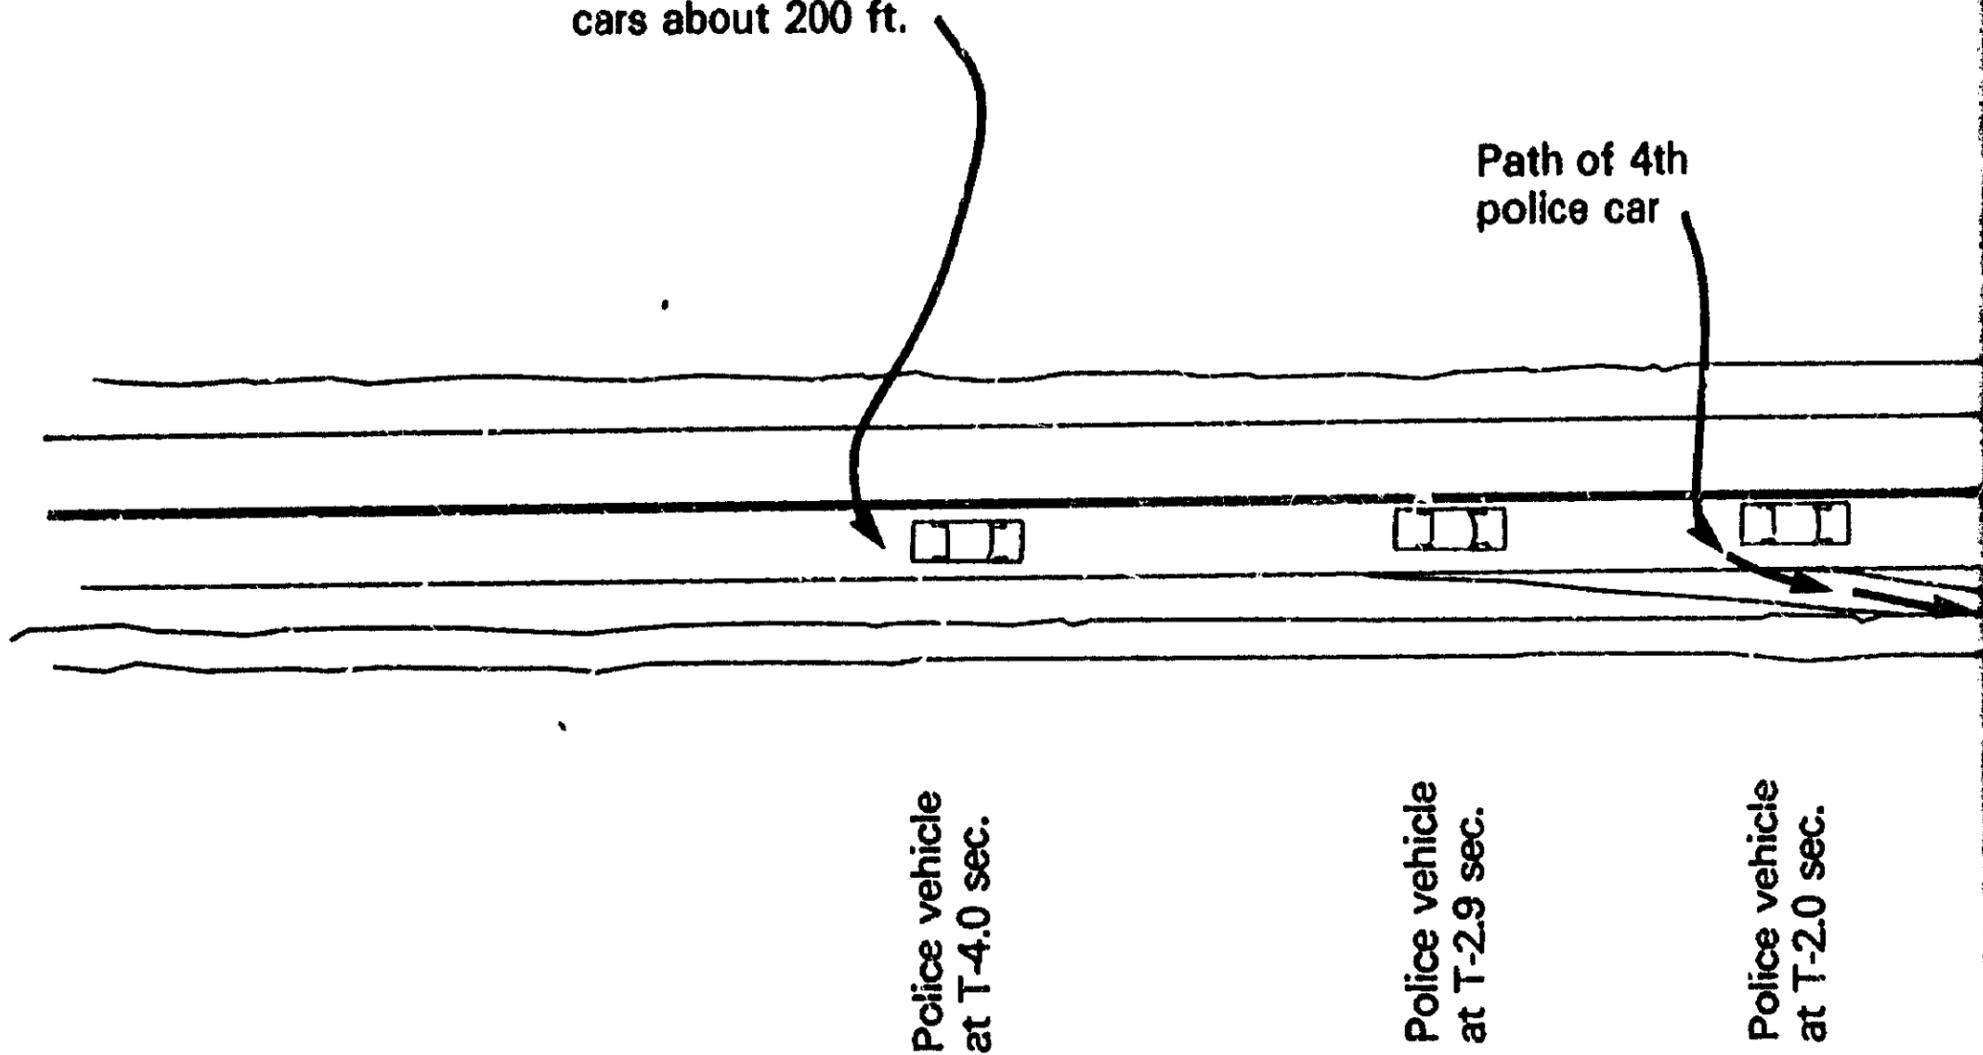
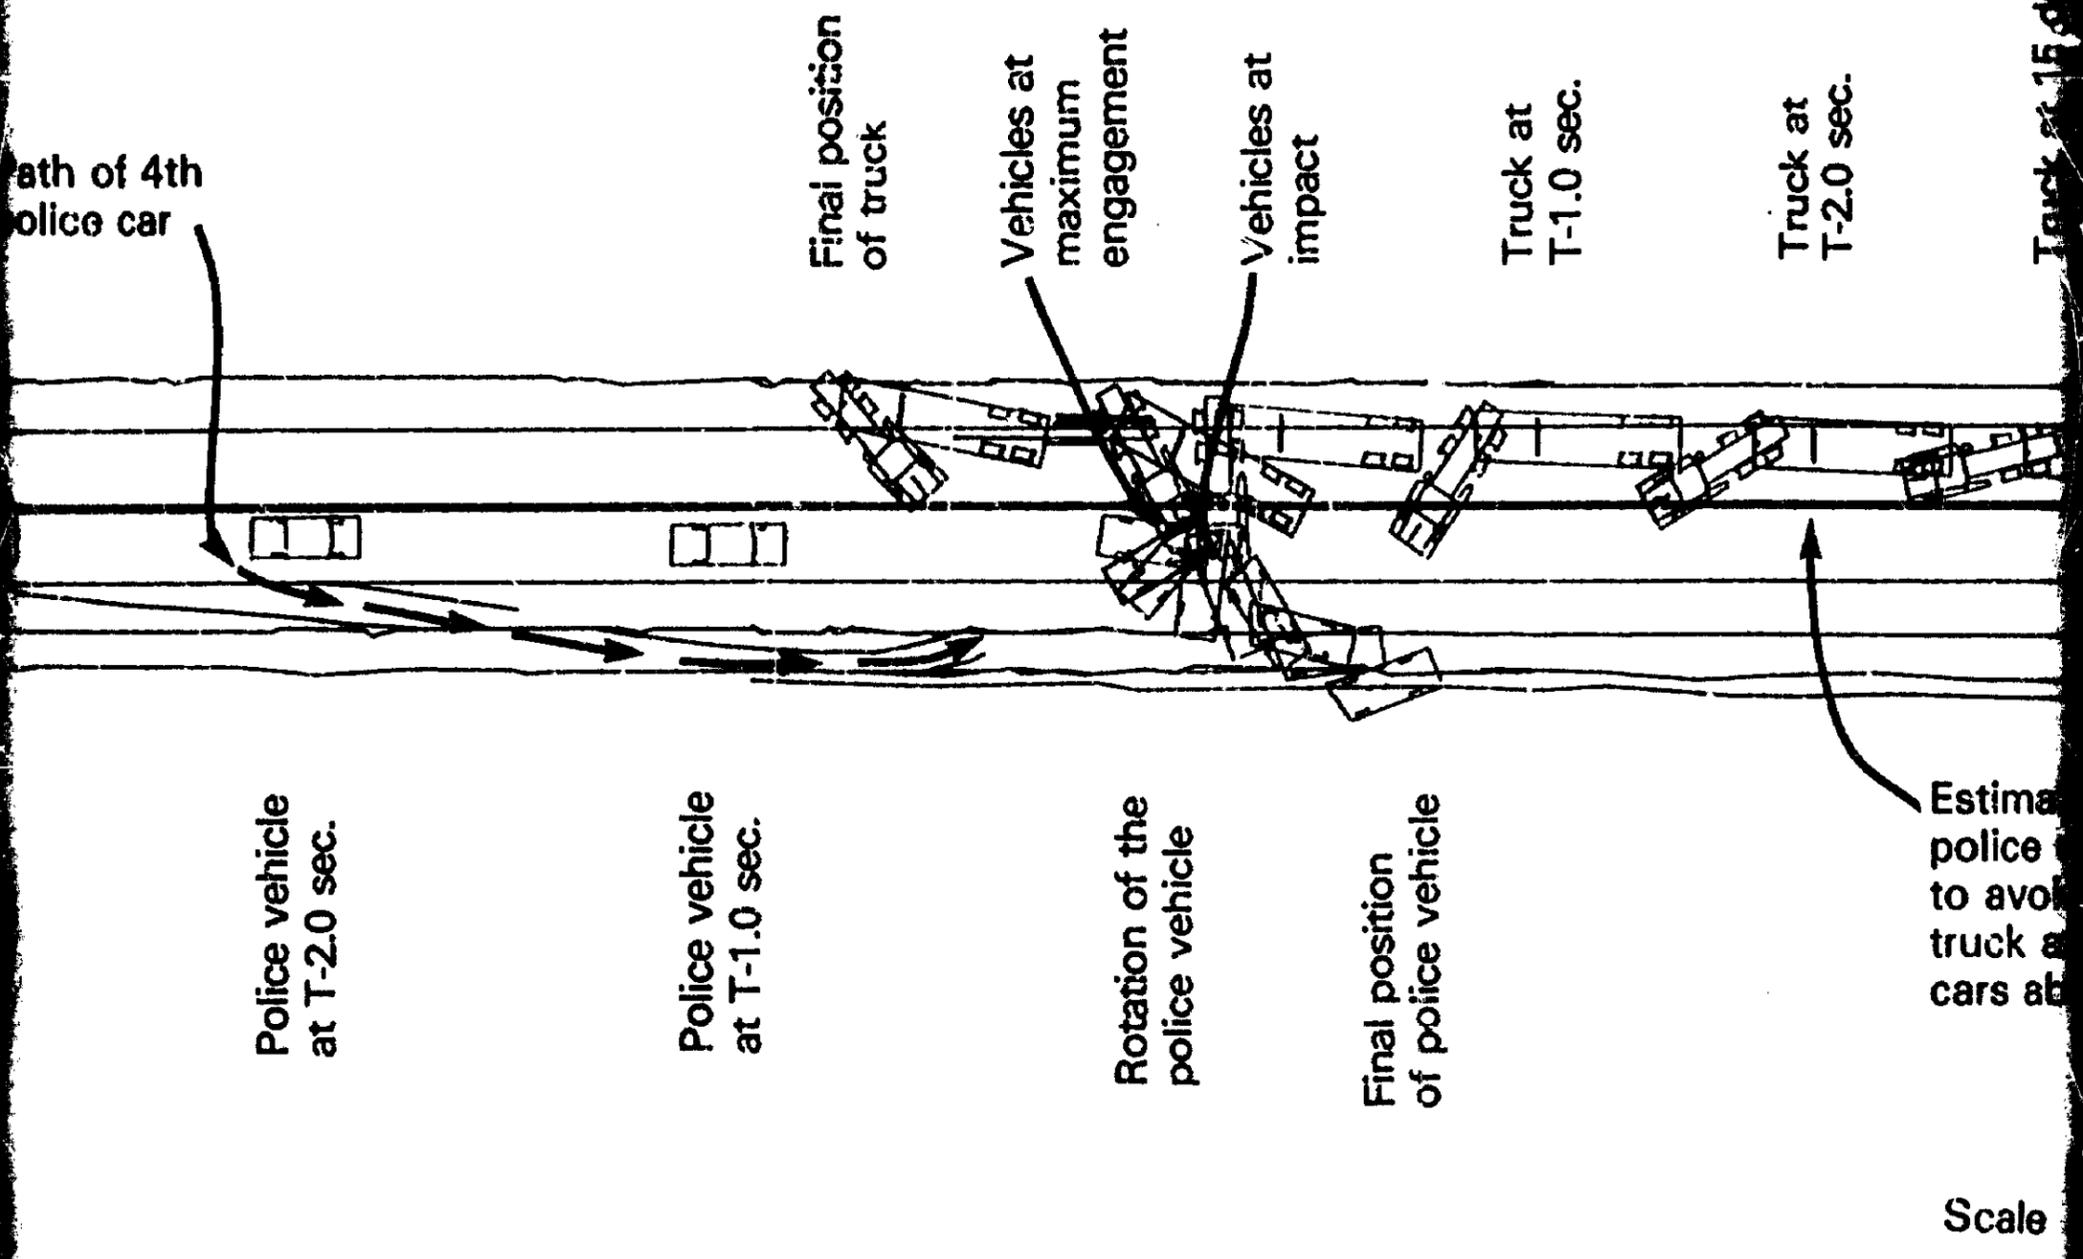
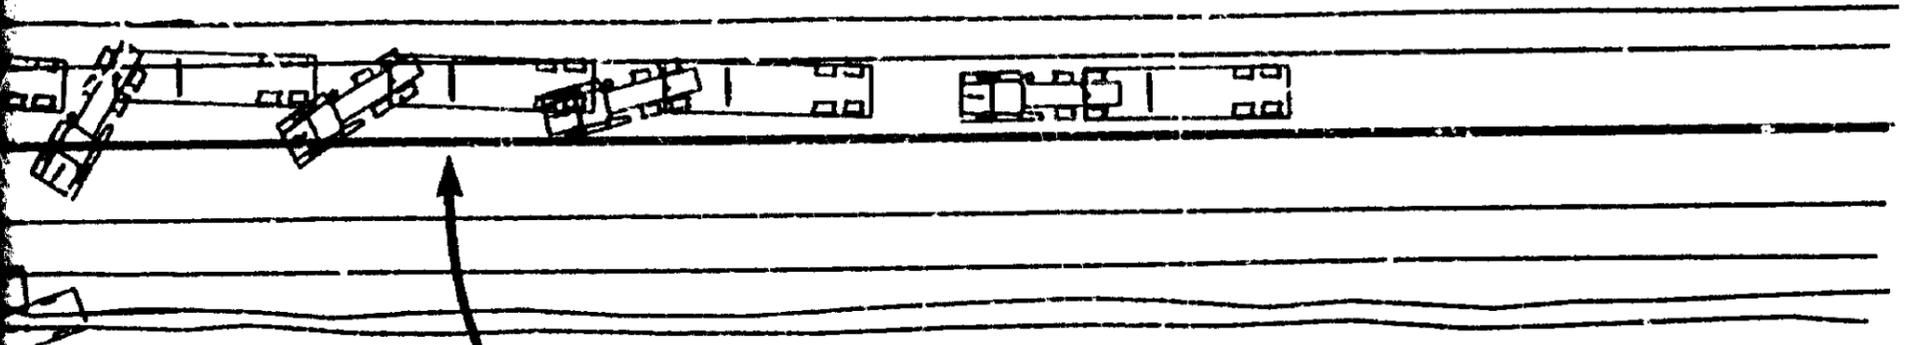
5. - Relative positions of the vehicles during the accident

In avoiding involvement in the accident, the police car immediately behind the patrol car struck by the truck turned abruptly, leaving a tire mark on the shoulder similar to that made by a vehicle braking on wet pavement and left a path through the grass beside the highway. Projecting the path of the following police car back to the center of the lane at the point its driver made an initial brake application, it was calculated that the following police car was traveling about 45 mph when its driver first realized that a hazard was ahead and began taking evasive action. The calculations indicate that there was a 200- to 250-foot headway between the patrol car struck by the truck and the following police car. The speed of the patrol car struck by the truck was established as about 45 mph since the police cars had been traveling together for an extended time. (See figure 5.)

Estimated position of 4th
police car in caravan when driver
reacted to rotating truck and applied
brakes at T-1.0 sec. Headway between
cars about 200 ft.

Initial speed of truck = 40 mph
Initial speed of car = 45 mph

Truck at
T-1.0 sec.

Truck at 15 degrees
and beginning to
slide. T-2.9 sec.

Truck at full
brake application.
Time = -4.0 sec.

Final position
of police vehicle

Estimated position of 2nd
police car in caravan in order
to avoid being struck by rotating
truck at T-2.0 sec. Headway between
cars about 225 ft.
