HIGHWAY ACCIDENT REPORT - COLLISION OF ISLE OF WIGHT COUNTY,  
VIRGINIA SCHOOLBUS WITH CHESAPEAKE AND OHIO RAILWAY COMPANY  
FREIGHT TRAIN, STATE ROUTE 615, NEAR CARRSVILLE, VIRGINIA,  
APRIL 12, 1984

National Transportation Safety Board  
Washington, DC

Jan 85

1. Report No. NTSB/HAR-85/02	2. Government Accession No. PB85-916202	3. Recipient's Catalog No.	
4. Title and Subtitle Highway Accident Report— Collision of Isle of Wight County, Virginia, Schoolbus with Chesapeake and Ohio Railway Company Freight Train, State Route 615, Near Carrsville, Virginia, April 12, 1984		5. Report Date January 25, 1985

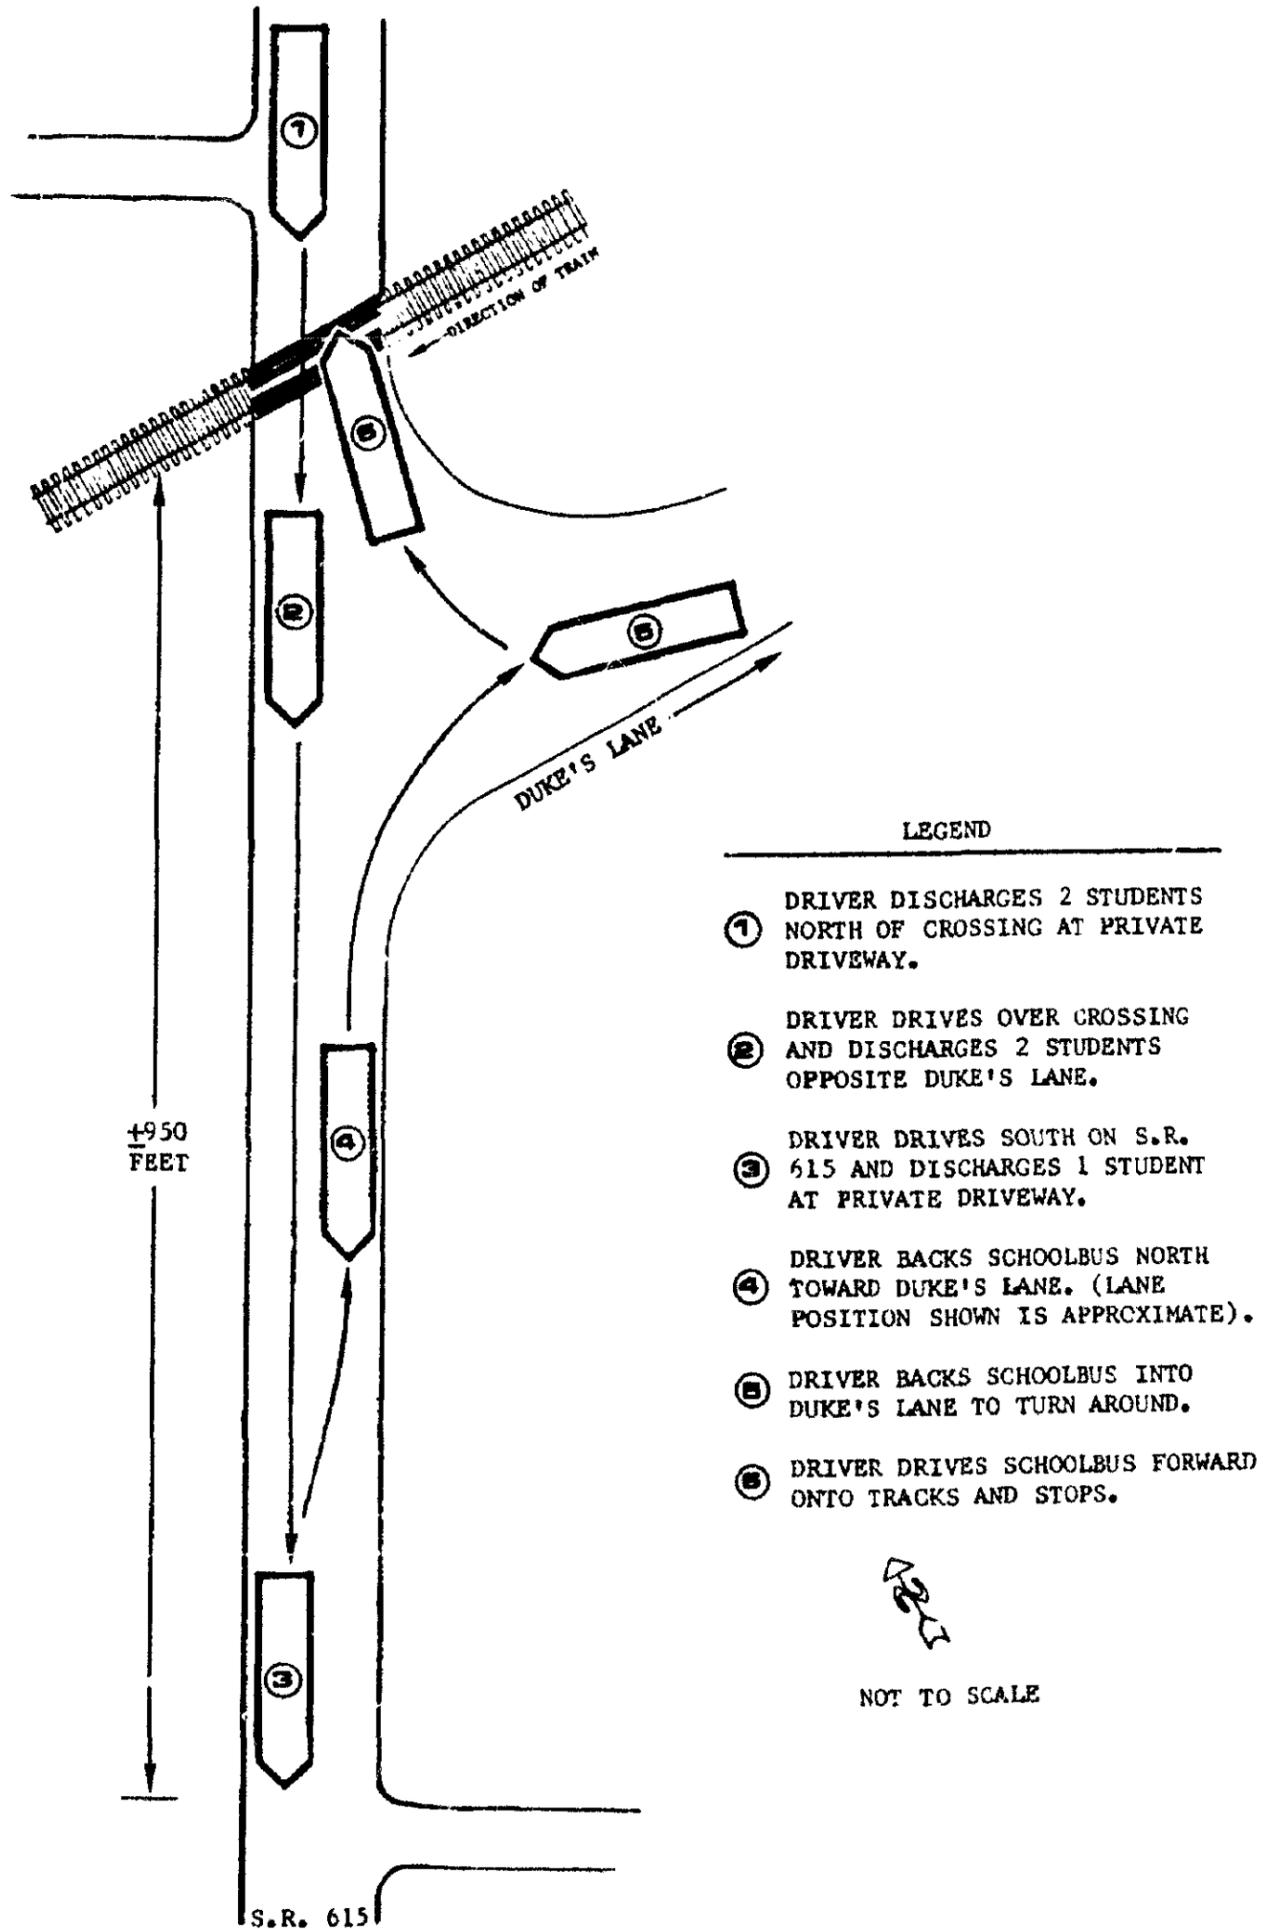
Figure 1.--Movements of schoolbus before the collision.

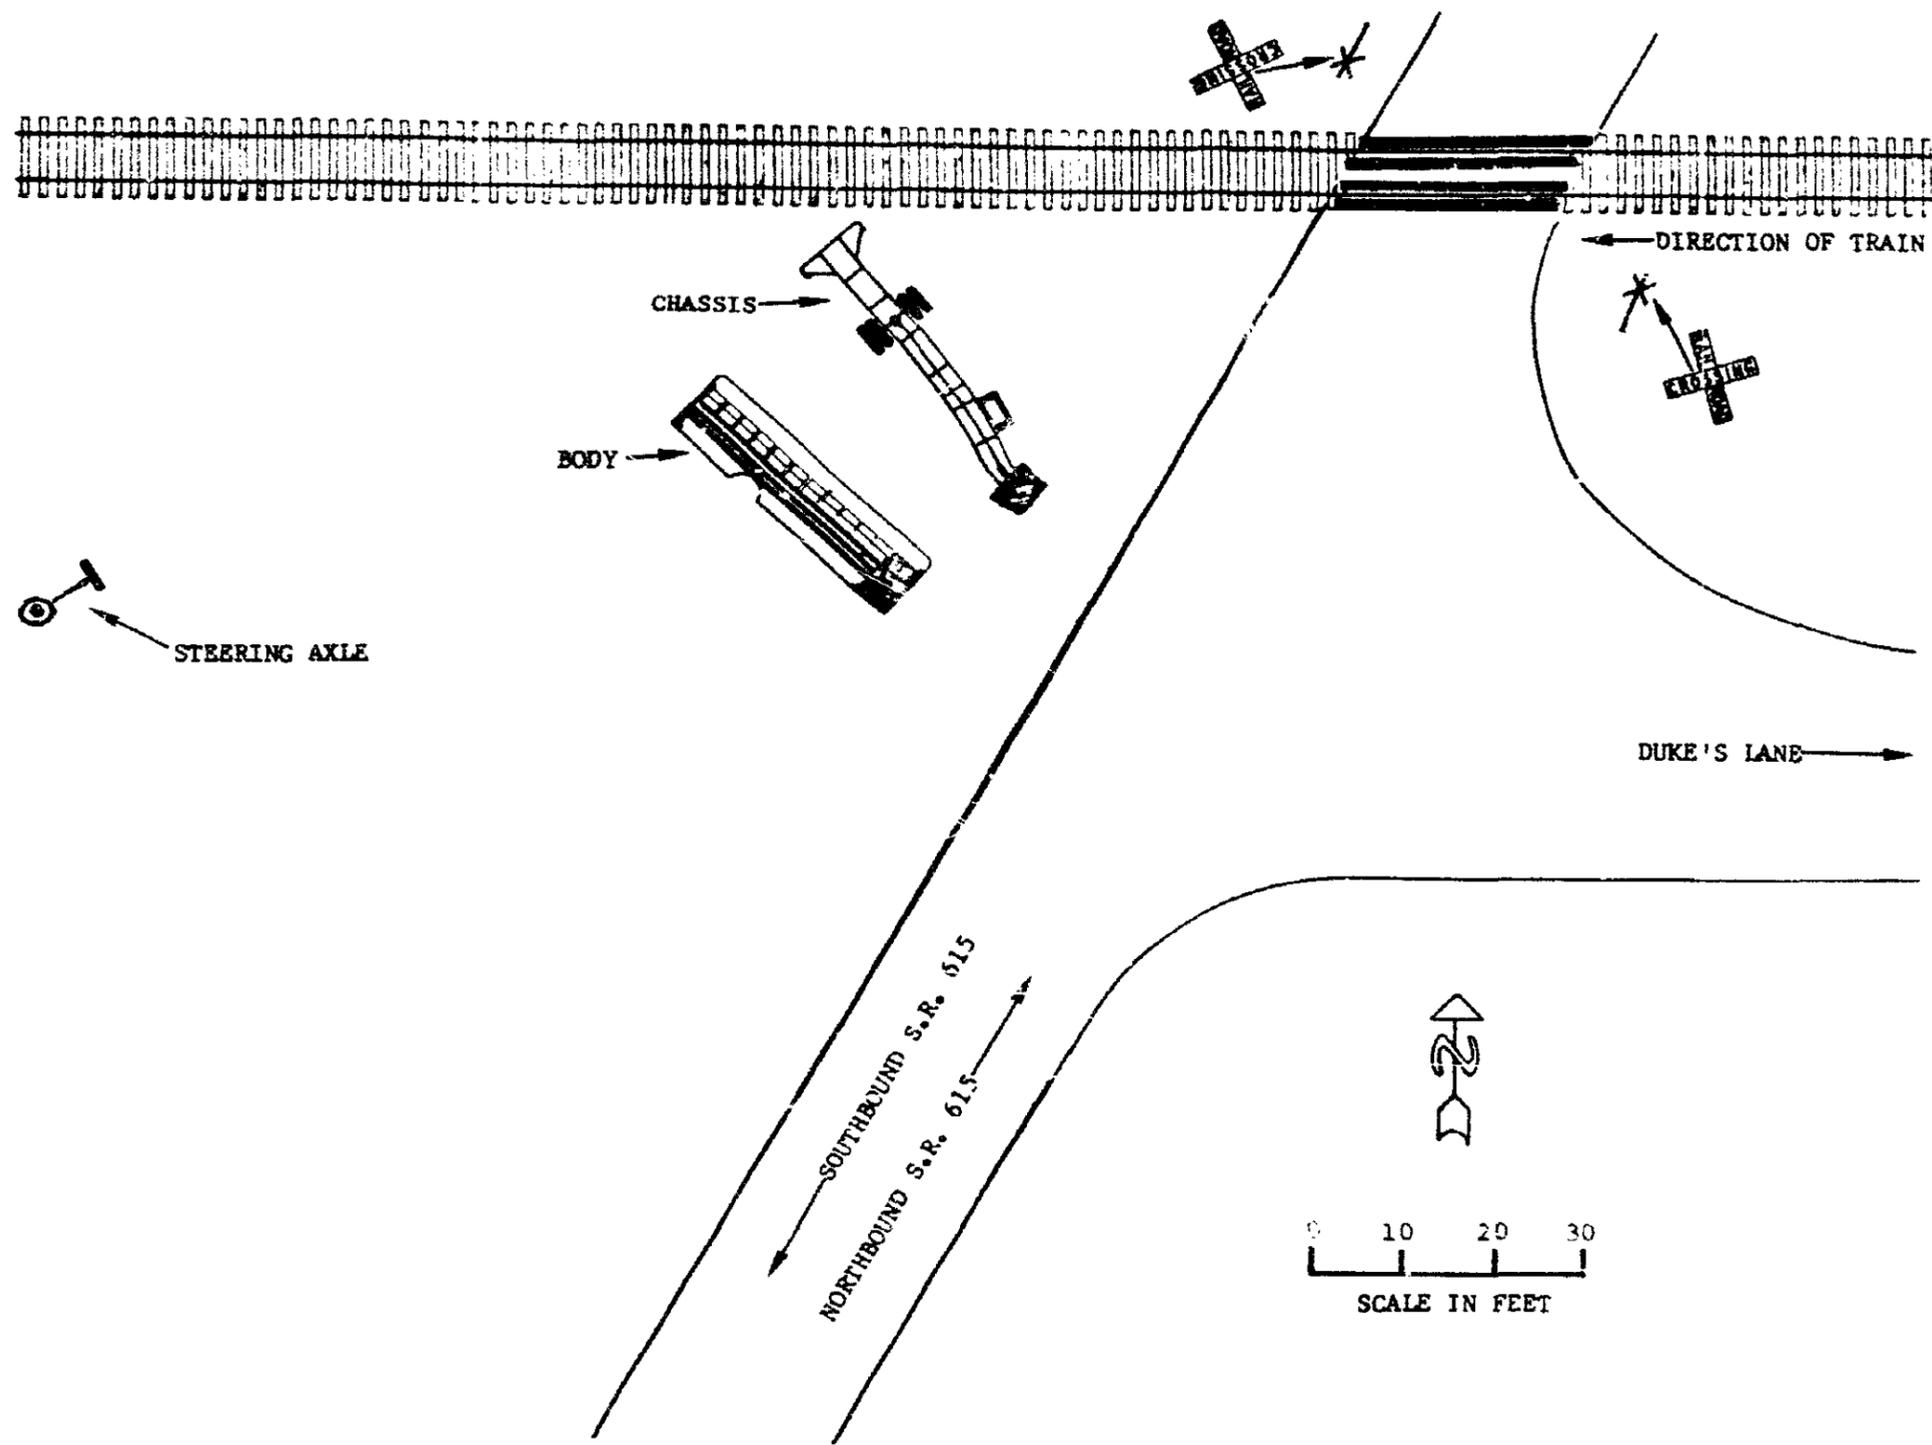
The schoolbus body and the steering axle separated from the chassis at impact. The bus body rotated 180° counterclockwise, rolled over 270° to the right, and came to rest on its left side about 80 feet southwest of the crossing. The chassis, with the engine still mounted to it, came to rest upside down between the bus body and the crossing. A fire started in the engine area after the chassis came to rest. The steering axle of the schoolbus came to rest west of the schoolbus body. (See figure 3.)

Figure 3.--Accident site.

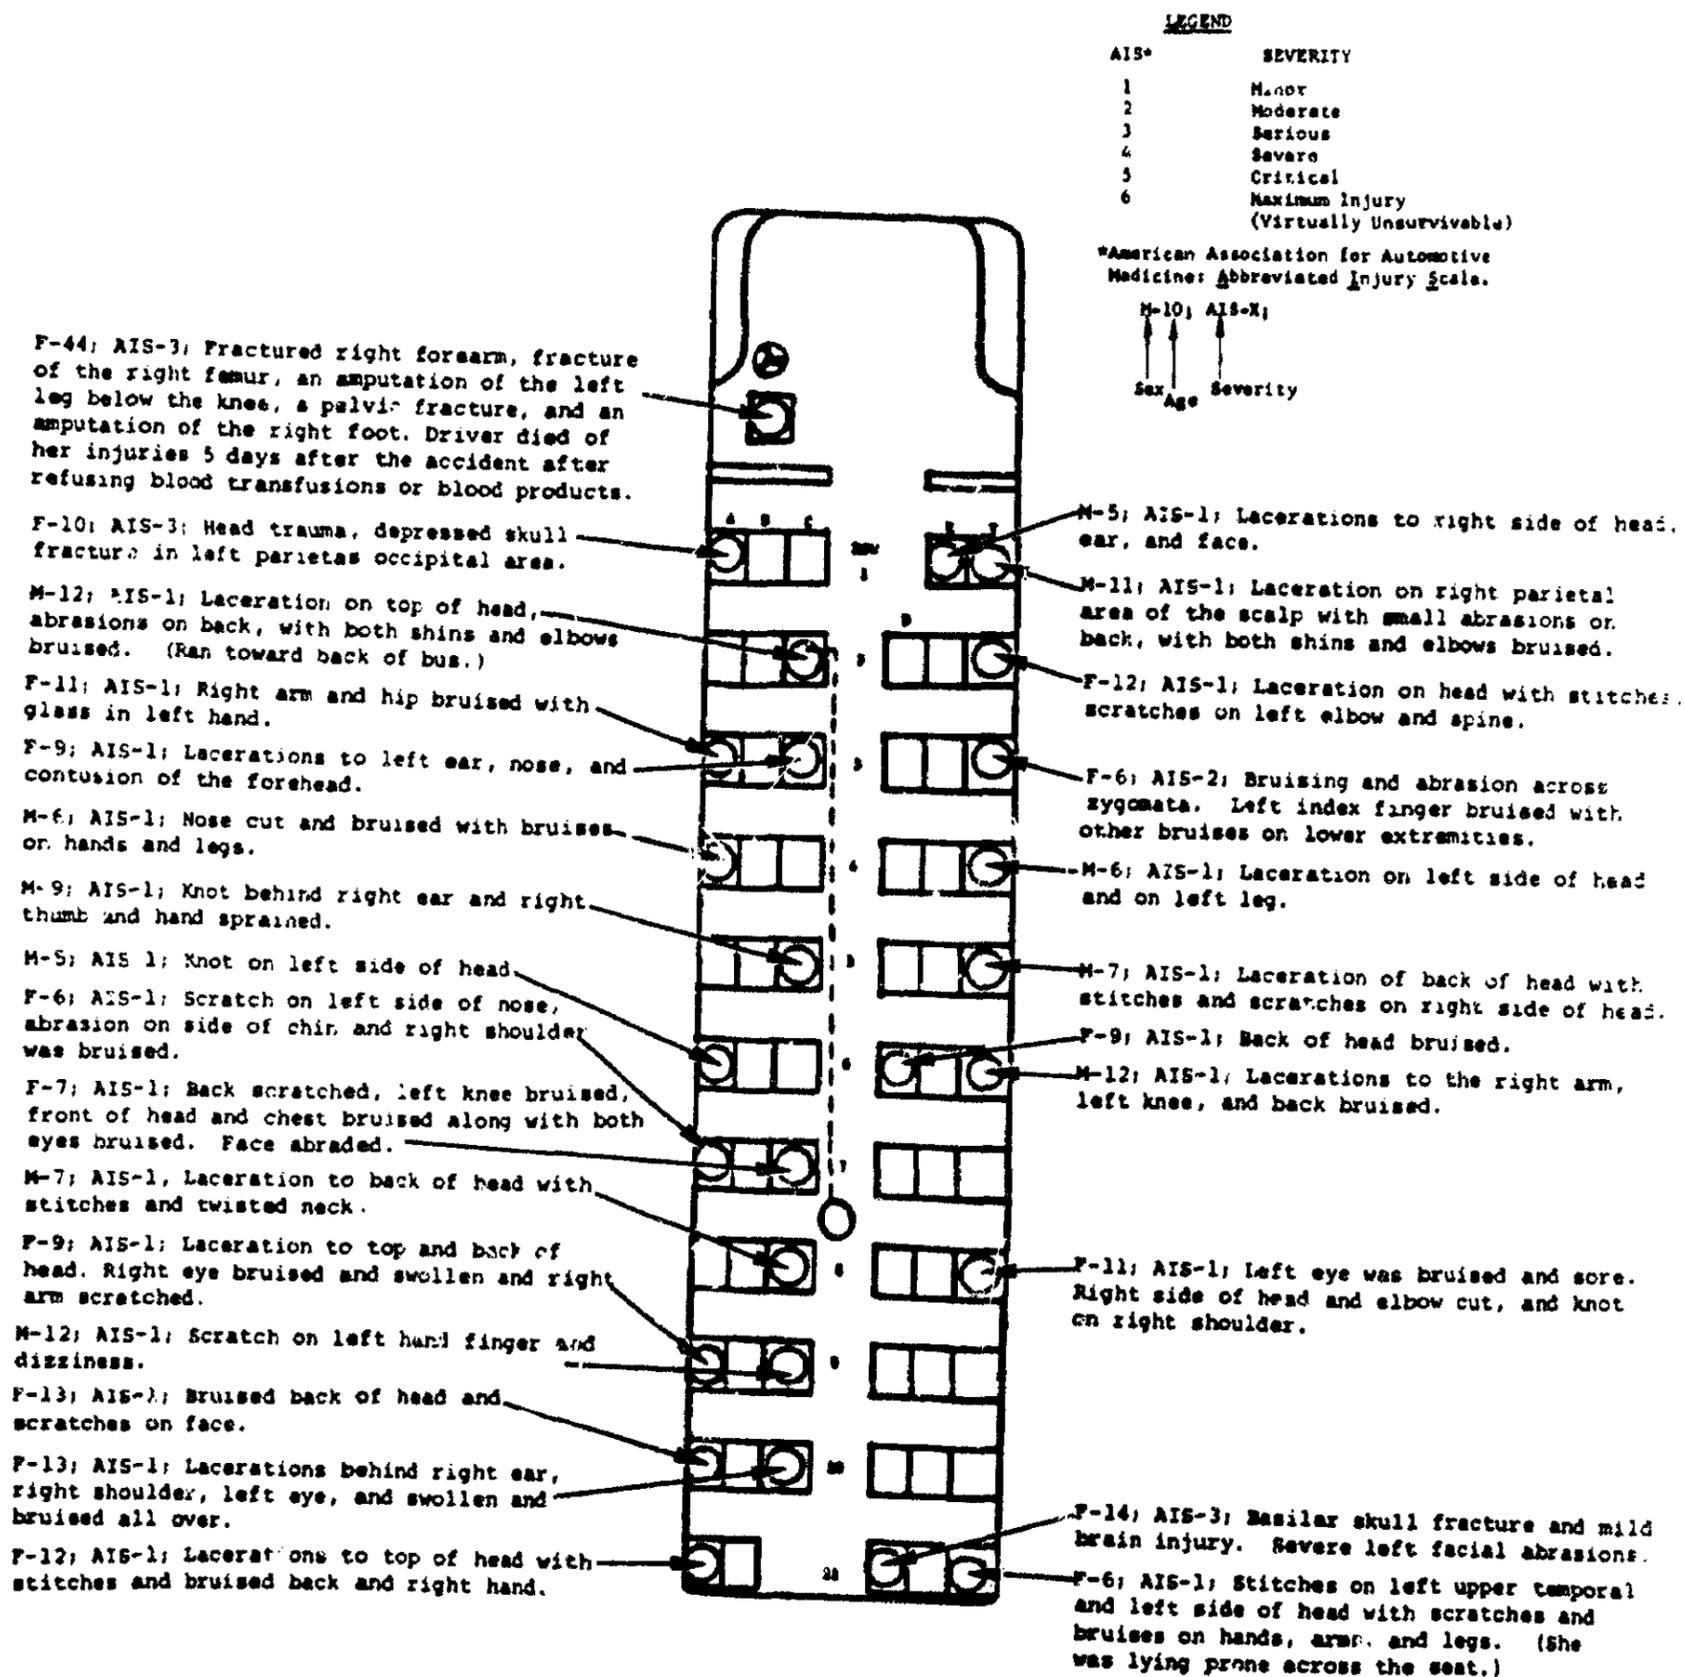
Two of the 26 schoolbus passengers were seriously injured (AIS 3 injuries). (See figure 8.) A 10-year-old occupant sitting in the window seat behind the driver next to the window sustained head trauma and a depressed skull fracture on the left side of the head. A 14-year-old occupant sitting in the last aisle seat on the right sustained a fracture at the base of the skull with mild brain injury as well as severe left facial abrasions. A 6-year-old child occupying this same seat was lying prone with her head on the 14-year-old's lap. The 6-year-old child suffered minor AIS 1 injuries including cuts to the left side of the head requiring stitches with scratches and bruises on her back, arms, and legs.

Figure 8.--Schoolbus Occupant Seating and Injury Chart.

The 10-year-old child sitting in the first seat behind the driver and the 14-year-old child sitting in the rear aisle seat on the right were the most seriously injured. The child sitting behind the driver was close to the area of the first impact with the train and probably was thrown head-first toward the right side of the bus when the train struck the front right side. This child sustained head trauma, including a depressed skull fracture. The installation and use of a seat belt by this child probably would have prevented or mitigated this injury.

The 14-year-old child sitting in the rear aisle seat on the right, and a 6-year-old child lying prone on the same seat with her head in her 14-year-old sister's lap, were seated immediately in front of the second impact area at the right rear of the bus. The force of the second impact initially would have propelled both of these children to the right rear. Because of her size and initial seating position, the 14-year-old child sustained her basilar skull fracture when her head, which was above the padded seat back, probably contacted the frame of the emergency door at the right rear of the bus. Because of her prone position in the seat, the 6-year-old was propelled into the padded seat back instead of the hard interior surfaces above the back of the right rear seat.

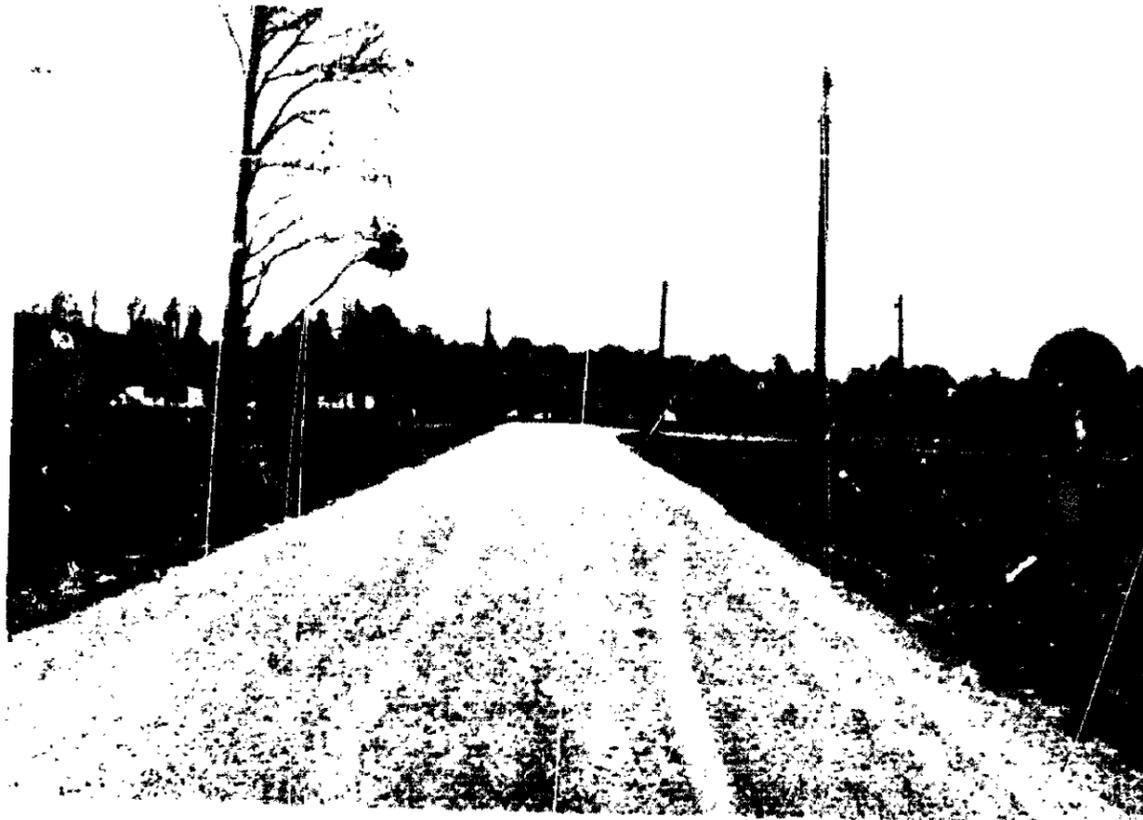
Figure 9.--April 1984 view of northbound SR 615 at accident grade crossing.

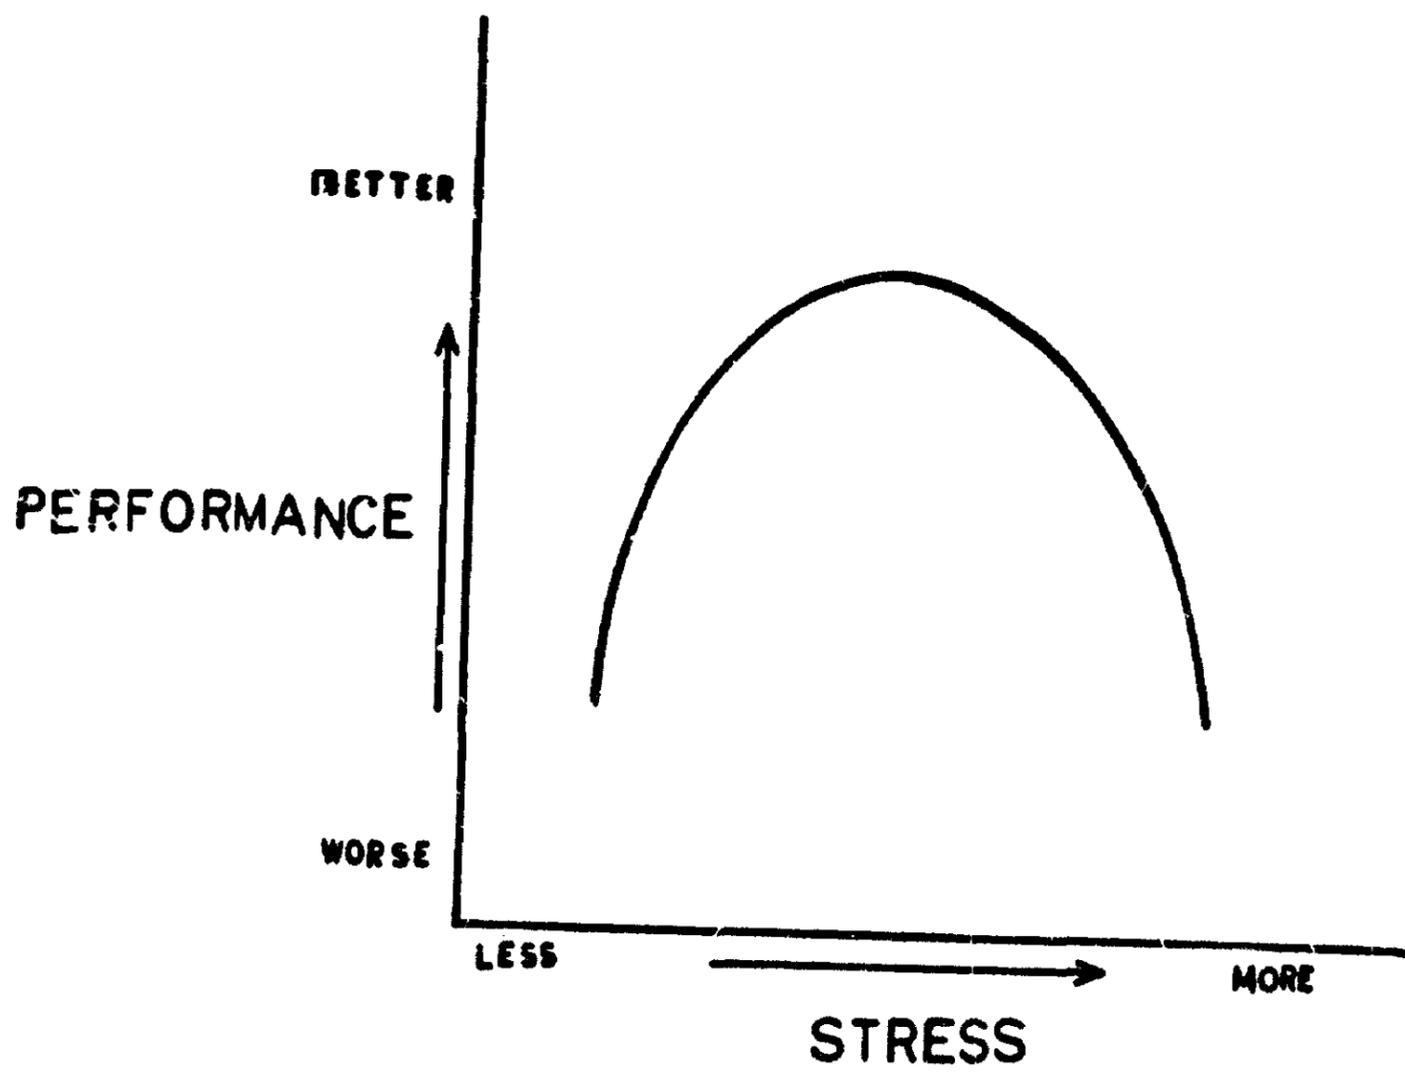
This driver had been experiencing both continuing and immediate stress both on and off the job, which may have affected her perception, her judgment, and her ability to react appropriately to the approaching train. While some level of stress can enhance performance, excess stress can lead to substandard performance. Initially as stress increases, performance improves until some optimal relationship occurs. Any further increase in stress will result in performance degradation. When a person becomes overloaded because of any stress, there is a narrowing of his/her attention. Any central task will be focused upon while quality of the performance of any peripheral tasks will deteriorate. <sup>4/</sup> (See figure 12.)

Figure 12.--The relationship between stress and performance.
