Highway Accident Report - Collision of  
Tuba City School District Schoolbus and  
Bell Creek, Inc., Tractor-Semitrailer,  
US 160 near Tuba City, Arizona, April 29, 1985

1. Report No. NTSB/HAR-85/06	2. Government Accession No. PB85-916207	3. Recipient's Catalog No.	
4. Title and Subtitle Highway Accident Report--Collision of Tuba City School District Schoolbus and Bell Creek, Inc. Tractor-semitrailer, US 160 Near Tuba City, Arizona, April 29, 1985		5. Report Date December 10, 1985

COLLISION OF  
TUBA CITY UNIFIED SCHOOL DISTRICT SCHOOLBUS  
AND BELL CREEK, INC. TRACTOR-SEMITRAILER,  
U S 160 NEAR TUBA CITY, ARIZONA,  
APRIL 29, 1985

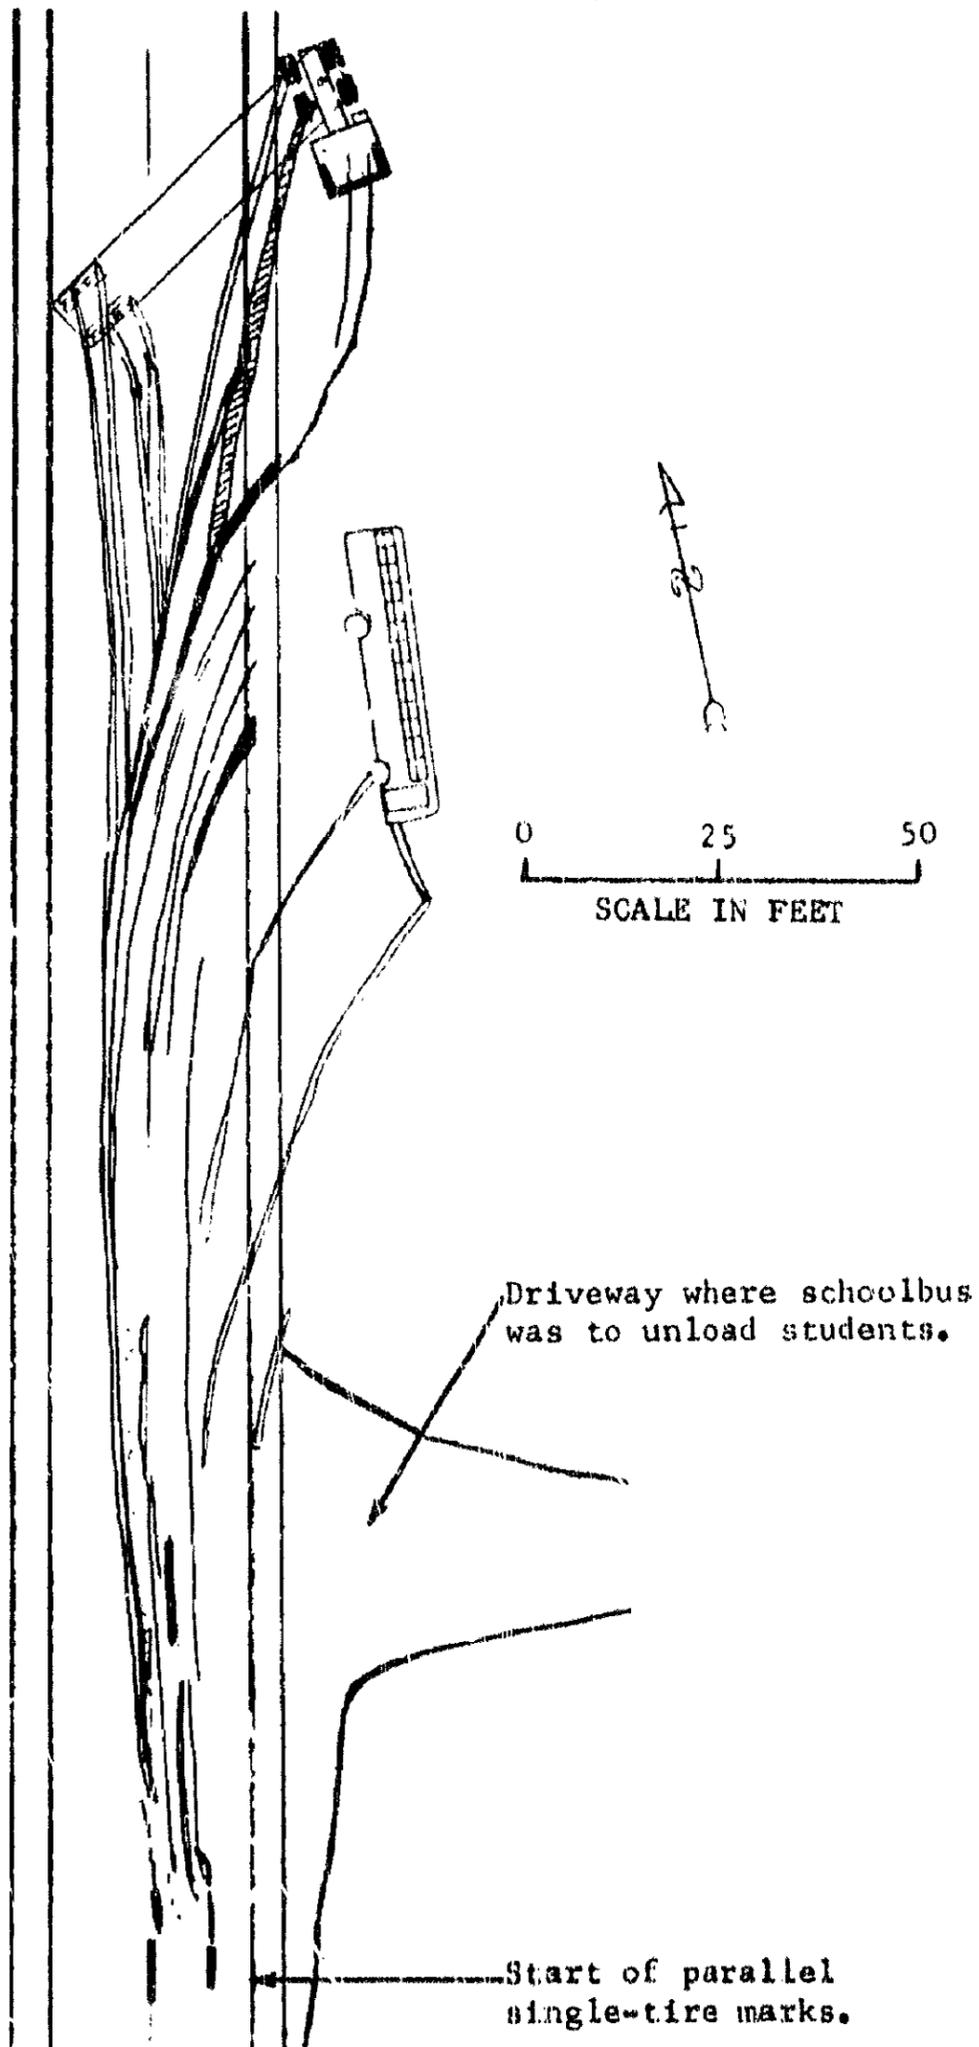
Figure 1.--Plan view of accident site.

Two parallel single-tire marks were found about 146 feet west of the final rest position of the front of the schoolbus. One tire mark was on the centerline and the other was about 8 feet to the right of the centerline. These tire marks were followed immediately by gouges and other tire marks leading to the final rest positions of the accident vehicles. (See figure 1.)

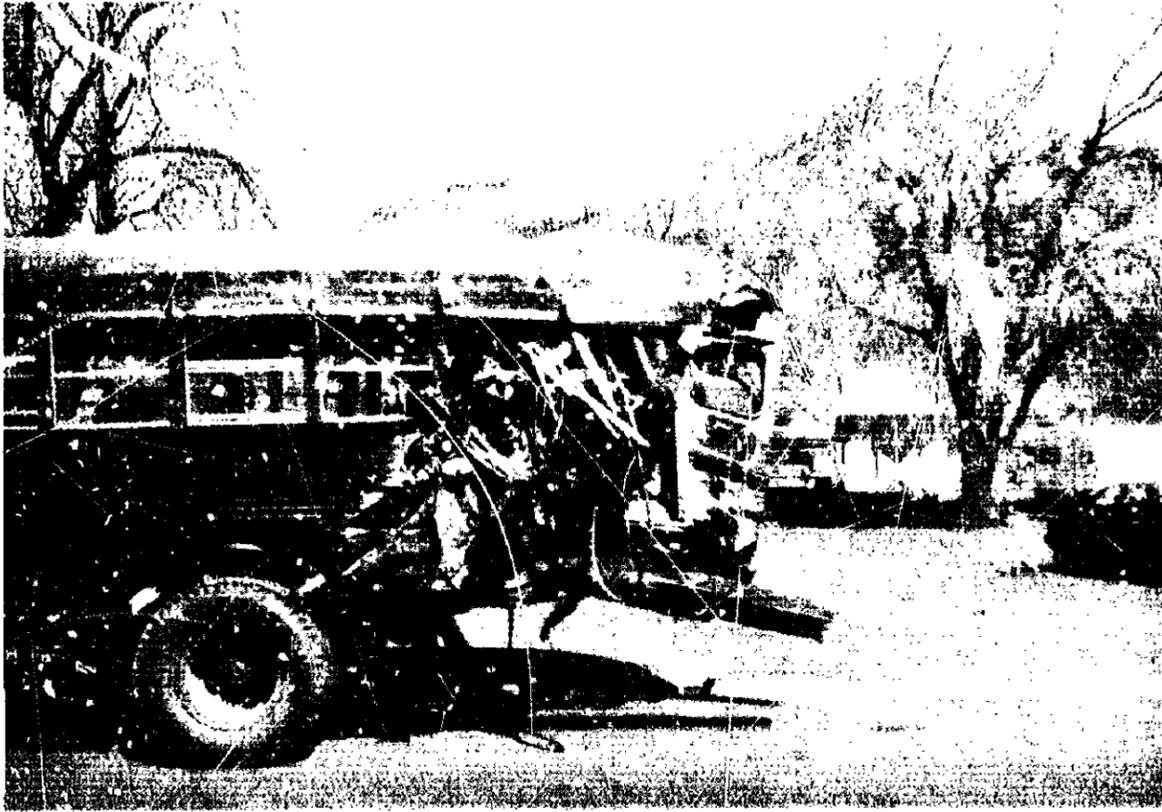
Figure 4.--Damage to left side of schoolbus.

The right rear of the schoolbus was displaced forward and about 2.5 feet to the left, and the left rear was displaced forward about 9.7 feet. There were no exterior body panel separations between the roof and the rear body side panels. The extensive crush prevented inspection of all the side body panel joints at the left rear. However, of the joints that were visible, no exterior body panel separations were noted at this location. (See figure 4.) The rear 11 feet of both the longitudinal frame rails which formerly ran the entire length of the vehicle were bent 37 inches to the left. The emergency door at the rear was inoperable due to collision damage. (See figure 5.) The rear bumper, which was torn loose from its mounting to the longitudinal frame rails, had a rubber tire transfer 8 inches from its far right side.

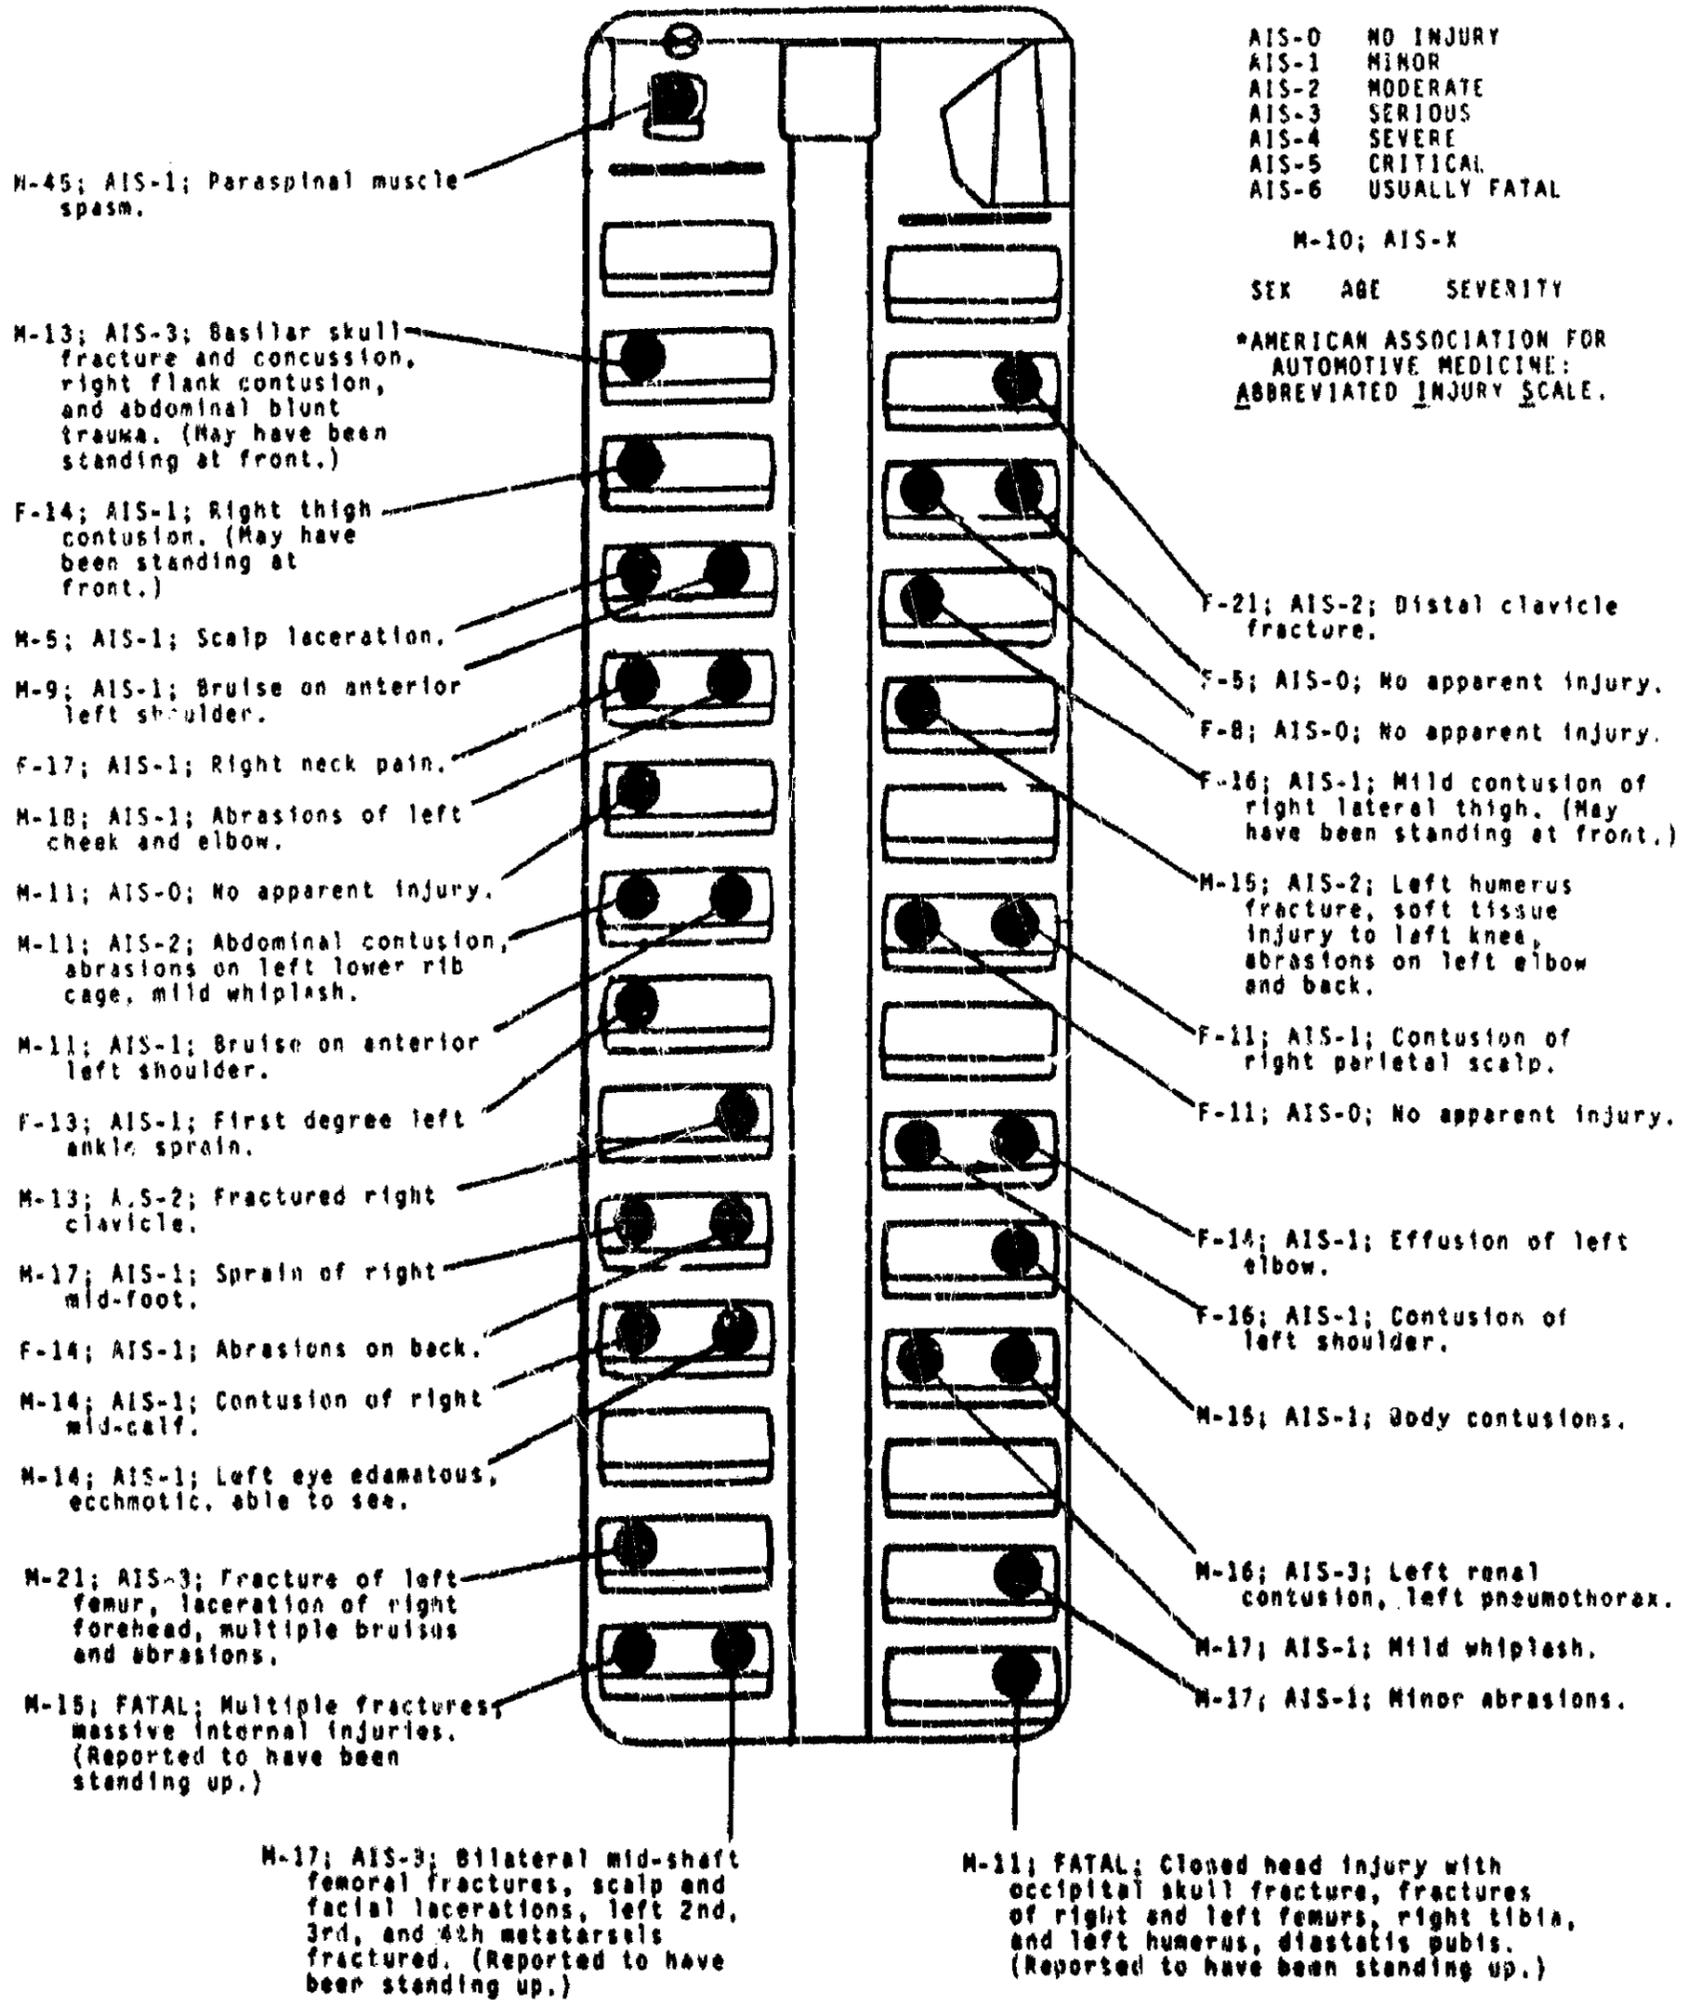
Figure 10.--Schoolbus occupant seating and injury chart.

The two fatally injured students and three of the four seriously injured students were seated in the last four rows of seats. The fourth seriously injured student was seated in the second row window seat on the left before the collision. The fatally injured passengers sustained multiple fractures, massive internal injuries, and lacerations. One of the seriously injured passengers sustained a left renal contusion, and the others sustained multiple fractures, bruises, and abrasions. Four passengers sustained moderate injuries including humerus and clavicle fractures and an abdominal contusion. Minor injuries sustained by 18 students included sprains, contusions, bruises, and abrasions. (See figure 10.)

The two schoolbus passengers who sustained fatal injuries were occupying the left rear window seat and the right rear seat. The amount of crush damage in these areas did not provide survivable space. Three of the four schoolbus occupants who sustained serious injuries were also occupying the last four rows of the schoolbus where the crash forces were the greatest. The 21-year-old male occupant of the left window seat in the 13th row probably sustained his head laceration when he contacted the edge of the body panel joint which was exposed due to the joint separation of the adjacent maintenance access panel. The remaining passenger who sustained serious injuries was occupying the seat in the second row behind the schoolbus driver before the collision. This passenger was about to exit the schoolbus at the stop where the collision occurred and sustained his basilar skull fracture because he probably was standing up in the aisle and was thrown backward by the force of the collision, striking his head on some object inside the schoolbus when the collision occurred.

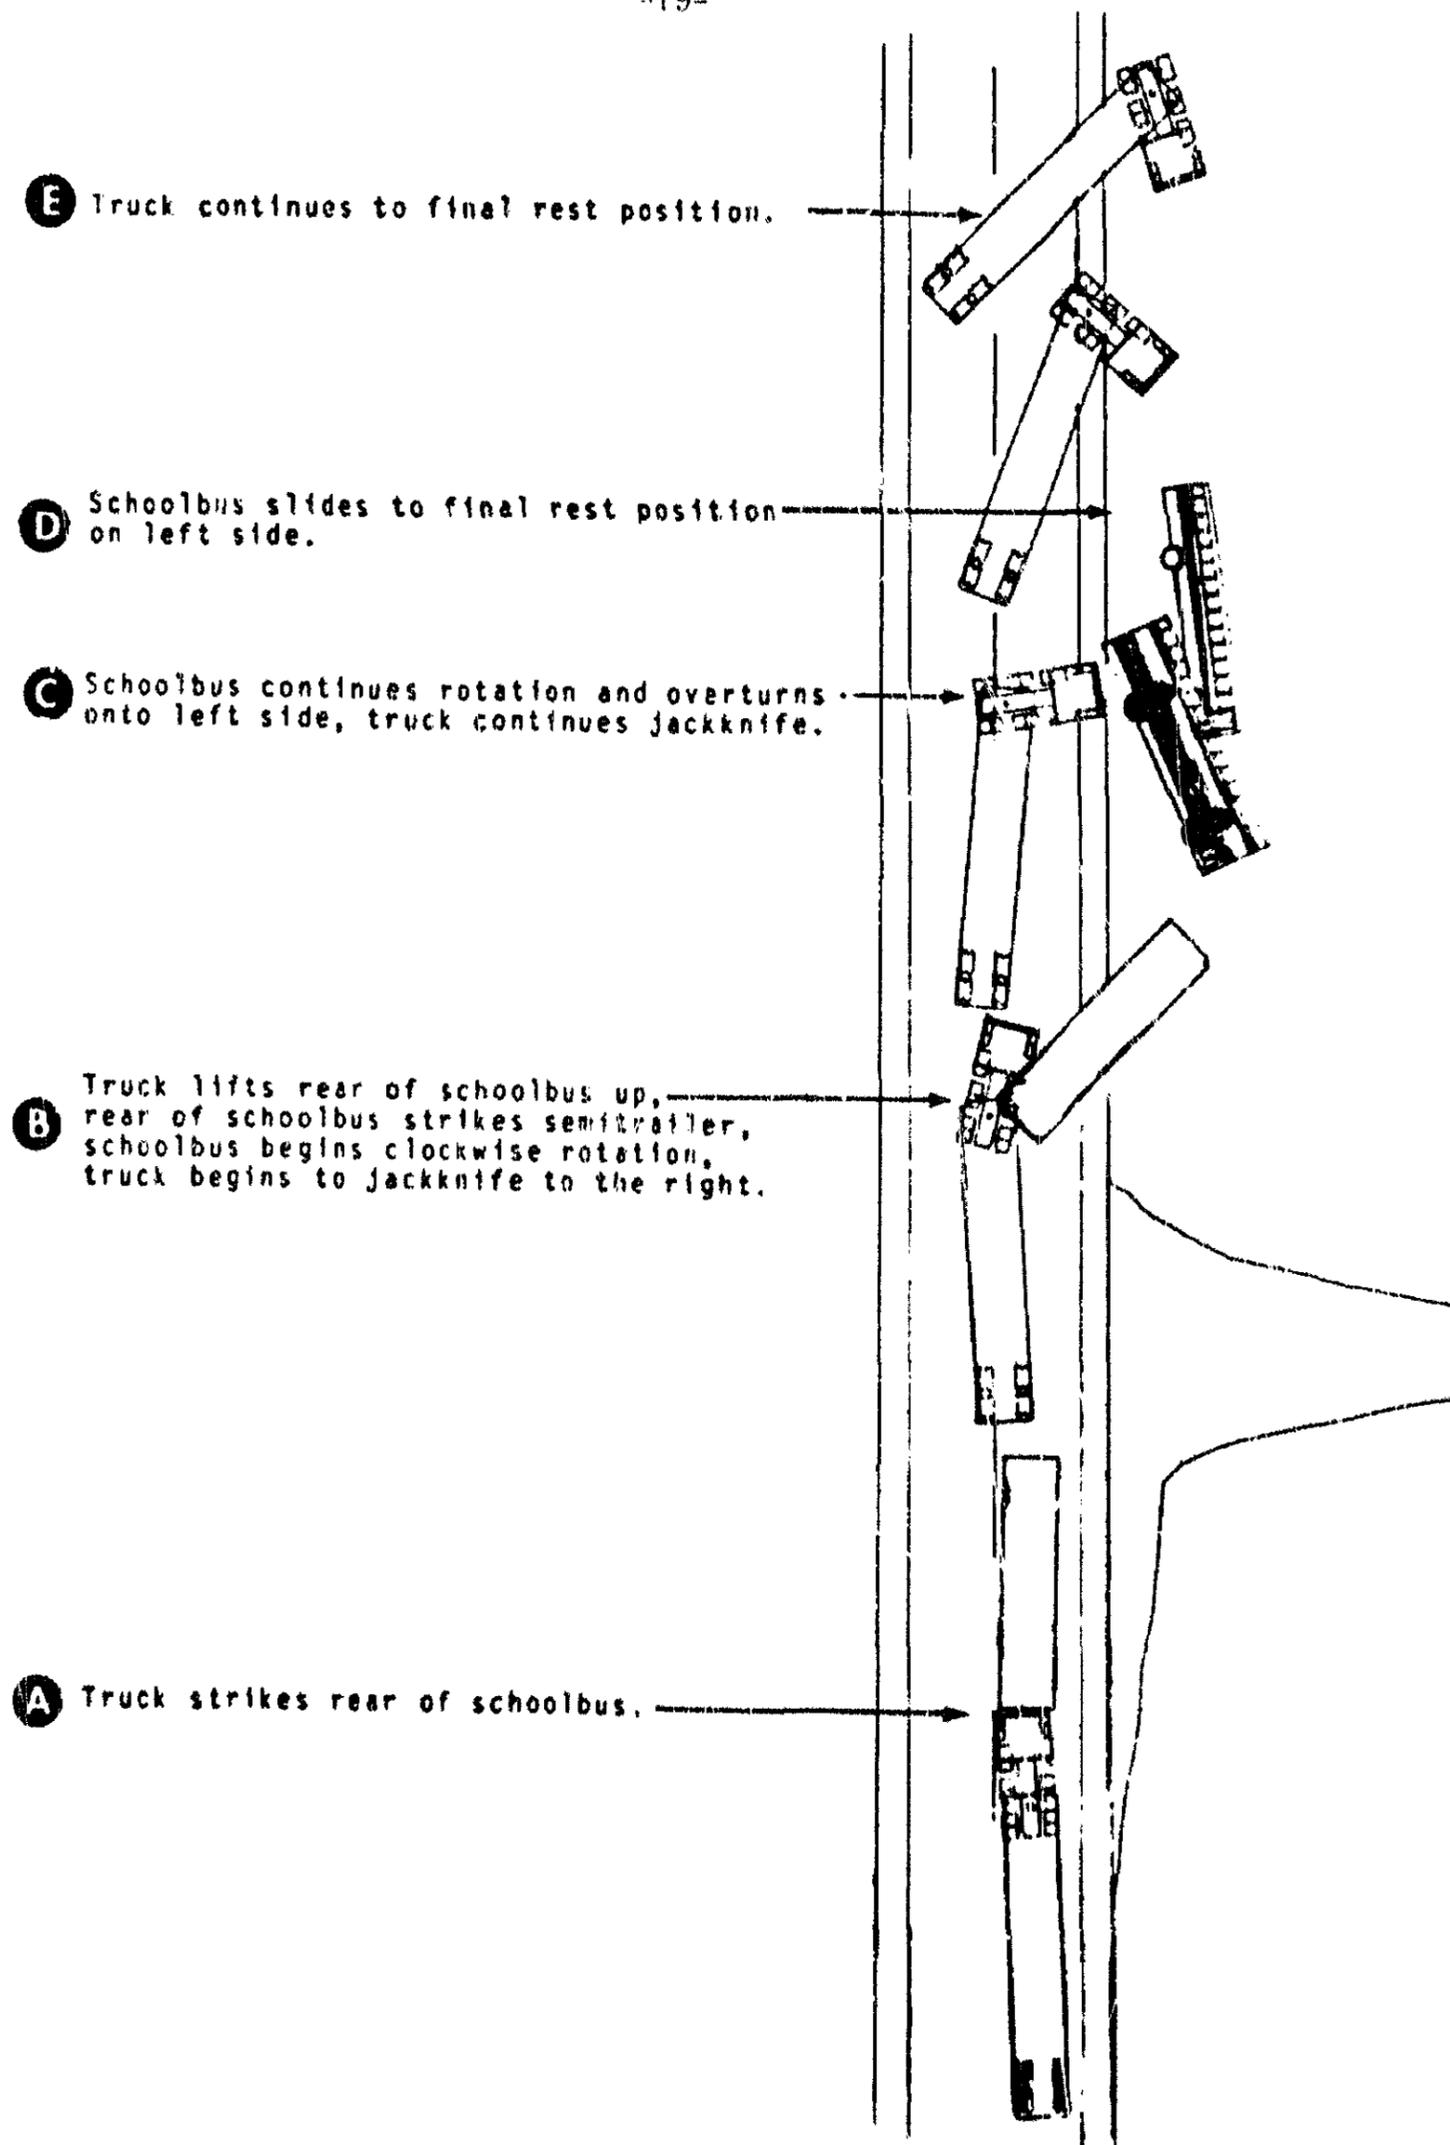
Figure 12.-- Accident sequence.

Based upon the damage pattern to the vehicles, with the greatest deformation to the Bell Creek tractor on its right side, and the greatest deformation to the schoolbus on its left side, and the fact that the bus rotated clockwise 155 degrees after impact, the Safety Board believes that, at the time of impact, the Bell Creek vehicle struck the rear of the schoolbus at an angle to the left. The Safety Board believes that this angle is attributable to a left steering maneuver begun immediately before the collision.

The location of the tire overload marks, given the overall length of the schoolbus, also shows that at the time of the collision the right front entrance door of the schoolbus was adjacent to the driveway where the schoolbus driver was to unload several of his passengers. The schoolbus therefore was positioned to unload passengers and probably was not moving. The rearward displacement of the left side of the right front restraining barrier is attributed to contact with this barrier by one or more of the passengers who were preparing to exit the schoolbus when the collision occurred. These occupants were apparently standing in or immediately adjacent to the entrance/exit stairwell and were thrown into the padded restraining barrier by the force of the collision. Based upon this evidence and the statements of the westbound witnesses and the schoolbus driver, the Safety Board believes that the schoolbus was stopped at the time of the collision.
