Highway Accident Report - Multiple Vehicle
Collision and Fire, U. S. 13 near Snow Hill
North Carolina, May 31, 1985

(U.S.) National Transportation Safety Board.
Washington, DC

5 Aug 86

1. Report No. NTSB/HAR-86/02		2. Government Accession No. PB86-913202		3. Recipient's Catalog No.	
4. Title and Subtitle Highway Accident Report— Multiple Vehicle Collision and Fire, U.S. 13 Near Snow Hill, North Carolina, May 31, 1985				5. Report Date August 5, 1986

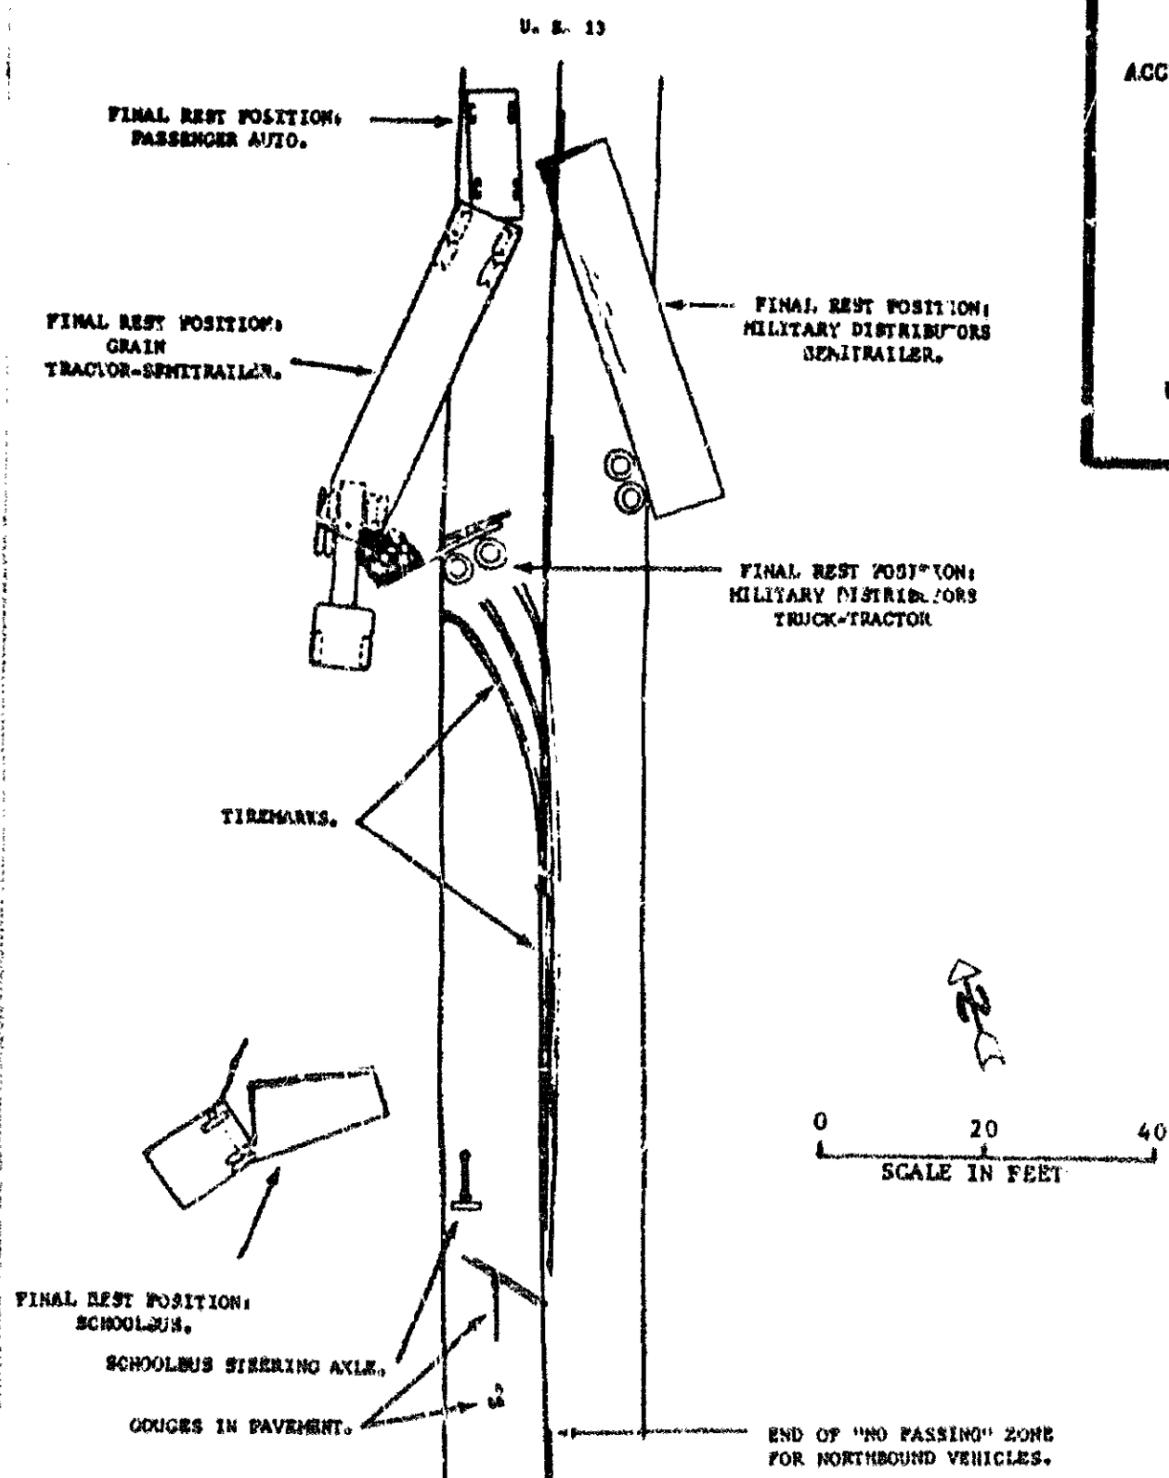
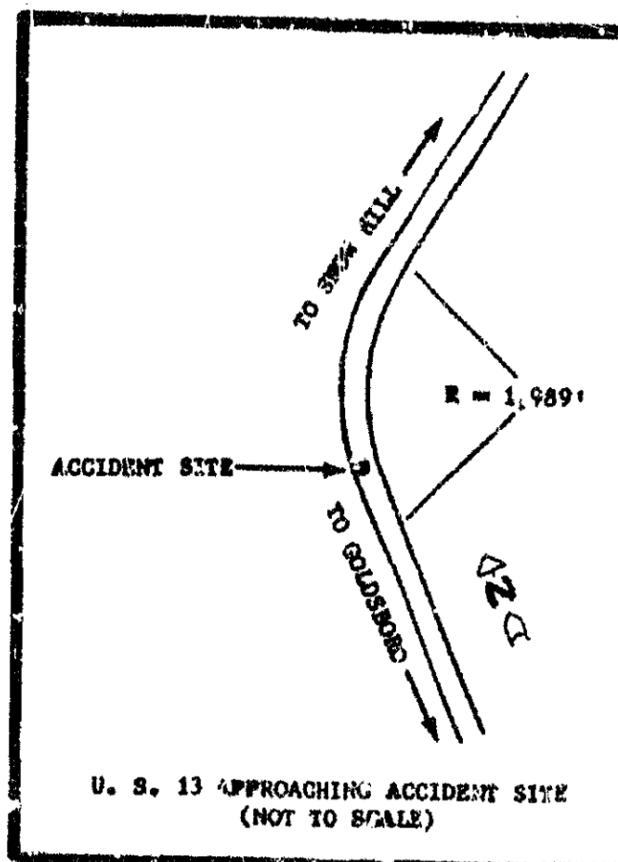
Figure 4.--Plan view of accident site.

After the collisions, the MDV tractor and the grain truck's tractor and semitrailer caught fire. The driver of the straight truck reported that he saw the grain truck's battery, which before the collision was mounted outboard of the grain truck-tractor's left longitudinal frame rail between the cab and the first drive axle, "explode" and start the fire. The MDV tractor and the grain truck-tractor were destroyed in the fire, and the grain truck semitrailer sustained fire damage to the left front. The schoolbus, the passenger auto, the straight truck, and the MDV semitrailer were not involved in the fire. (See figure 4.)

northbound lane and about one foot east of the center of the highway. These marks widened as they continued northbound and crossed the centerline into the southbound lane about 50 feet north of where they began. In the southbound lane, the marks led up to within about 4 feet of the tires of the MDV truck tractor at its final rest position, overturned on its right side. One tire mark ended at the right edge of the pavement in the southbound lane. (See figure 4.)

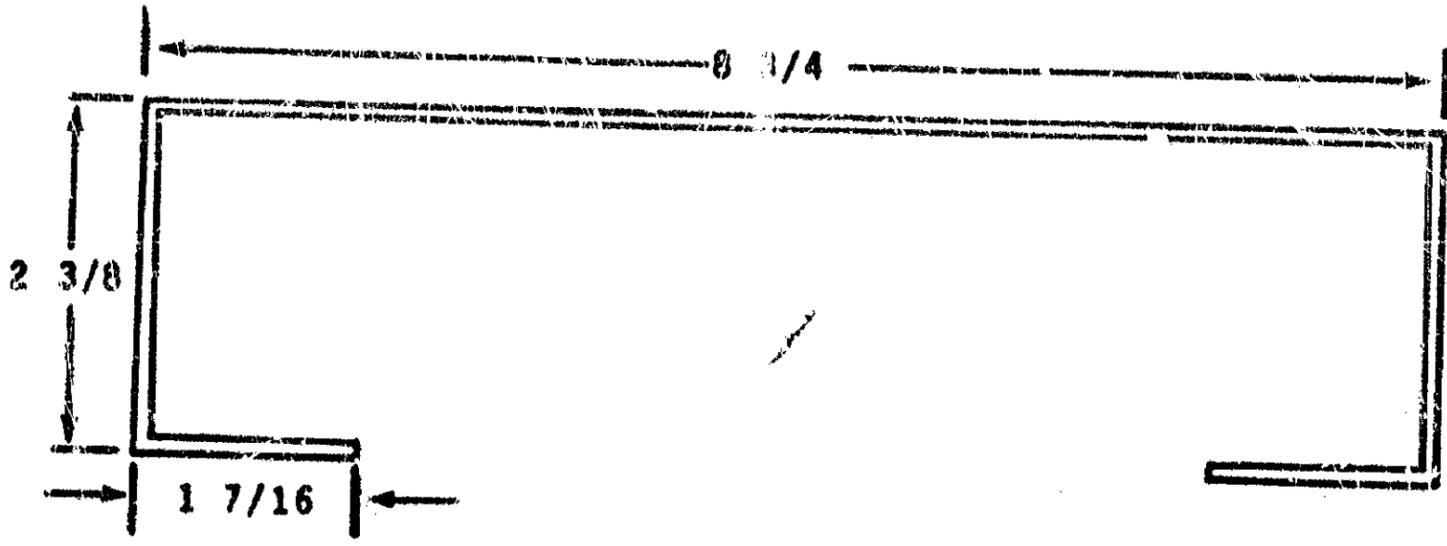
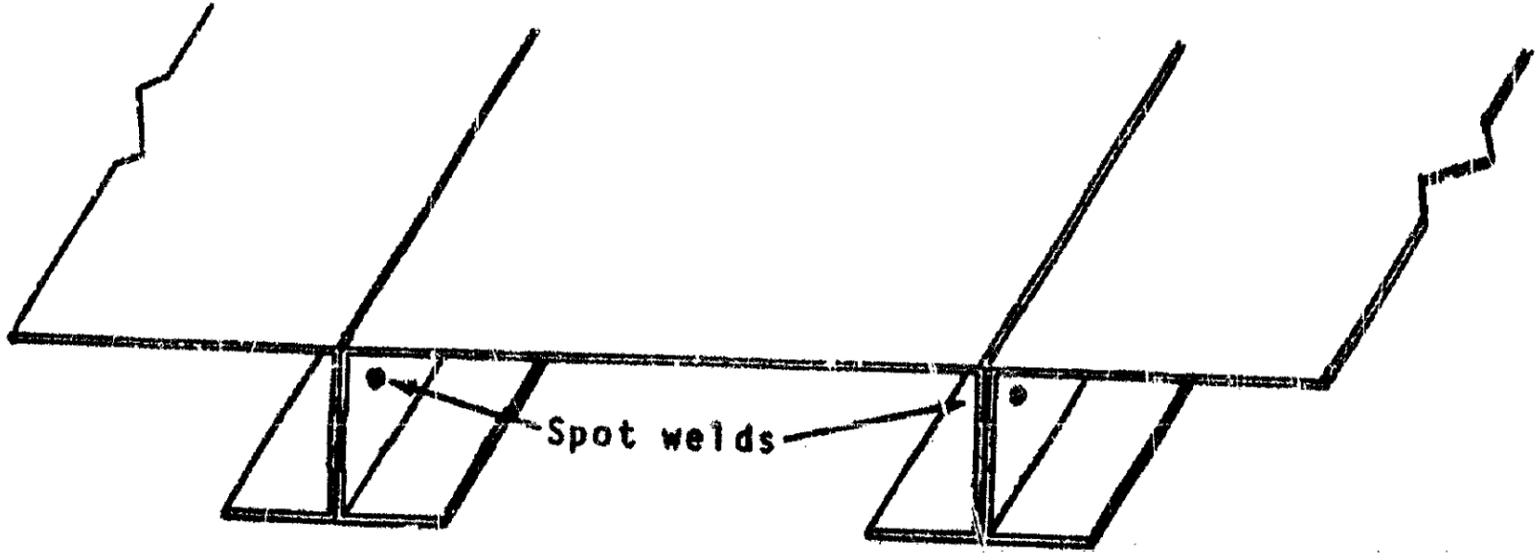
Figure 5.--Schoolbus floor construction.

The schoolbus floor consisted of 0.075-inch-thick steel material bent into C-shaped channels. These channels were joined together by an exterior steel "cap" around the outside perimeter of the floor, by welds along the flanges at each end, by welds on the underside of the floor structure about 2 1/2 inches long located about 14 inches inboard of the outside edge of the floor structure, and by 12 spot welds 1/2 inch in diameter and about 6 5/8 inches apart near the center of the flanges on each channel. (See figure 5.) The collision separated two of these floor channel sections at the floor joint located near the seat legs of the fourth row of bench seats in front of the schoolbus drive axle. The floor separation created a triangular opening across the schoolbus floor which measured about 45 inches wide at the left sidewall. The schoolbus floor was crushed inboard about 7 inches immediately in front of this opening. The floor was relatively undamaged behind this opening and was 98 inches wide. (See figures 6 and 7.) The schoolbus driver reported that there were no defects in the vehicle she was driving, and a postaccident examination of the vehicle did not disclose any defects.

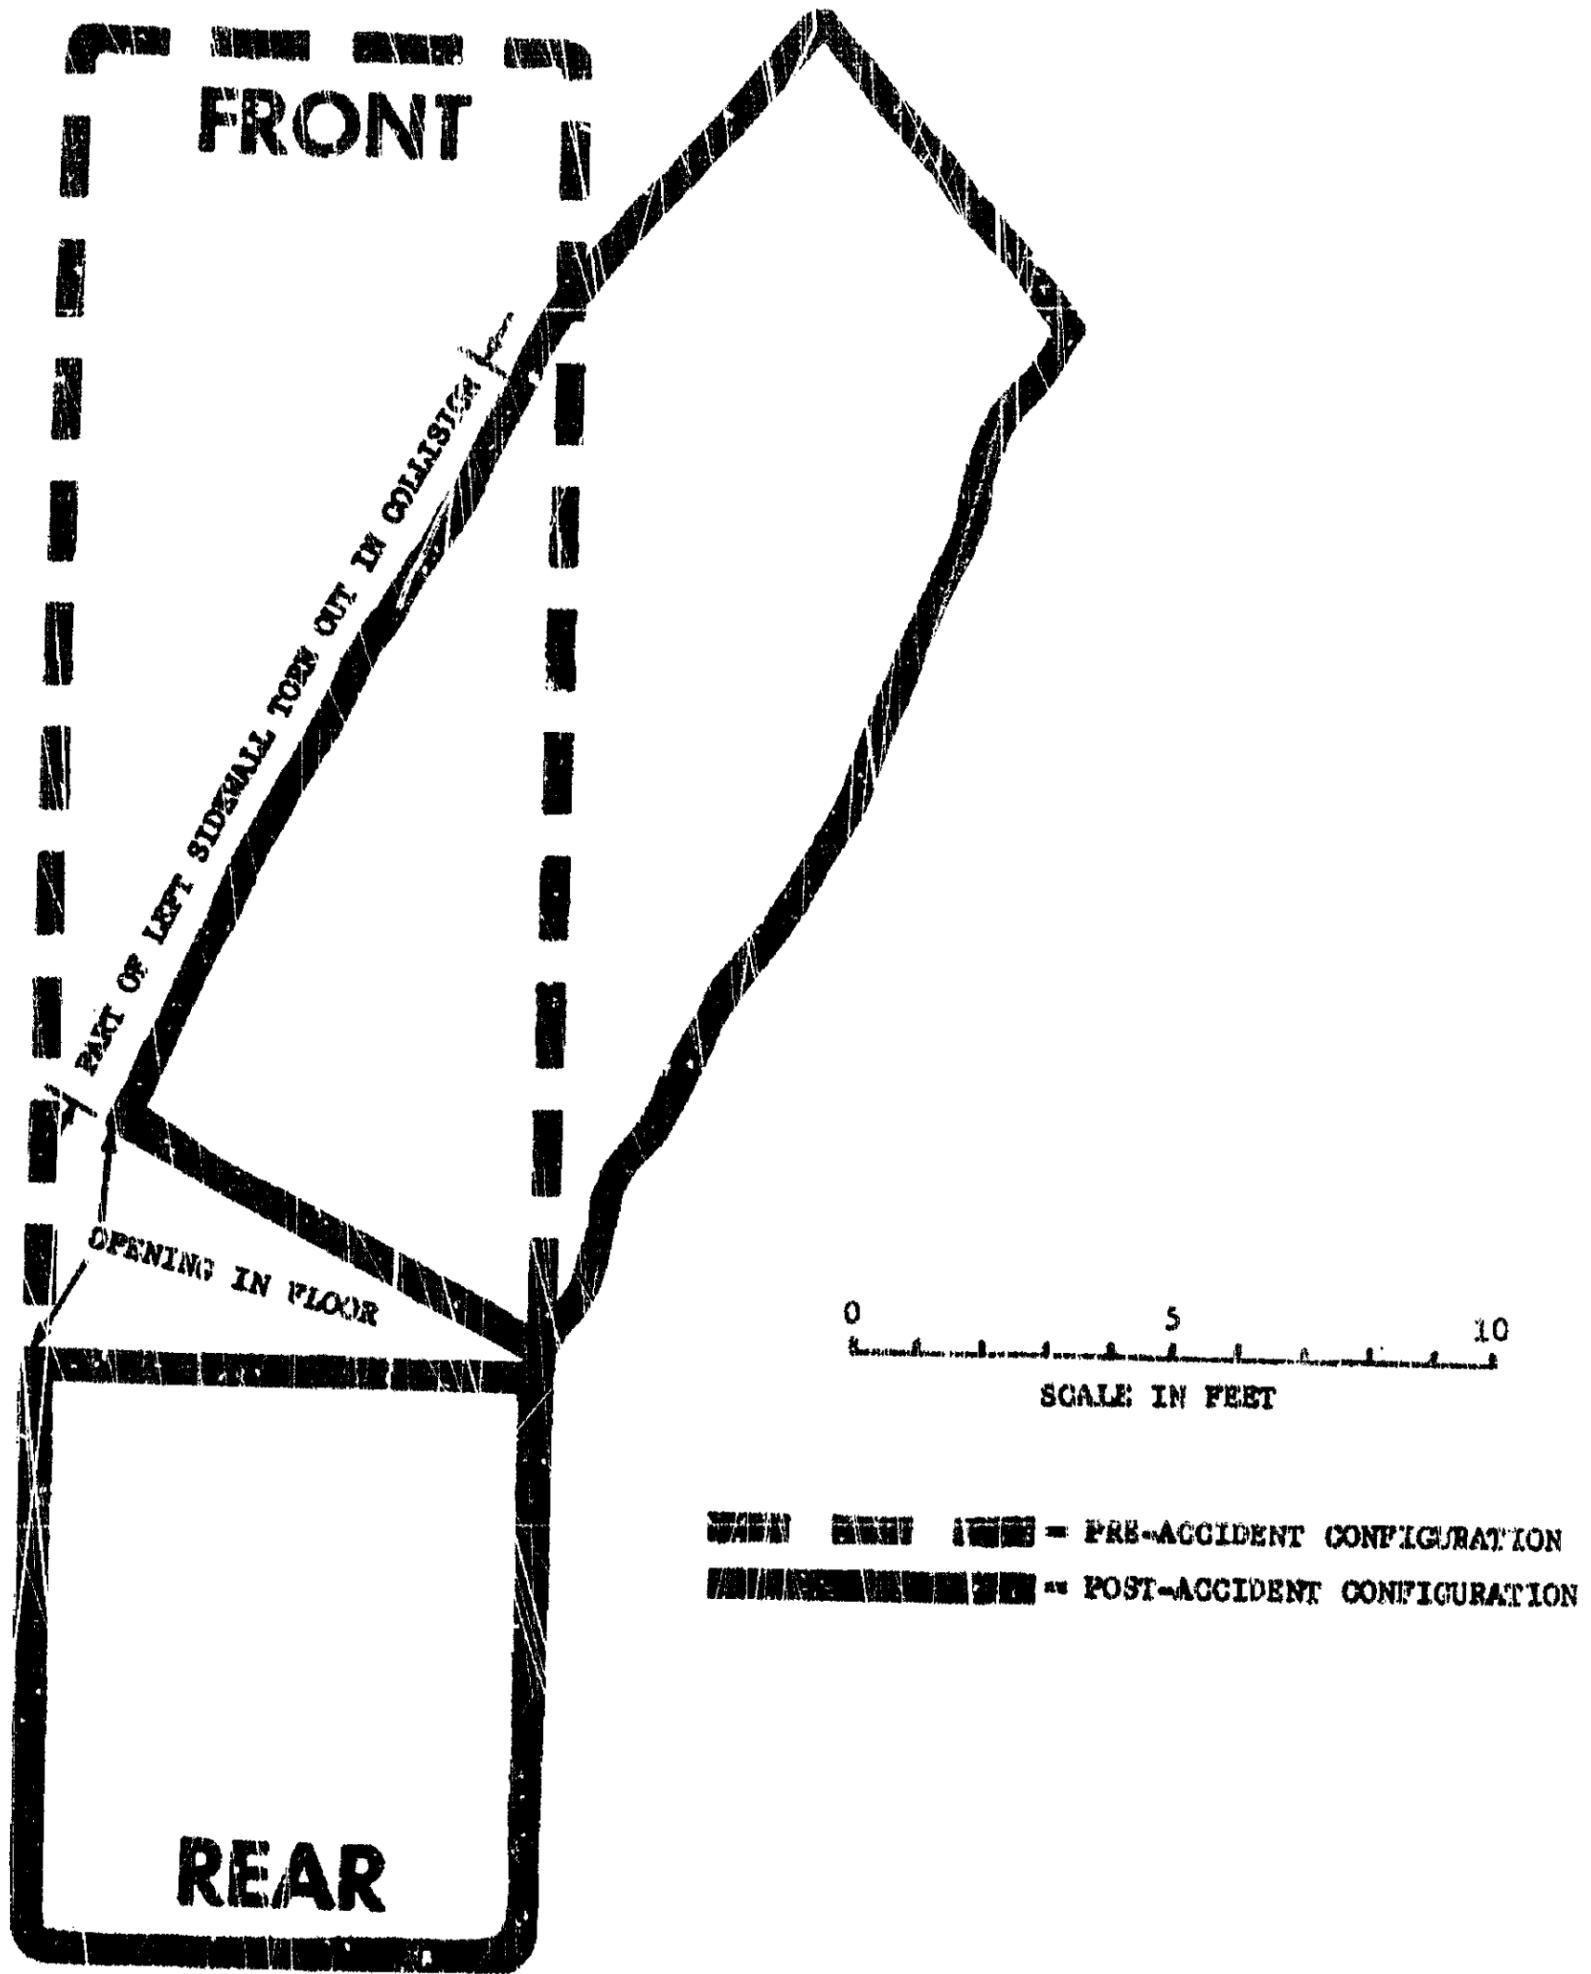
Figure 7.—Deformation of schoolbus body at floor level

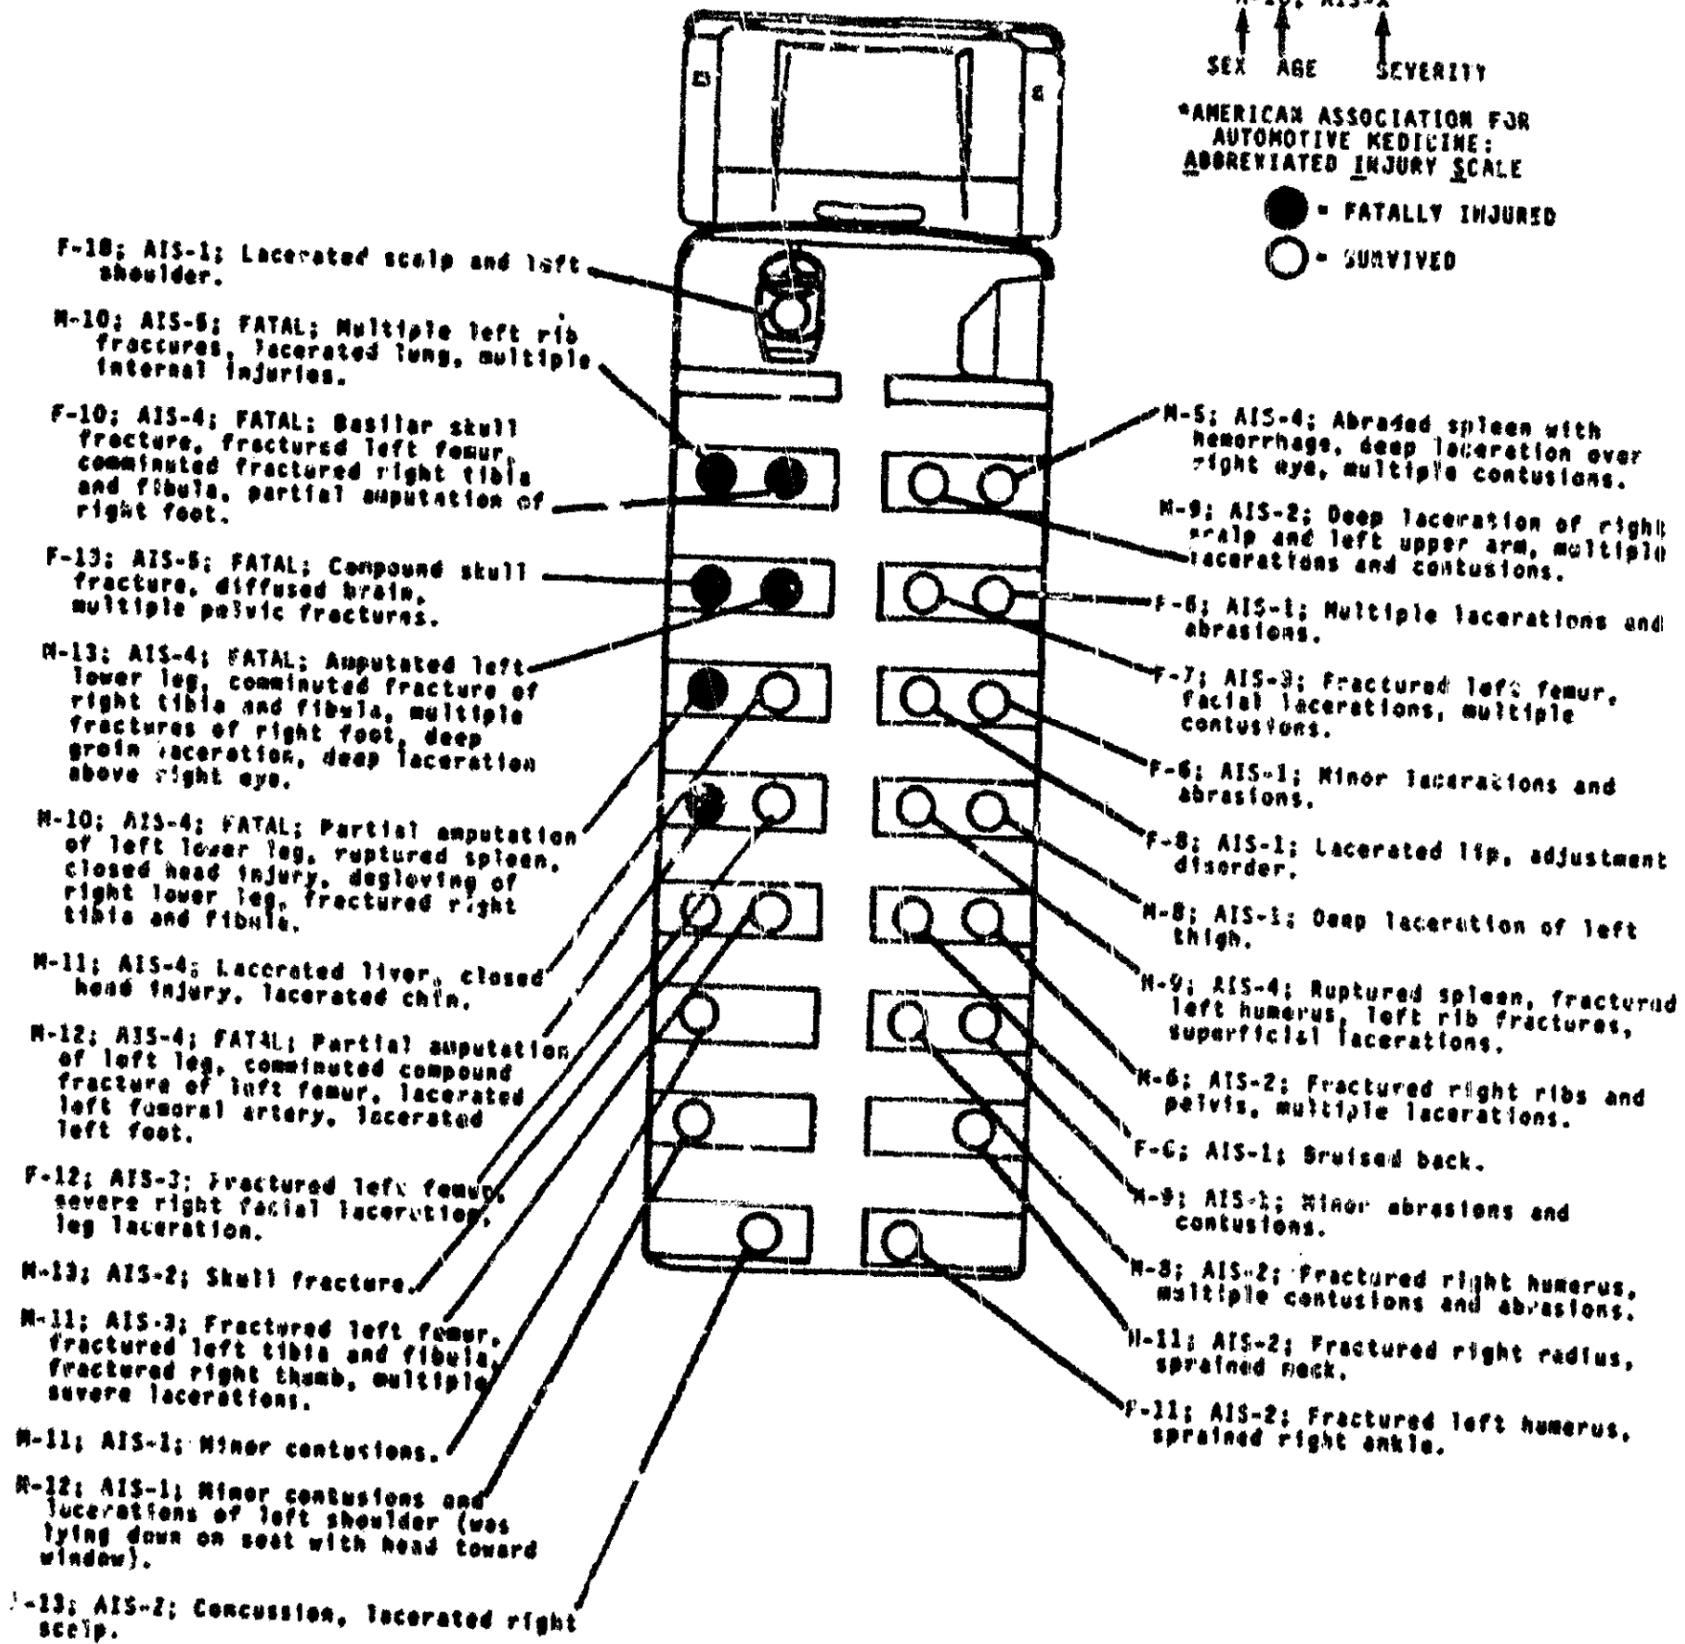
Figure 9.--Schoolbus occupant seating and injury chart.

The six schoolbus passengers who died were seated on the left side behind the driver; two in the first seat, two in the second seat, and one each in the outboard seats of the third and fourth rows next to the left sidewall. Their injuries included multiple fractures (including skull fractures), internal injuries, limb amputations, and severe lacerations. All six surviving students who were either seriously or severely injured were seated in the first five rows of the schoolbus; these students sustained fractures, lacerations, and some moderate internal injuries, abrasions, and contusions. (See figure 9.)

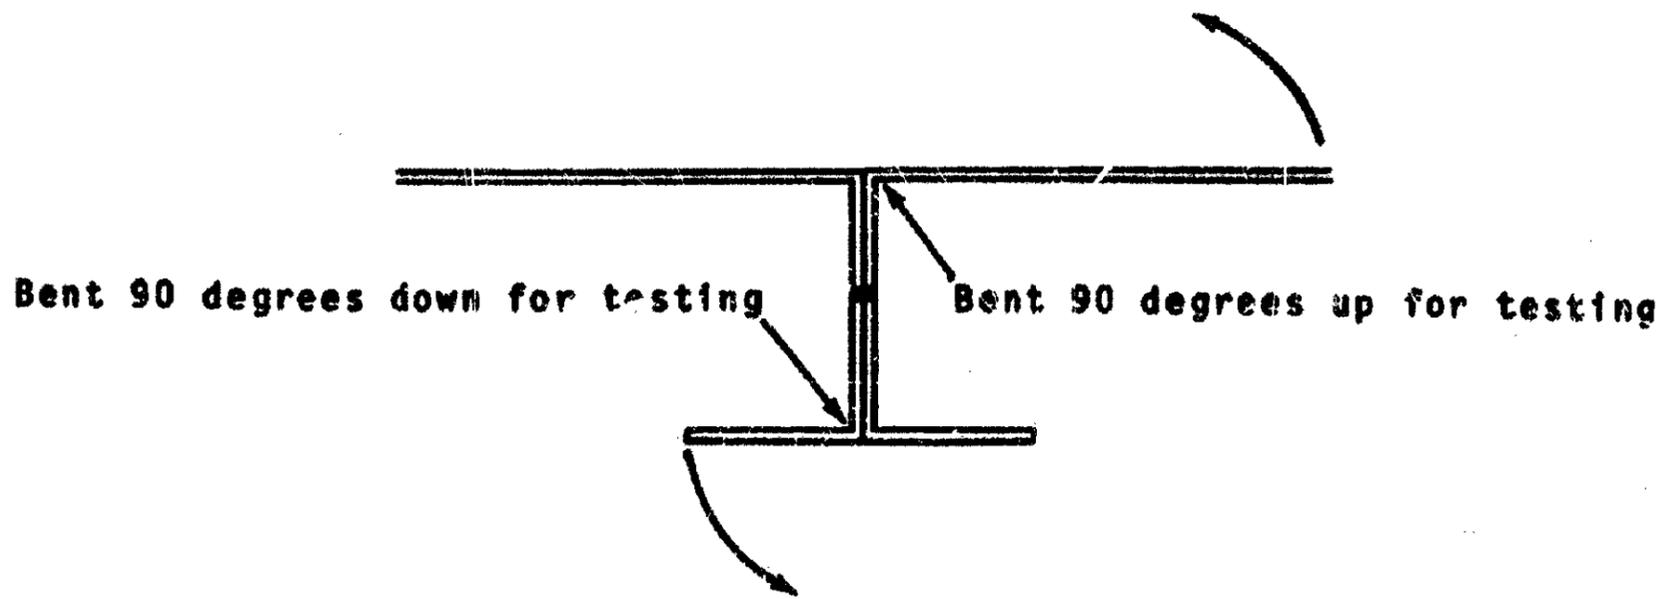
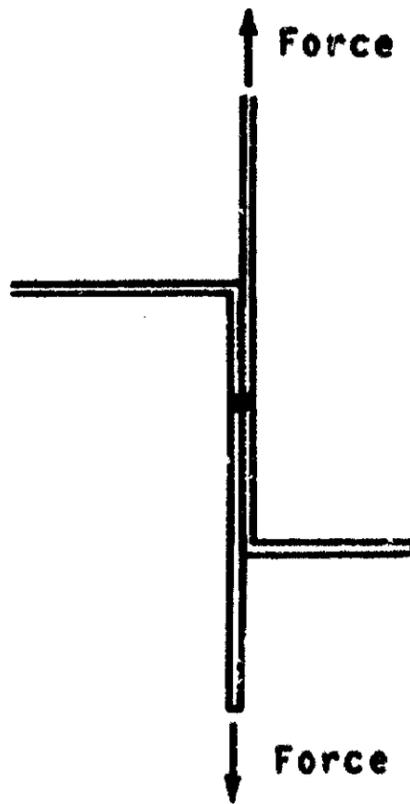
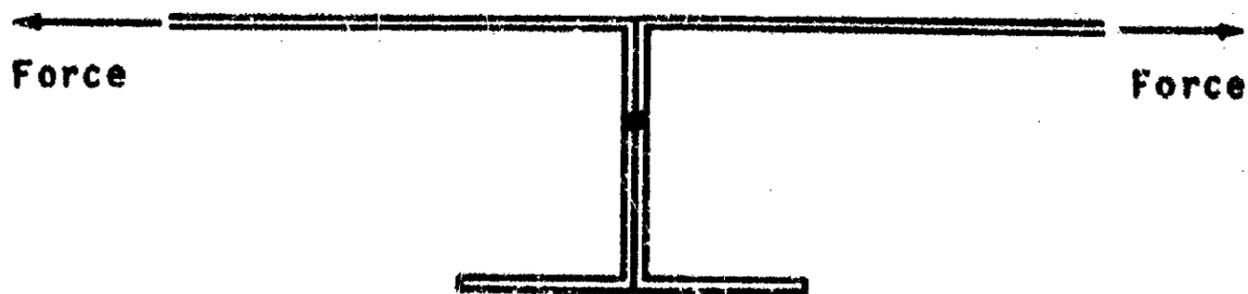
Figure 10.--NHTSA and Safety Board floor joint strength test procedures.

The Safety Board test procedure did not involve a modification of the floor panel joint configuration. The floor panel joint was mounted in a test fixture which applied equal and opposite forces to each floor panel subjecting the joint to peeling forces. (See figure 10.)

Safety Board tests of three floor joint specimens from the Snow Hill accident schoolbus determined that the first floor joint specimen failed at 1,328 pounds; the second specimen failed at 1,226 pounds; and the third joint specimen failed at 1,214 pounds. The strength of the strongest joint specimen tested (2,213 psi) was 7 percent of the strength required for the floor joint to meet the joint strength requirement of FMVSS 221.
