Highway Accident Report
Tractor-Semitrailer/Station Wagon
Runaway, Collision, and Fire
Van Buren, Arkansas, June 21, 1985

(U.S.) National Transportation Safety Board
Washington, DC

1. Report No. NTSB/HAR-86/03		2. Government Accession No. PB86-916203		3. Recipient's Catalog No.	
4. Title and Subtitle Highway Accident Report -- Tractor-Semitrailer/Station Wagon Runaway, Collision, and Fire, Van Buren, Arkansas, June 21, 1985				5. Report Date August 8, 1986

**TRACTOR-SEMITRAILER/STATION WAGON
RUNAWAY, COLLISION, AND FIRE
VAN BUREN, ARKANSAS
JUNE 21, 1985**

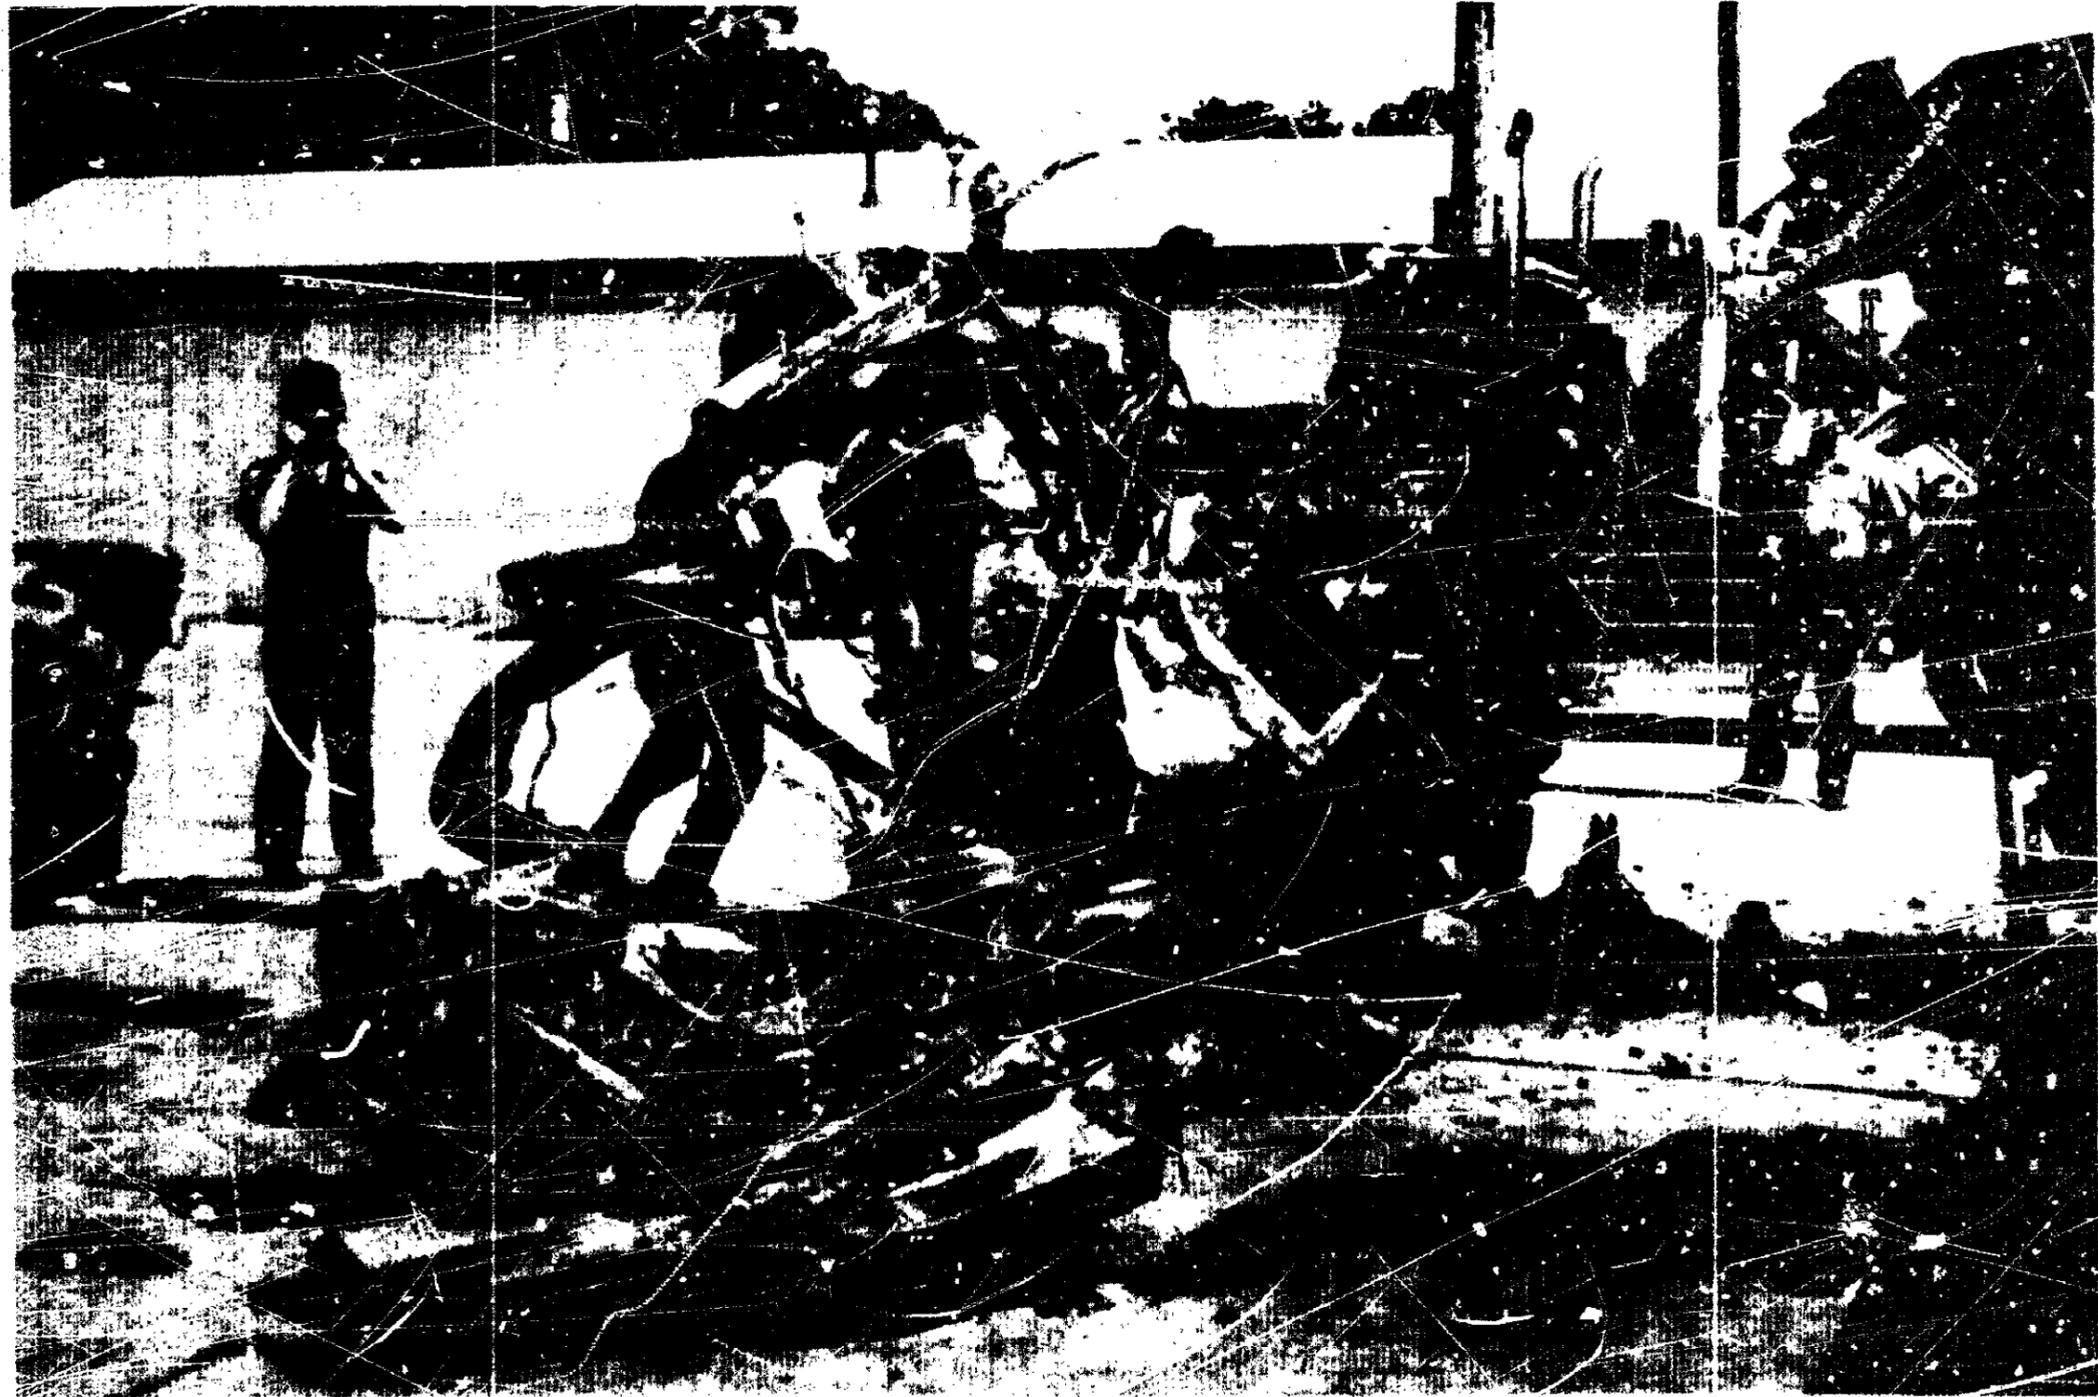
Figure 5.—Remains of station wagon.

Station Wagon.--The four-door, 1977 Oldsmobile station wagon was equipped with a V-8 engine, automatic transmission, power steering, and power brakes. At the time of the accident, the station wagon and its seven occupants weighed about 5,243 pounds. As a result of the impact, there was no survivable space available in the station wagon. As a result of the postcrash fire, all flammable and low melting temperature materials in the station wagon were destroyed. The front bumper was bent 8 inches inward on the left side and the chassis sustained massive impact damage in the rear. The rear axle, the rear bumper, and the trailer hitch were separated from the chassis, and both frame rails were bent at a 15° angle to the right. The bottom of the gas tank was ruptured 15 inches laterally. (See figure 5.)

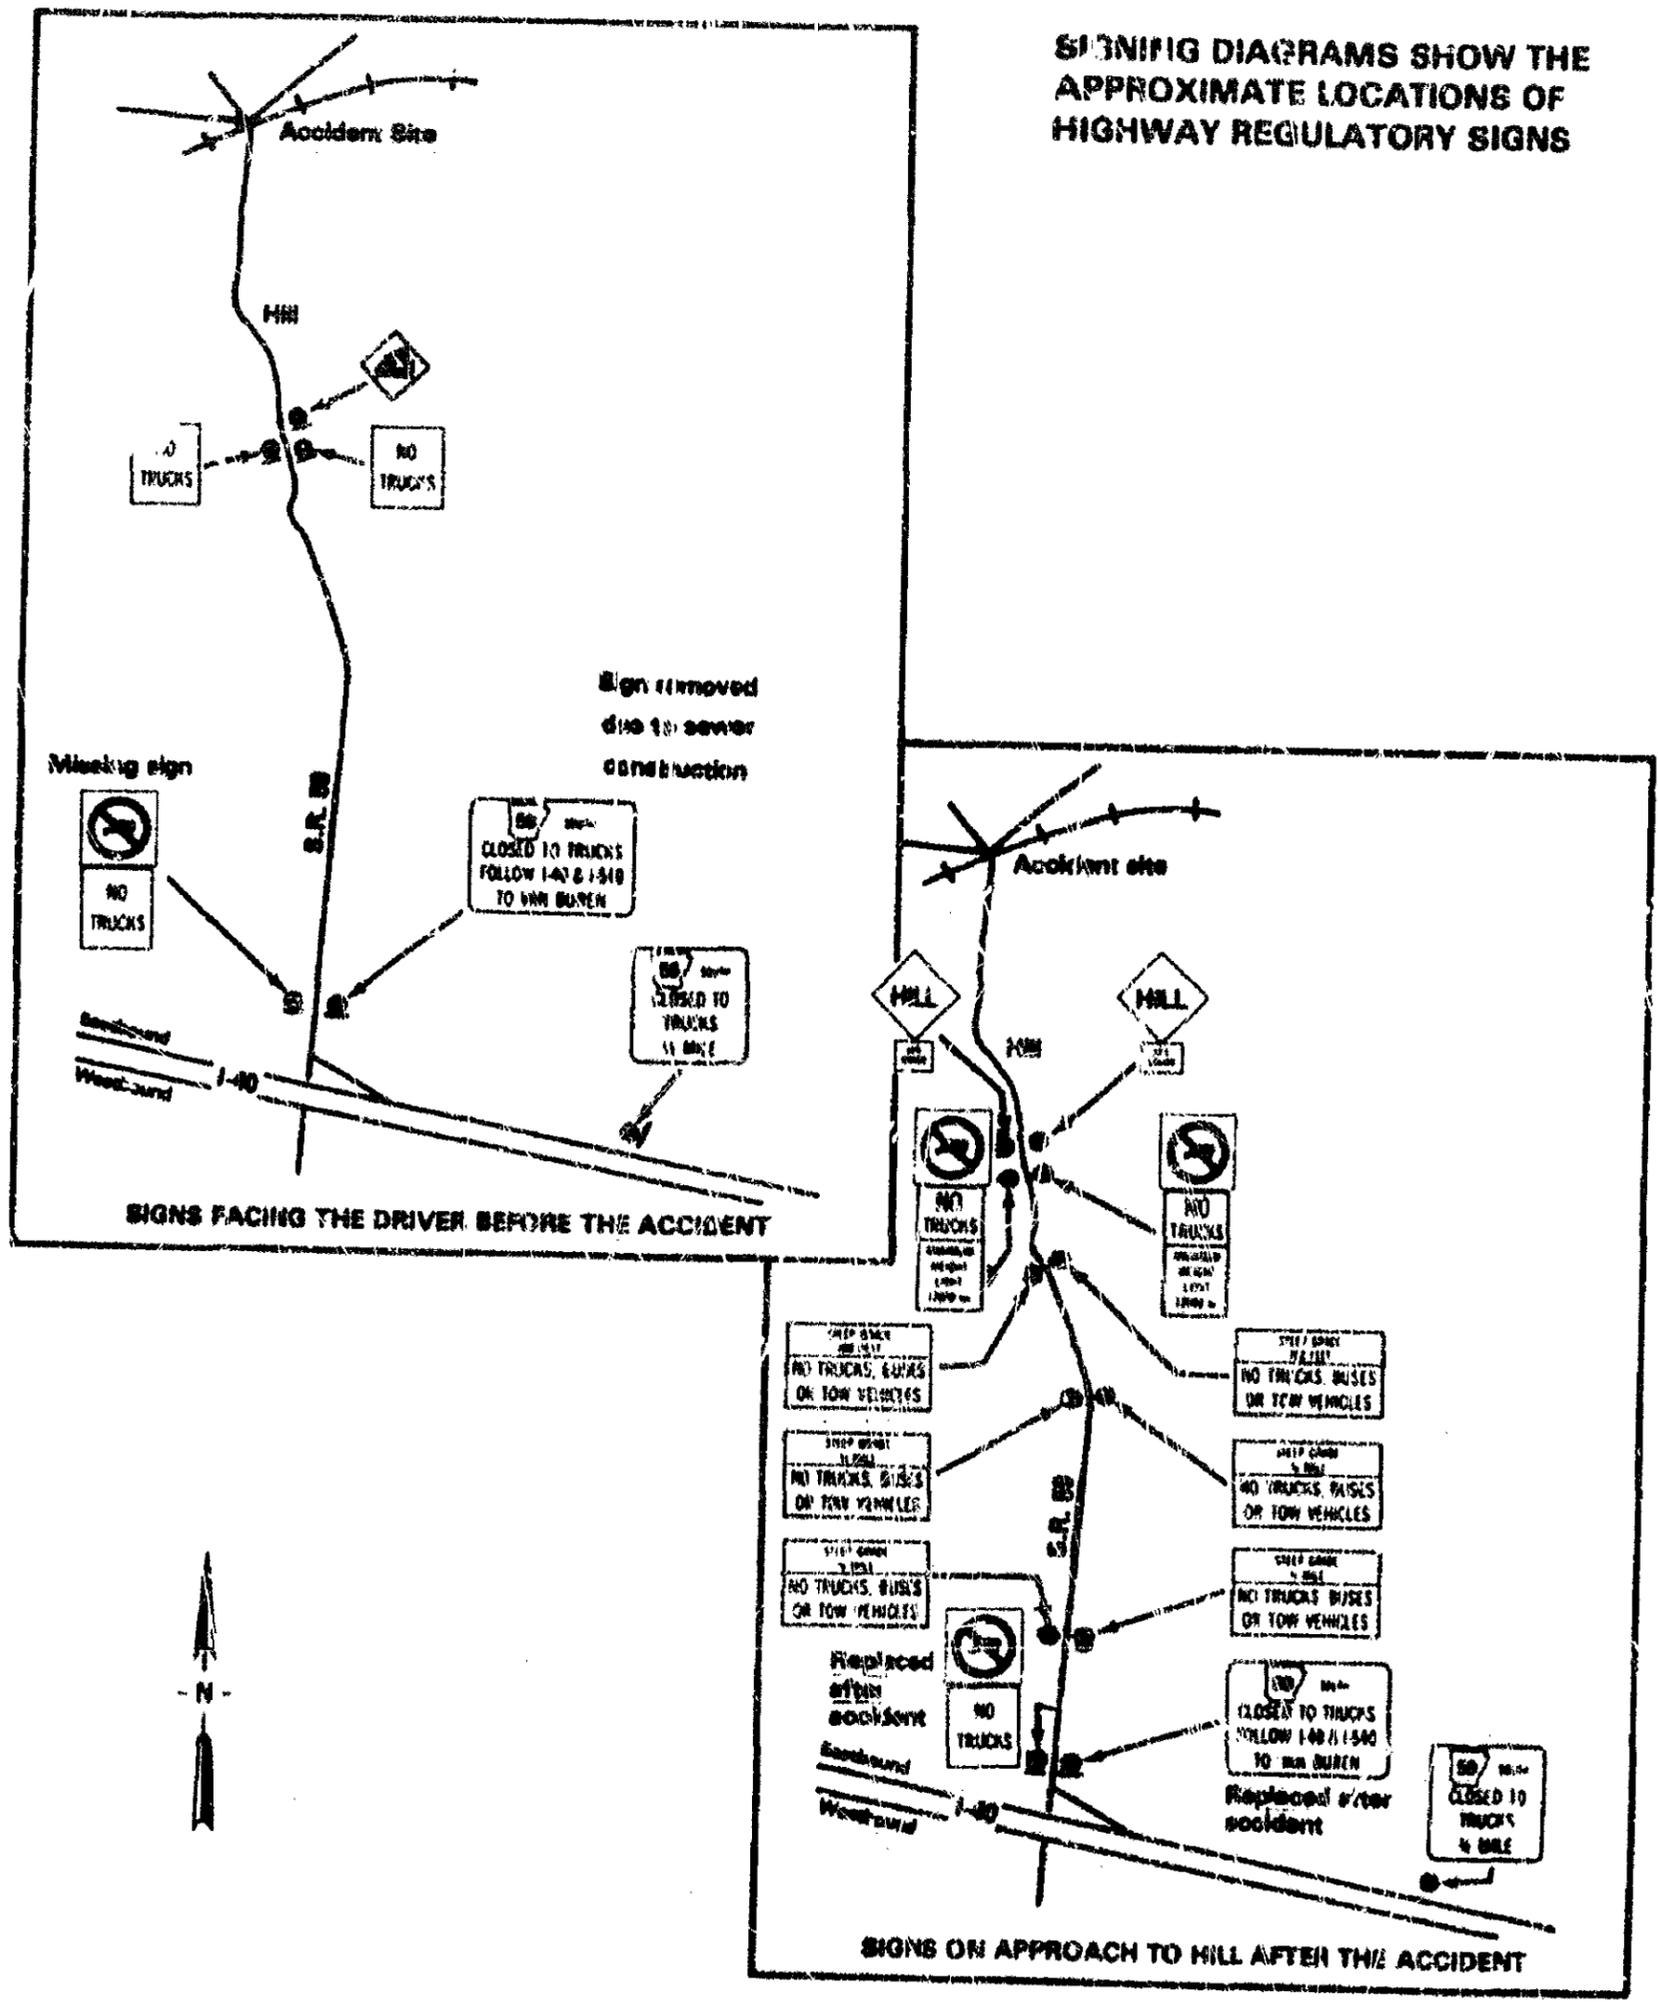
Figure 6.—Highway signing on the approach to the accident site.

Signing.--At the time of the accident, highway regulatory signs in two locations warned truckdrivers traveling east on I-40 and south on SR 59 that trucks are prohibited on southbound SR 59. (See figure 6.) The signs were located on eastbound I-40 about 1/2 mile from the southbound SR 59 exit and on southbound SR 59 at the hillcrest about 6,300 feet south of I-40.

A private sewer construction crew that was working in the area had removed a regulatory sign on the right side of the access road south of the intersection of the I-40 exit ramp and facing southbound SR 59. In addition, a small regulatory sign opposite this sign on the left side of the road in the sewer construction area was missing. The permit, which was issued by the Arkansas State Highway and Transportation Department (ASHTD), required the contractor to "protect traffic," allowed the use of portable signs, and required signing to be in compliance with the Federal Highway Administration's Manual on Uniform Traffic Control Devices (MUTCD). However, the permit contained no specific provisions for maintaining, in place, where appropriate, highway signs during construction.
