Highway Accident Report  
Intercity Bus Loss of Control and Collision with  
Bridge Rail on Interstate 70 Near  
Frederick, Maryland, August 25, 1985

(U.S.) National Transportation Safety Board  
Washington, DC

22 Jan 87

1. Report No. NTSB/HAR-87/01	2. Government Accession No. PB87-916201	3. Recipient's Catalog No.	
4. Title and Subtitle Highway Accident Report--Intercity Bus Loss of Control and Collision with Bridge Rail on Interstate 70 Near Frederick, Maryland, August 25, 1985		5. Report Date January 22, 1987

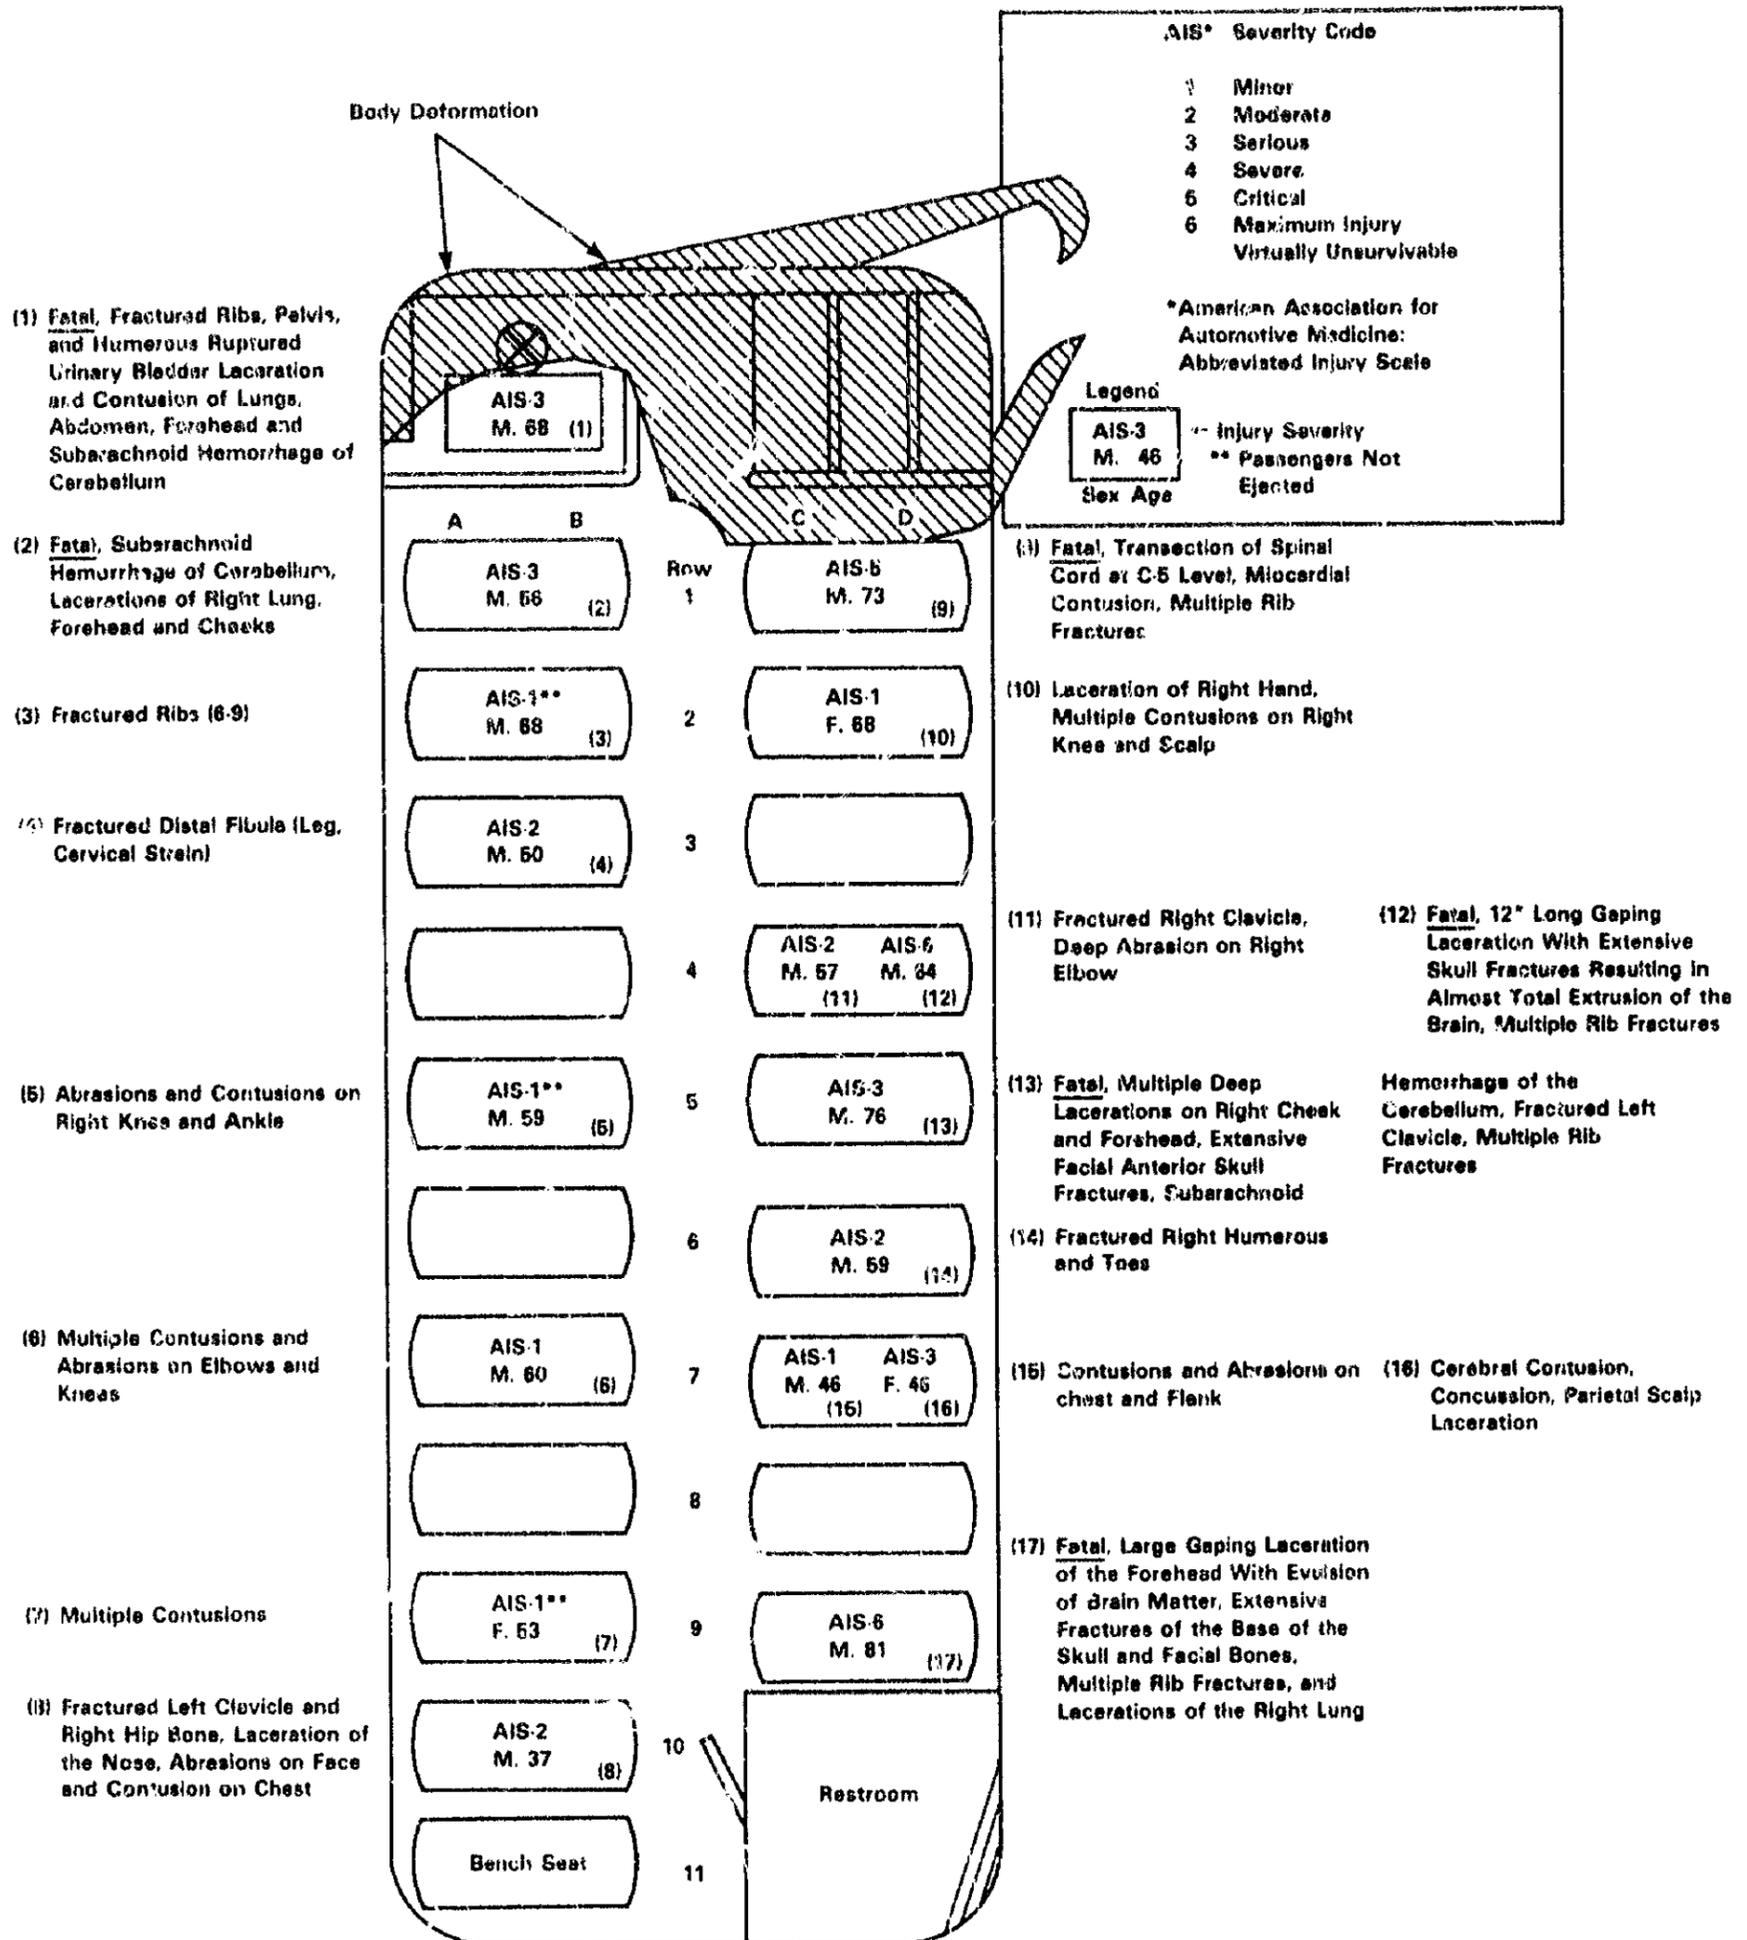
The busdriver and 13 passengers were ejected from the bus. Only the driver's seat was equipped with an occupant restraint. However, the driver was not wearing the lap belt at the time of the accident.

Figure 3.—Bus seating chart noting occupant age, sex, AIS injury severity, and seat location.

The three passengers who were not ejected sustained only minor injuries in the accident and were seated in the second, fifth, and ninth rows on the left side of the bus. One passenger remained inside the bus because he was pinned in his seat, another passenger anticipated the collision and braced himself appropriately, and the third passenger's ejection path was blocked by a loose seat cushion.

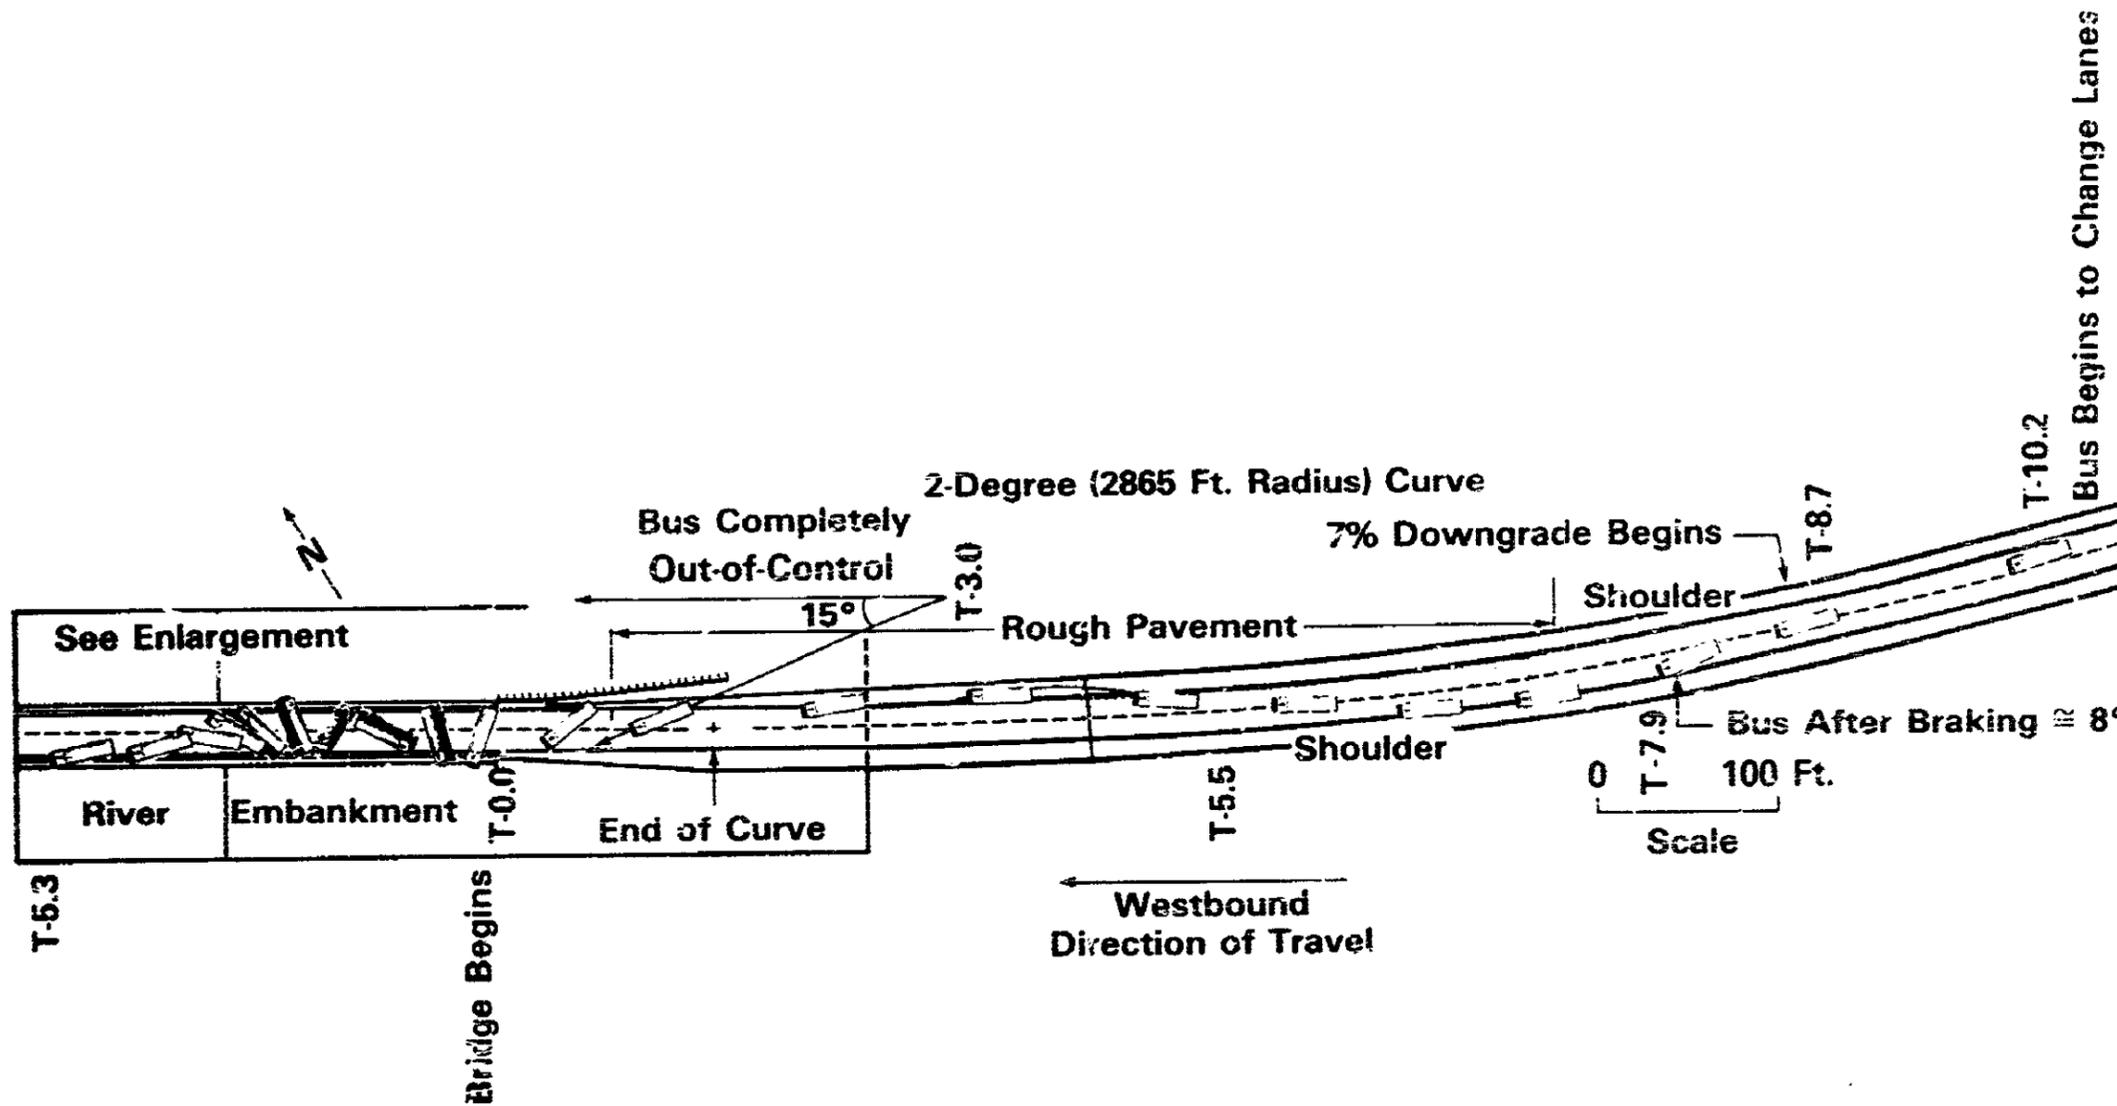
Figure 4.—Accident site on I-70 westbound lanes near Frederick, Maryland.

entire dynamic sequence, the bus traveled between 900 and 1,100 feet from the point where the initial loss of control occurred to its final resting position on the bridge. (See figures 4 and 5.)

Based on the analysis of the accident dynamics, and the distance the bus slid to rest, the busdriver probably lost control of the bus initially while traveling between 58 and 63 mph, and the bus probably struck the bridge rail between 48 and 53 mph. The speed at which the bus in the postaccident vehicle handling tests appeared to be on the verge of instability tends to corroborate these estimated speeds. Near loss of control of the test bus began just before 62.9 mph during the change in lanes from right to left while the driver was braking the vehicle.

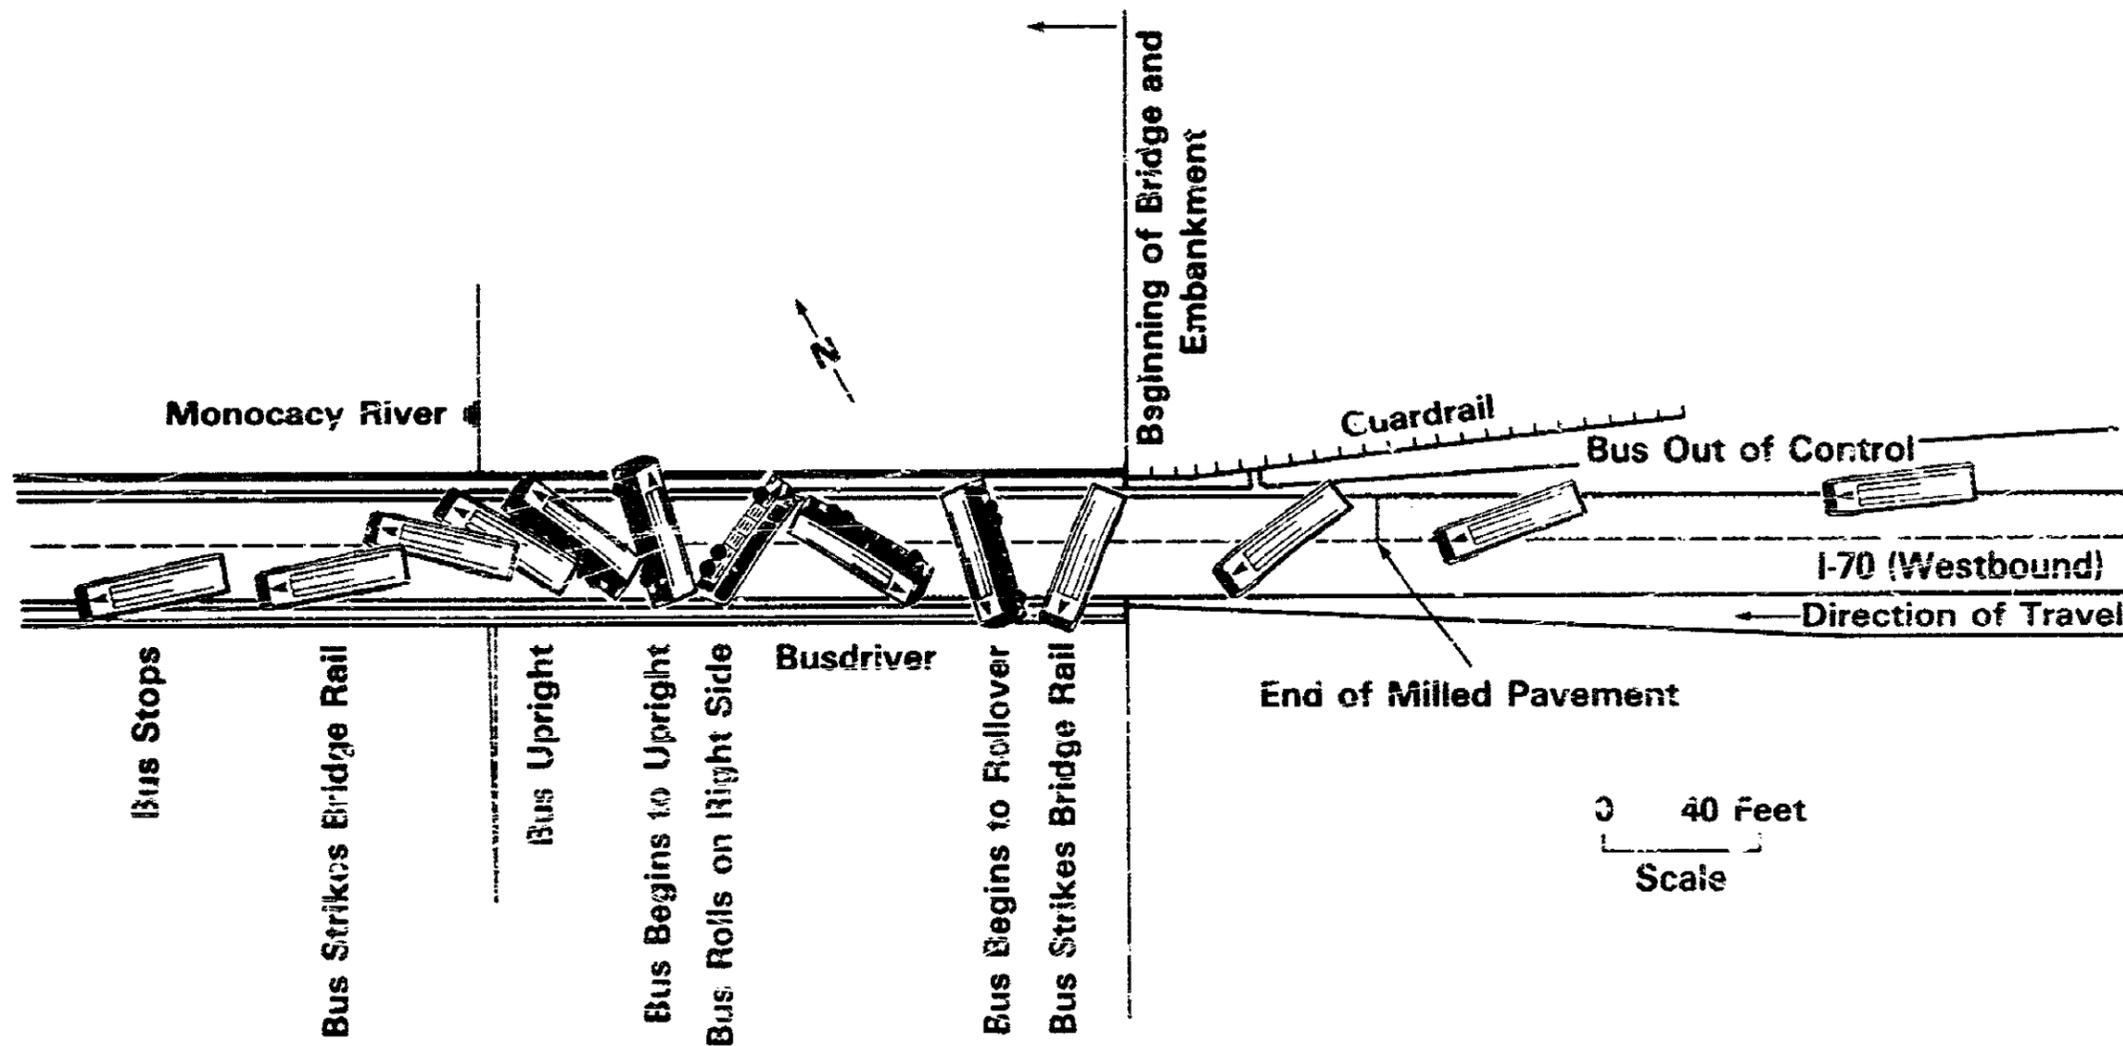
Figure 5.—Enlargement of bus dynamics.
