Highway Accident Report - Schoolbus-Loss of  
Control and Collision with Guard Rail and Sign  
Pillar, U.S. Highway 70 near Lucas and Hunt Road  
St. Louis County, Missouri, November 11, 1985

(U.S.) National Transportation Safety Board  
Washington, DC

14 Apr 87

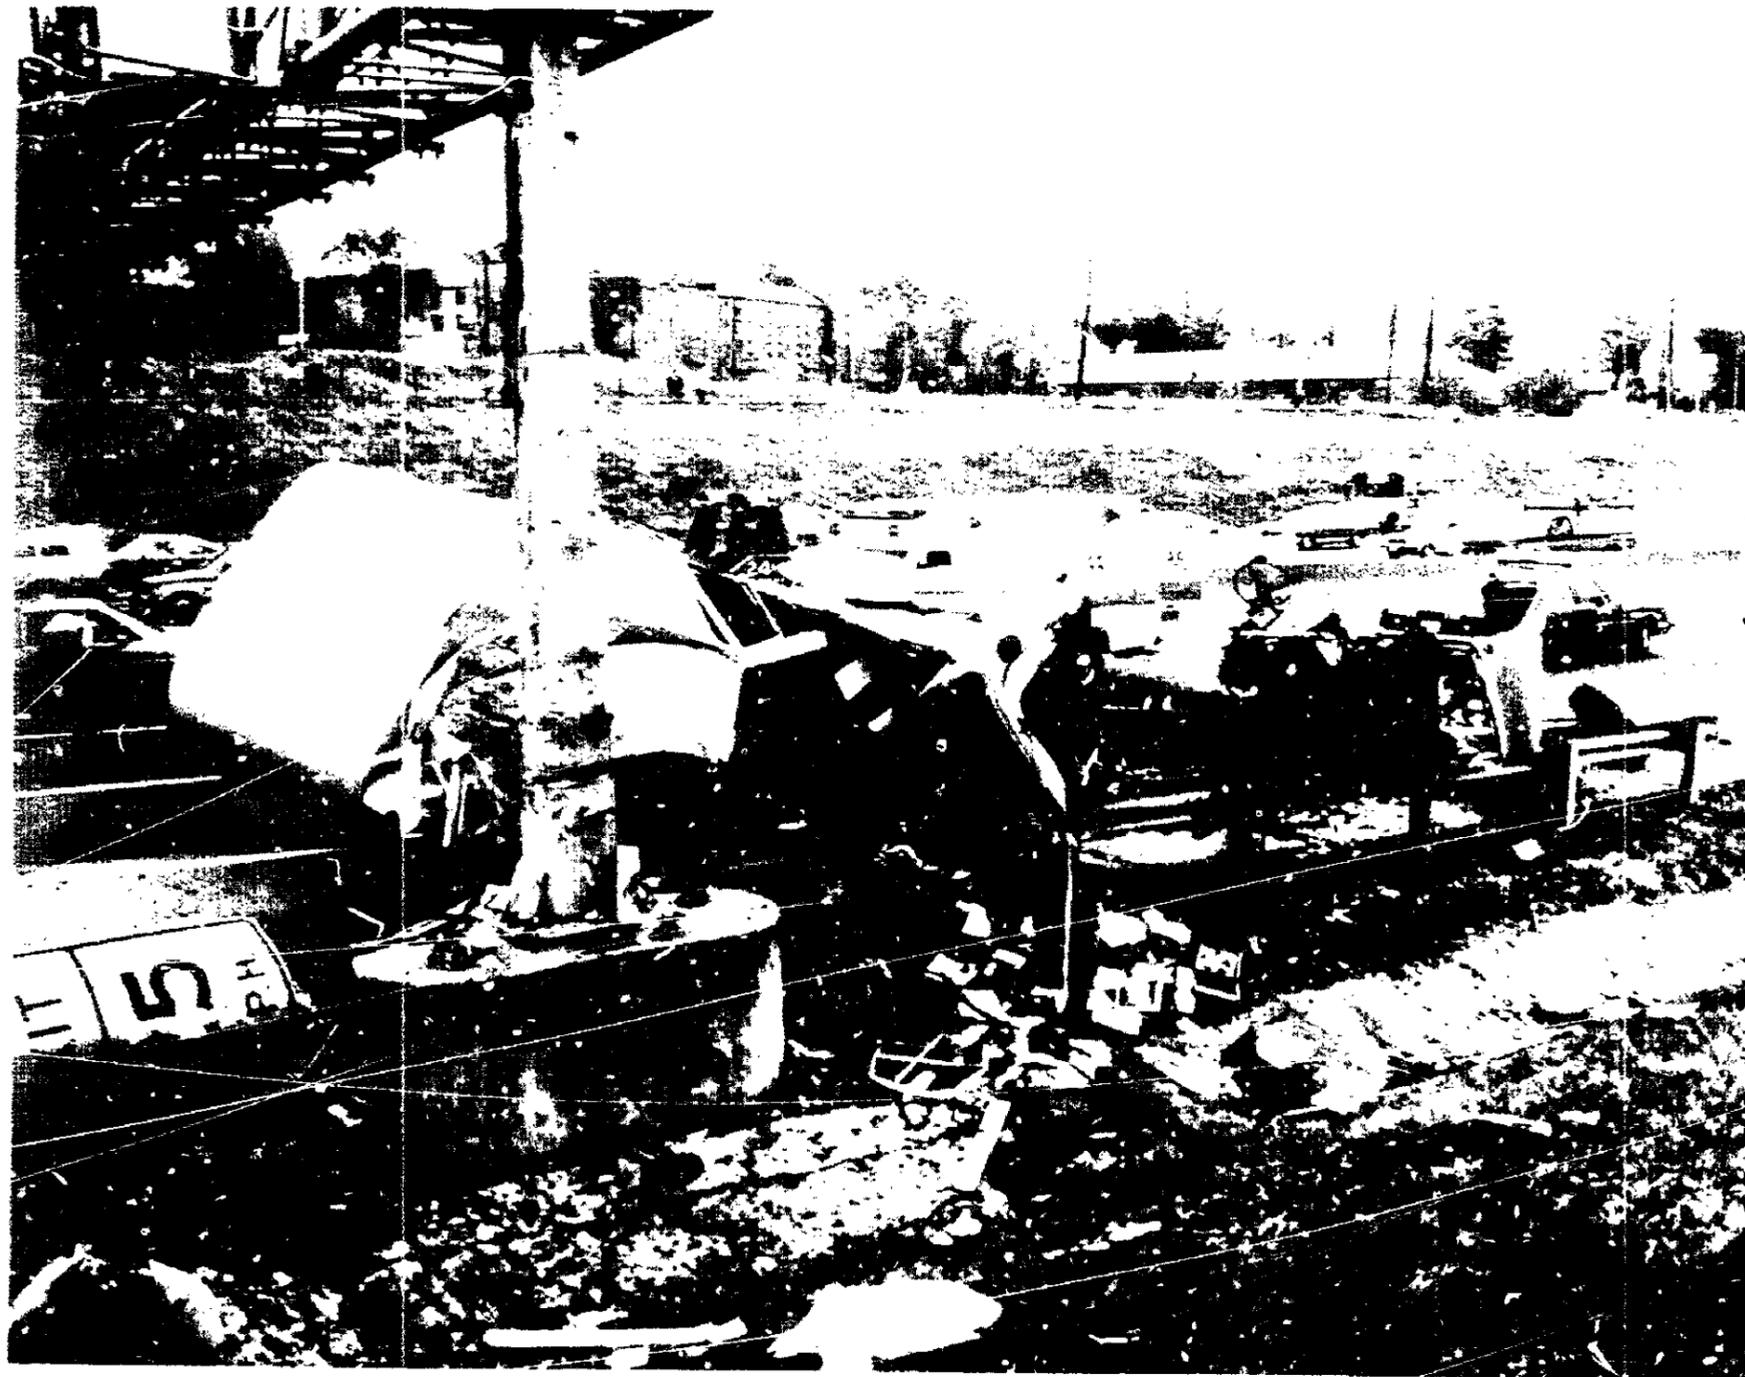
Figure 3.--Opening at front of schoolbus body.

There was extensive contact damage to the front of the schoolbus body. Both front support pillars of the body were separated at their point of attachment to the roof and the roof was displaced downward and to the driver's right. The first two support pillars separating the windows on the right side separated from their attachments to the schoolbus body at the bottom of the window wells. A 24-inch wide semi-circular indentation started at the right front of the roof and extended back obliquely 8.6 feet toward the center of the schoolbus body. This indentation was at a 54° angle to horizontal level and penetrated downward to a distance of 24 inches above the floor at the right front of the schoolbus body.

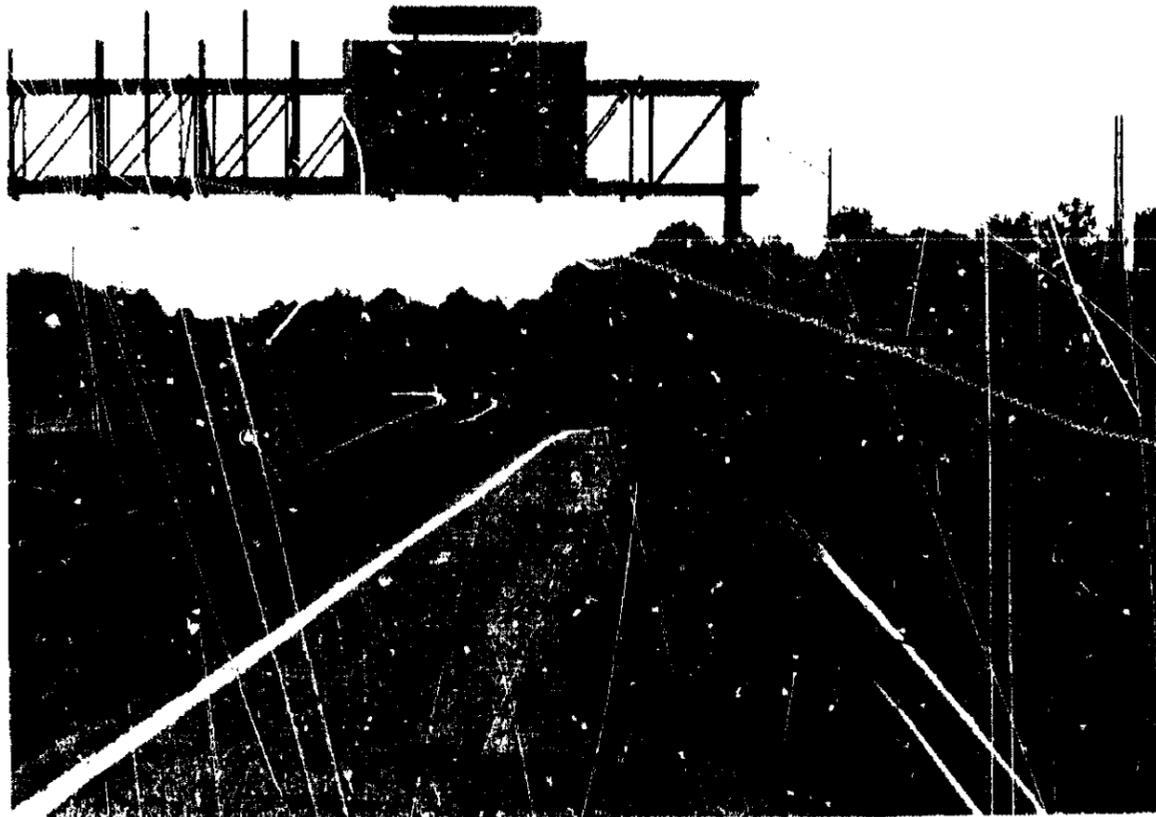
Based upon measurements and photographs taken of the damaged guard rail at the accident site by the St. Louis County Police Department, the first contact damage to the guard rail started about 27 feet west of the pillar. Continuing eastward, the amount of deflection of the guard rail increased until at a point about 12 feet west of the pillar the guard rail was deflected about 4 feet, 2 feet past the north face of the concrete pedestal.

Figure 8.—Guard rail and sign support pillar looking east.

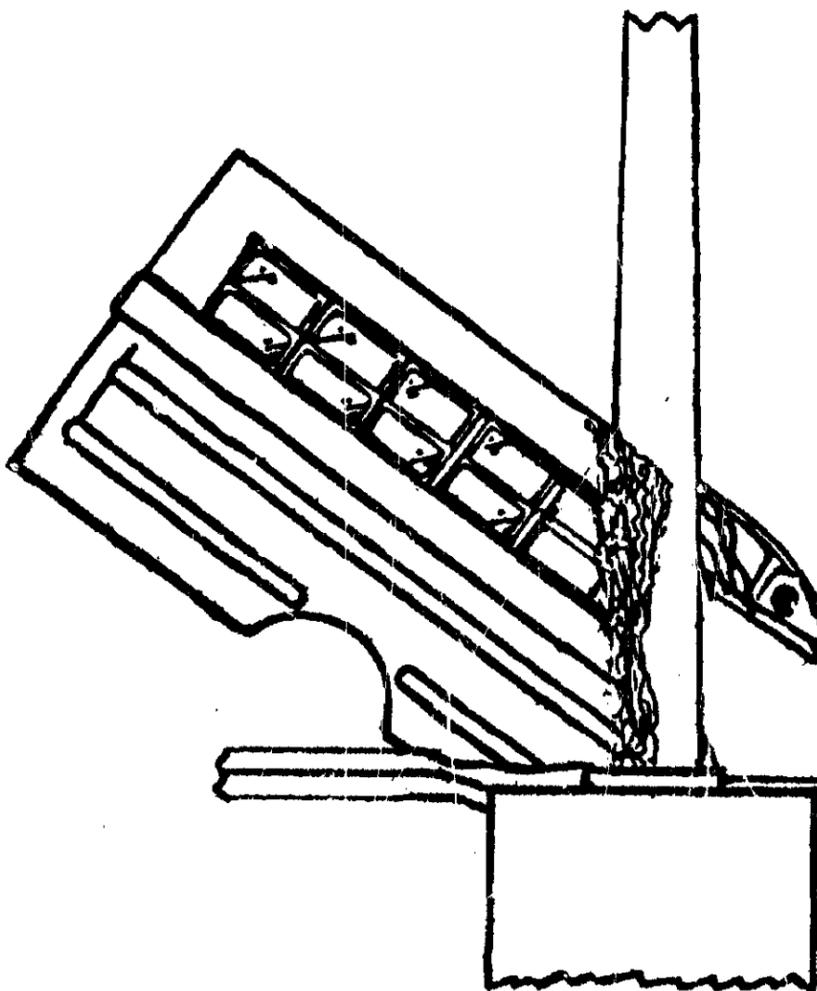
At the same time the chassis was being redirected back toward a path parallel to the guard rail, the momentum of the upper part of the schoolbus body carried it further outboard over the guard rail as the collision sequence progressed and until the right front of the schoolbus body collided with the top of the concrete pedestal and the sign pillar. The angle of the 24-inch wide semicircular indentation extending obliquely across the schoolbus roof shows that at the point of maximum engagement the schoolbus body rode up on the sign pillar to an angle of about  $54^\circ$  to horizontal level. (See figure 13.)

Figure 13.--Side view of collision of schoolbus body with sign pillar.

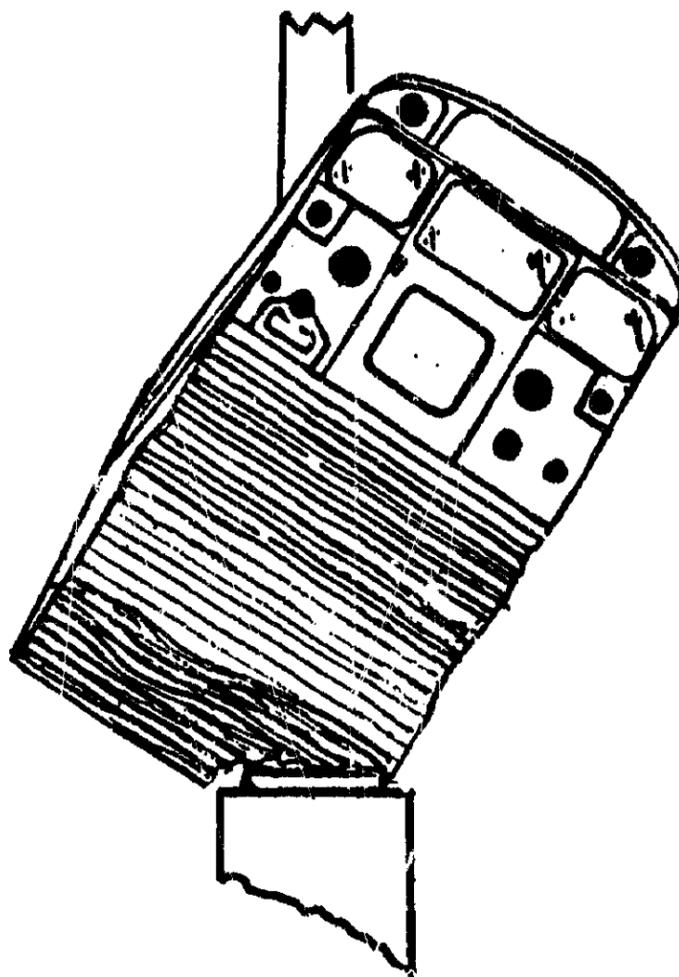
Figure 14.—Rear view of collision of schoolbus body with sign pillar.
