Highway Accident/Incident Summary Report  
Alexandria, Virginia, April 4, 1987

(U.S.) National Transportation Safety Board  
Washington, DC

1. Report No. NTSB/HAR-87/04/SUM	2. Government Accession No. PB87-916210	3. Recipient's Catalog No.	
4. Title and Subtitle Highway Accident/Incident Summary Report		5. Report Date December 30, 1987

Accident No.:	DCA-87-MH-004
Location:	Alexandria, Virginia
Date:	April 4, 1987
Time:	7:15 p.m. e.s.t.
Occupants:	1 driver, 65 passengers
Operator:	Spirit of '76 Tours
Damage:	Approximately \$25,000
Injuries:	1 fatal; 32 nonfatal
Type of Accident:	Collision with arched stone overpass

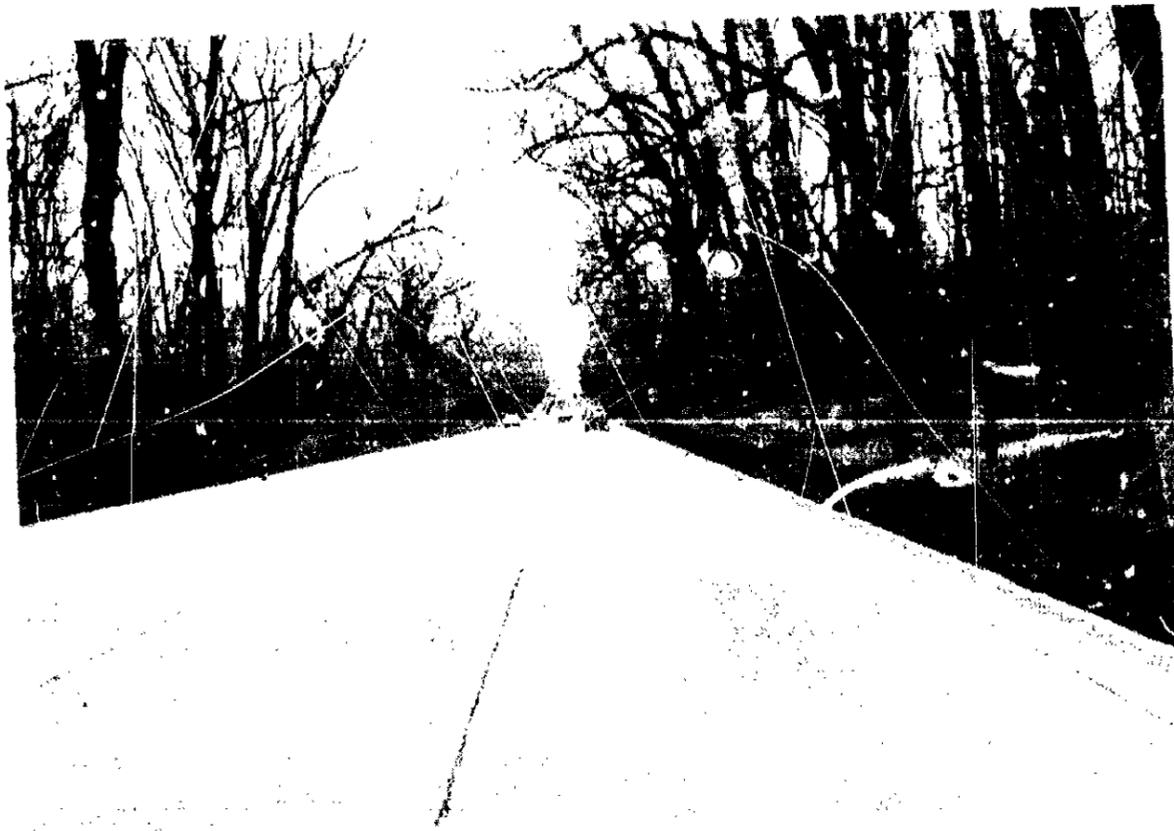
Control Devices" (MUTCD) 1/ be acquired and installed in advance of and over each lane at the overpass. (See appendix D.) The design and ordering of the signs was in the NPS procurement process when the accident occurred. As an interim measure, the NPS installed temporary "Low Clearance" signs in advance of both approaches to the overpass on December 19, 1986. These signs, however, were not in conformance with the MUTCD.

Figure 2.—Southbound approach to accident site showing W12-2 warning signs.

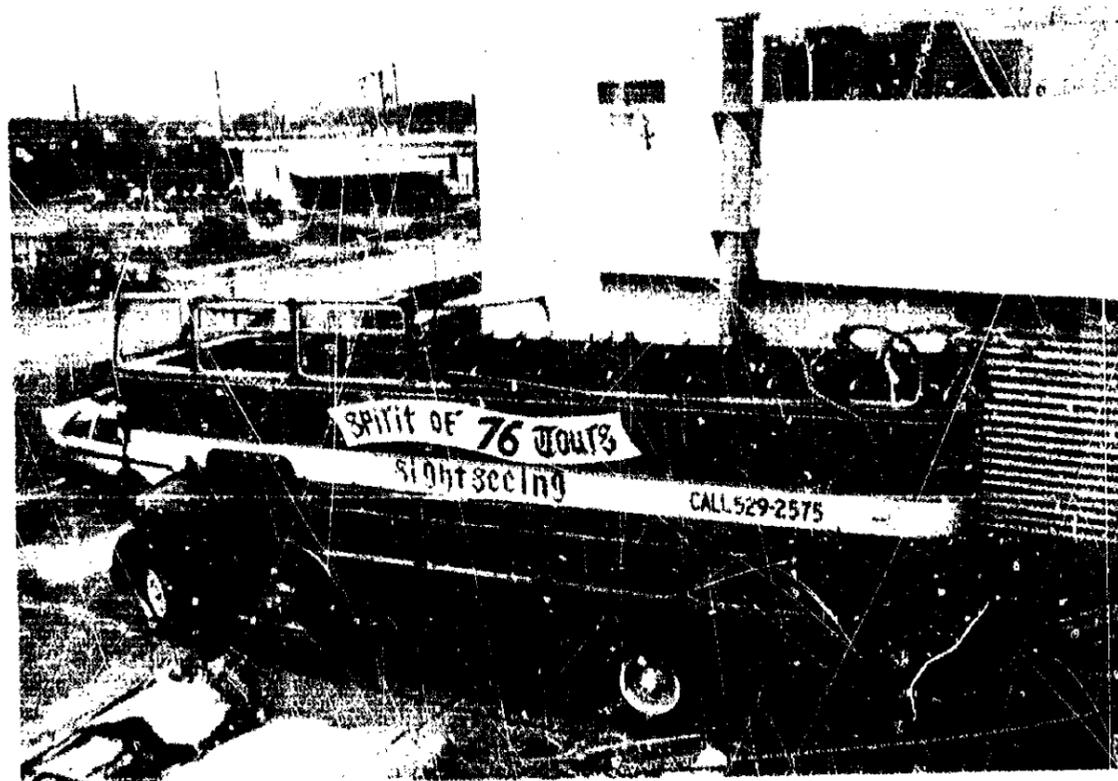
The bus was a British 1964 Bristol "LODEKKA" Model FLF right-hand drive (separate driver's compartment) double-decked sightseeing tour bus. (See appendix B, figure 4.) It had five forward speeds and was designed to transport 70 passengers--38 on the upper level and 32 on the lower level. The exits consisted of a main entry which was a four-panel folding door on the forward left side, a floor-level emergency exit door in the rear on the main level, and an emergency exit window above the last seat across the rear of the upper level. The bus height was 13 feet 2 inches, the length was 30 feet, the wheelbase was 19 feet 2 inches, and the width was 7 feet 11 1/2 inches. There was no placard indicating vehicle-height clearance in the driver's compartment. Safety Board investigators inspected the bus on April 8, 1987, at the U.S. Park Police Station, Anacostia, Washington, D.C.

The damage to the right front of the upper level extended downward vertically 26 inches. At the center line of the upper level, the damage extended downward 18 inches. At the front of the bus, the roof was compressed 34 inches rearward, and the entire roof was sheared at the upper deck window belt line. No other damage was noted on the bus. The inspection did not reveal any preexisting mechanical conditions that may have contributed to the accident.

Figure 4.--Double-decked British sightseeing tour bus.

Since these vehicles may be driven in this environment, the Safety Board believes that double-decked buses should have a placard or decal indicating vehicle height in the driver's compartment for quick reference. This will ensure that busdrivers will take appropriate action when they come to a low-clearance structure.

Recommend that members apply a placard or decal indicating vehicle height to the interior of double-decked buses for the driver's quick reference. (Class II, Priority Action) (H-87-62)

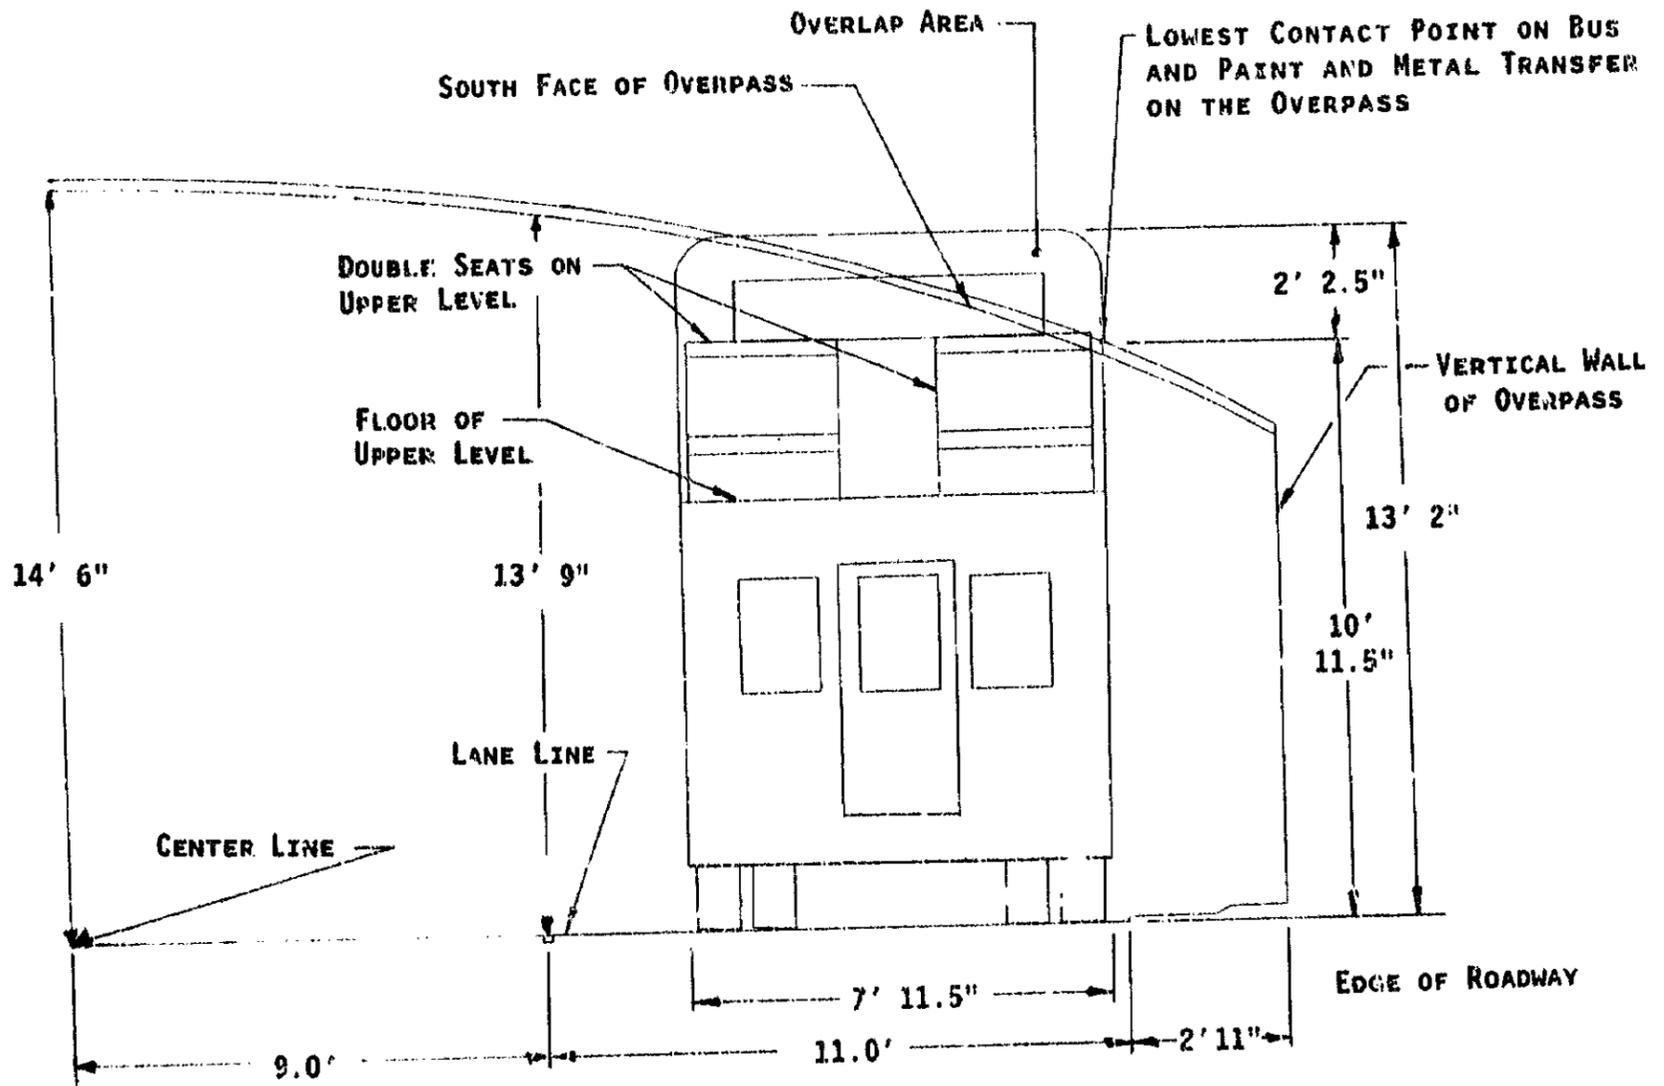
DIAGRAM OF ARCHED STONE OVERPASS AND TOUR BUS COLLISION POINT

At the accident site, the concrete-surfaced parkway is an undivided, four-lane roadway, 40 feet wide with 9-foot-wide left lanes and 11-foot-wide right lanes. The overpass was not illuminated nor was it marked with reflectorized delineators to assist in identifying the size and shape of the underpass. Due to the arched configuration of the stone overpass, the outside lanes have less clearance because the arch tapers from approximately 14 feet 6 inches at the center line to 10 feet 2 inches at the edge of the roadway. (See appendix B, figure 3.) The 13-foot 2-inch bus went under the bridge in the right lane. (See appendix C for a diagram of the arched stone overpass and tour bus collision point.) There were no tire marks on the approach to the overpass. Postimpact tire marks, 34 feet long, began 15 feet past the southern exit of the overpass. The tire marks indicated that the busdriver applied the service brakes after the bus exited the overpass. The bus came to rest 200 feet south of the overpass.

VIEW OF REAR OF BUS IN SOUTH BOUND  
RIGHT LANE
