Highway Accident Report - Trailways Lines, Inc.
Intercity Bus Collision with Rising Fast
Trucking Company, Inc., Interstate Highway 40
near Brinkley, Arkansas, July 14, 1986

(U.S.) National Transportation Safety Board
Washington, DC

21 Jul 87

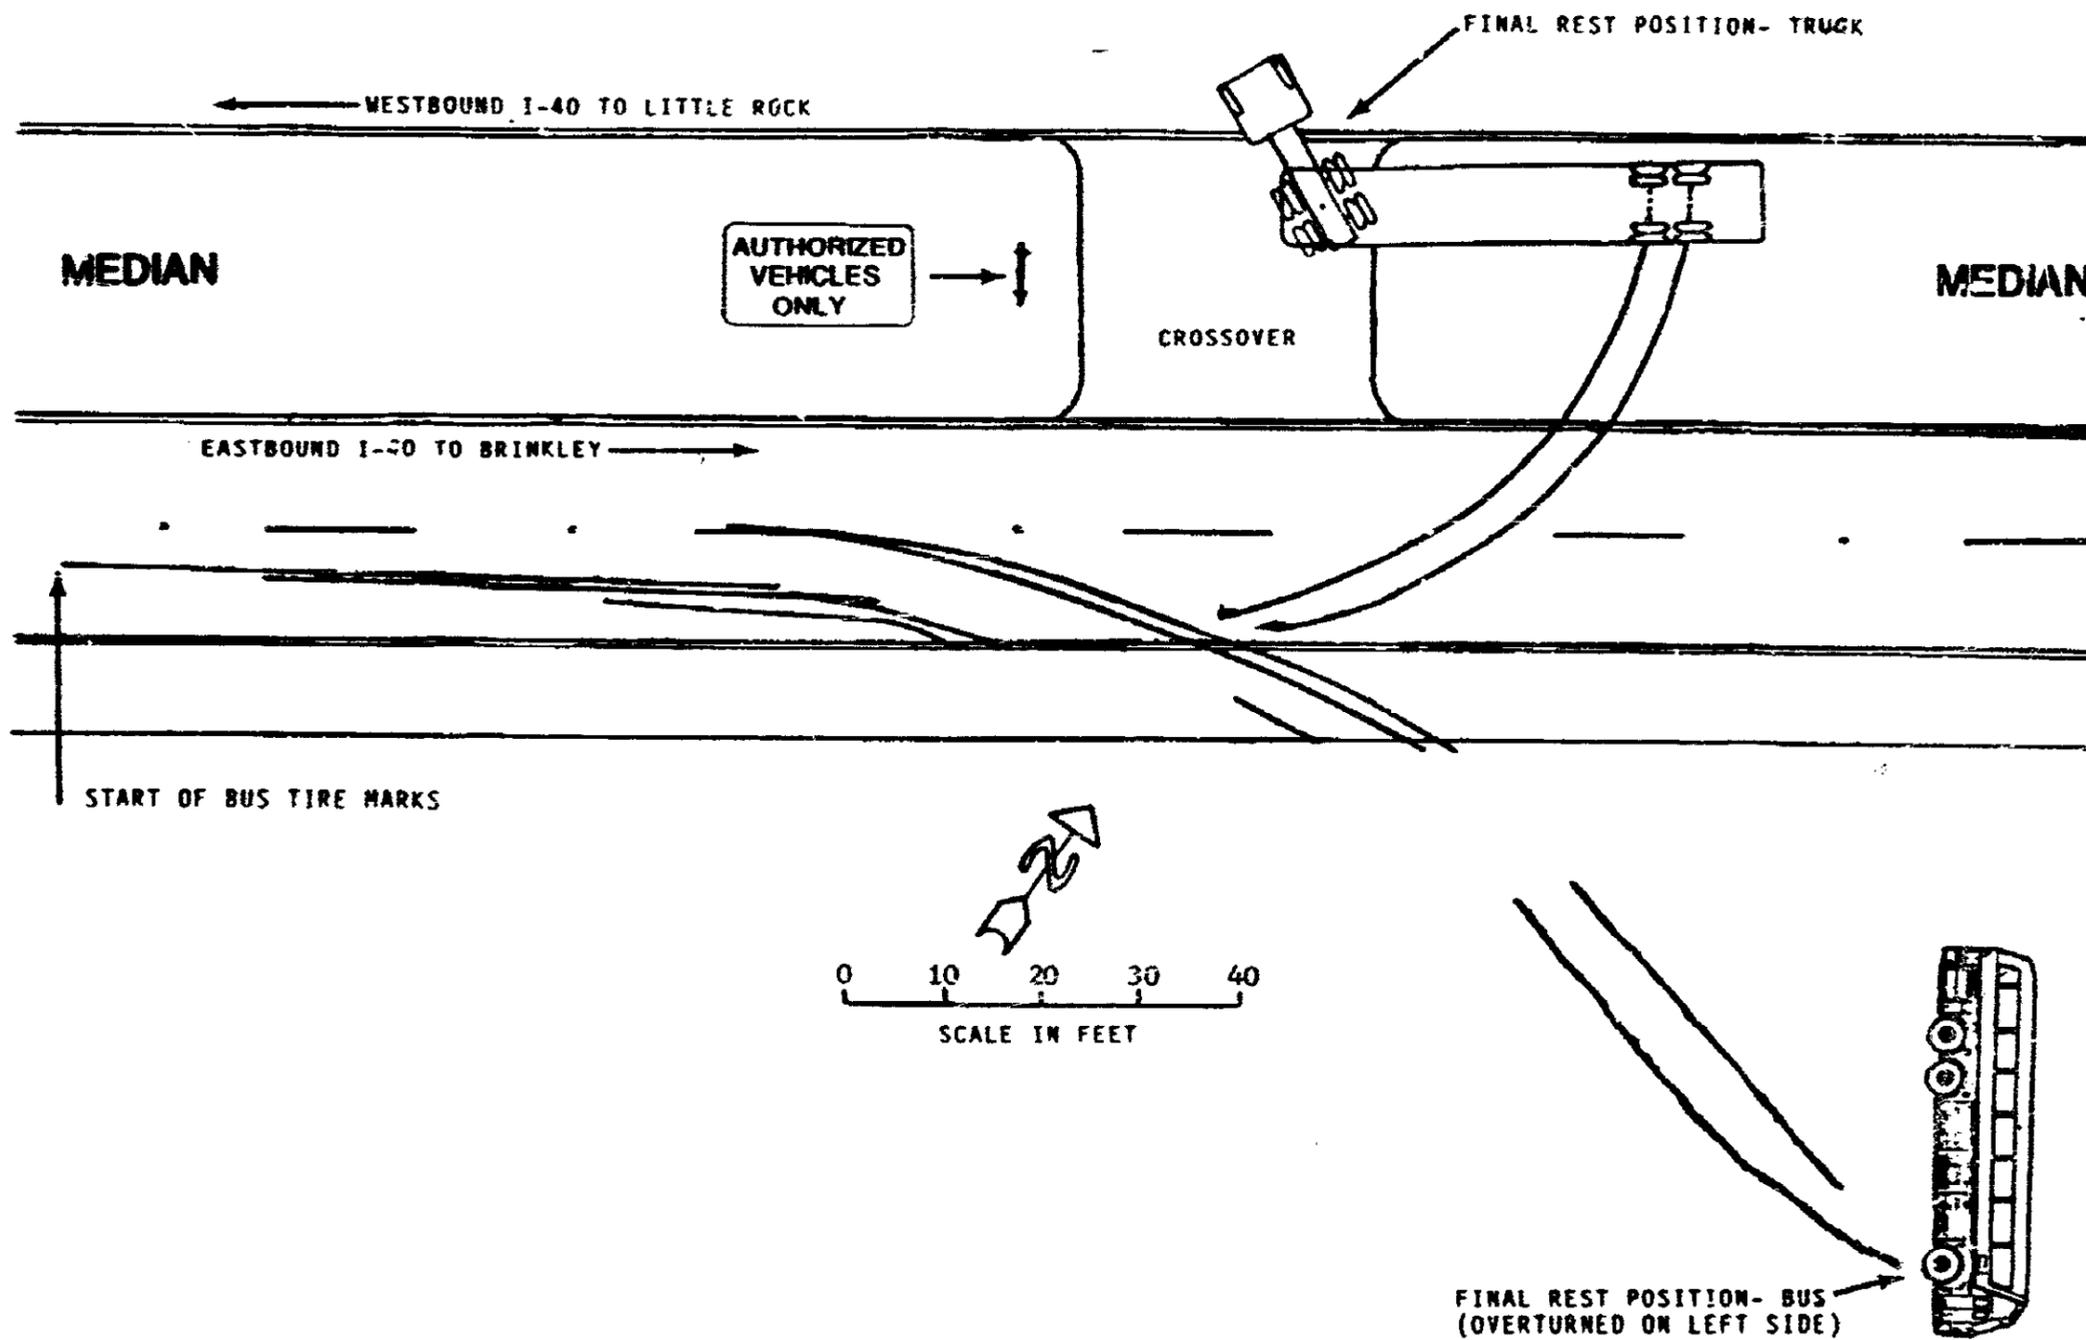
Figure 4.—Plan view of accident site.

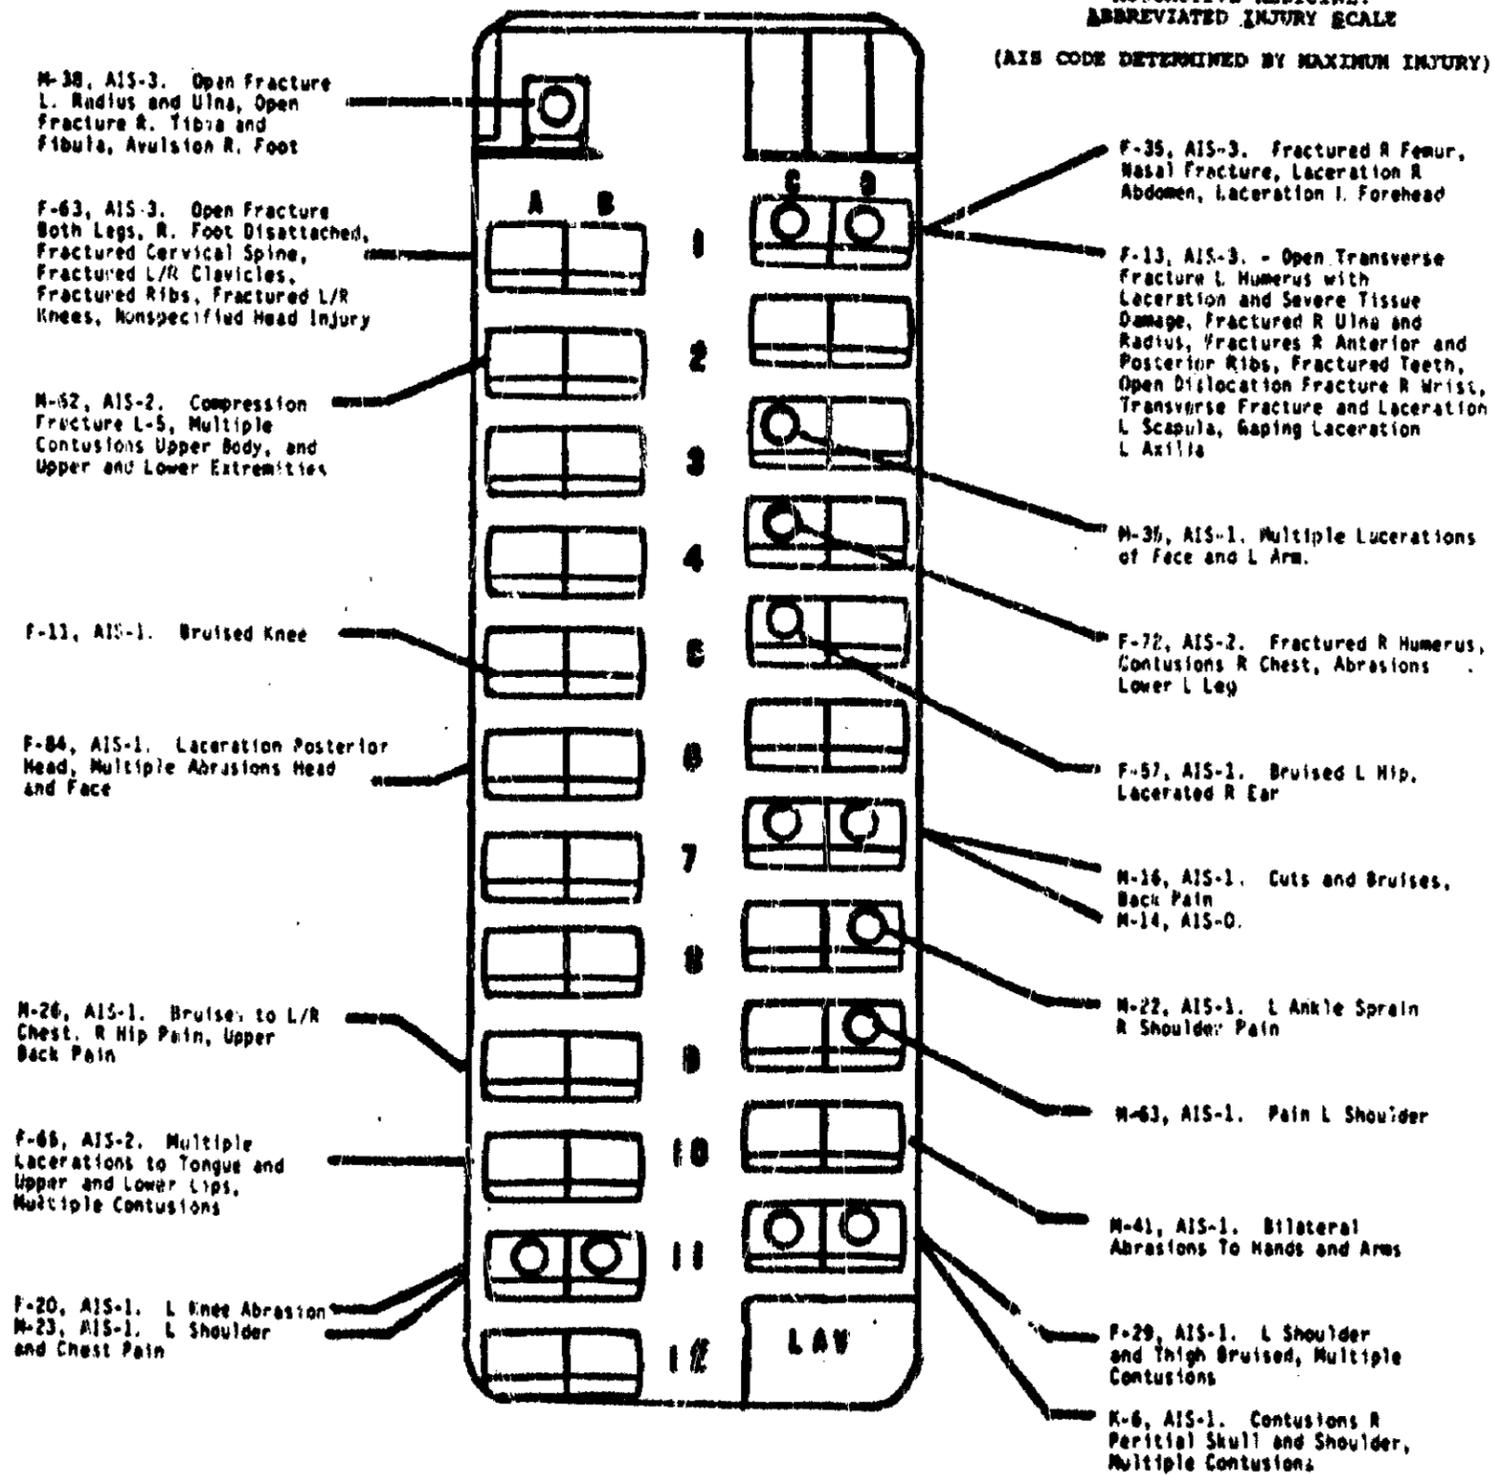
Figure 5.--Partial bus occupant seating and injury chart.

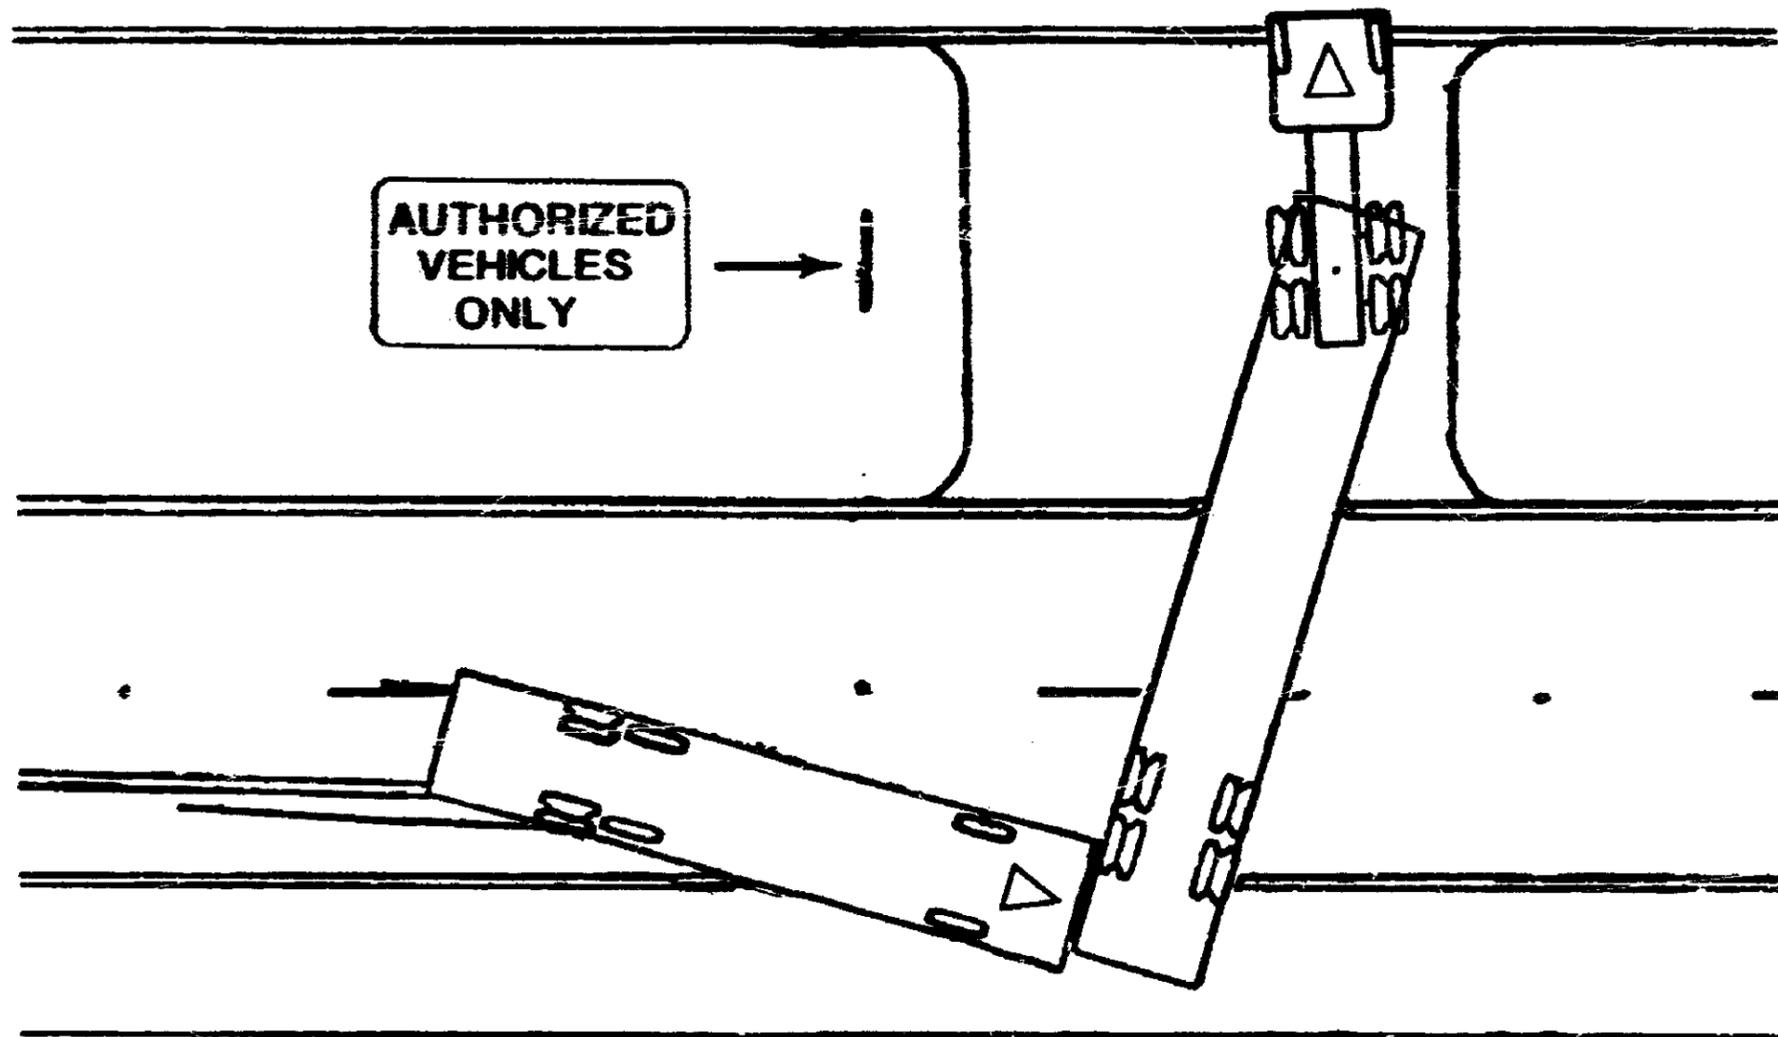
The straight 82-foot-long skidmarks leading to the point of the collision indicate that the bus driver applied the brakes and, therefore, decelerated the bus before the collision occurred. Safety Board investigators calculated that the speed of the bus when the driver first applied the brakes was between 65 and 72 mph.

Figure 6—Estimated positions of Trailways and RFT vehicles at point of impact.
