Highway Accident Report: Pickup Truck/Church  
Activity Bus Head-on Collision and Fire near  
Carrollton, Kentucky, May 14, 1988

(U.S.) National Transportation Safety Board  
Washington, DC

28 Mar 89

1. Report No. NTSB/HAR-89/01	2. Government Accession No. PB89-916201	3. Recipient's Catalog No.	
4. Title and Subtitle Highway Accident Report--Pickup Truck/Church Activity Bus Head-on Collision and Fire near Carrollton, Kentucky, May 14, 1988		5. Report Date March 28, 1989

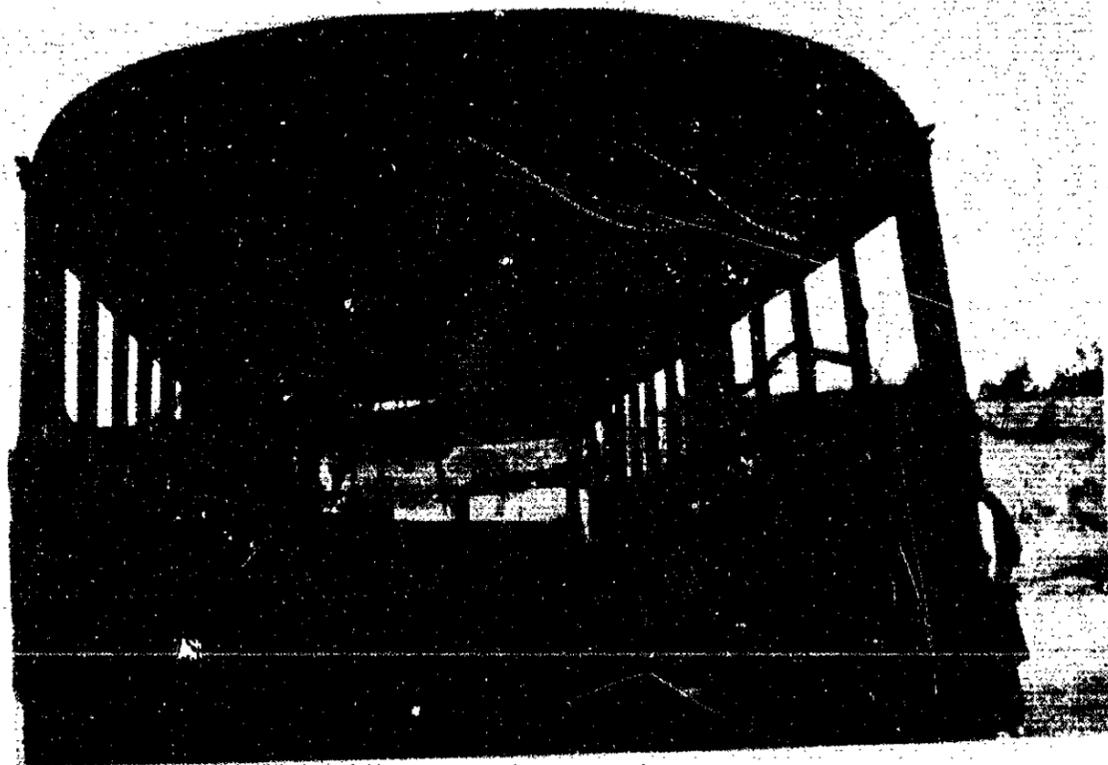
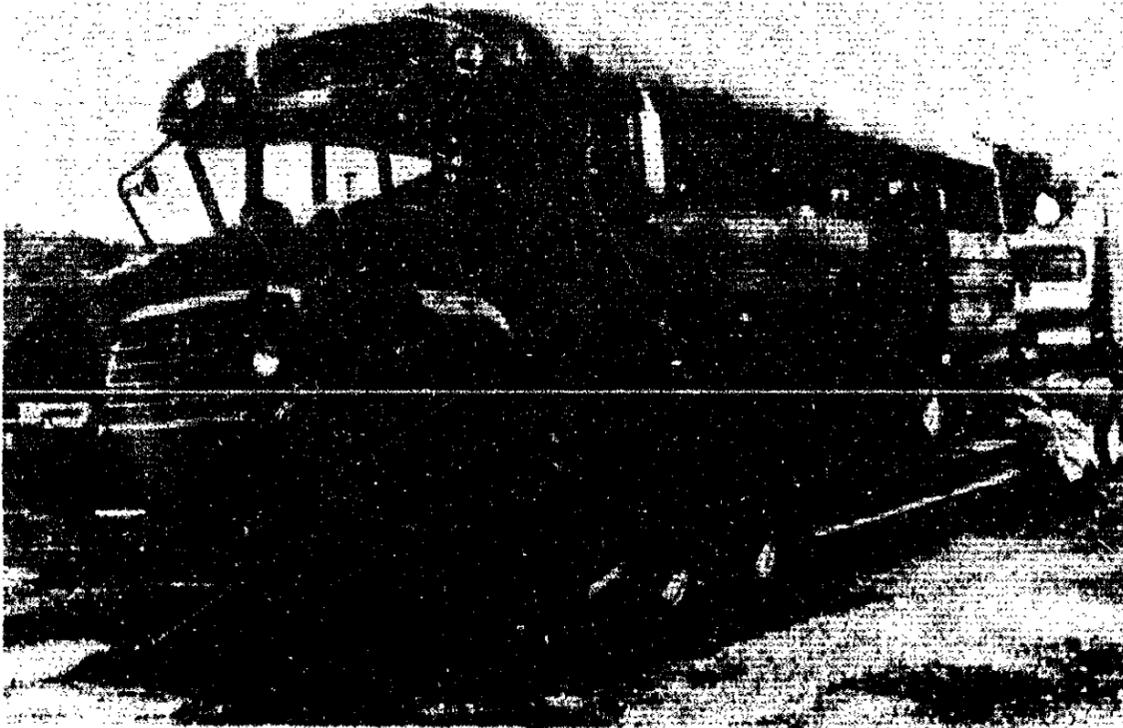
The bus sustained extensive fire damage. The right front of the bus, the entire hood, and the entire roof had burn damage. The left side bumper and grille were not damaged by fire. Fire damaged the entire right side of the bus with the exception of a portion of sheet metal directly behind the right rear wheel well. The left side of the bus also was burned, except for sheet metal in the area directly in front of the left rear wheel well and the bottom panels of sheet metal which extended behind the left rear wheel well to the end of the bus. The top half of the rear emergency door sustained fire damage. The front tires and the right rear tires were burned. The entire interior of the bus was consumed by fire except for metal seat frames and walls. (See figures 4, 5, and 6.)

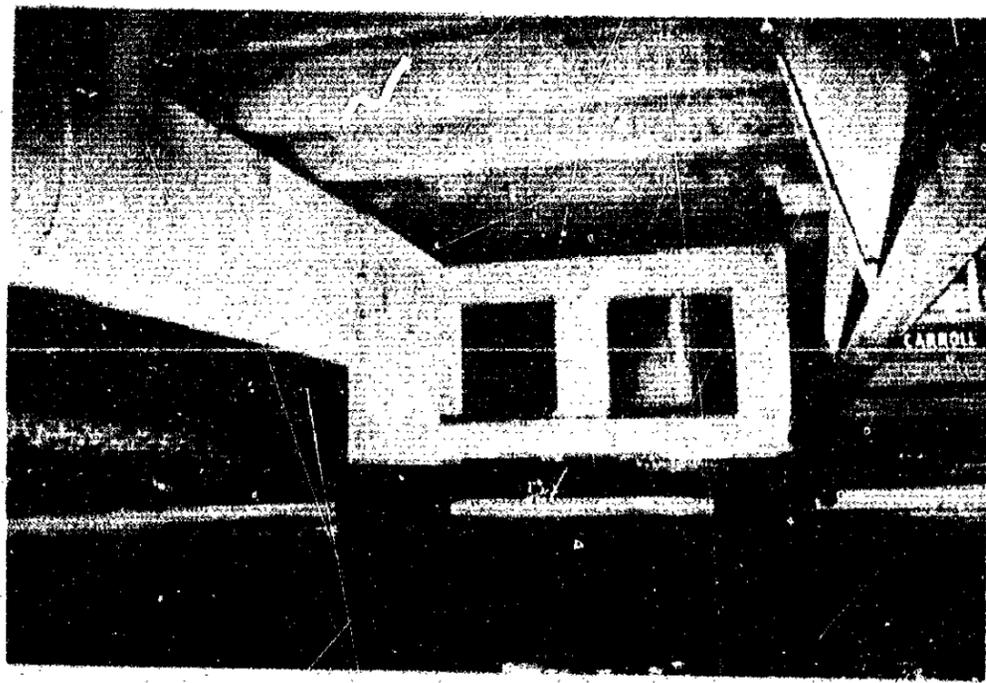
Figure 7.--Fuel tank guards

The fuel tank was found approximately 28 inches rearward of its original position as indicated by a mark made by the rear retaining strap. The forward strap was severed. The investigating police officer informed Safety Board investigators that part of the fuel tank rearward movement was caused by the tow truck operator as he attempted to secure chains to the fuel tank to remove the bus. The front of the tank contained a 5-inch-square dented (inward) area on the right midsection of the front end of the tank. A 3-inch-long horizontal gash was found in the middle of the dent.

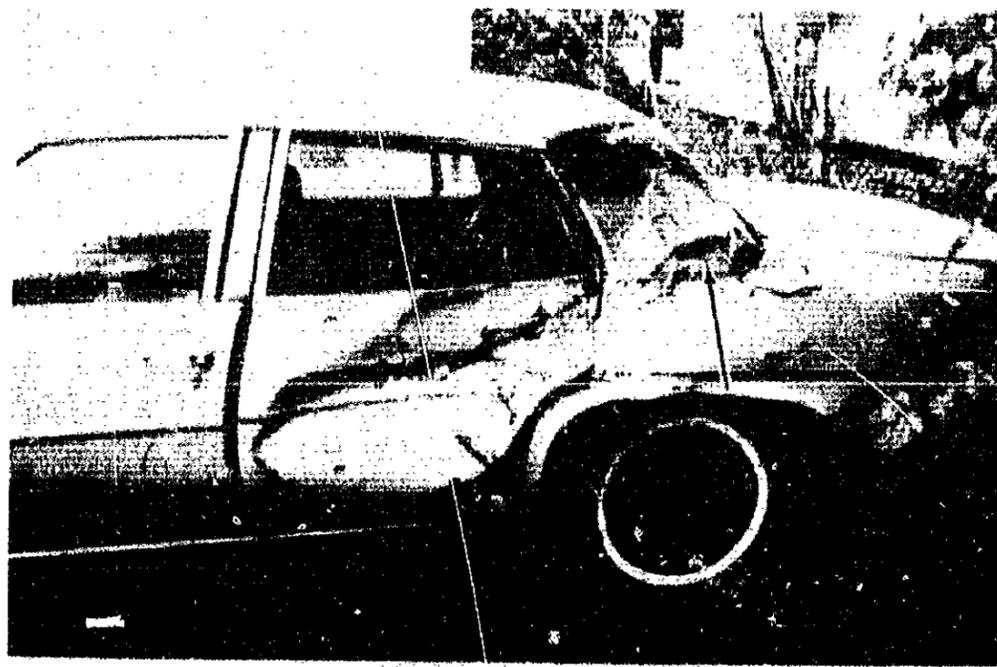
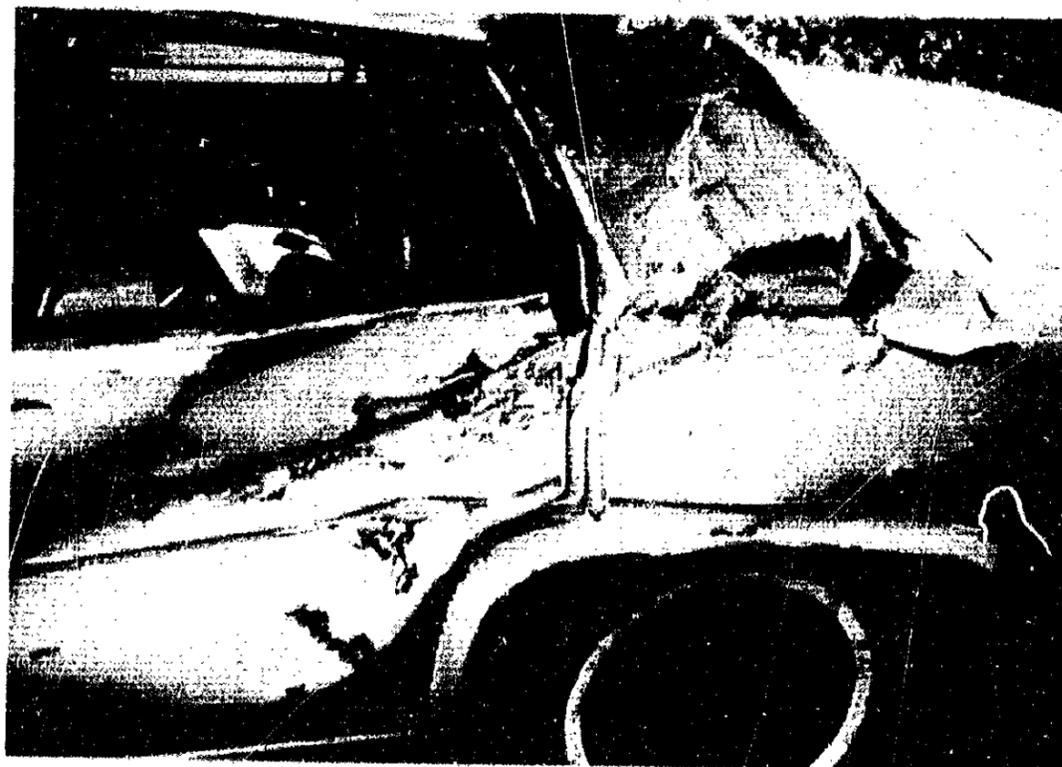
Figure 8.--1977 Cadillac.

The left rear door was scraped and dented, with the damage extending diagonally upward to the left rear vinyl roof. The left rear door window was broken and pieces of glass along with broken pieces of red plastic taillight lens were strewn throughout the rear of the car. "Toyota" was printed on one piece of the taillight lens. Grass and mud were trapped near the front license plate of the car. Blue paint samples from the Cadillac were visually matched with blue paint chips found on the left rear of the pickup truck. Also, a piece of blue vinyl roof material imbedded in the left rear corner of the pickup truck was visually matched to the damaged blue vinyl roof material of the Cadillac. No mechanical inspection was conducted on the car. (See figure 8.)

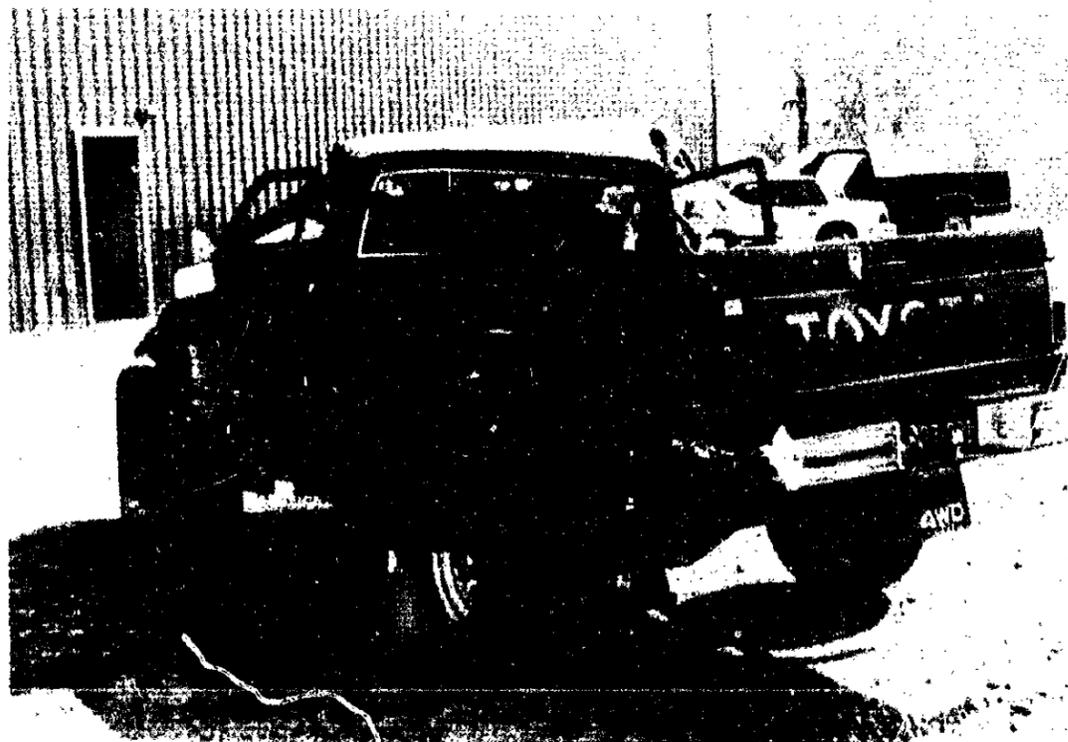
Figure 9.--Pickup truck

The entire front and right front side of the pickup truck were severely damaged during impact. The front hood had separated and the roof had buckled upward. The front engine compartment was depressed rearward. The right front A-pillar had been pushed rearward and outward, and the right front door was ajar and pushed rearward 18 inches. The right front dashboard was pushed rearward into the passenger seat. The right front wheel had separated from its axle and twisted to the right. Glass from the front windshield had shattered and folded downward, and glass from the right and left doors was missing. The left rear side body panel was scraped and dented, and the left rear corner of the bumper was pushed inward. The left rear taillight was broken off and a piece of blue vinyl material had snagged on the damaged bumper. Blue paint transfers were located on the left rear side of the truck and yellow paint transfers were located on the front bumper and grille area of the truck. The right front bumper was pushed rearward approximately 36 inches. A lug nut and bolt from the right front wheel of the bus was found in a crevice of a frame member and an imprint of the lug nut and bolt was located on the front bumper immediately to the left of the front license plate area. (See figure 9.)

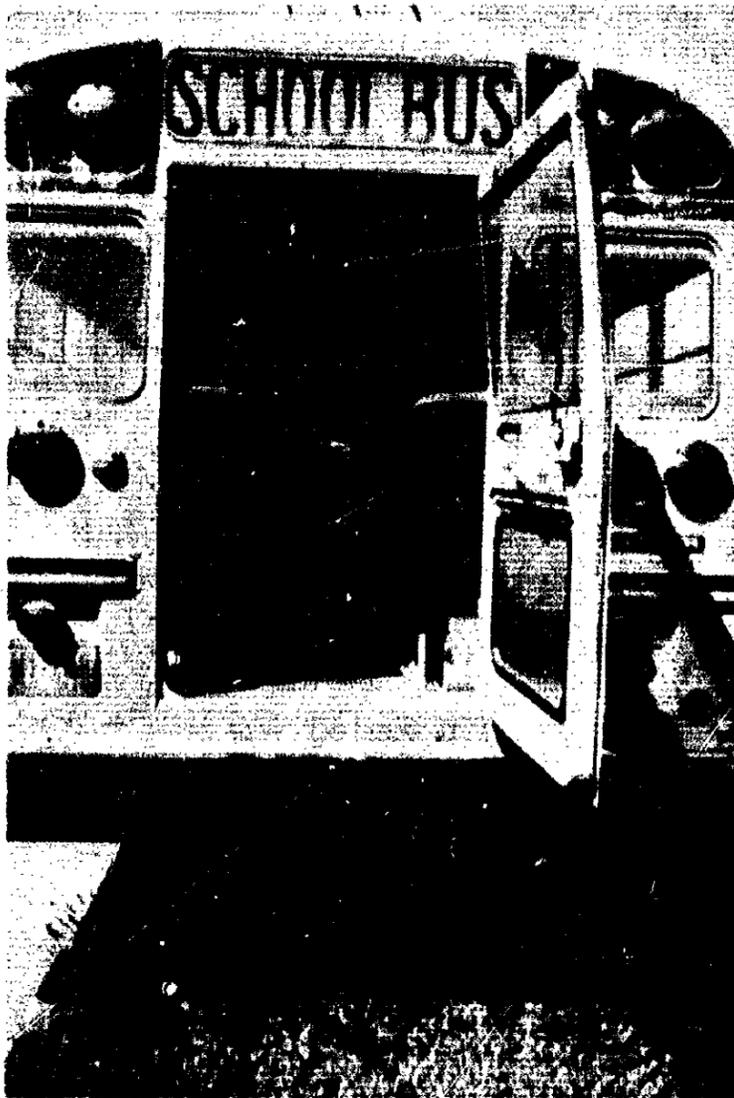
Figure 12.--Prestandard school bus emergency exit doorway

The bus rear door was about 56 inches high and about 36 inches wide. However, the two rear bench seats infringed on the emergency exit door space as much as 24 inches in width leaving an aisle width leading to the rear exit door of 12 inches at the floor and 15 inches at the top of the seatback. (See figure 12.)
