Highway Accident Report: Collision of Levy County, Florida  
School Bus and Airdrome Tire Centers, Inc.  
Truck near Bronson, Florida, August 28, 1987

(U.S.) National Transportation Safety Board, Washington, DC

1 May 89

1. Report No. NTSB/MAR-89/02	2. Government Accession No. PB89-916202	3. Recipient's Catalog No.	
4. Title and Subtitle Highway Accident Report-- Collision of Levy County, Florida School Bus and Airdrome Tire Centers, Inc., Truck near Bronson, Florida, August 28, 1987		5. Report Date May 1, 1989

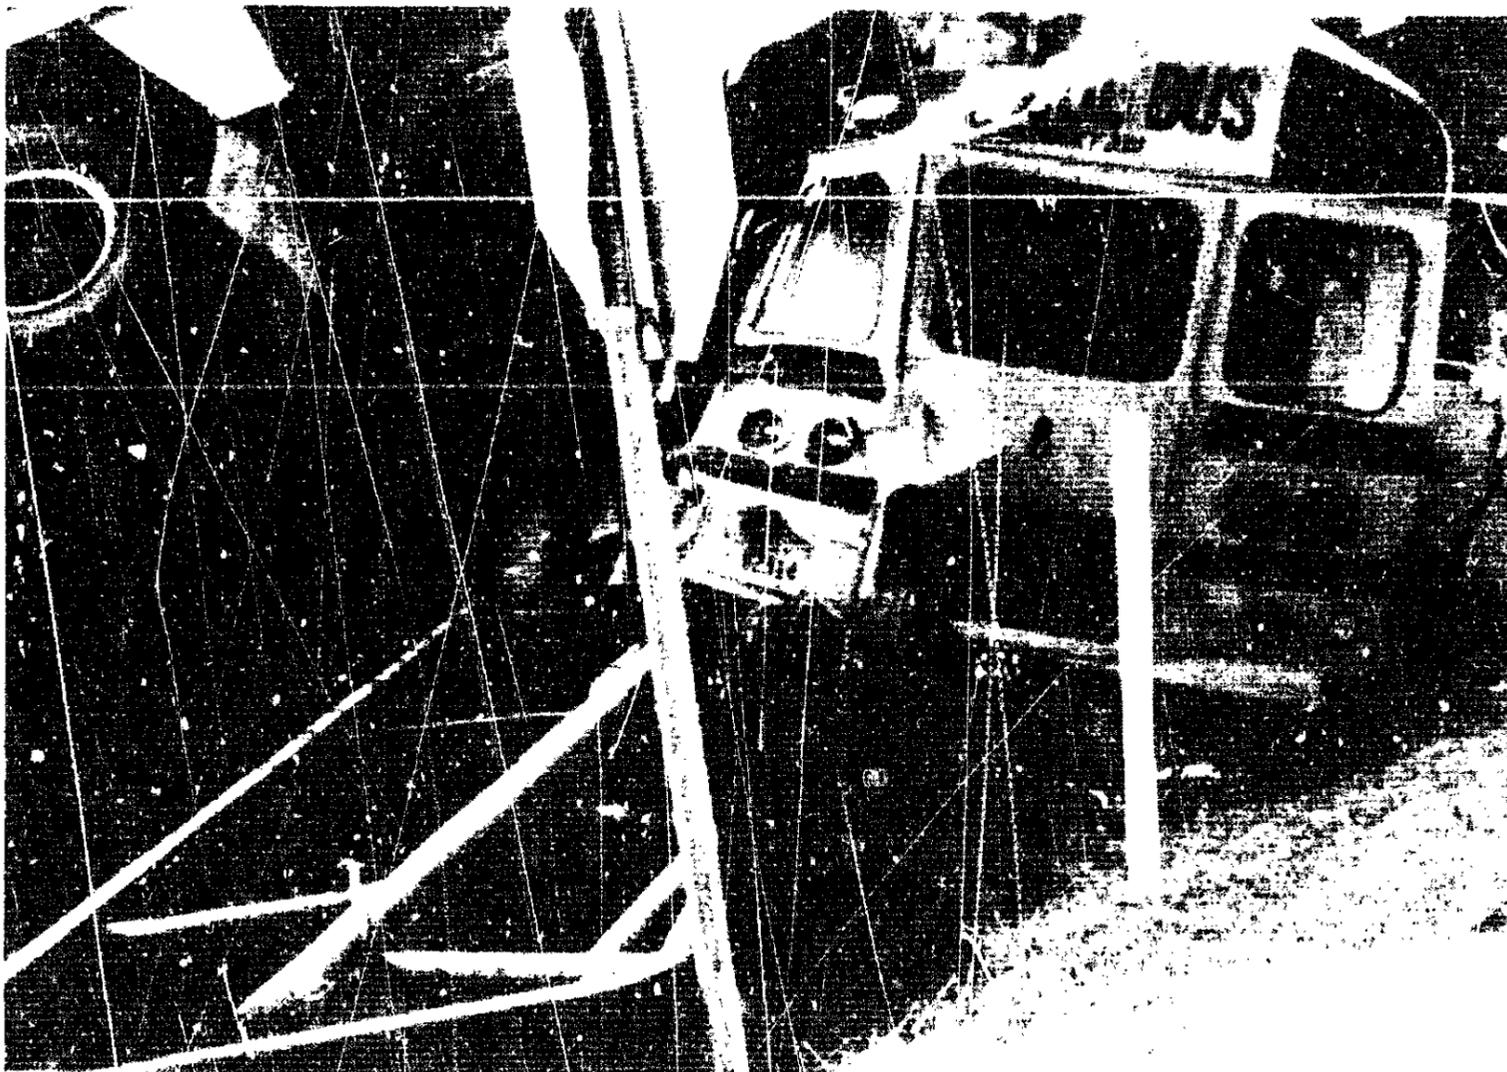
Figure 3.--The school bus body shifted forward and off its chassis.

The final phase of the collision sequence occurred when the front of the school bus struck the dirt embankment at the northwest corner of the intersection. This final collision caused the rear of the school bus body, which was now separated from the chassis, to slide forward, to compress the first seven floor panels and the first four rows of seats, and to invert the first floor panel with the restraining barriers still attached.

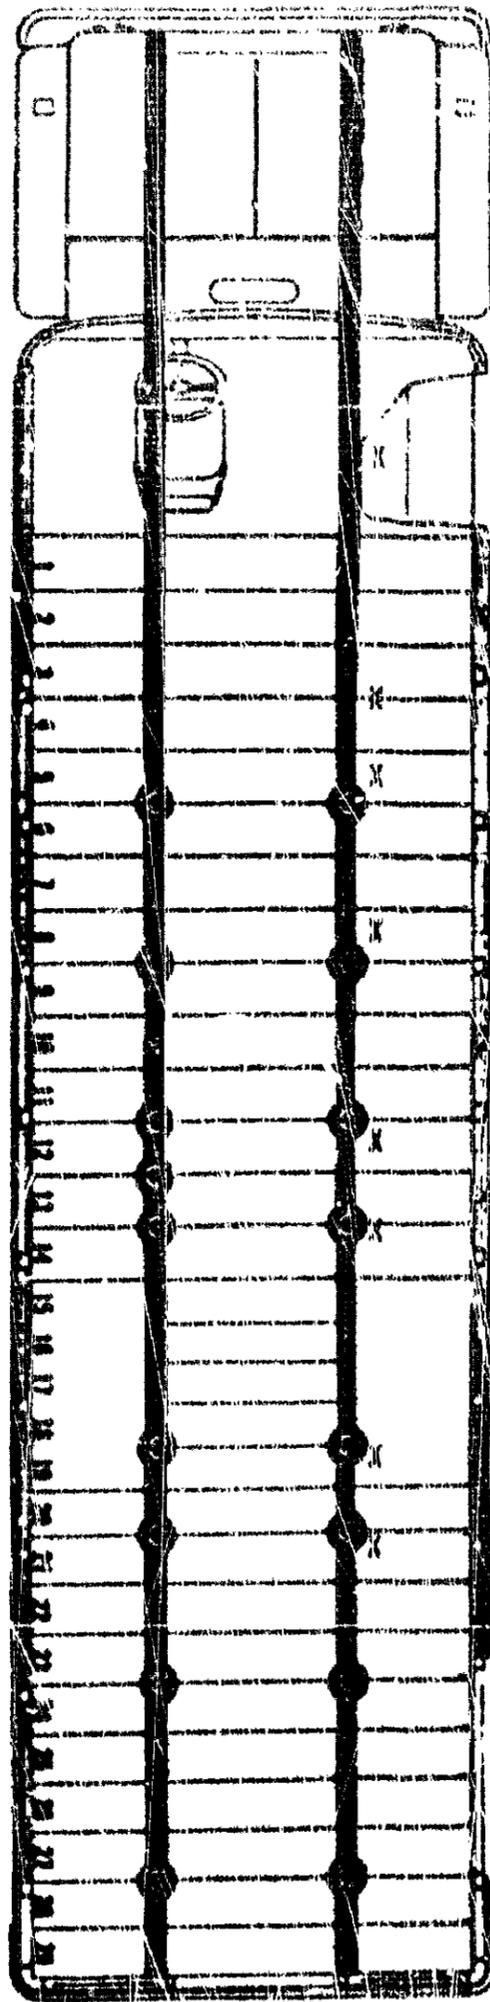
The top flange of the right longitudinal frame member was bent upward at eight points along its length. Although 8-inch marks were found on the inside vertical flange of the right frame member aft of where mounting clips joined floor panels 23 and 24 and 27 and 28, the upper flange adjacent to where these clips were mounted before the accident was not bent upward when these clips separated. (See figure 10.)

Figure 10.--Preaccident location of body mounting clips  
 and postaccident locations where upper flange of the  
 right frame member was bent upward.

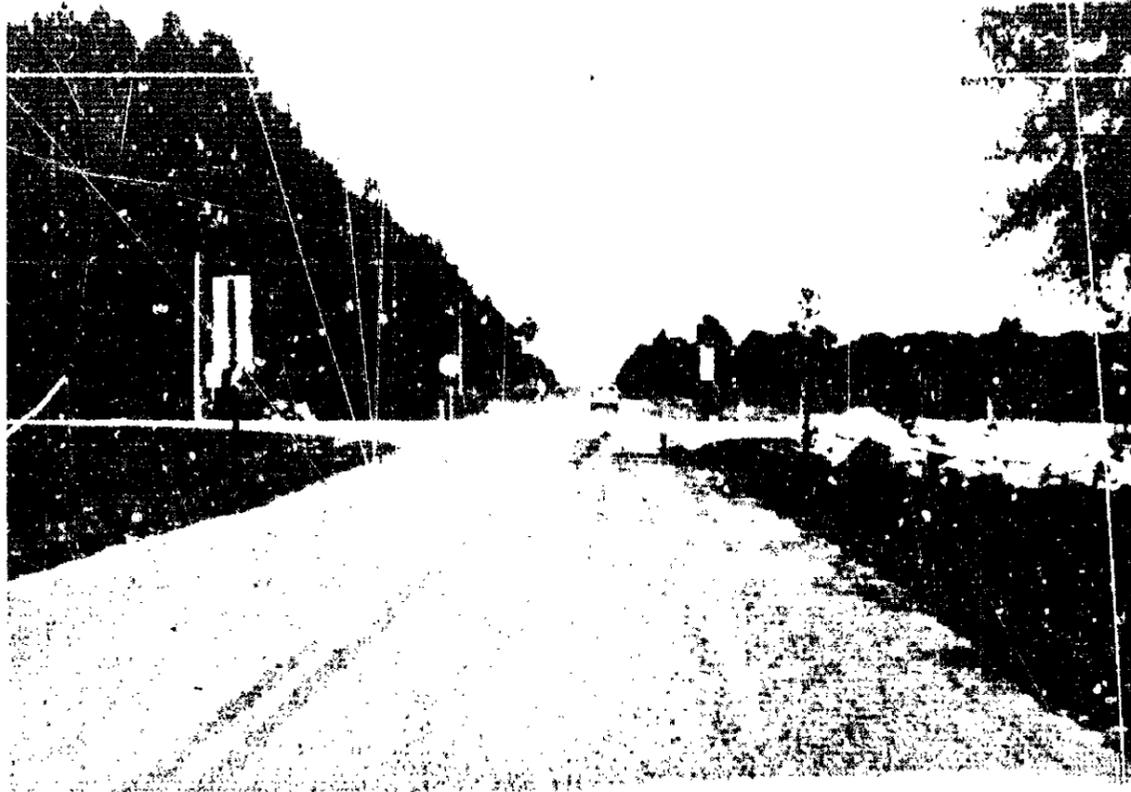
The accident occurred at the intersection of rural Levy CR 337 and CR 32. CR 337 is 18 feet wide and CR 32 is 20 feet wide. The right-angle intersection is controlled by stop signs on the CR 337 approaches. The surfaces of both two-lane roads were in good condition. The westbound CR 32 approach to the intersection is straight and level, and the northbound CR 337 approach to the intersection is straight and has a +0.48 percent grade. (See figure 13.)

Figure 13.--View of northbound CR 337 approach to CR 32
