Highway Accident Report: Greyhound Lines, Inc., Intercity
Bus Loss of Control and Overturn Interstate Highway 65 in
Nashville, Tennessee, November 19, 1988

(U.S.) National Transportation Safety Board, Washington, DC

8 Aug 89

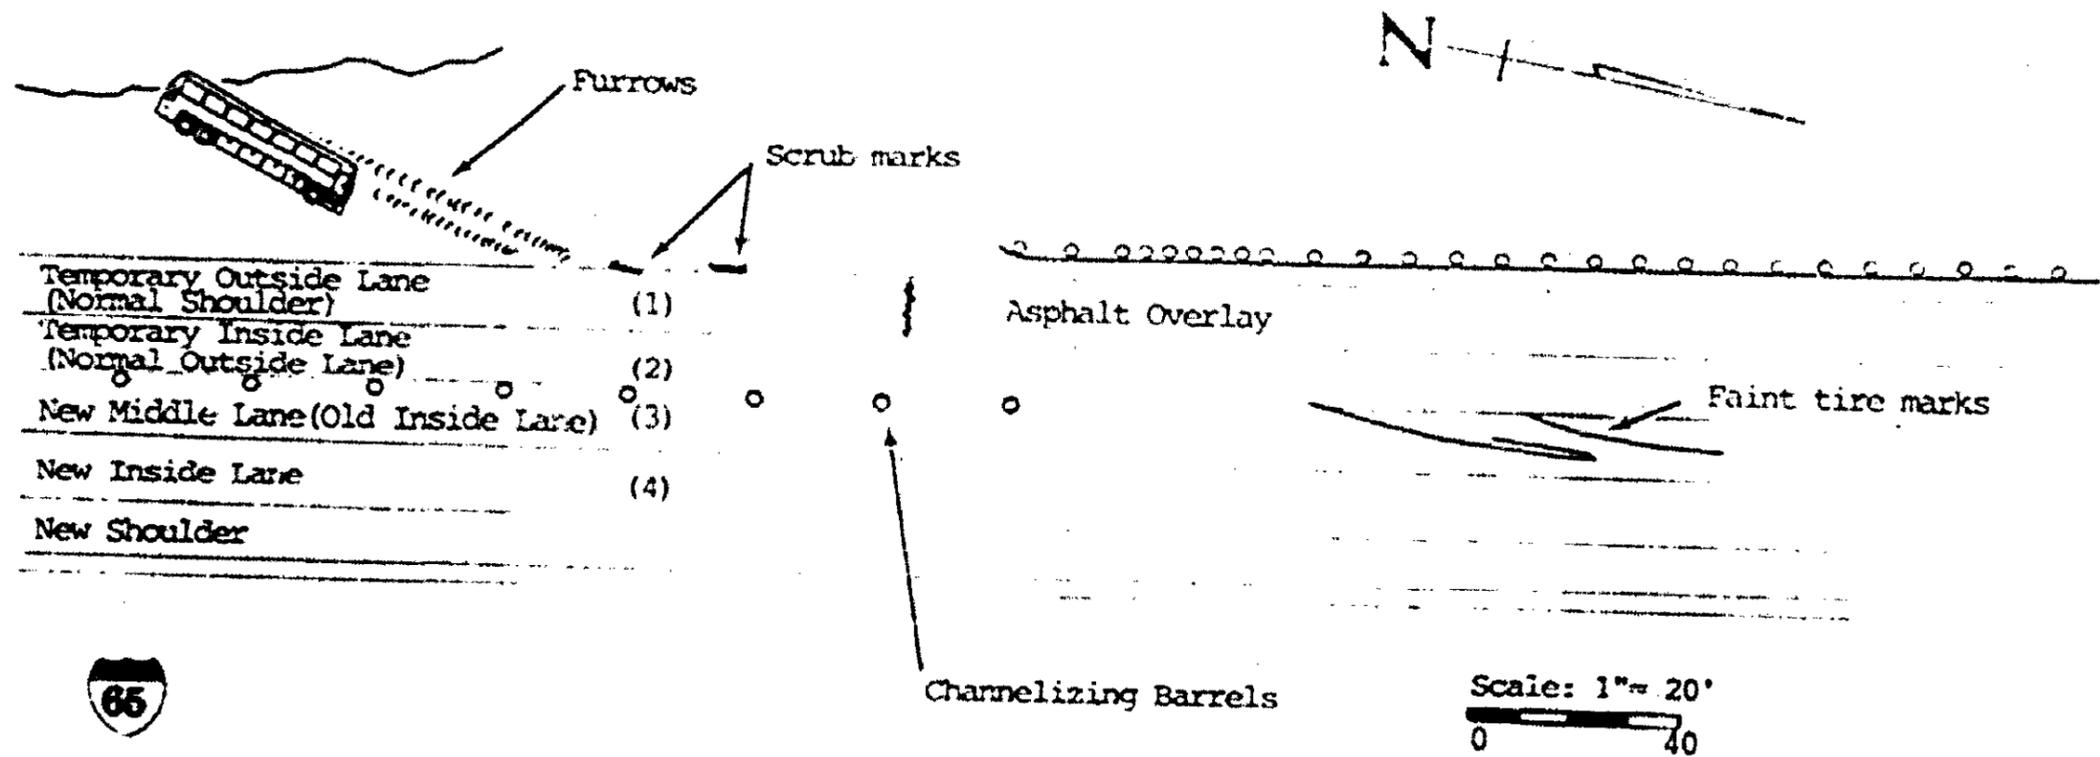
Figure 2.--Accident scene diagram.

Physical Evidence of the Accident.--Three faint, rightward curving tire marks were found in the new middle lane (lane 3, previously the left concrete lane, which was closed to traffic) beginning 158 feet north of the south end of the asphalt overlay. Additional tire marks were located at the right edgeline of the asphalt lane (lane 1), about 60 feet south of the south end of the overlay. There was a nine inch gouge mark just east of the edgeline, about 55 feet south of the south end of the overlay. Furrows in the grass roadside extended diagonally from the edgeline tire marks to the final rest position of the bus. Several of the channelizing barrels used to close lanes on the left to traffic were damaged and displaced in the vicinity of the accident site.
