Highway Accident Report - Collision between Mission
Consolidated Independent School District School Bus and Valley
Coca-Cola Bottling Company, Inc. Tractor-Semitrailer
Intersection of Bryan Road and Texas Farm-to-Market
Road 676 Alton, Texas, September 21, 1989

(U.S.) National Transportation Safety Board, Washington, DC

17 Jul 90

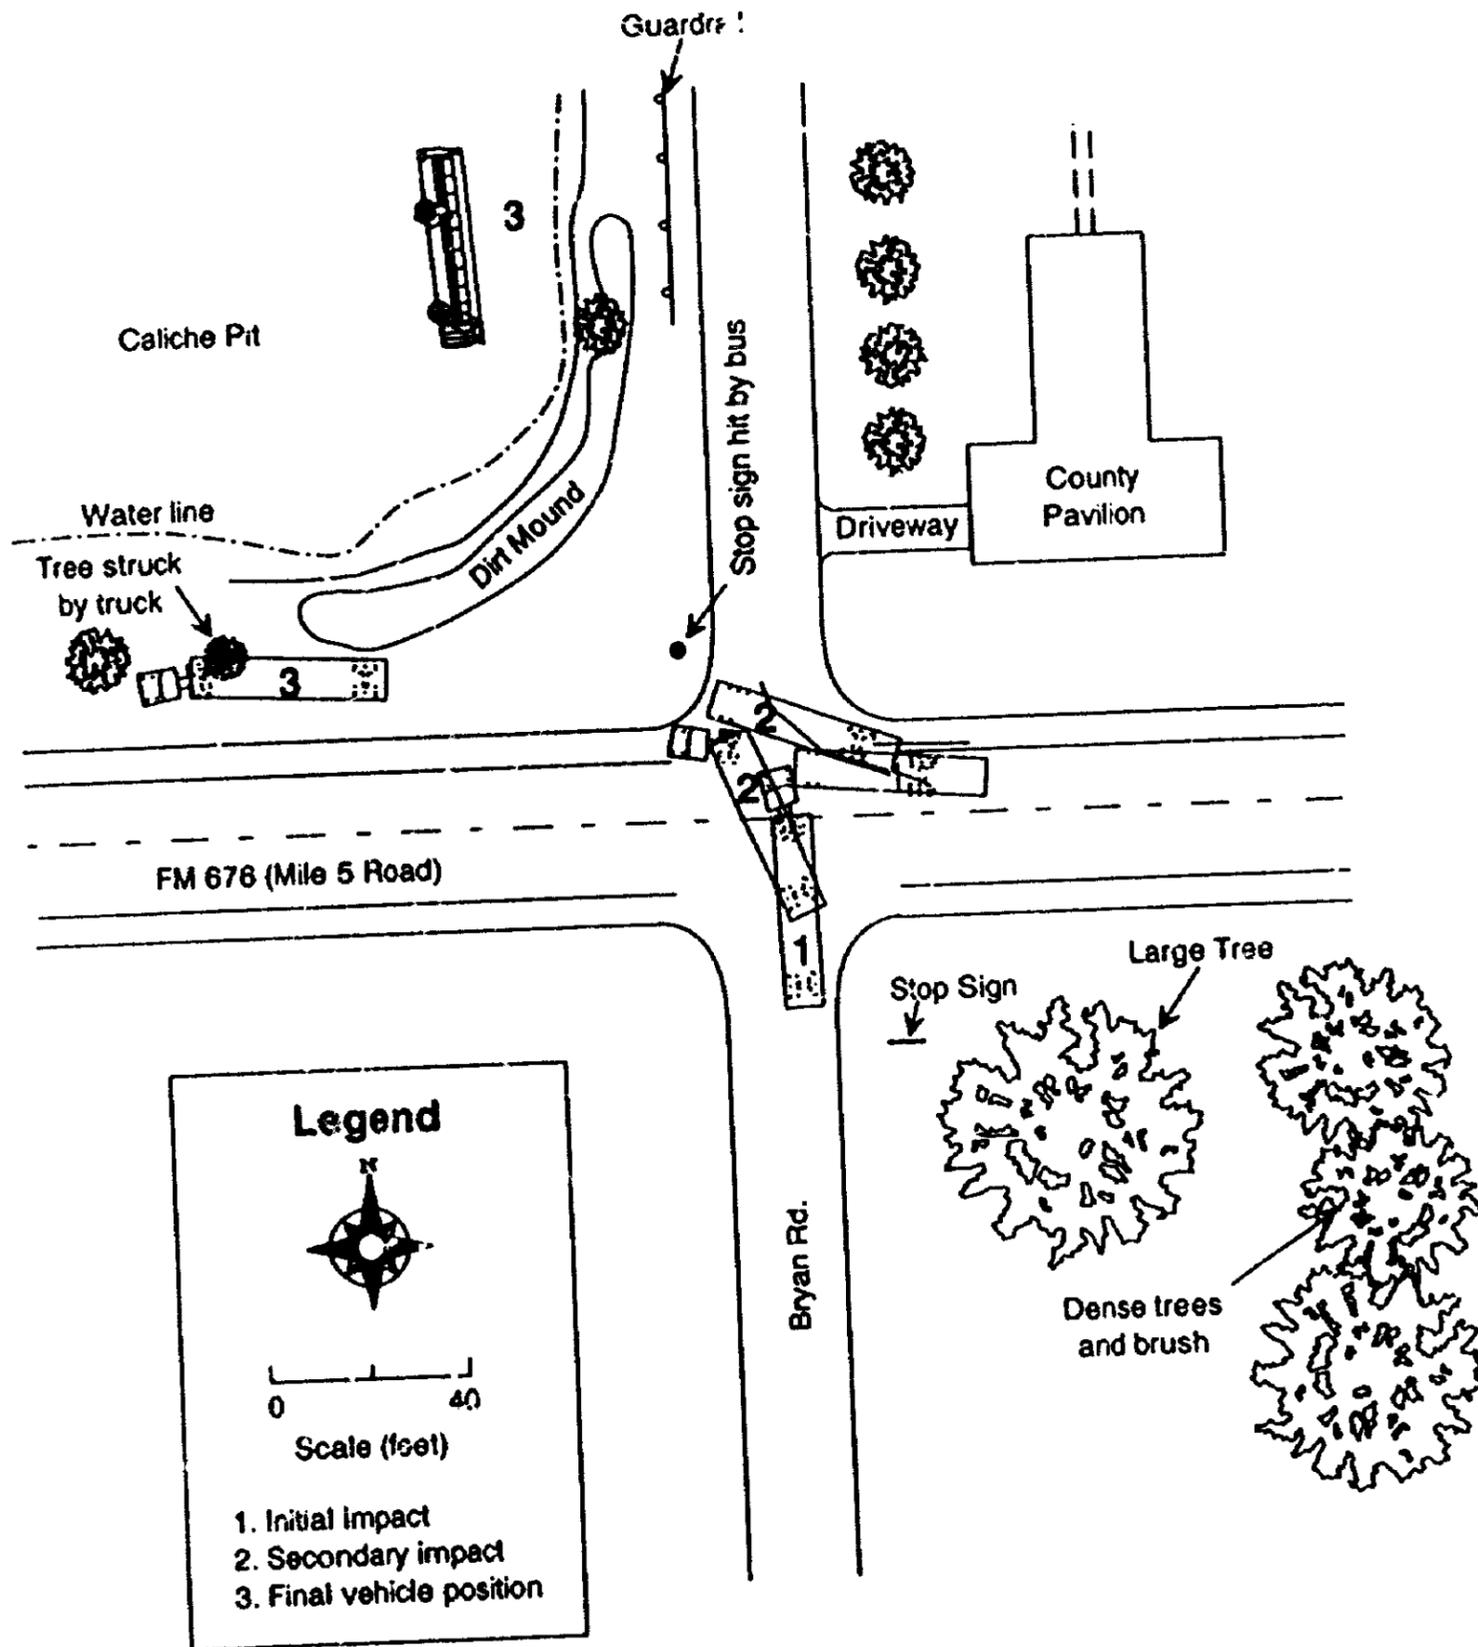
Figure 2.--Plan view of accident scene.

To explore the visibility under these speed conditions, the visibility tests were conducted in two phases. Both phases involved positioning the vehicles at a certain distance from the intersection, moving them forward in measured increments, and making observations. The vehicles were moved toward the accident intersection to simulate the drivers' actions and to determine their ability to perceive each other's vehicle. The first tests involved placing both vehicles approximately 600 feet from the intersection and moving them forward in 25 foot increments until visual contact was made, and then movement was made in smaller increments. This simulated both vehicles moving at the same speed toward the intersection. The test bus driver was not able to clearly see the test truck because of the trees and shrubs until the truck was approximately 150 feet from the intersection and the school bus was 170 to 160 feet from the intersection. The visibility of both drivers was completely obscured by a line of trees and brush parallel to an irrigation ditch about 75 feet east of the edge of Bryan Road. In addition, a large tree in the southeast quadrant, 38 feet from FM 676 and 42 feet from Bryan Road, partially obscured their visibility. (See figure 2.)

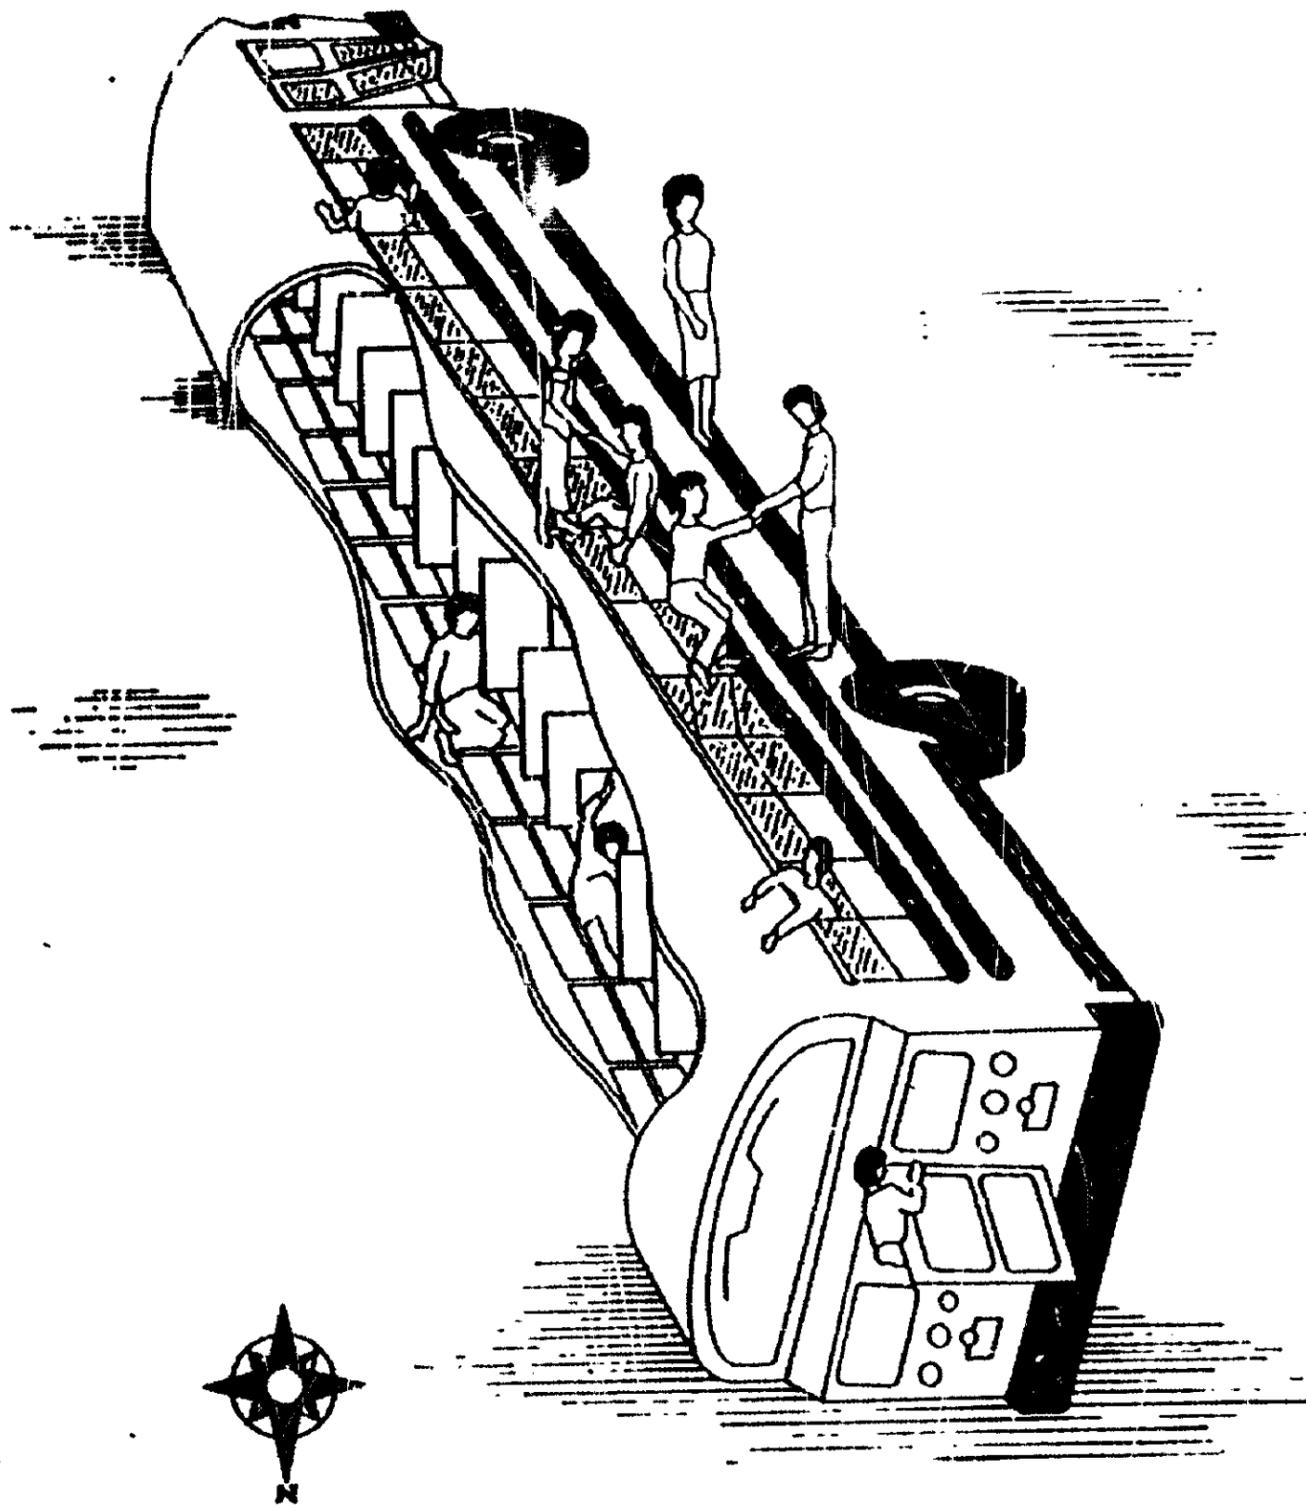
Additionally, the larger students had difficulty getting out of the open bus windows. One student became stuck in a window opening because he was wearing a backpack; however, he was rescued by two other students who removed the bulky pack and pulled him through the window.

Figure 3.--Illustration representing how some of the students reported escaping from the submerged school bus. The illustration is based on the condition of the bus when it was examined by the Safety Board. Only a few students are shown for illustrative purposes.
