**NATIONAL  
TRANSPORTATION  
SAFETY  
BOARD**

**HIGHWAY ACCIDENT REPORT**

**MAYFLOWER CONTRACT SERVICES, INC., TOUR BUS  
PLUNGE FROM TRAMWAY ROAD AND OVERTURN CRASH  
NEAR PALM SPRINGS, CALIFORNIA  
JULY 31, 1991**

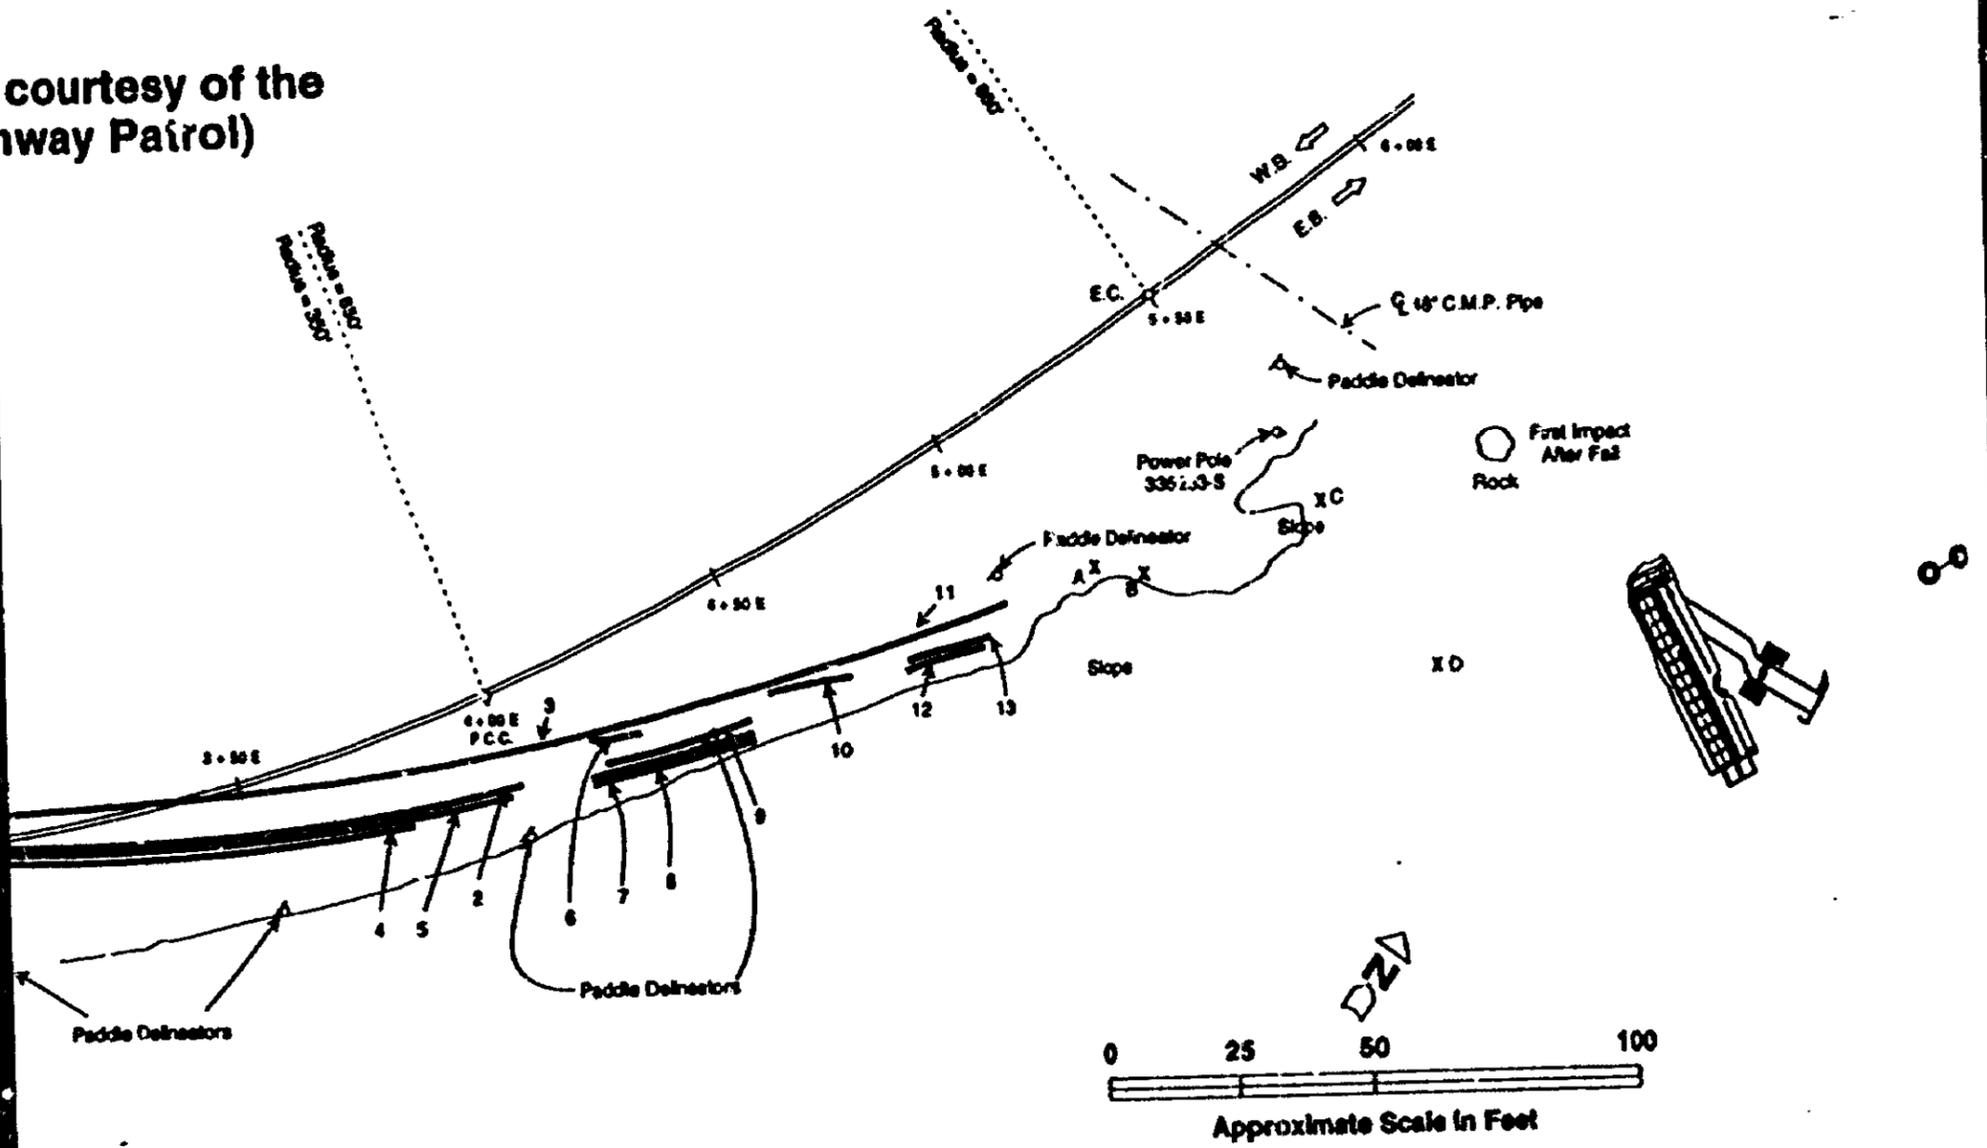
ad evidence diagram.

Tire Marks.--During the August 1991 test, skid marks made by the similar bus were straight and indicated locked wheels sliding over the road surface. The tire marks attributed to the accident bus immediately before it ran off the road were curved and striated. These tire marks did not result from locked wheels and skidding but from the tires sideslipping while rotating on the road surface. The Safety Board concludes that the yaw tire marks were not caused by braking and indicate the busdriver was attempting to steer around the curve when the bus left the road.

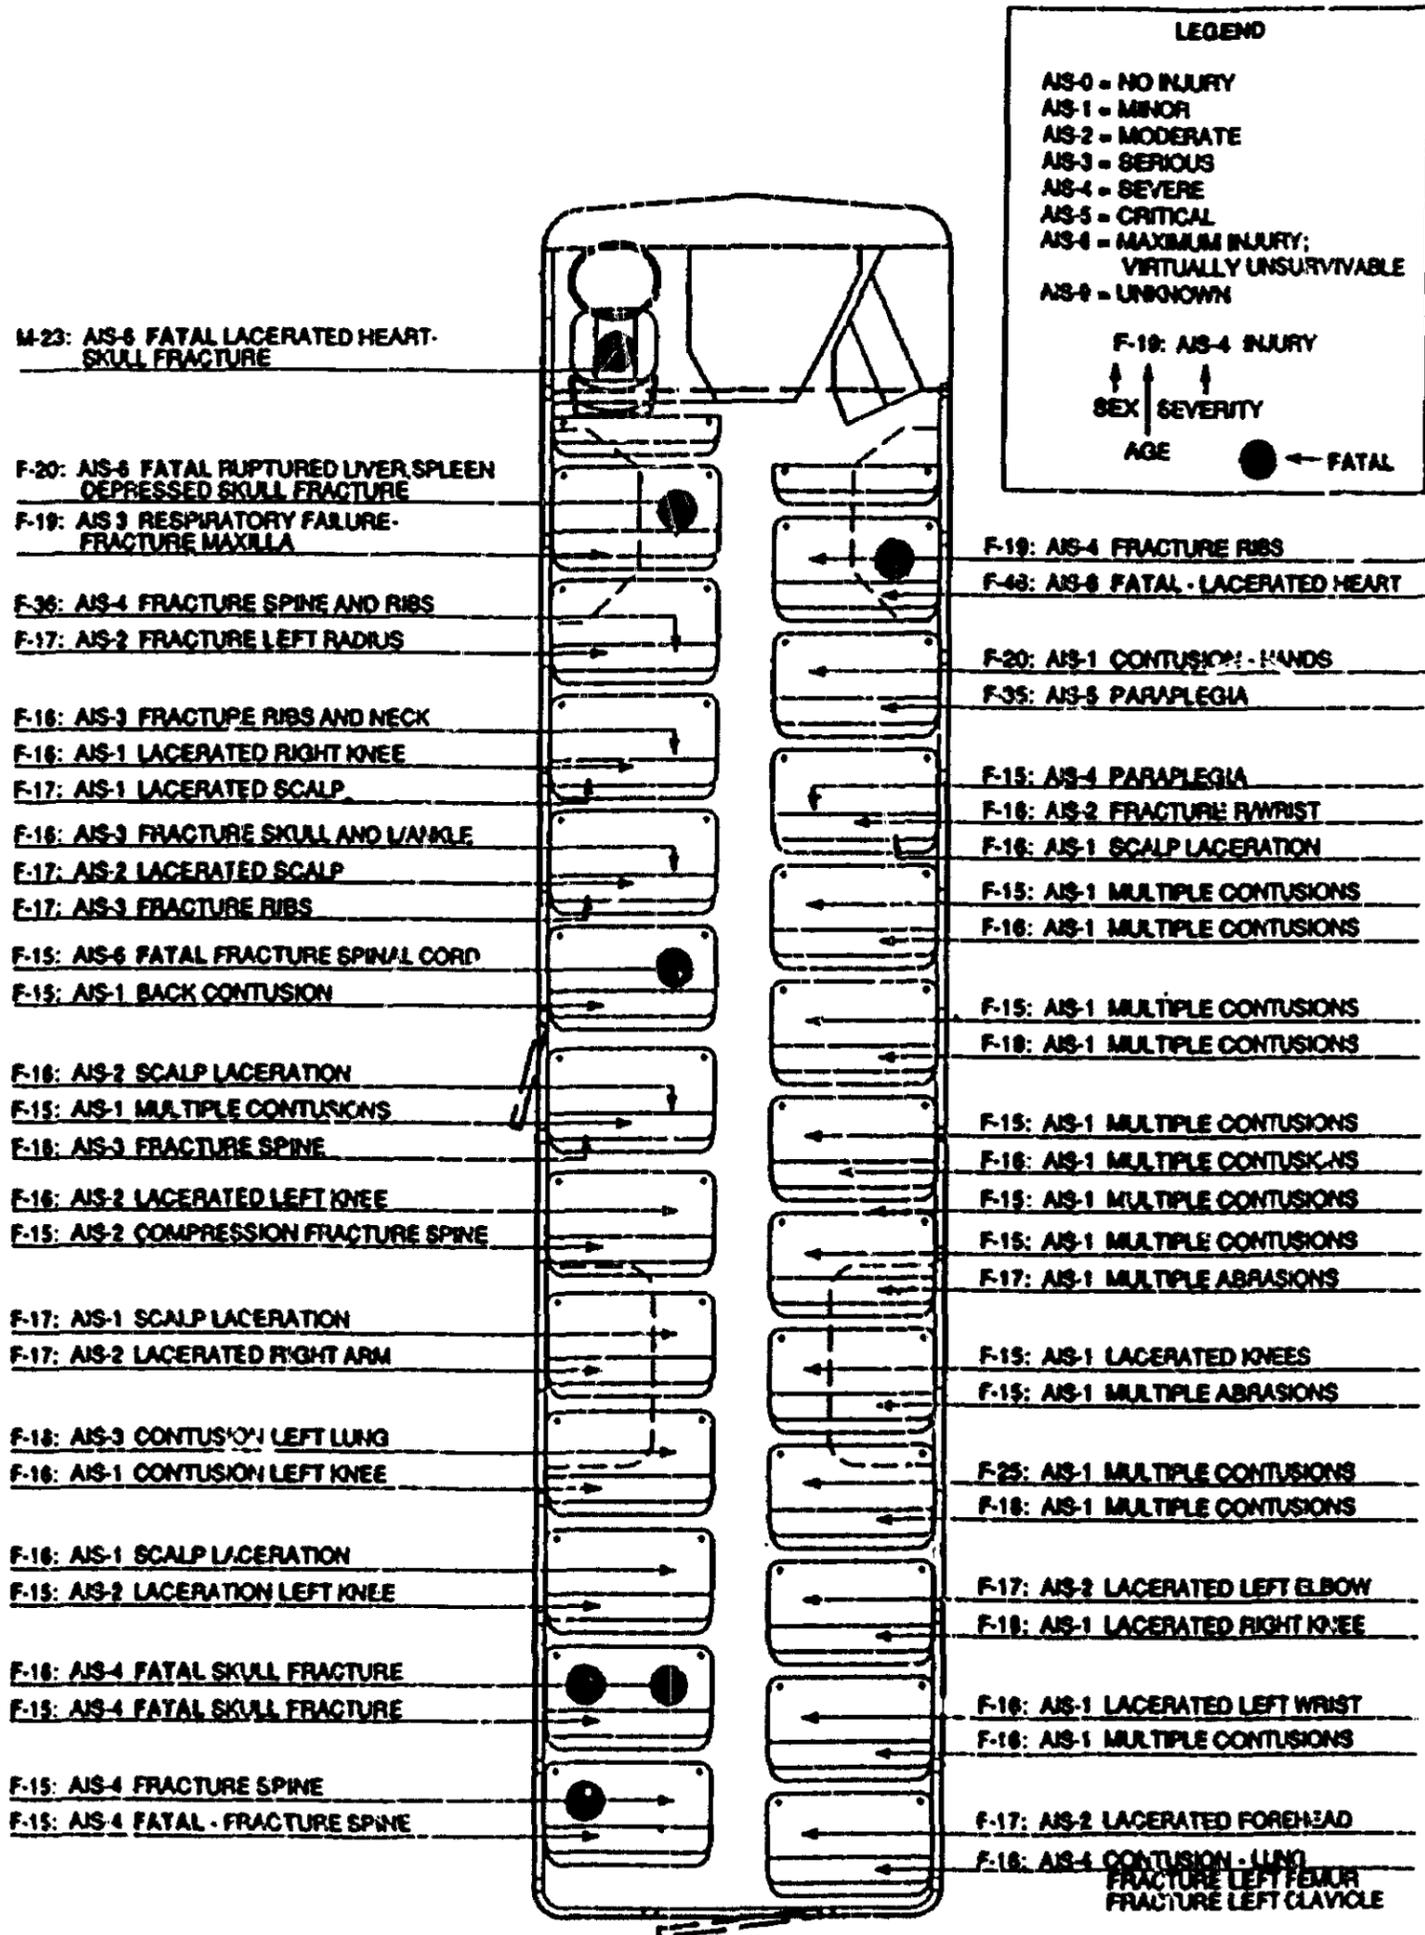
According to police investigators, 14 passengers (11 survivors and 3 fatalities) were fully ejected into a terrain depression beneath the bus. Eight passengers were partially ejected, and 22 passengers and the busdriver were not ejected from the bus. The busdriver was not wearing the available lap belt. If the other nine passengers were ejected is not known. (See figure 6 for injury distribution details.)

Figure 6.--Bus occupant seating and injury distribution diagram.
