**NATIONAL  
TRANSPORTATION  
SAFETY  
BOARD**

**HIGHWAY ACCIDENT REPORT**

**GASOLINE TANK TRUCK/AMTRAK TRAIN  
COLLISION AND FIRE IN  
FORT LAUDERDALE, FLORIDA  
MARCH 17, 1993**

**ADOPTED: FEBRUARY 15, 1994**

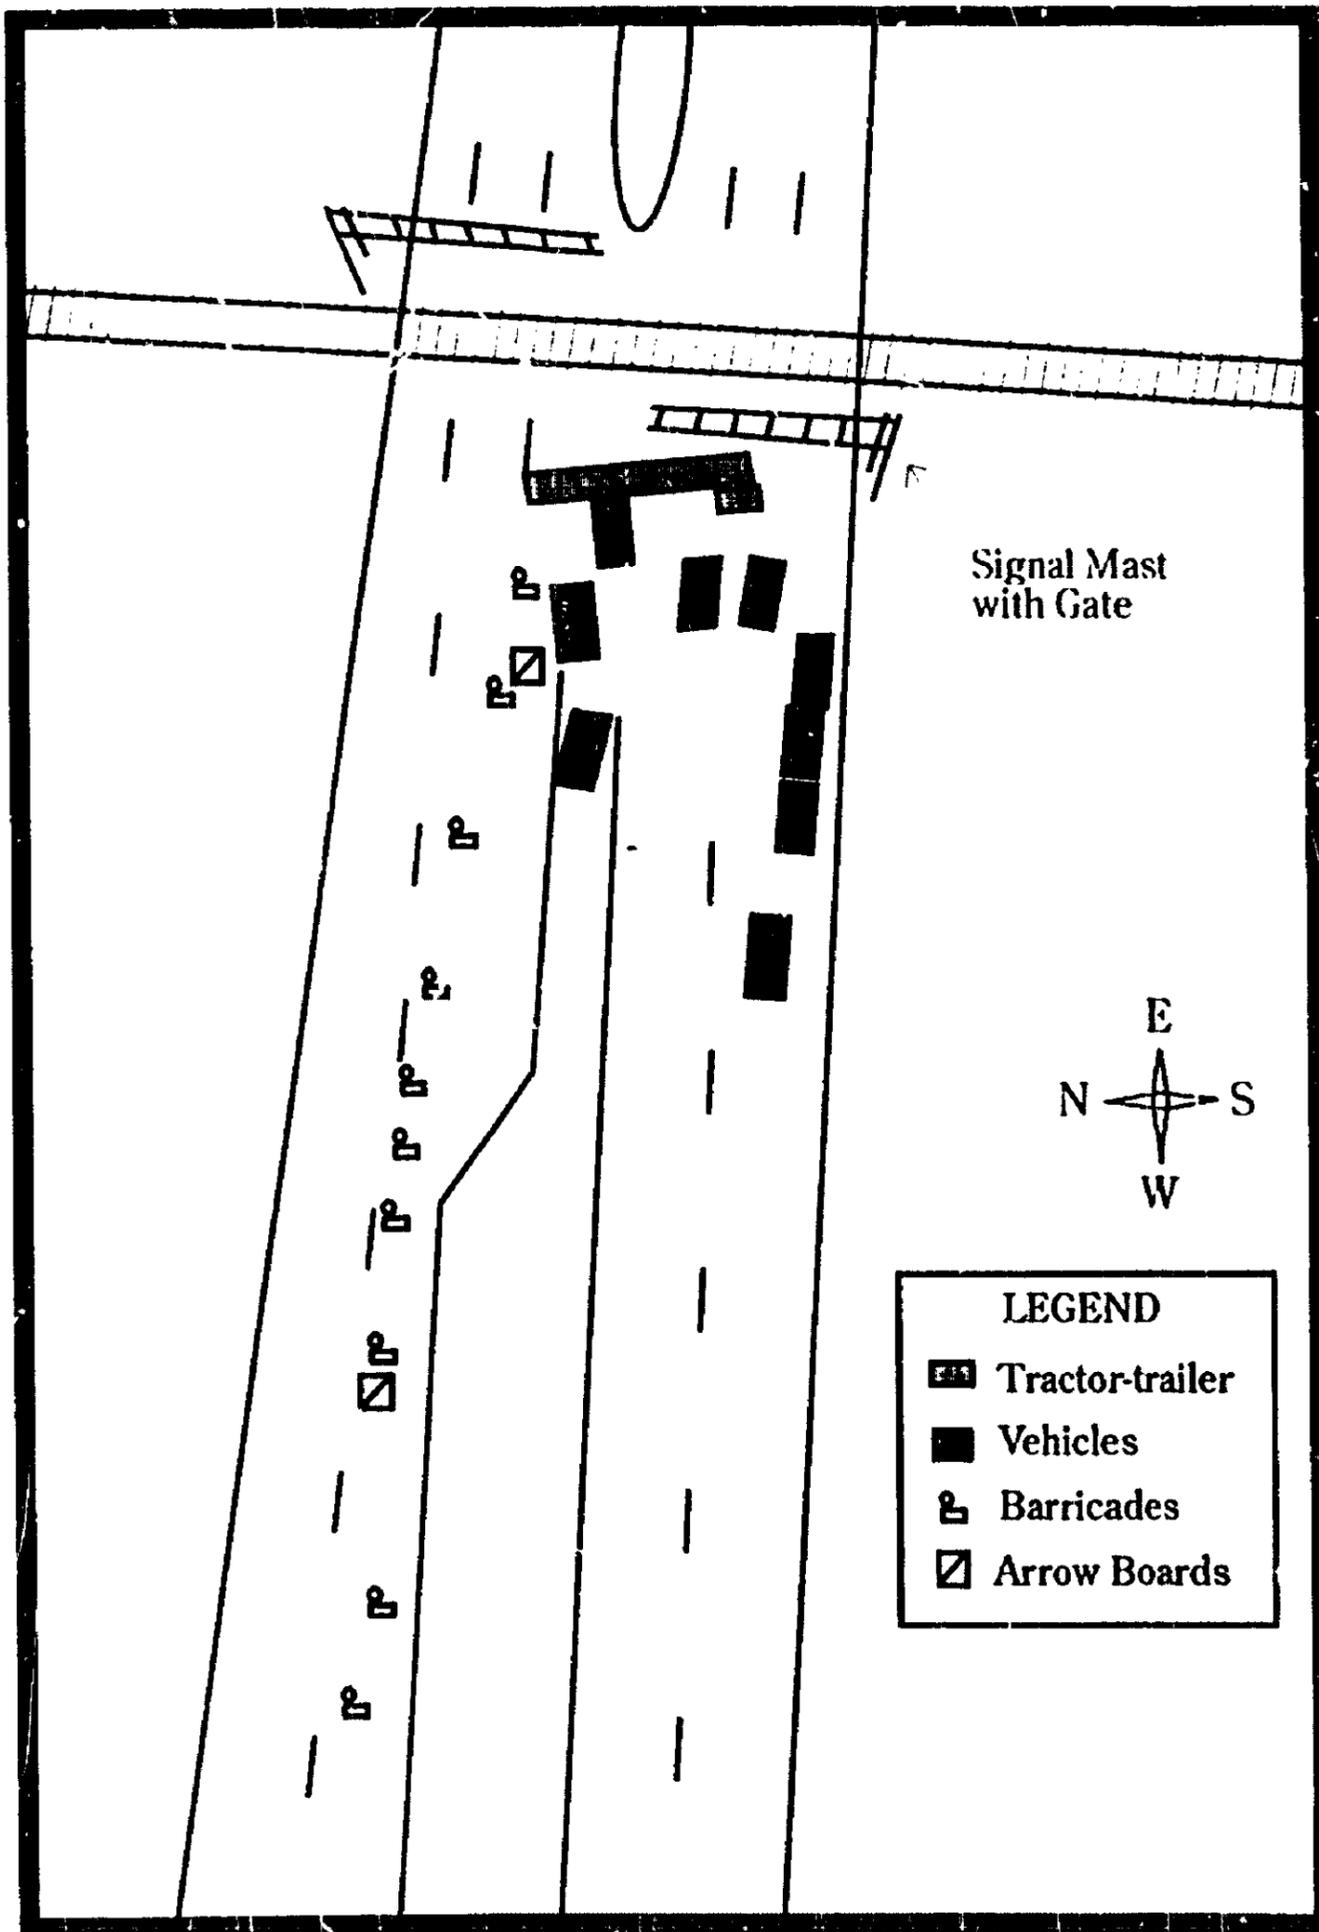
Figure 2.--Position of vehicles after collision.

Nine witnesses stated that as the truck was proceeding slowly across the railroad track, the train struck the right rear of the semitrailer, causing the truck to rotate in a clockwise direction. The tractor and semitrailer separated and came to rest almost parallel to the track on the west side of the crossing (see figure 2). The semitrailer ruptured, spewing gasoline that immediately ignited. The fire engulfed nine vehicles on the west side of the crossing. The train remained on the track and traveled about 278 feet before it came to rest.
