HIGHWAY ACCIDENT REPORT

COLLISION OF SMALL SCHOOL BUS  
AND TRACTOR-SEMITRAILER  
NEAR SNYDER, OKLAHOMA  
NOVEMBER 10, 1993

**Adopted: November 29, 1994  
Notation 6491**

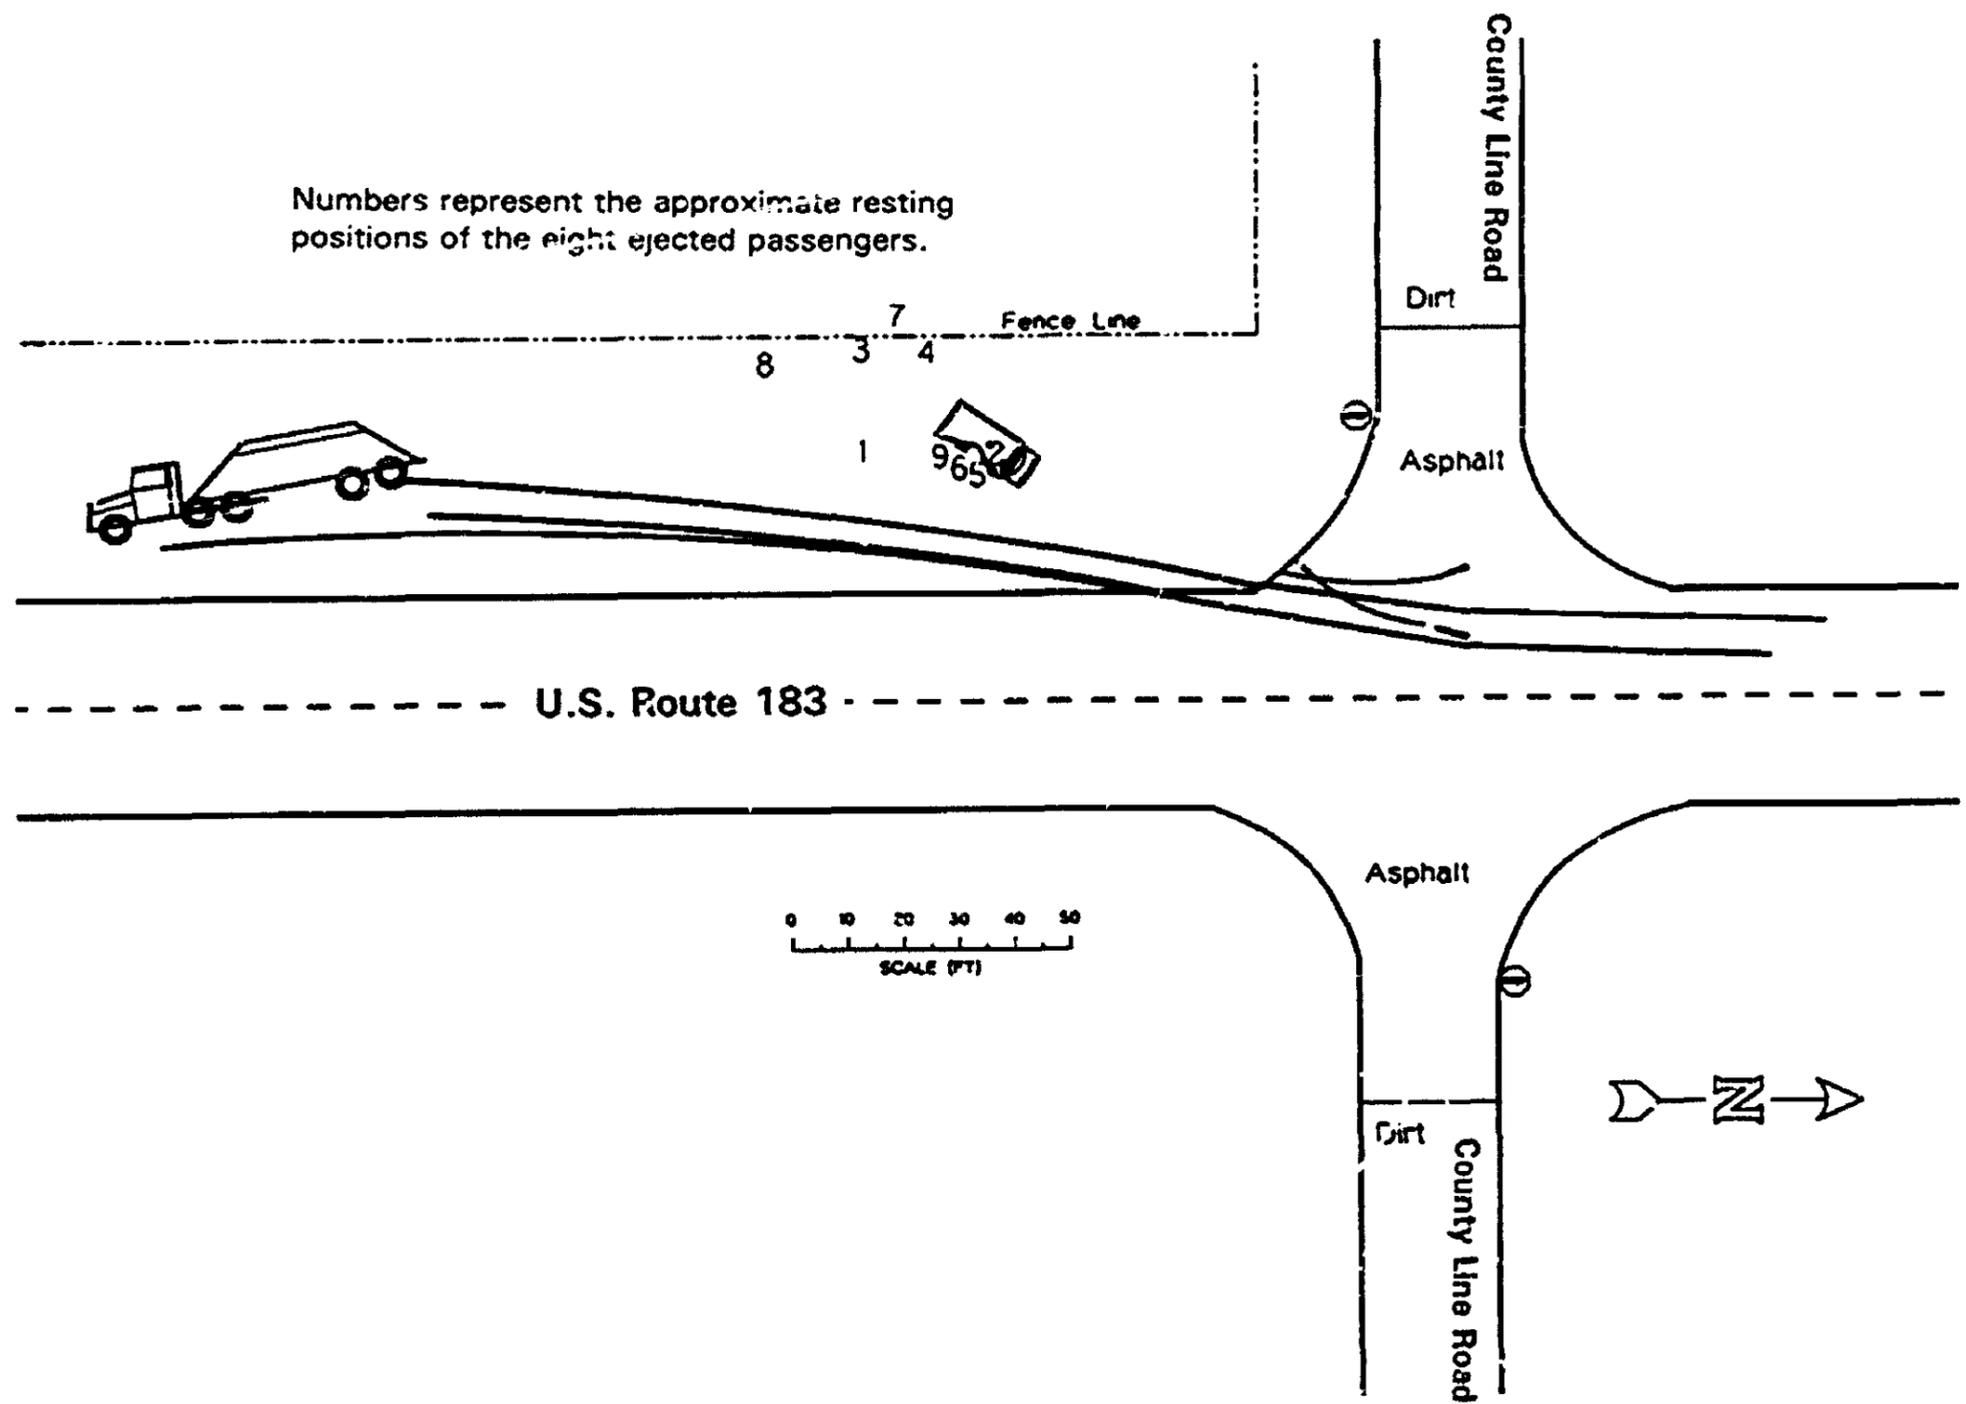
Figure 1. -- Postaccident diagram.

**Sequence of Events** -- Based on the physical evidence (including paint transfers, vehicle damage, tire marks, and other markings at the accident site), the Safety Board believes that the following sequence of events took place. The truckdriver swerved to the right, applied the brakes, and skidded 40 feet before striking the right side of the bus at an angle 3 degrees to the right of perpendicular. The impact caused the school bus to suddenly move southward and to rotate clockwise. A secondary impact, which occurred between the right front of the school bus and the right side of the tractor, slowed the clockwise rotation of the bus. The two vehicles separated, and both continued moving southward. The bus left the paved roadway and entered the dirt shoulder. The bottom right-rear corner of the bus dug into the ground, and the vehicle lost considerable momentum. The bus tilted toward its right side, traveled down the dirt embankment, and came to rest in an upright position facing northeast, 90 feet from the point of impact. The tractor-semitrailer traveled another 250 feet on the right shoulder and overturned onto its right side.

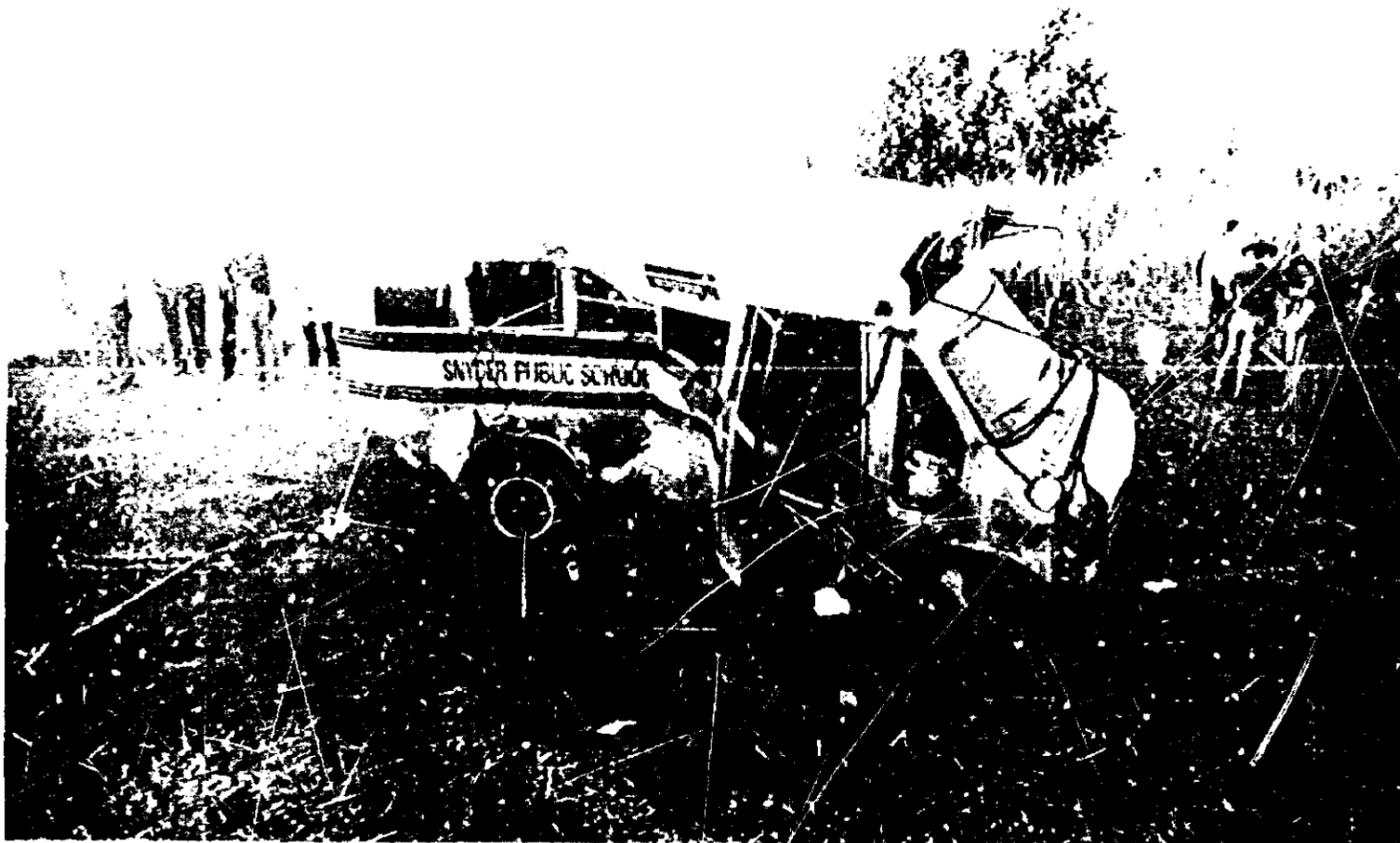
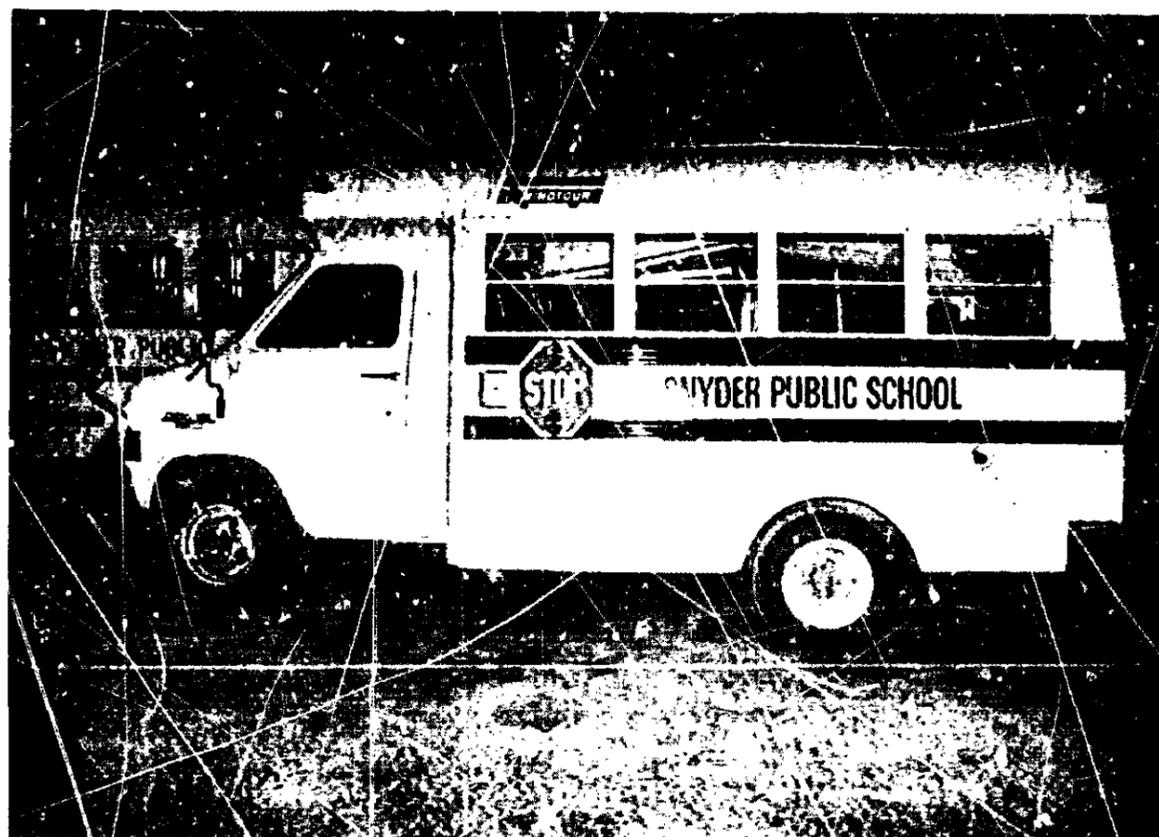
Figure 3. -- Right and left views of the school bus after the accident.

**School Bus** -- Most of the damage was along the right side of the bus. (Figure 3 shows a view of each side.) The deformation began 7 inches from the right-rear corner and extended forward for 139 inches, ending at the forward hinge of the folding entrance doors. Contact damage between the bus and the front of the truck began 22 inches from the right-rear corner and extended forward for 96 inches (approximately the width of the tractor), stopping at the rear of the folding entrance doors. In this contact area, an imprint from the right side of the truck bumper was visible on the sheet metal. The maximum intrusion into the right side of the bus was 29 inches.

The right-side window frames were deformed, and the window glass was missing. The right side and top of the roof were creased. The right-front entrance door was deformed; the rear portion of the bilateral door was hanging outward, and the front portion was twisted and bent and lying on the ground. The right-front and right-rear bottom corners of the bus were crushed.

On the right side of the bus, the front, rear, and roof were splattered with dirt, but the left side was clean. The impact area was also free of dirt. Hairs were embedded in the cracked front windshield. Both front and rear on the interior right sidewall, blood was splattered near the roof. Near the top of the exterior right-rear sidewall, one area was creased and "clean," and white striation marks angled downward; another area immediately to the right was smeared with tissue and blood.

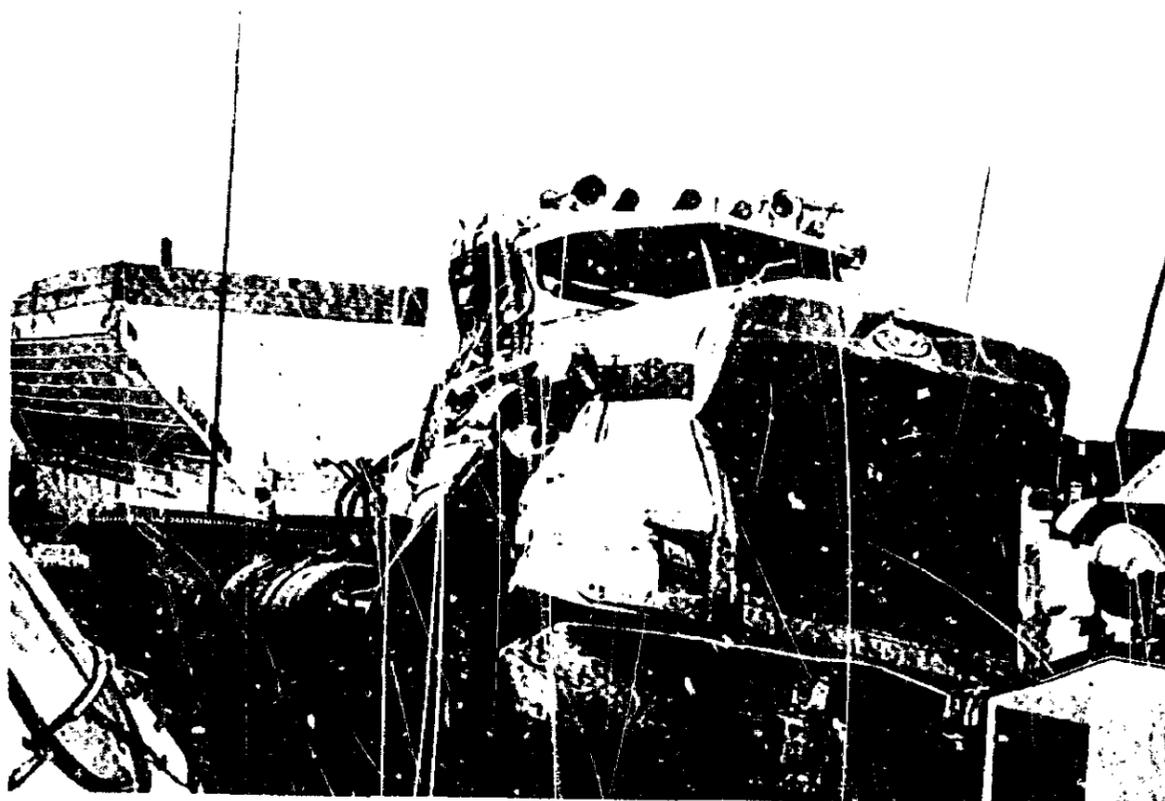
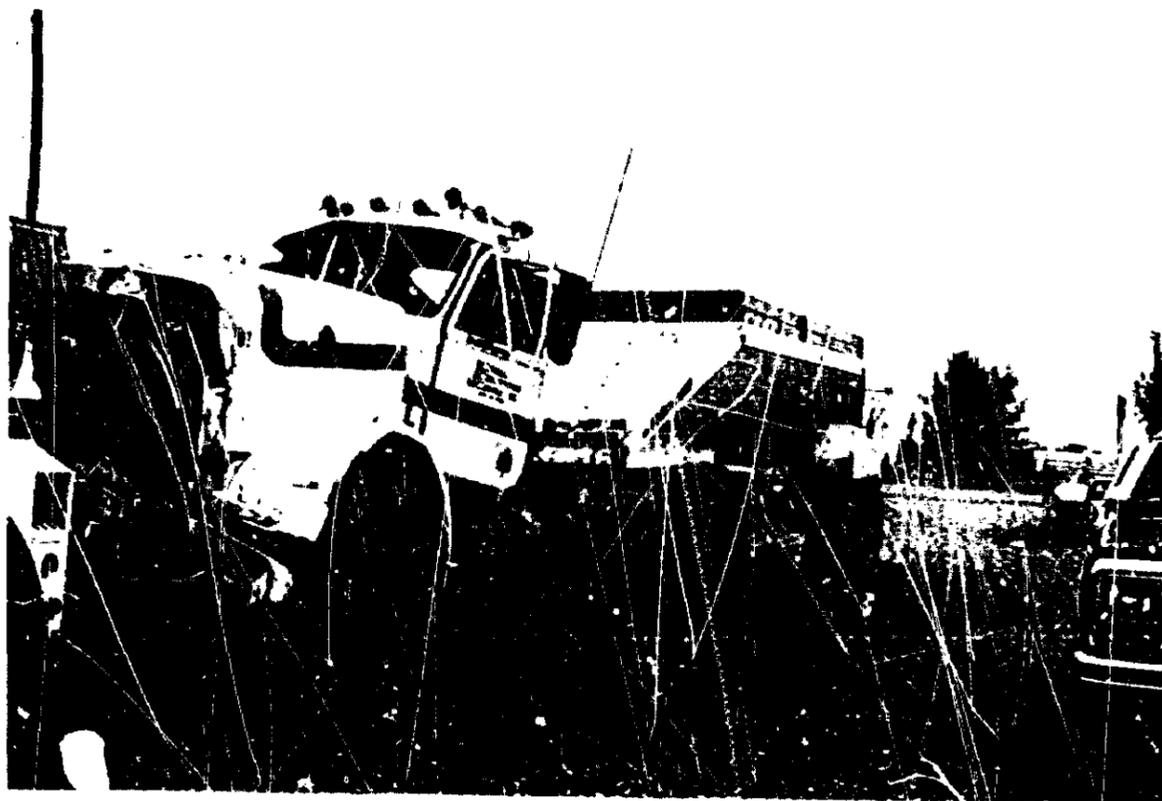
**Figure 5. -- The tractor-semitrailer after the accident.**

**Tractor-Semitrailer** -- The photographs in figure 5 show the damage to the tractor-semitrailer. The front bumper of the tractor was displaced rearward and about 3 inches to the right. The fenders, hood, and grill were displaced 4 to 5 inches rearward. The windshield glass was broken. Yellow paint transfers were on the bumper, the hood, and the passenger steps of the tractor. The right side of the tractor was crushed when the truck overturned. The semitrailer was intact except for scrape marks and creasing on the right side.

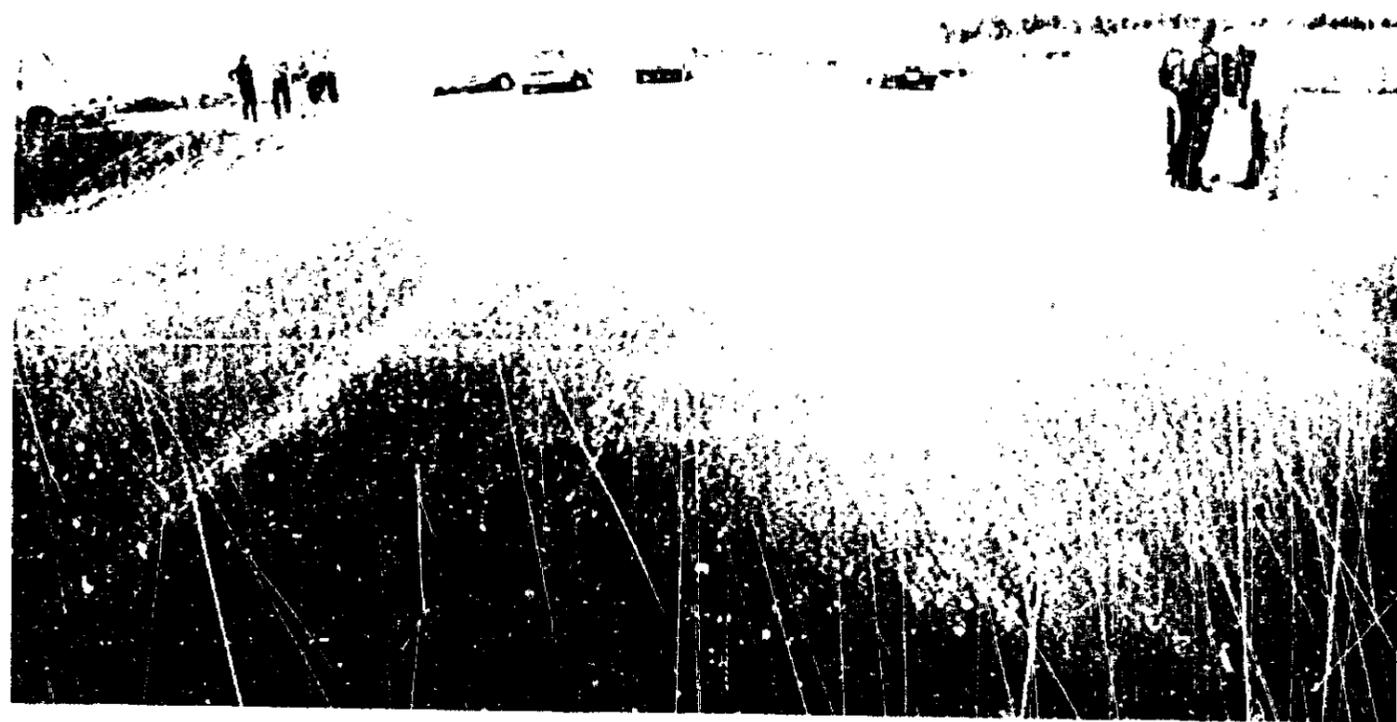
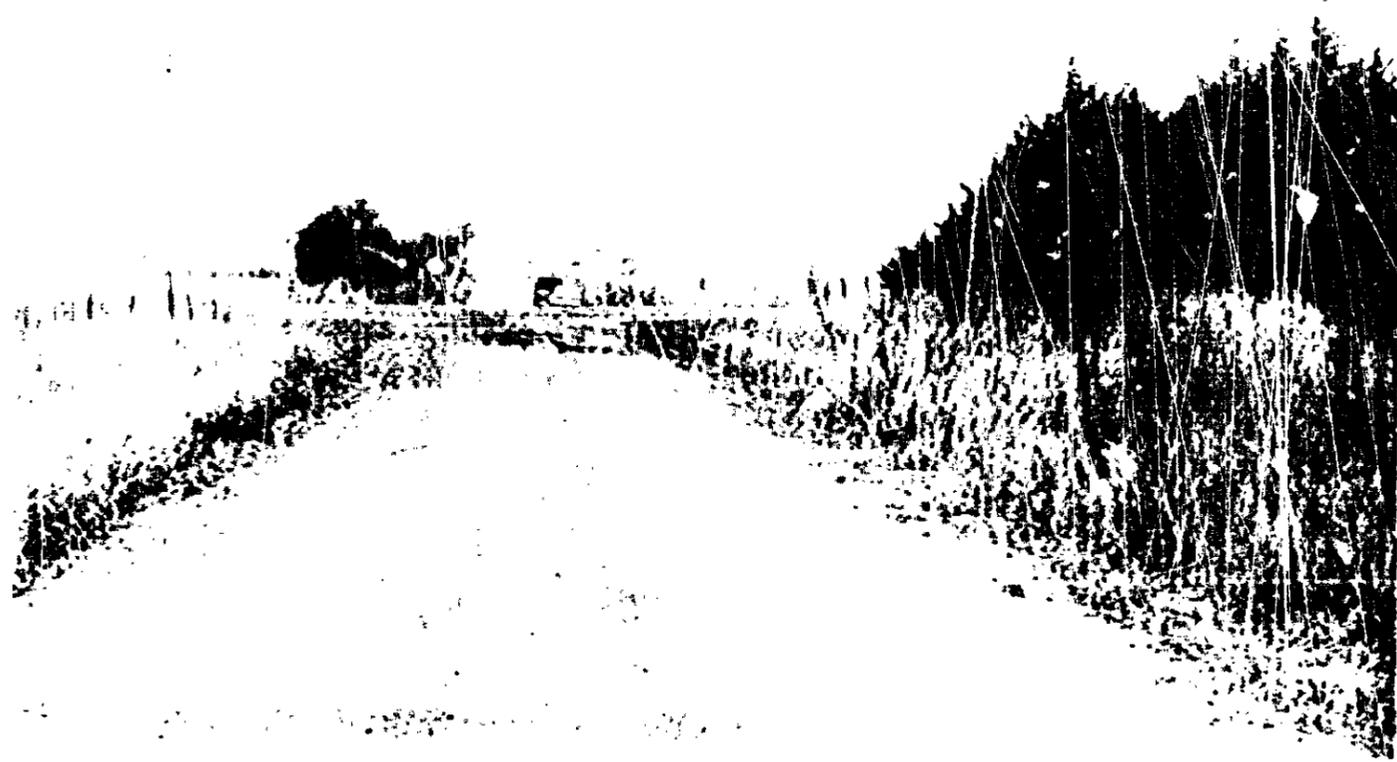
Figure 6. -- U.S. Route 183 (top) and County Line Road.

**U.S Route 183** -- The highway runs north and south, and the posted speed limit is 55 mph. At the accident site, Route 183 is straight, level, 40 feet wide, two-lane, and two-way. The highway had been repaved on October 27, 1993; 14 days later, when the accident occurred, it had no lane markings except for intermittent strips of yellow tape representing a center line. In 1991, the average daily traffic count for this section of Route 183 was 1,400 vehicles.

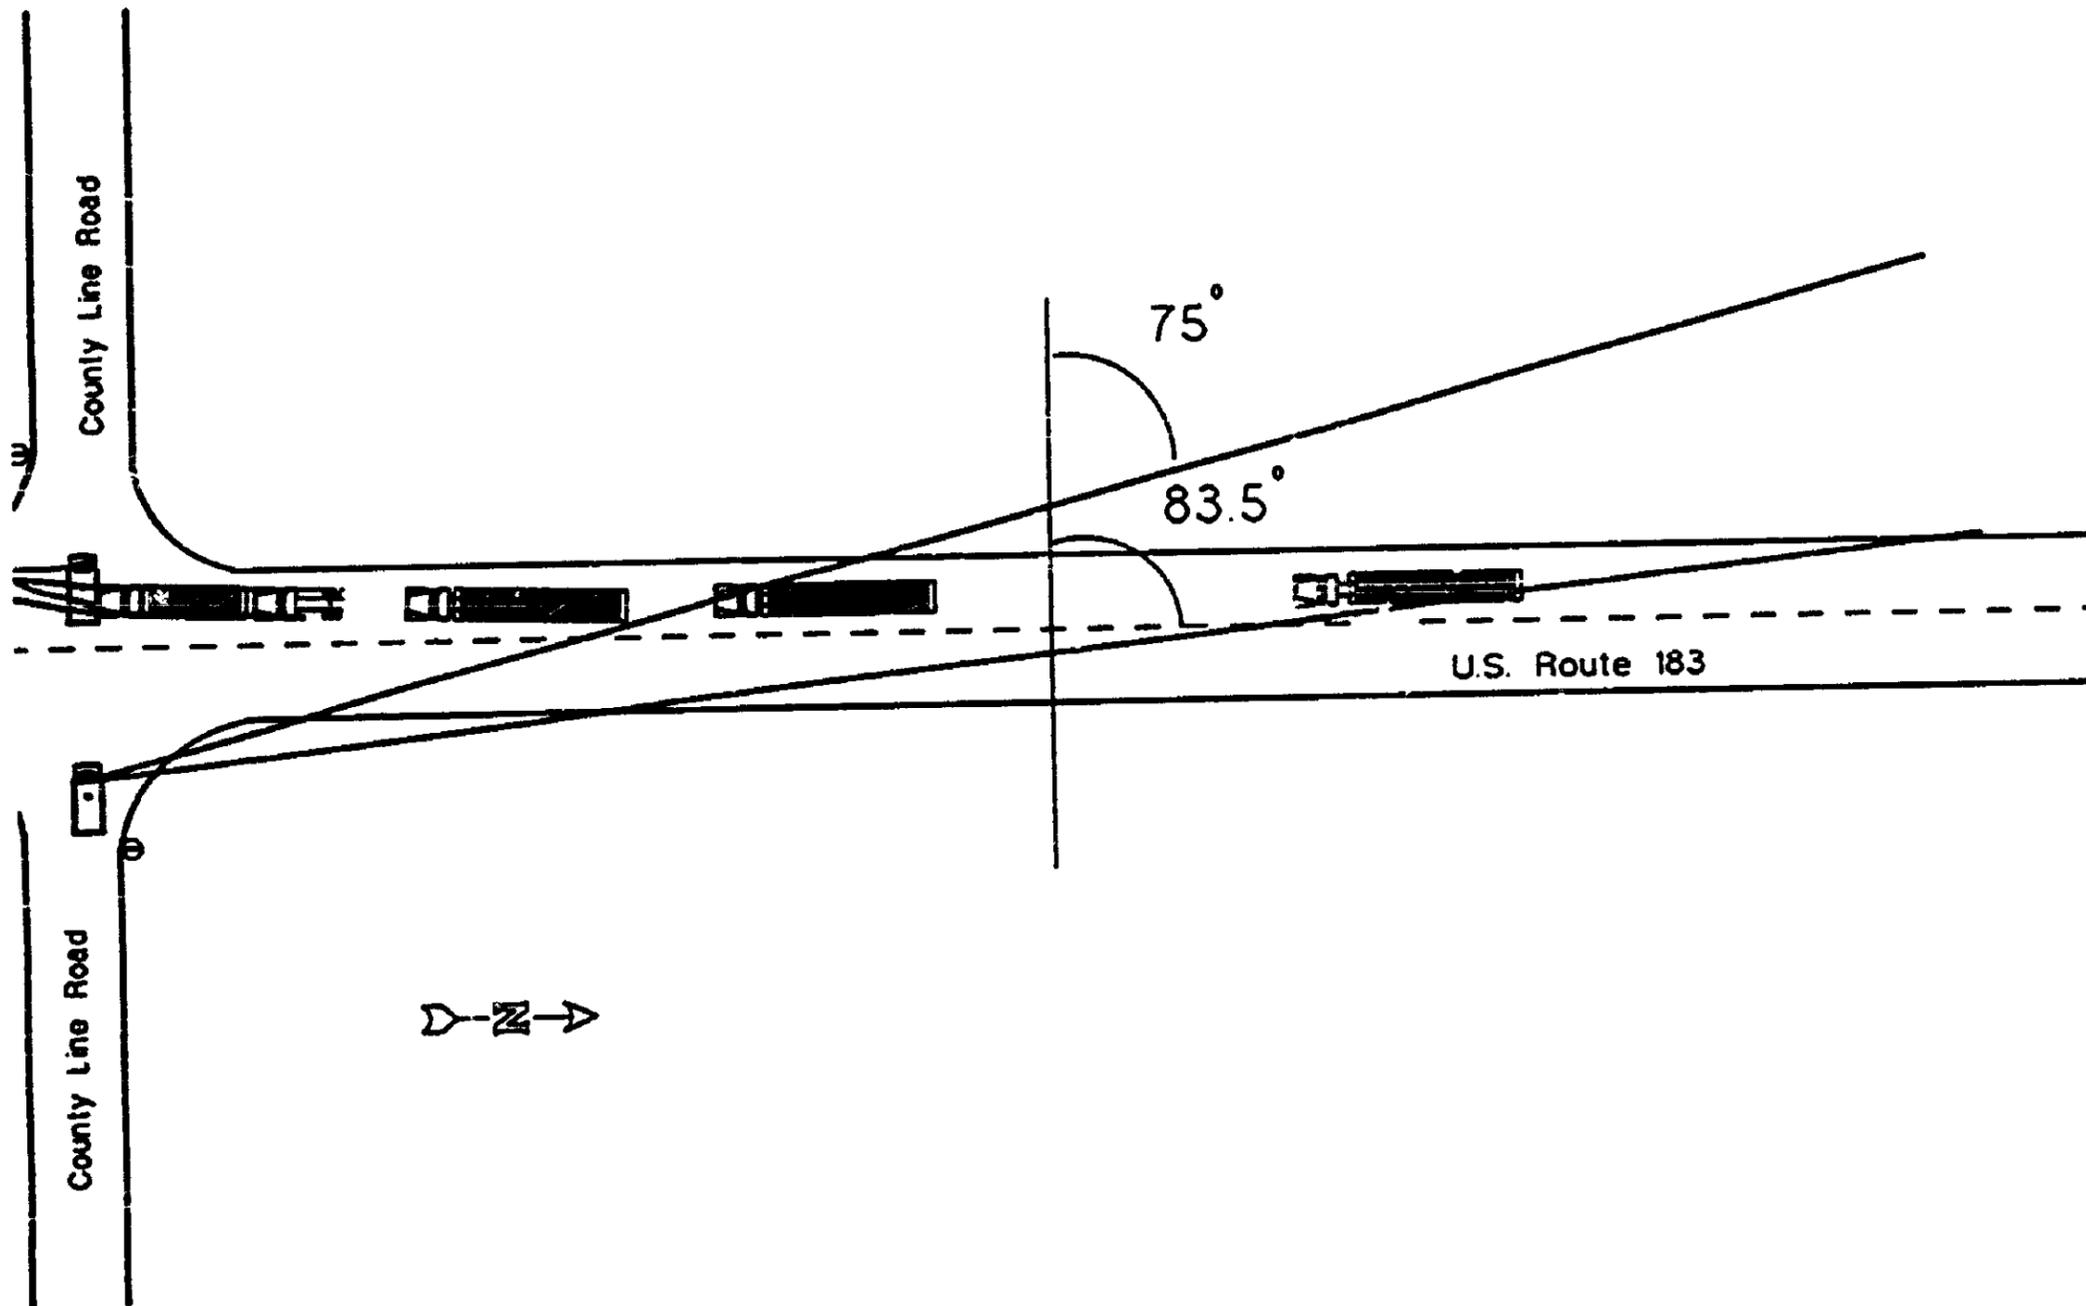
Figure 9. -- Line-of-sight obstruction at 10 feet from the intersection with the bus stationary. These conditions do not assess the effect of a moving bus.

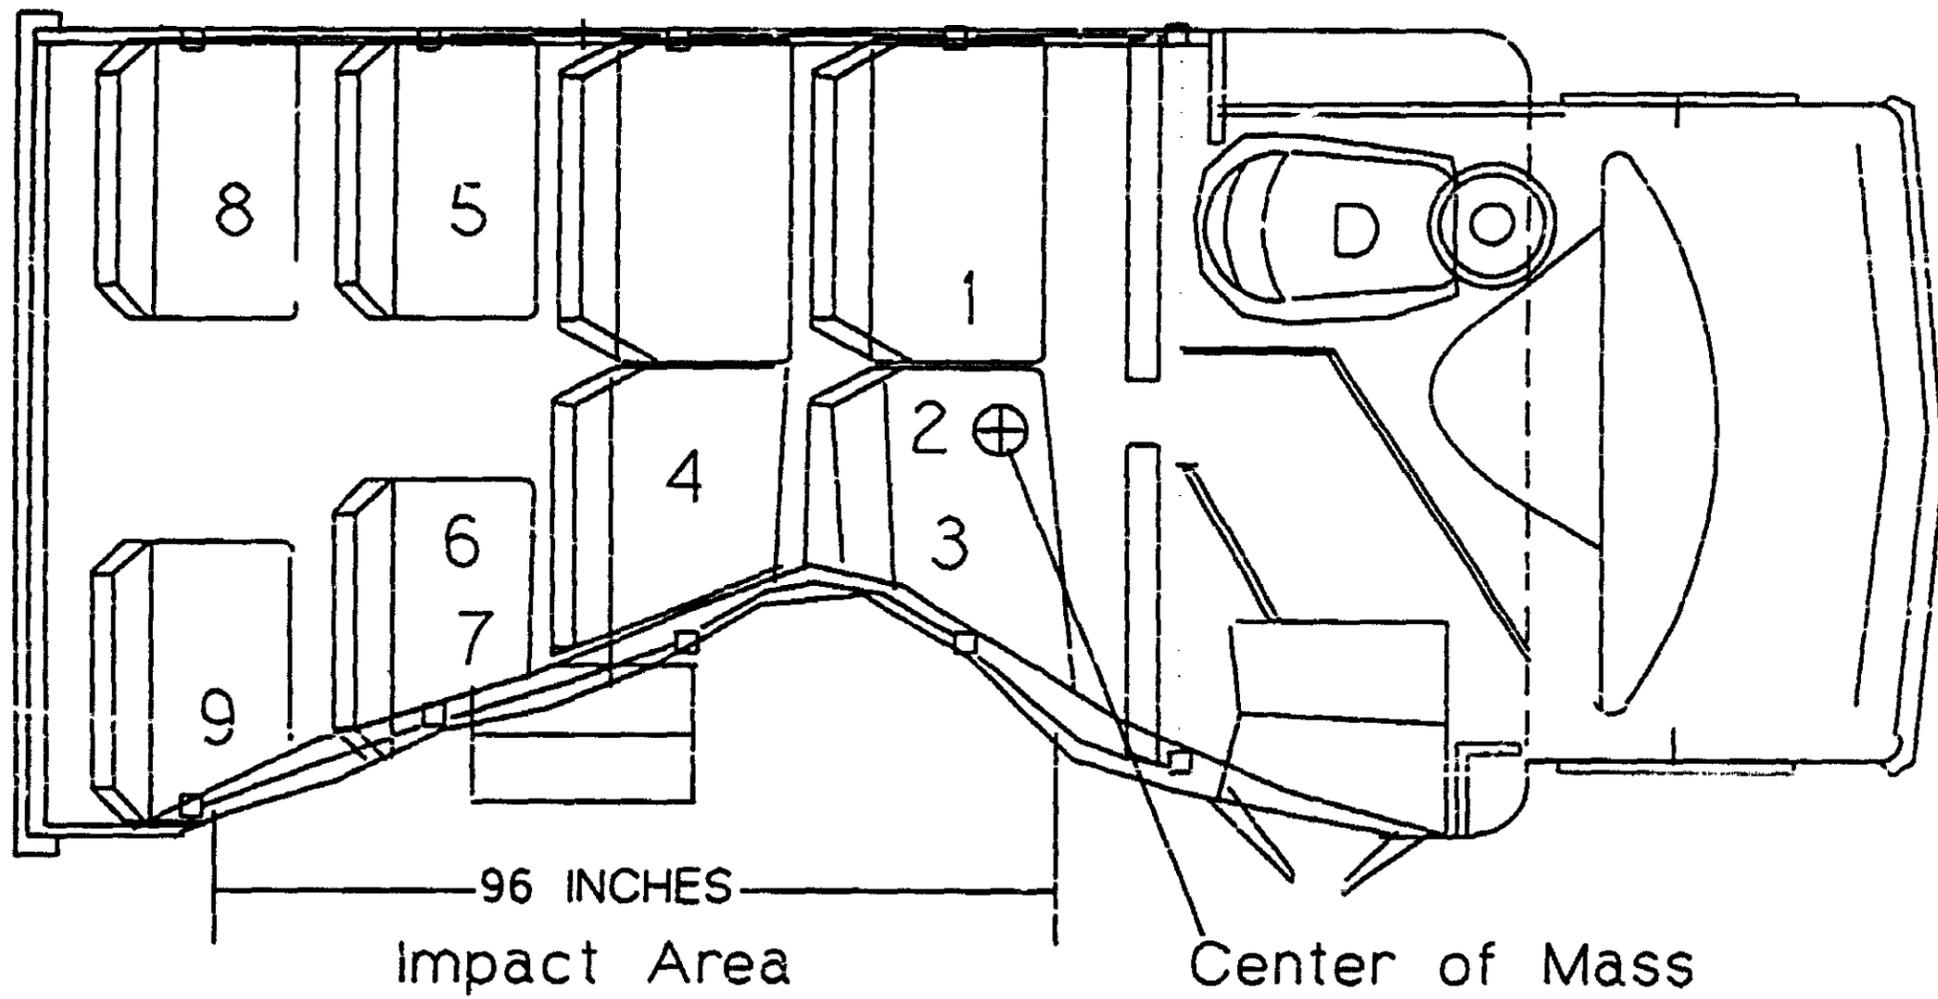
Figure 10. -- Collision Deformation -- Impact Area.

The three children who died at the scene (passengers 6, 7, and 9) were seated in rows 3 and 4 on the right side of the bus, where the impact occurred. (See figure 10.) The fourth fatally injured child (passenger 8) was seated in the 4th row on the left side of the bus. She died the following day from an undefined head injury. The surgeon who treated her stated that he saw no indication of lapbelt usage. No autopsies were performed on these students, and the precise causes of death are unknown.

Passengers 5, 6, and 9 were probably dragged or run over by the bus. They were found about 5 feet from the right side of the bus. Unlike the other ejected occupants, these three passengers had massive external injuries; their bodies were covered with dirt, and dirt was embedded in their wounds. These wounds probably were not sustained inside the bus. The bus interior had little evidence of body contact, and the amount of blood (a small splattering near the right sidewall and roof area) was negligible. On the outside of the bus, however, blood, tissue, creasing, and surface marks on the top right-rear side indicated contact with at least one

occupant. Passenger 5, who survived, had a lacerated pelvic area and a fractured pelvic bone. She was not in the impact area, and if she had been restrained, she would not have been ejected and her injuries might have been less severe. Passengers 6 and 9 died at the scene. Passenger 6 had two fractured thigh bones, a penetrating injury to the chest, and multiple lacerations and abrasions. Passenger 9 sustained a severely lacerated scalp, multiple bruises, and his left leg was almost severed below the knee. Passengers 6 and 9 were both on the perimeter of the impact area. Lapbelts would have prevented their ejection. They might have been injured by the lapbelt, the sidewall of the bus, or contact with other passengers. However, they would not have received the massive external injuries that were inflicted during and after their ejection, and their chances for survival might have been better.
