NTSB/HAR-95/01

**NATIONAL TRANSPORTATION  
SAFETY BOARD**

**HIGHWAY ACCIDENT REPORT**

**COLLISION OF AMTRAK TRAIN NO. 88 WITH  
ROUNTREE TRANSPORT AND RIGGING VEHICLE  
ON CSX TRANSPORTATION, INC., RAILROAD  
NEAR INTERCESSION CITY, FLORIDA  
NOVEMBER 30, 1993**

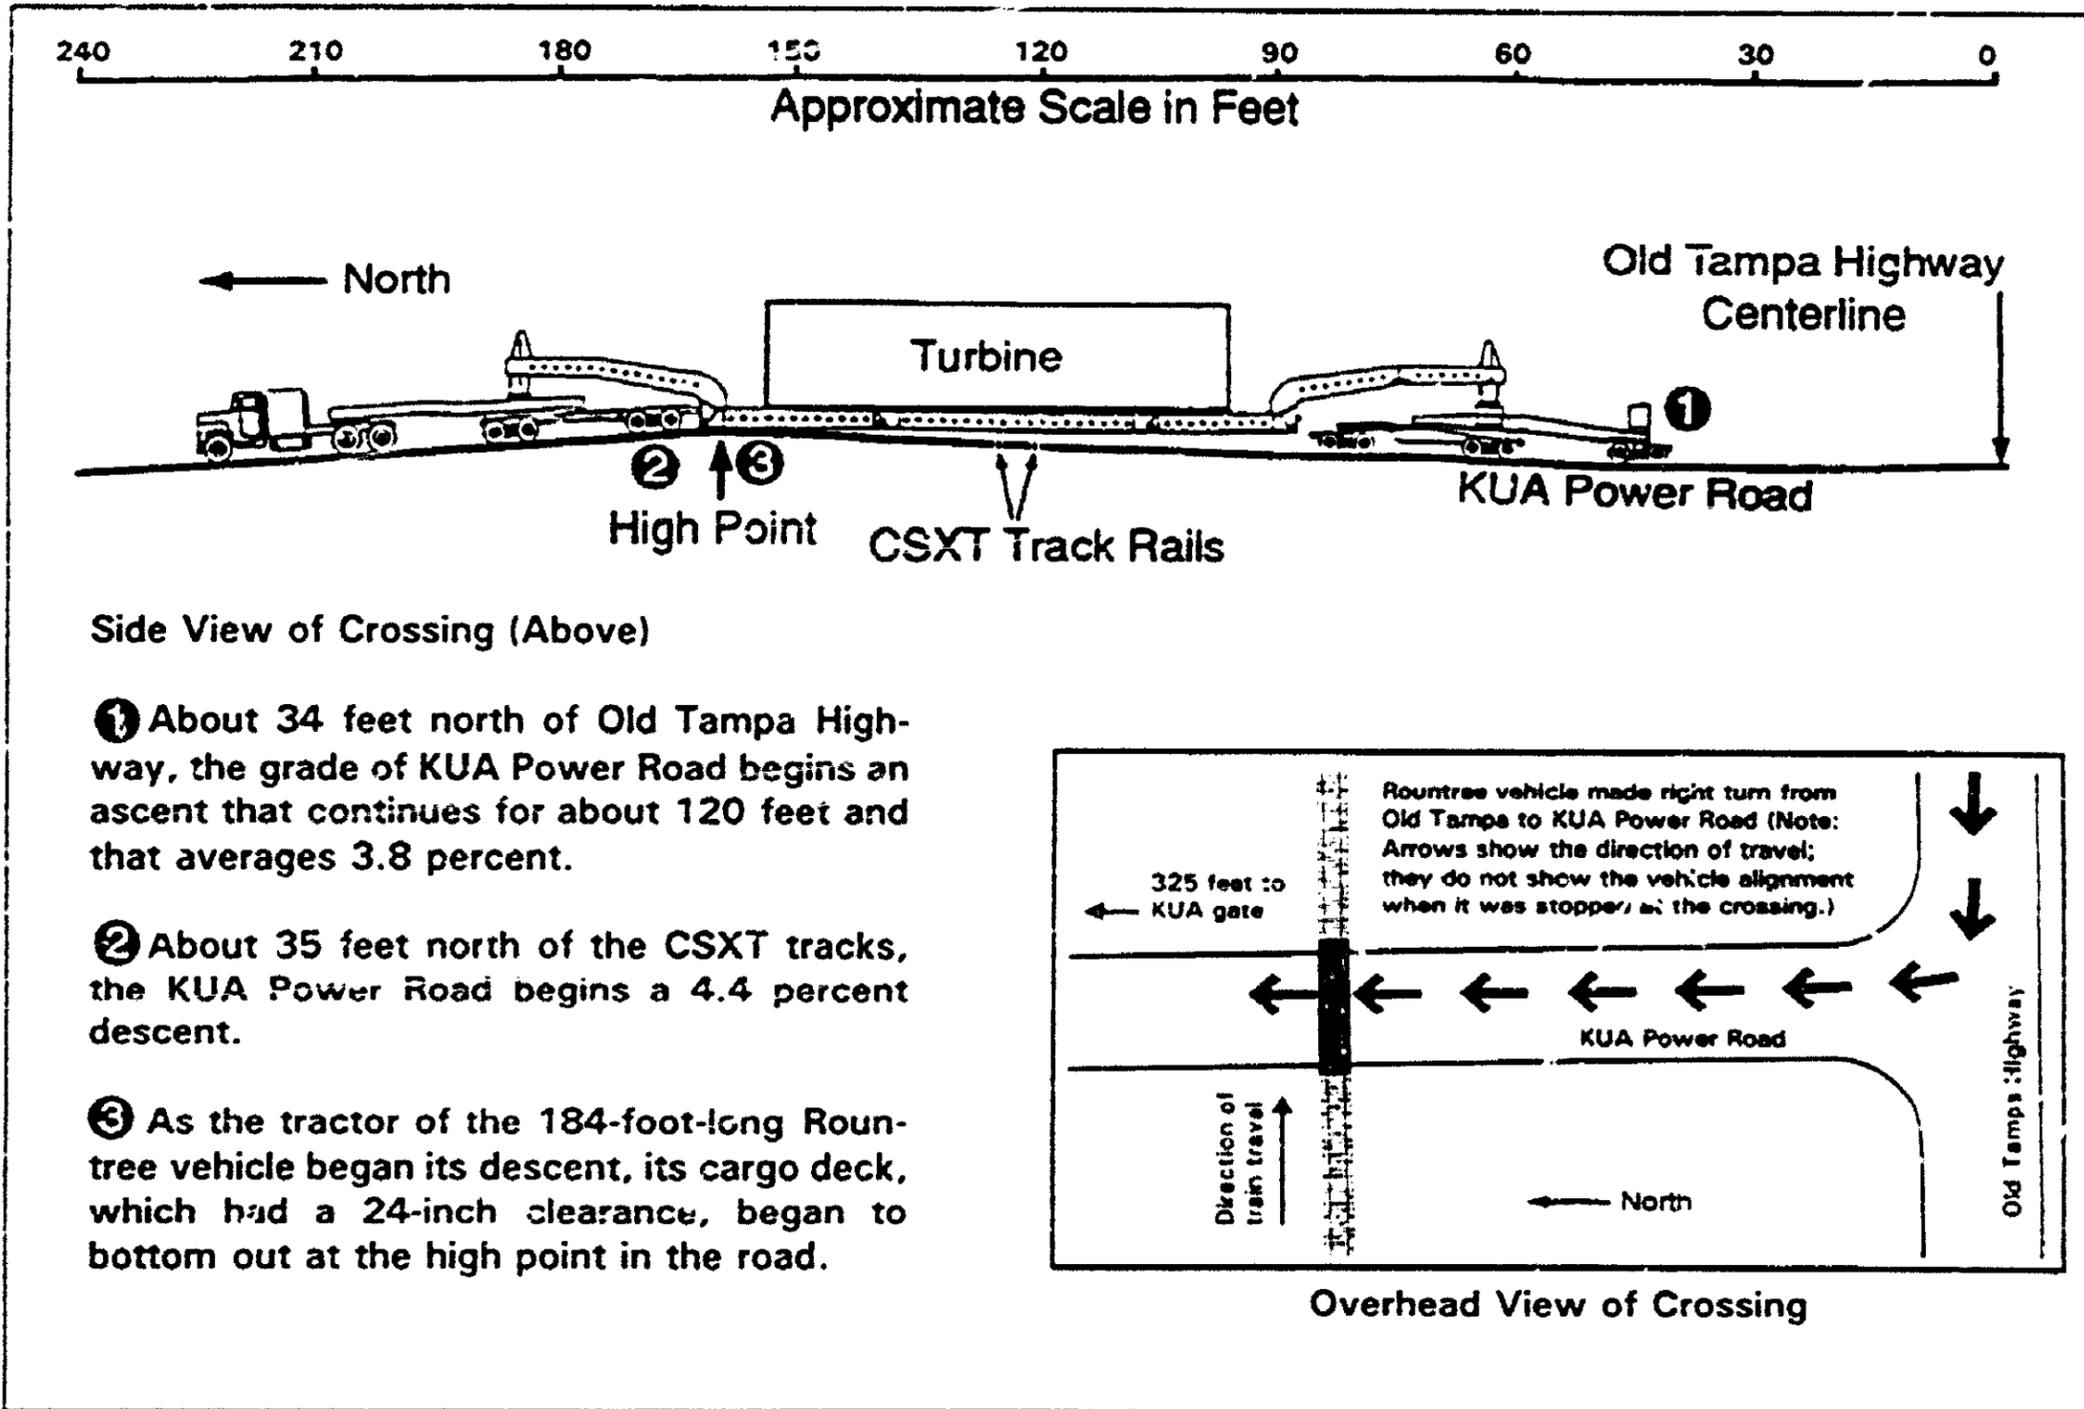
Figure 1.--Rountree vehicle on KUA Power Road grade crossing.

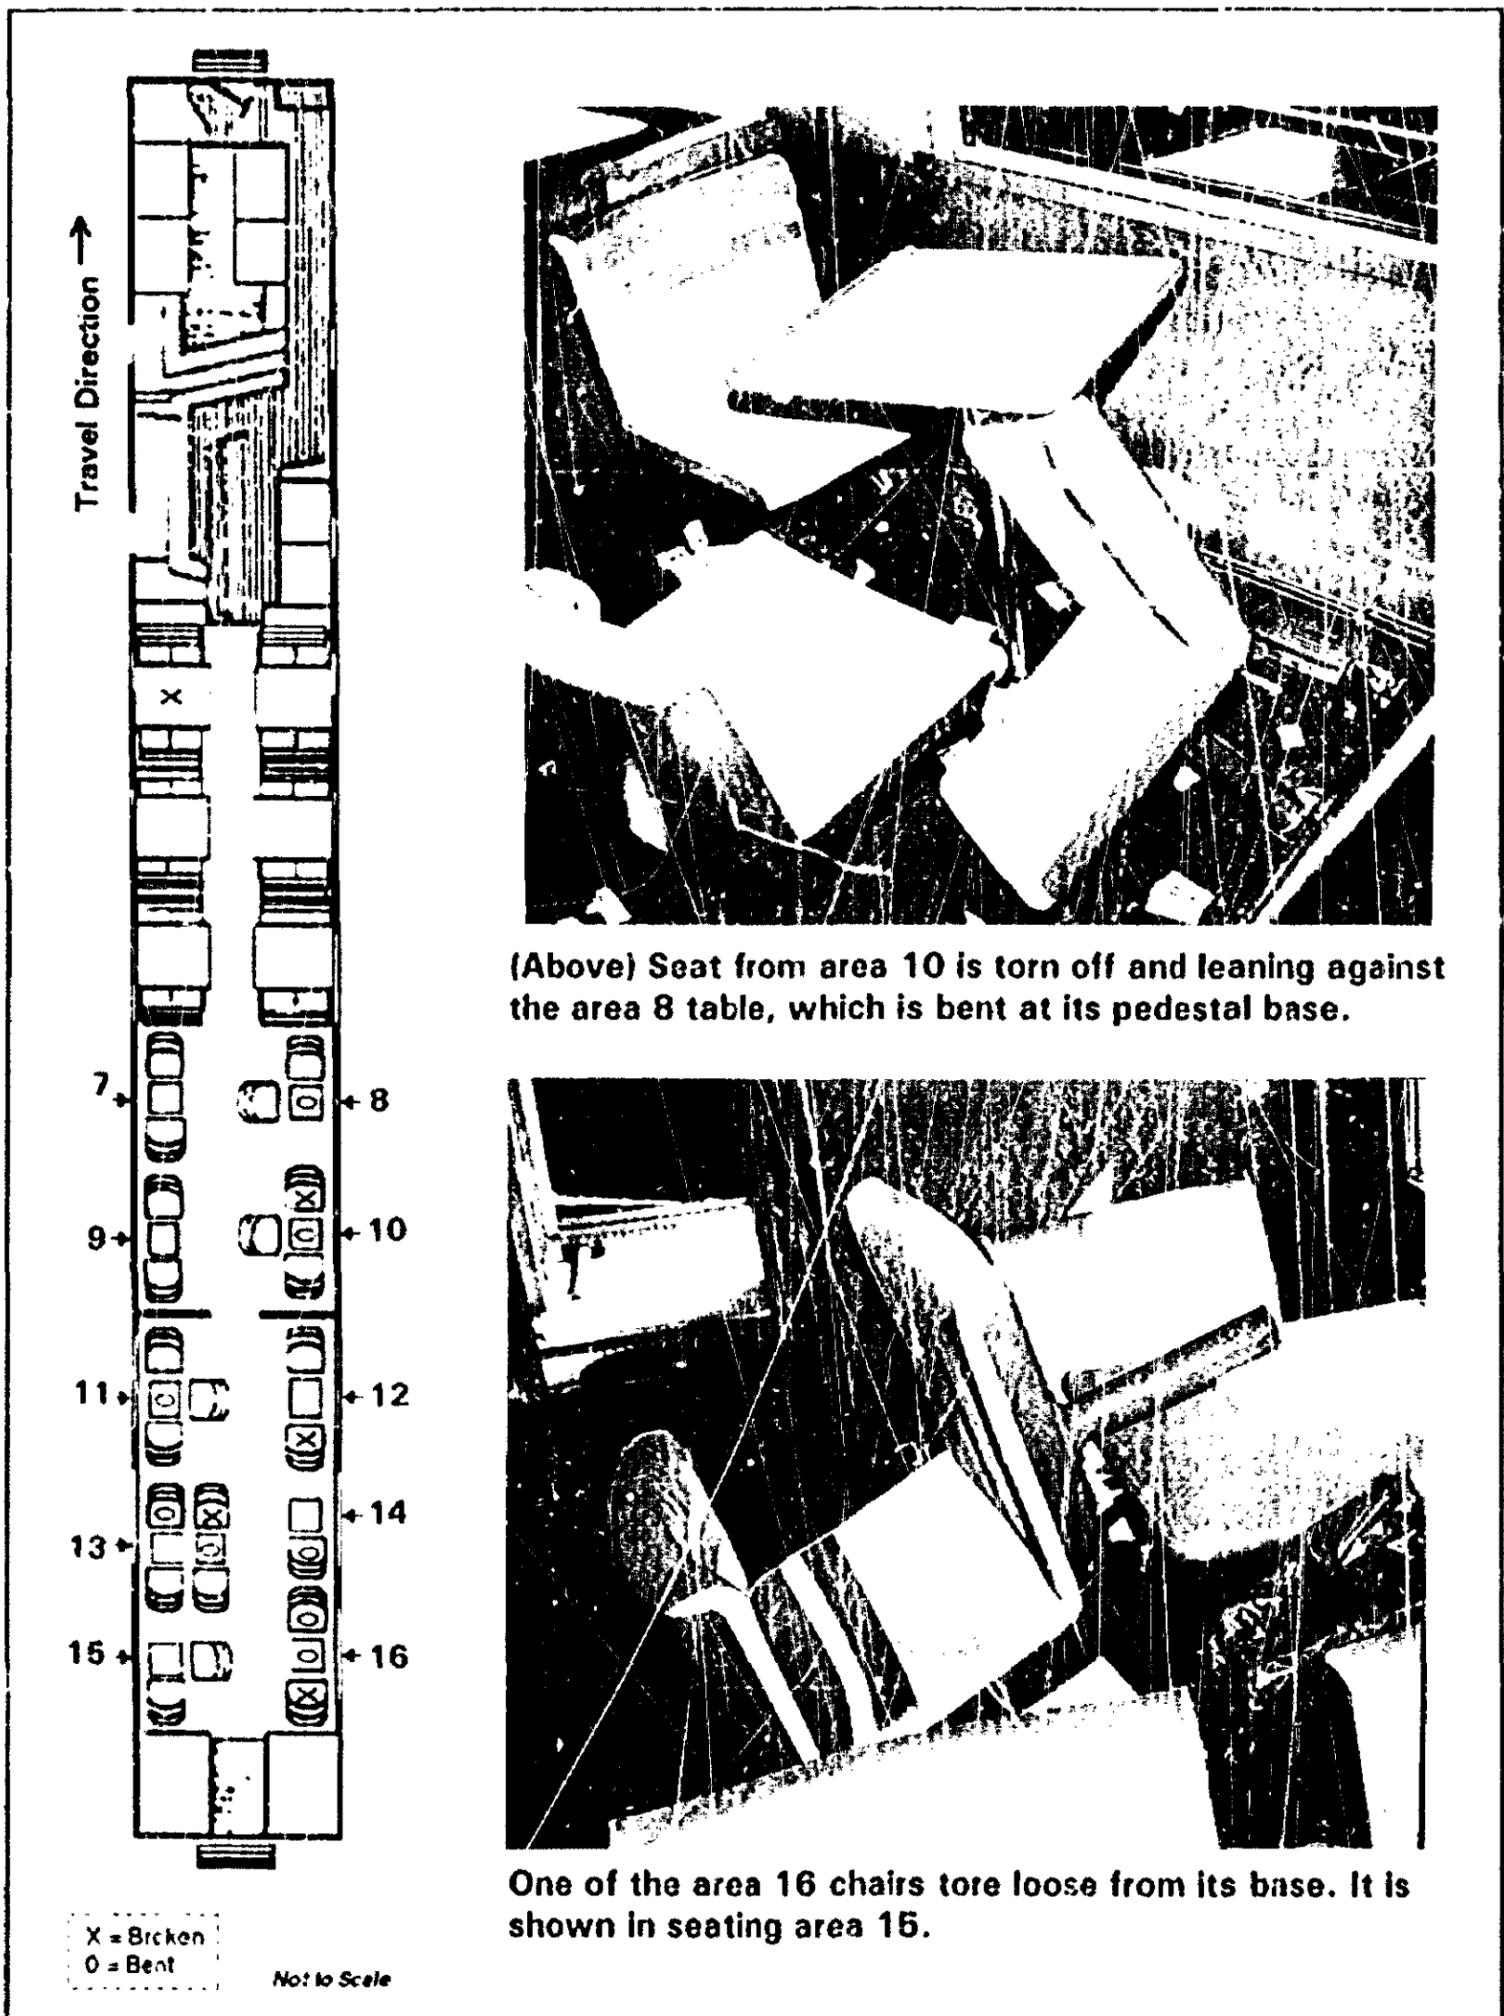
**Train.**--Upon striking the turbine, the locomotive nose, which contained a toilet and the event recorder, was crushed 12 inches. The locomotive came to rest on its left side about 28 feet north of the track line and about 364 feet east of the point of initial impact. Investigators found the automatic brake handle in the emergency position. The locomotive fuel tanks were breached, and diesel fuel was leaking. In the lounge car, investigators found four pedestal seats broken from their bases and five tables bent toward the front of the train. Safety Board investigators found that the pedestal seats had separated at the weld area where the pedestal was connected to the base. Amtrak's General Manager of Mechanical Standards and Compliances later stated that the pedestal seat should have collapsed or buckled along the pedestal support rather than separating from the base.

**Lounge Car Injuries.**--At the time of the accident, 12:40 p.m., 18 to 20 people were in the lounge (figure 10). In addition to the two injured OBS attendants noted above, an OBS attendant complained of minor injuries after being thrown against a lounge table and a lounge attendant received minor burns after being splashed with hot coffee. One passenger sustained chest trauma from striking tables, and another passenger received a head contusion after striking his head on a lounge partition wall. A passenger in a pedestal seat at table 11 received spinal trauma after she reportedly was thrown against and over the table. She said a broken chair also struck her right leg. Another passenger at table 11 was thrown more than 8 feet, striking table 10 with his left temple.

Figure 10.--Lounge car interior. Graphic shows location of damaged pedestal seats and tables.
