**MULTIPLE VEHICLE COLLISION WITH FIRE  
DURING FOG NEAR MILEPOST 118  
ON INTERSTATE 40, MENIFEE, ARKANSAS  
JANUARY 9, 1995**

**SPECIAL INVESTIGATION  
OF COLLISION WARNING TECHNOLOGY**

**HIGHWAY ACCIDENT REPORT**

**National  
Transportation  
Safety Board**

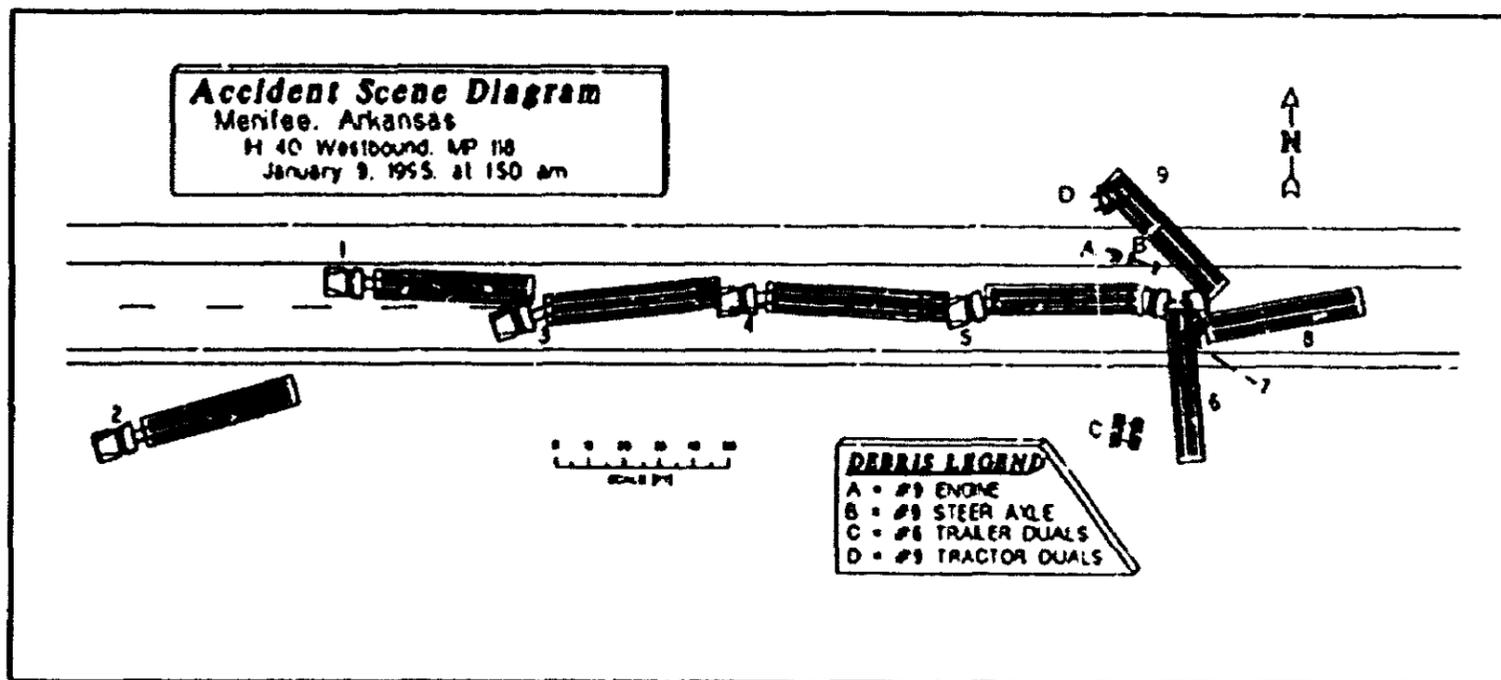
**Figure 2. -- Postaccident scene diagram showing position of vehicles.**

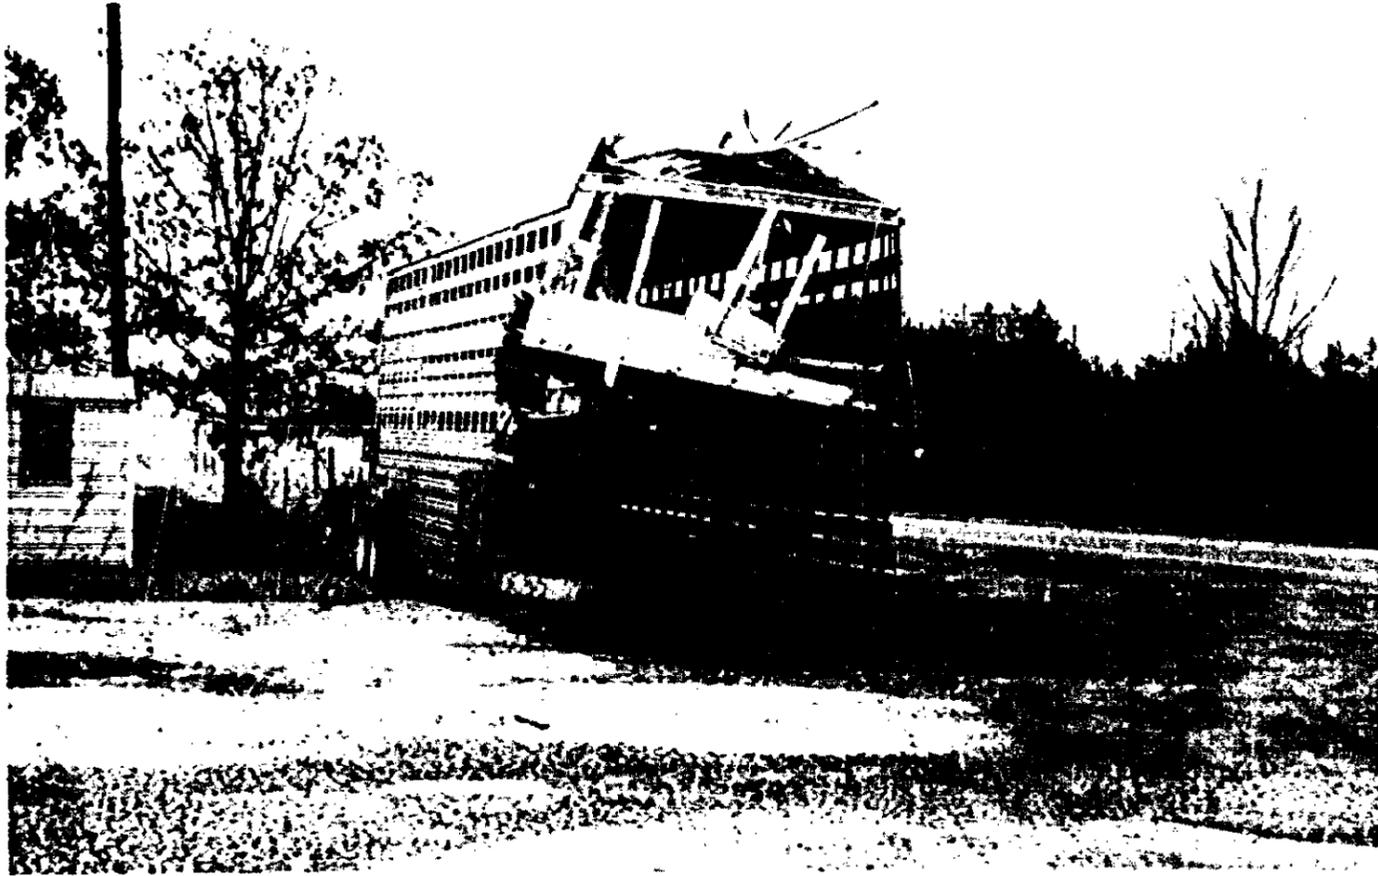
**Photograph 1. -- Combination 1 trailer (view from rear toward front).**

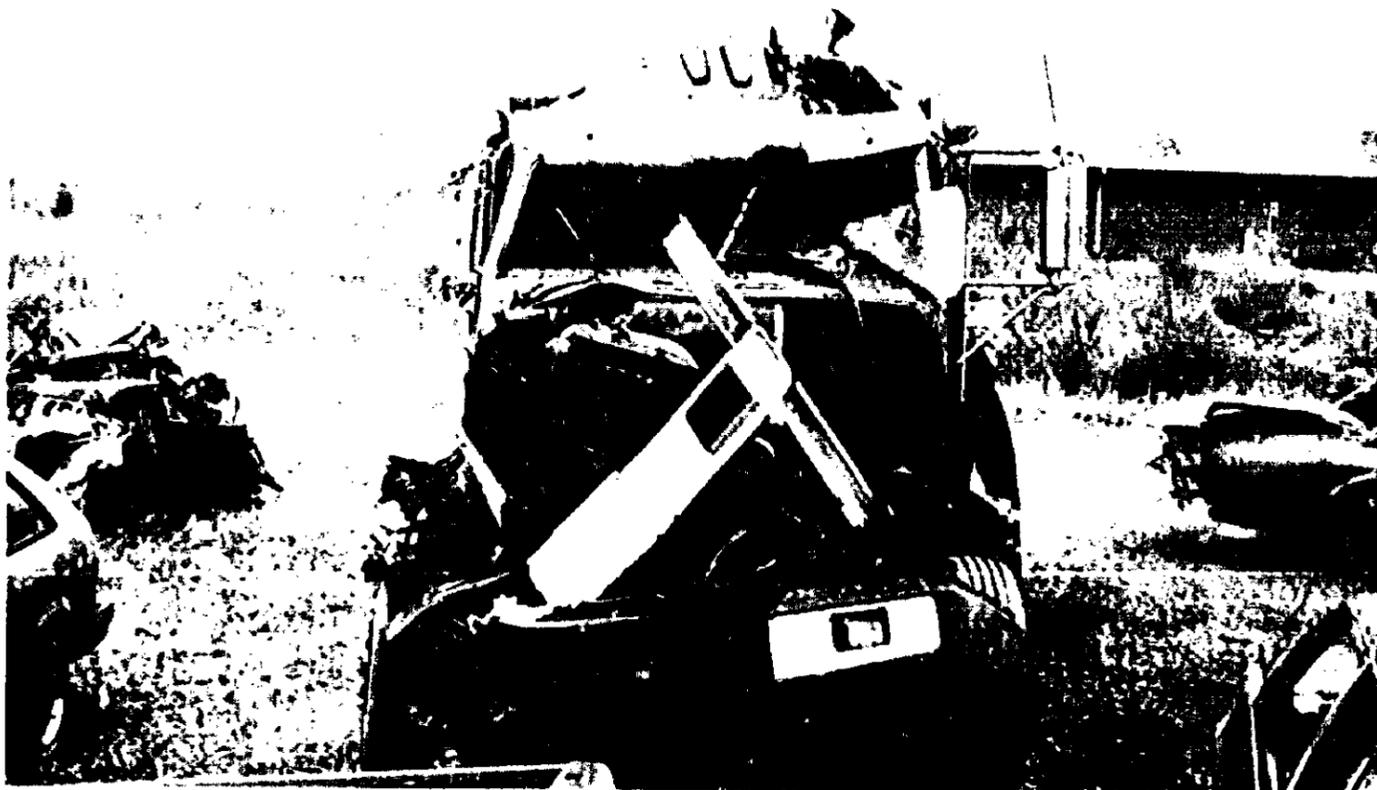
**Vehicle 2** -- Vehicle 2 was a 1992 Freightliner tractor in combination with a 1987 Barrett, 48-foot split level livestock semitrailer that was loaded with cattle. The combination weighed 78,100 pounds. Thirty-one inches of contact damage was on the tractor front bumper, grill, and fenders, extending from the right side toward the center. The front structure was shifted 11 inches to the right, and the right side wheelbase was reduced 18 inches. The front structure of the semitrailer had substantial damage. (See photographs 2 and 3 in appendix B.)

**Photograph 2. -- Combination 2 tractor.**

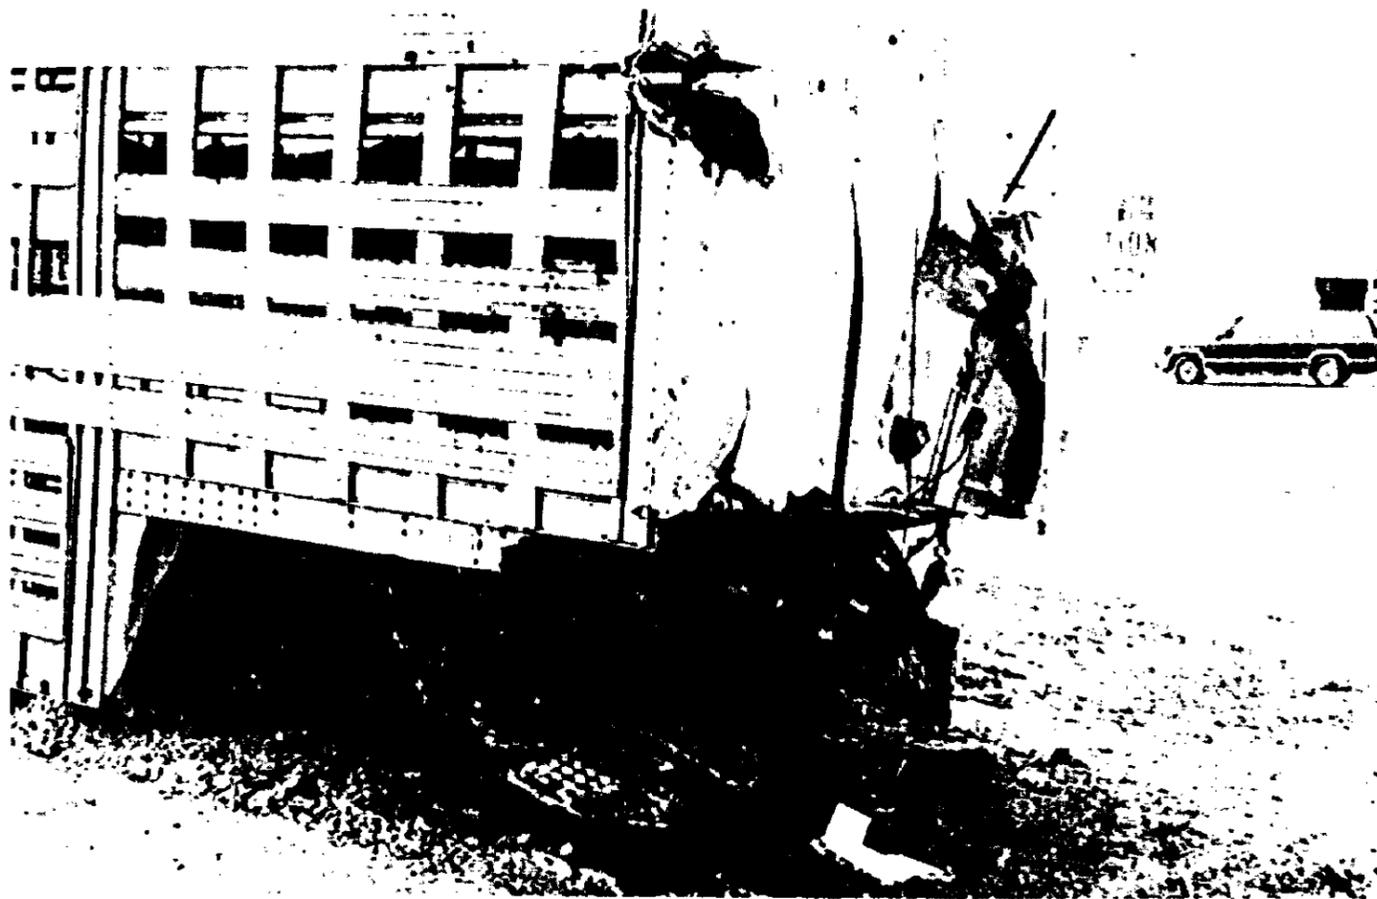
**Photograph 3. -- Combination 2 trailer (front damage).**

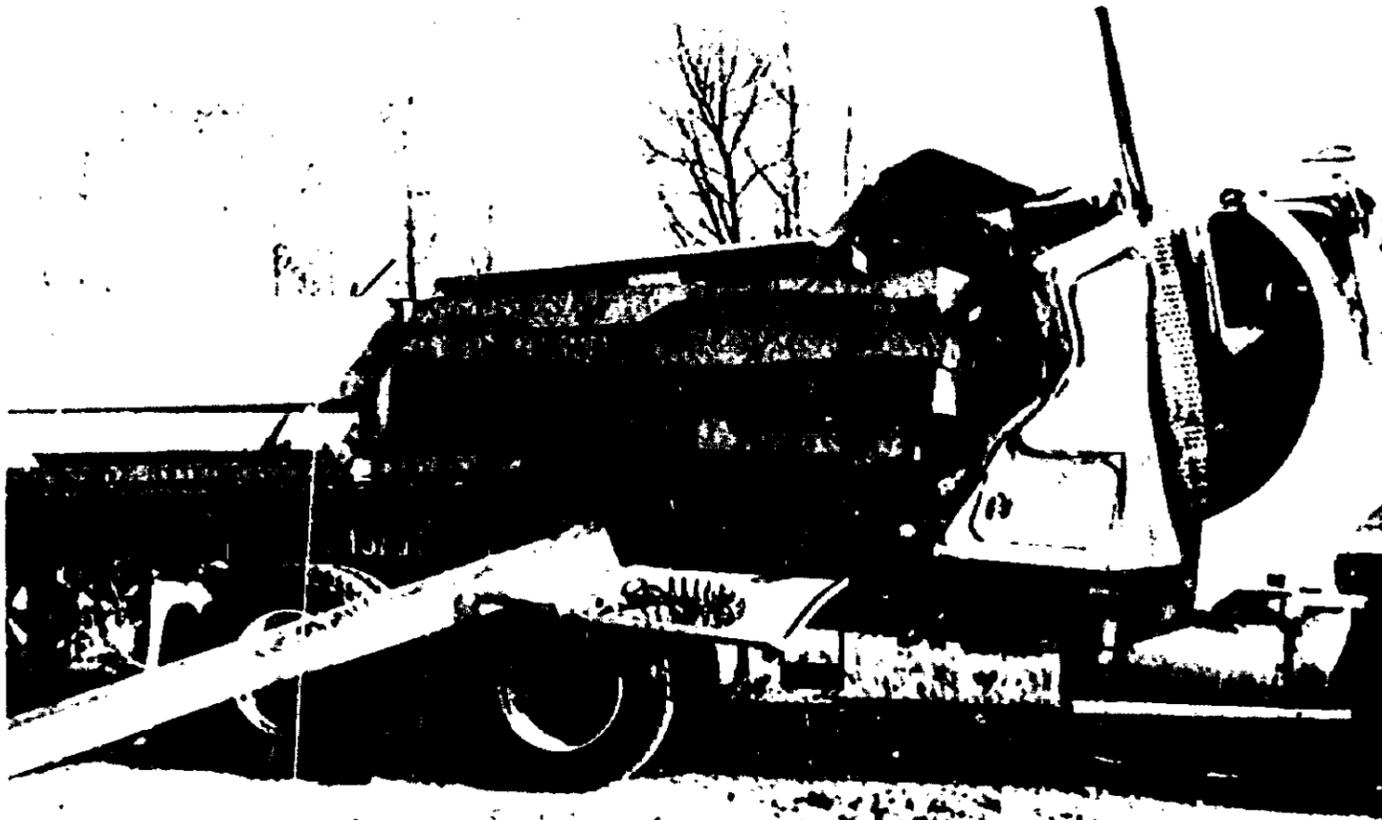
**Vehicle 3** -- Vehicle 3 was a 1995 Kenworth truck tractor in combination with a 1990 Fruehauf, 48-foot flatbed semitrailer that was loaded with railroad ties. The estimated weight of the combination was 79,000 pounds. The right front of the tractor had 34 inches of contact damage, beginning at the right edge and extending in toward the center. The right front wheel was turned outward 75 degrees; the right front airbrake hose was separated from its frame connection. The forward headwall of the right side fuel tank was punctured, allowing fuel to leak out. The rear of the semitrailer had 48 inches of moderate contact damage that extended from the left side toward the center. The cargo of wood ties moved forward 90 inches at impact, and the shifting cargo pushed down and fractured the front headerboard.<sup>4</sup> The rear of the sleeper cab was pushed inward approximately 24 inches. (See photographs 4, 5, and 6 in appendix B.)

**Photograph 5. -- Combination 3 (right side and rear tractor cab damage with headerboard deformation).**

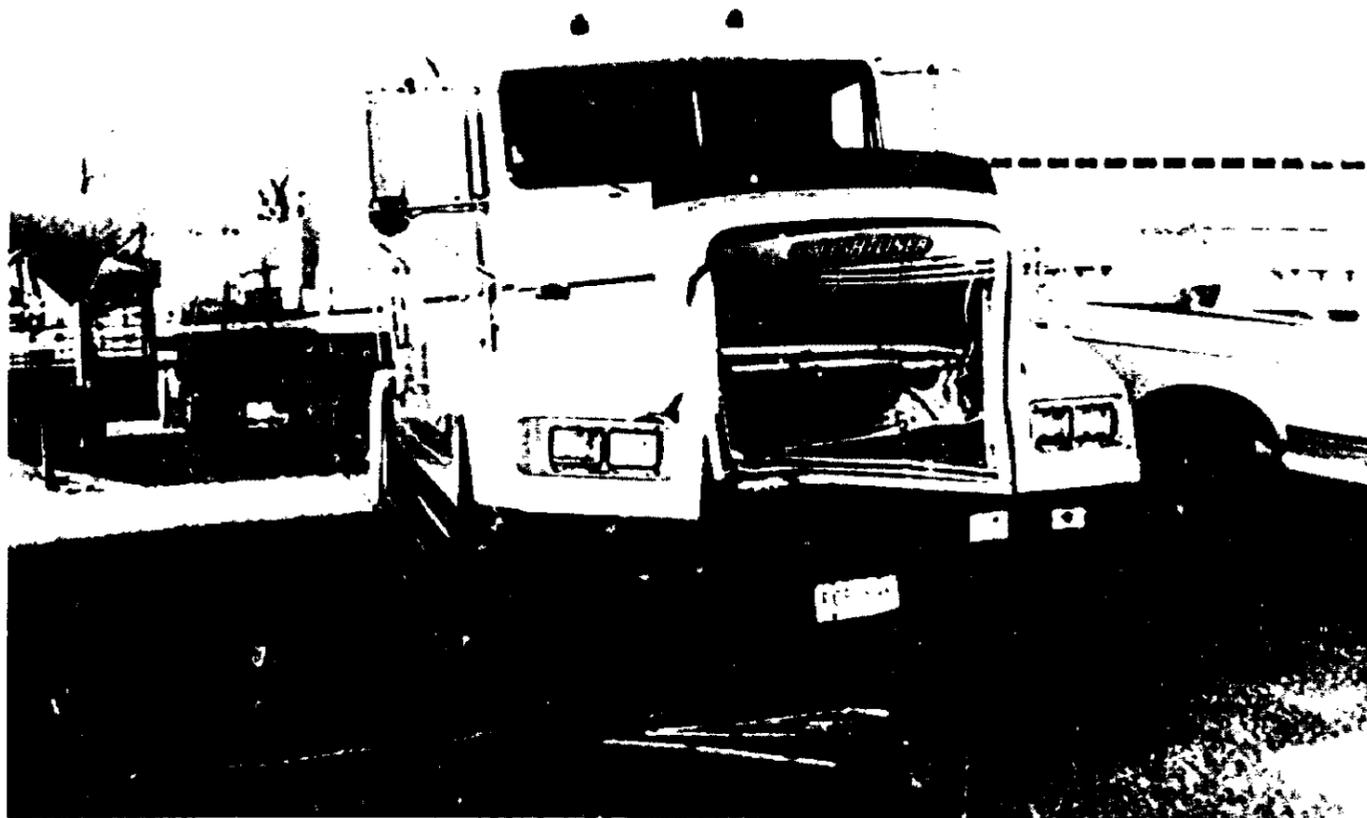
**Photograph 7. -- Tractor 4.**

**Vehicle 4** -- Vehicle 4 was a 1992 Freightliner tractor in combination with a 1994 Utility, 48-foot flatbed semitrailer loaded with wood railroad ties. The estimated weight of the combination was 80,000 pounds. The front of the tractor had radiator damage, and the semitrailer had 38 inches of contact damage on the left rear, extending from the left edge toward the center. Also, the headerboard on the front of the semitrailer was fractured similarly to the vehicle 3 semitrailer when its load shifted forward at impact. (See photographs 7 and 8 in appendix B.)

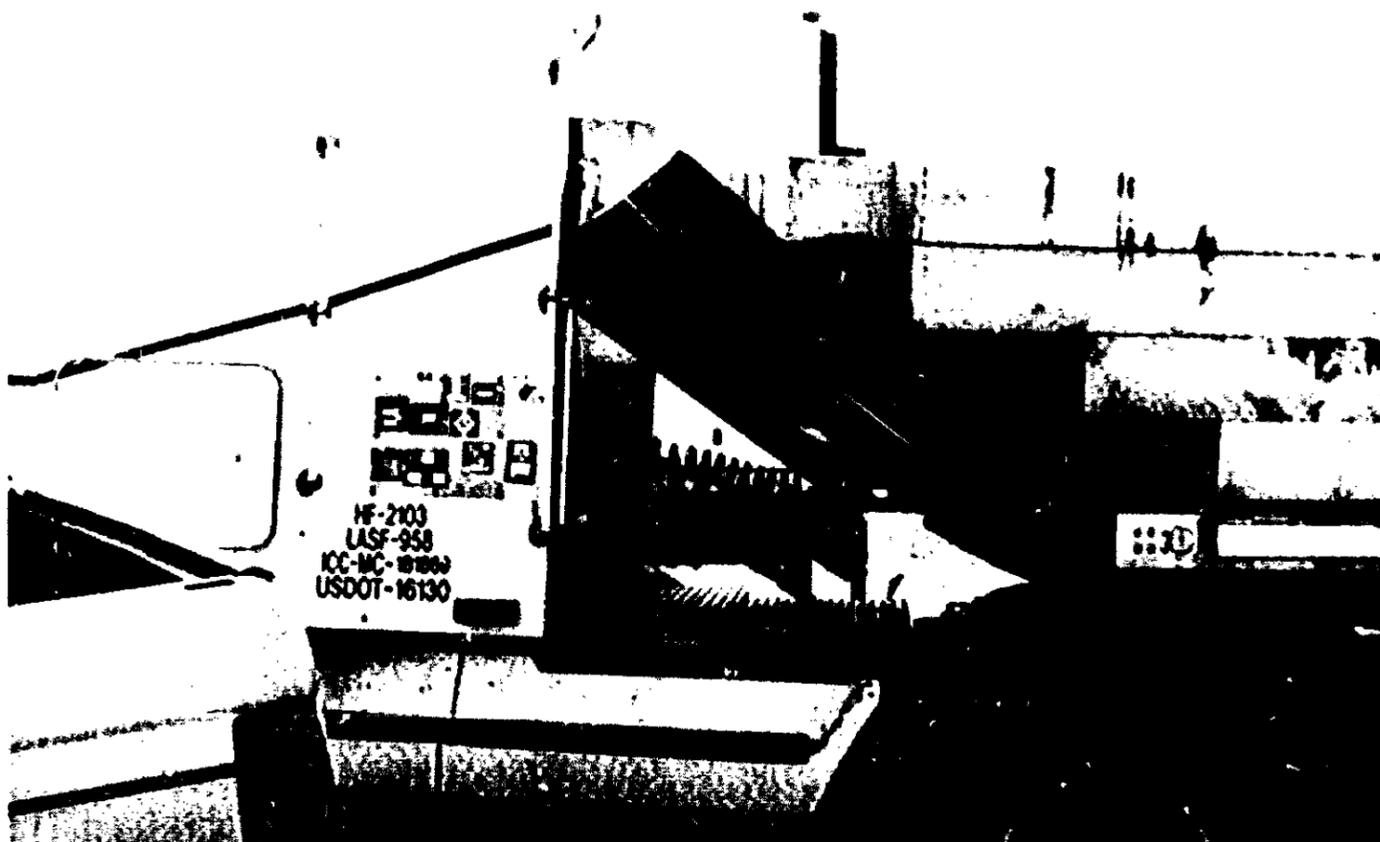
**Photograph 8. -- Combination 4 (left side tractor/trailer with headerboard deformation).**

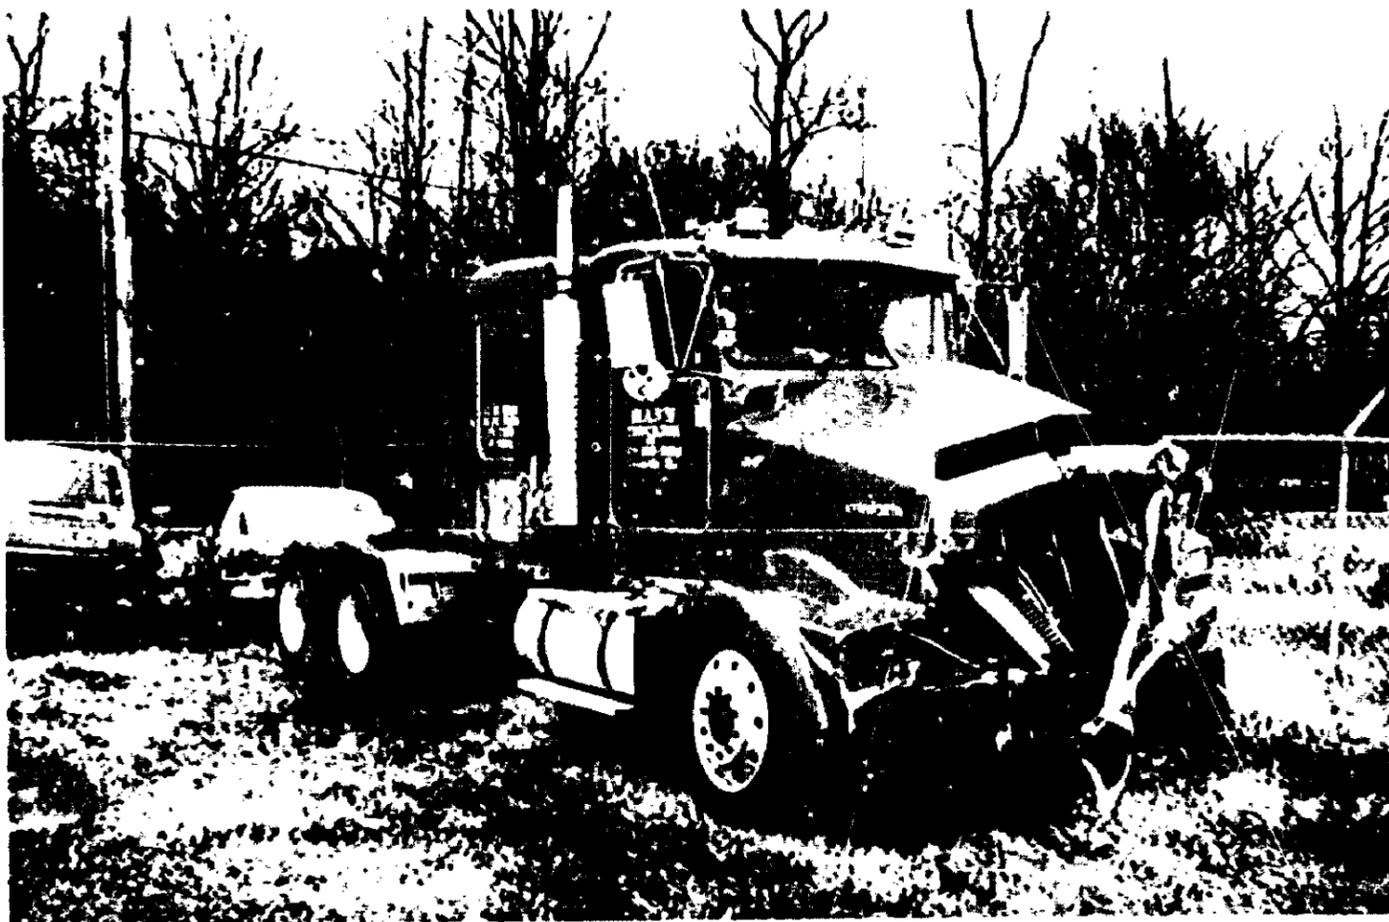
**Vehicle 5** -- Vehicle 5 was a 1995 Kenworth truck tractor in combination with a 1984 Utility, 45-foot semitrailer loaded with scrap metal. The combination weighed 78,460 pounds. The tractor sustained substantial damage on its front, and the semitrailer had extensive rear impact and fire damage. The steel bed was pushed inward 11 inches, and the axles were destroyed by the postcrash fire. (See photographs 9 and 10 in appendix B.)

Photograph 9. -- Combination 5 tractor.

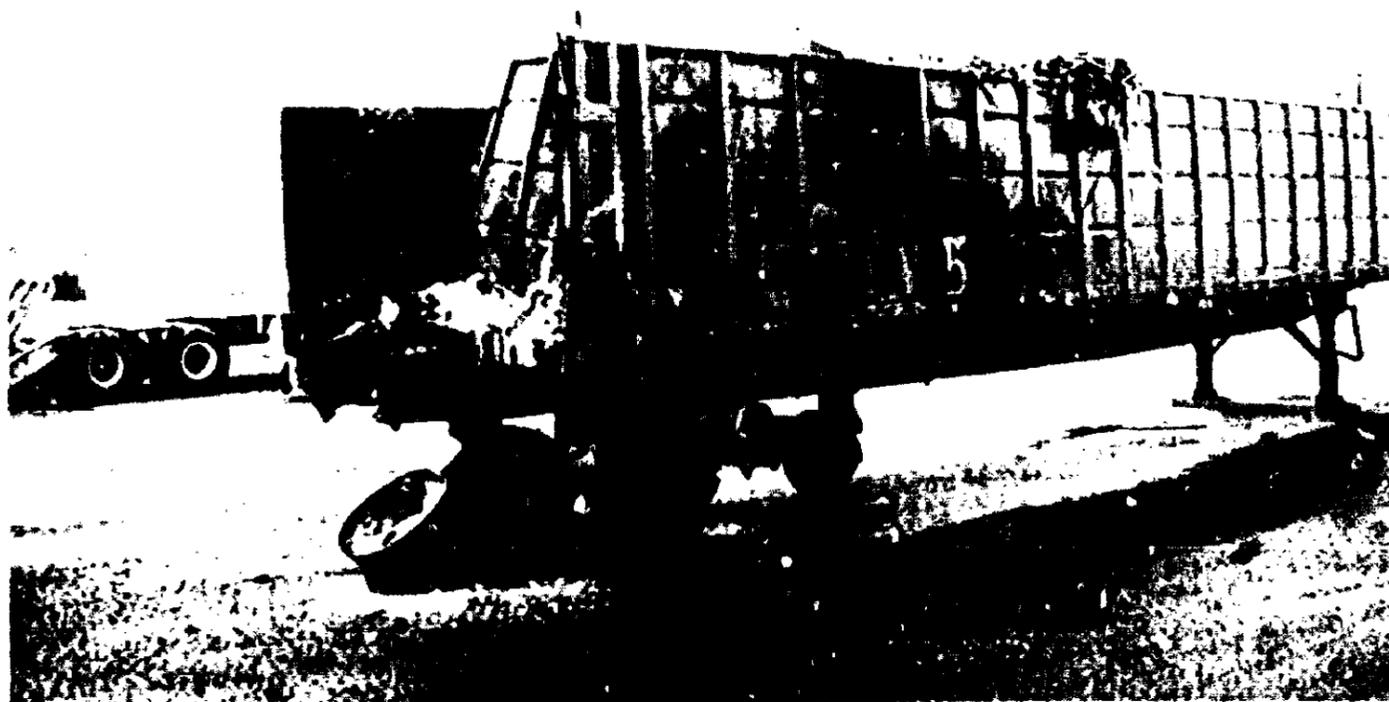
Photograph 10. -- Combination 5 trailer (rear impact and fire damage).

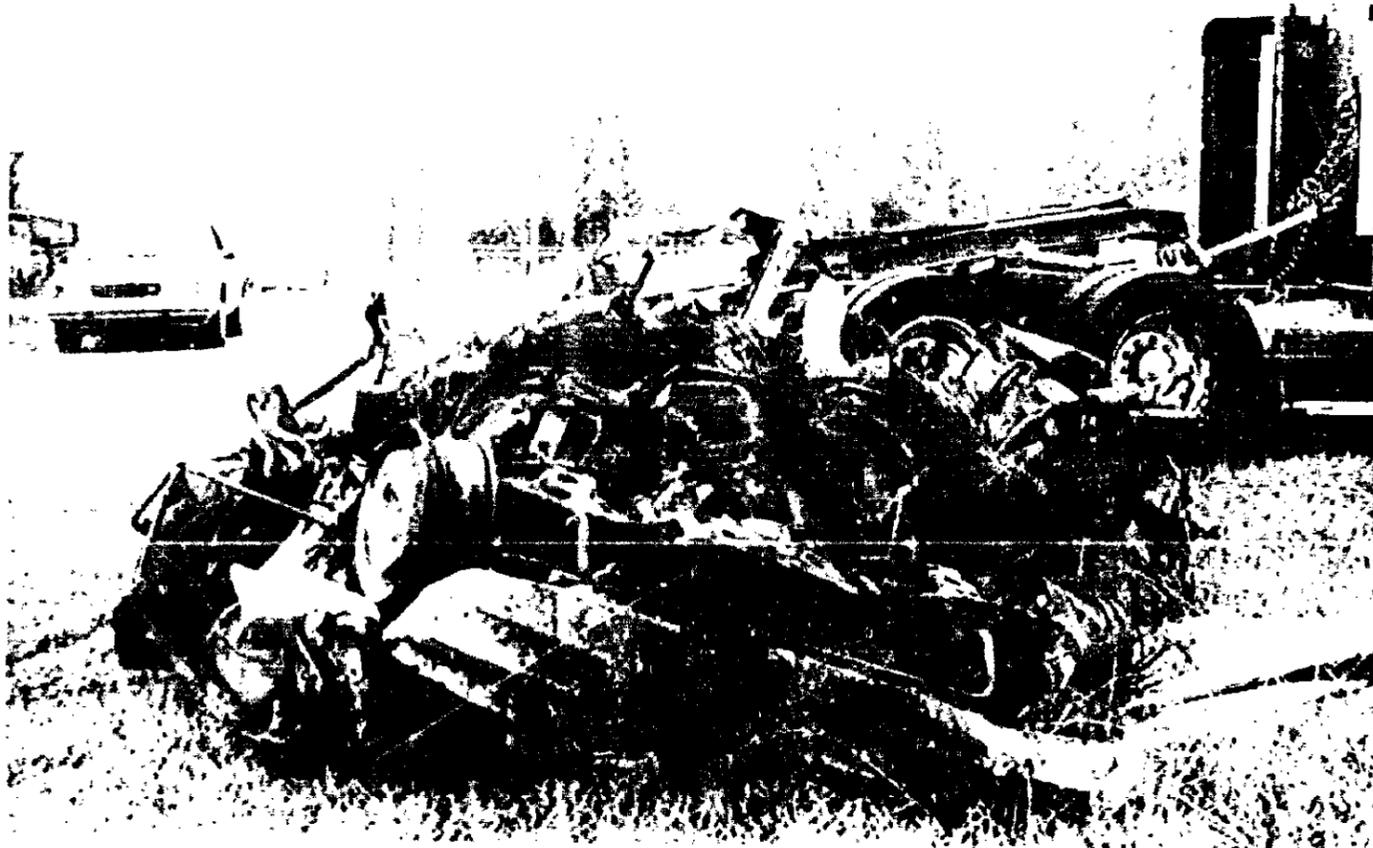
**Photograph 12. -- Vehicle 7 (crushed van remains).**
