NTSB/HIR-22/02

Bus Roadway Departure and Rollover

Pala Mesa, California

February 22, 2020

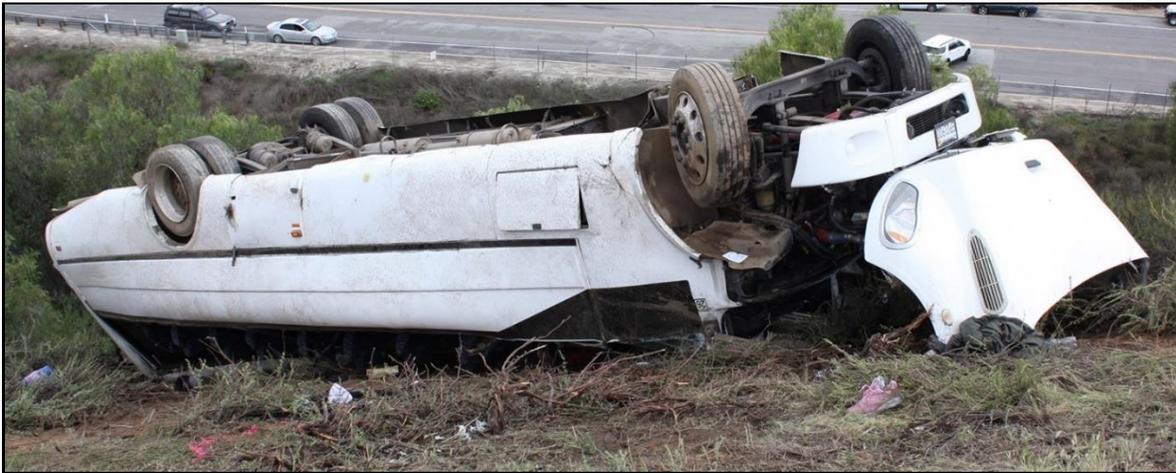
While completing the bridge crossing, the driver lost control of the bus, which eventually departed the roadway to the right, traveled about 81 feet farther before it rolled over 1.5 times (540°), moved across a 95-foot-wide clear zone, and slid about 16 feet down the embankment of the clear zone. The bus came to rest on its roof, 118 feet west of the white edge line of the roadway and 306 feet south of the end of the bridge deck (see figure 3).

Figure 3. Overturned bus on embankment. (Source: CHP)

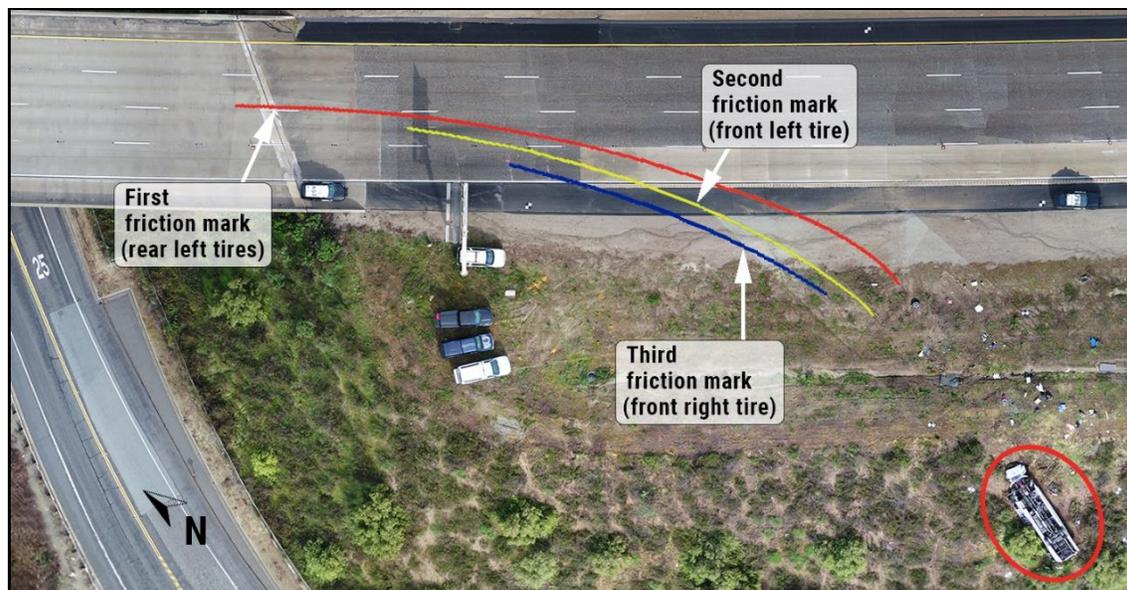
Three separate tire friction marks were identified on the roadway.⁴ The first mark—consistent with the wheel path of the bus’s left rear dual tires—started 1.7 feet into the right side of the center-left lane, about 14 feet before the south end of the bridge deck, and it arced south toward the right shoulder (see figure 4). Based on the start point of the first friction mark, the bus had yawed clockwise about 2° relative to the travel lanes when this mark was initiated.

Figure 4. Orthomosaic image rendered from aerial photographs depicting arcing path of bus from point of first roadway evidence to bus’s at-rest position. Image also shows three friction lines created by bus’s rear left tires (red), front left tire (yellow), and front right tire (blue). (Source: CHP, modified by the NTSB)

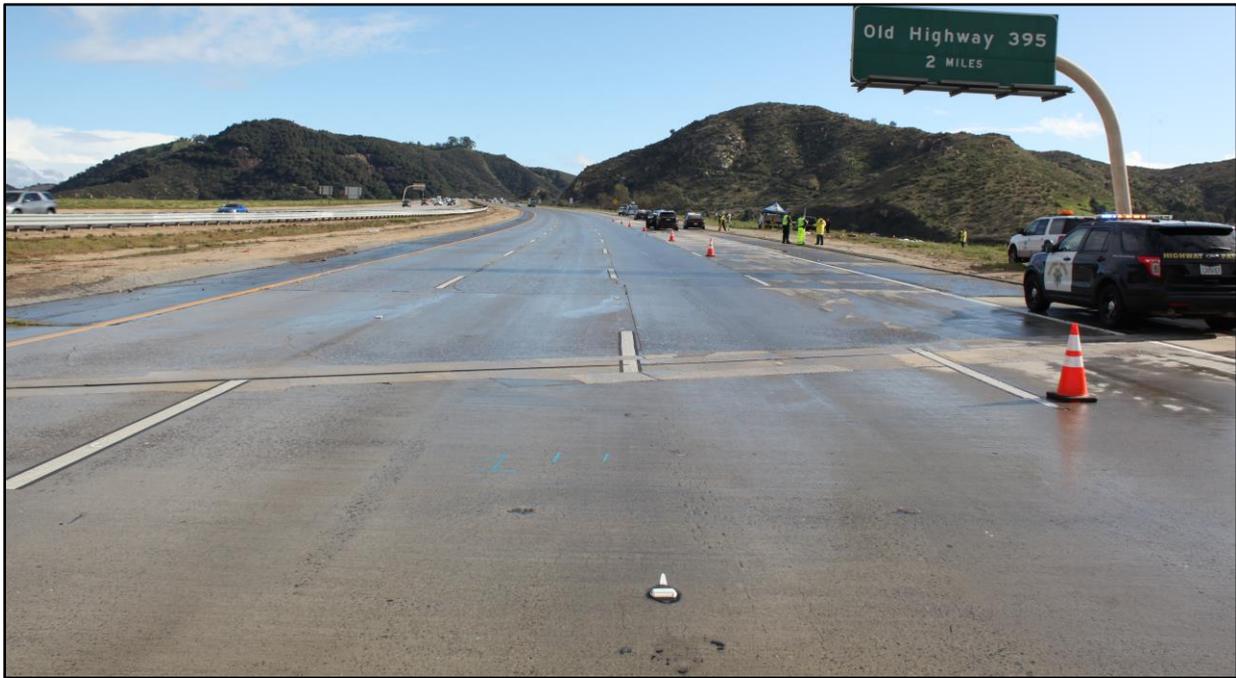
The second rainfall event at the location of the crash occurred between 2:00 p.m. and 2:30 p.m., while MAIT investigators were still on scene. Data from the unofficial weather station noted above indicated that 0.32 inch of precipitation fell within a 1-hour period surrounding the afternoon rainfall. The two rainfall events had similar 1-hour precipitation accumulations. The MAIT investigators observed the roadway for any signs of water ponding or pooling in the travel lanes during and after the afternoon rain but did not notice any such accumulations (see figure 5).

Figure 5. Looking south at I-15 southbound lanes from south end of bridge. Photograph taken at 2:53 p.m., about 30 minutes after second rainfall event on crash day ended. (Source: CHP)

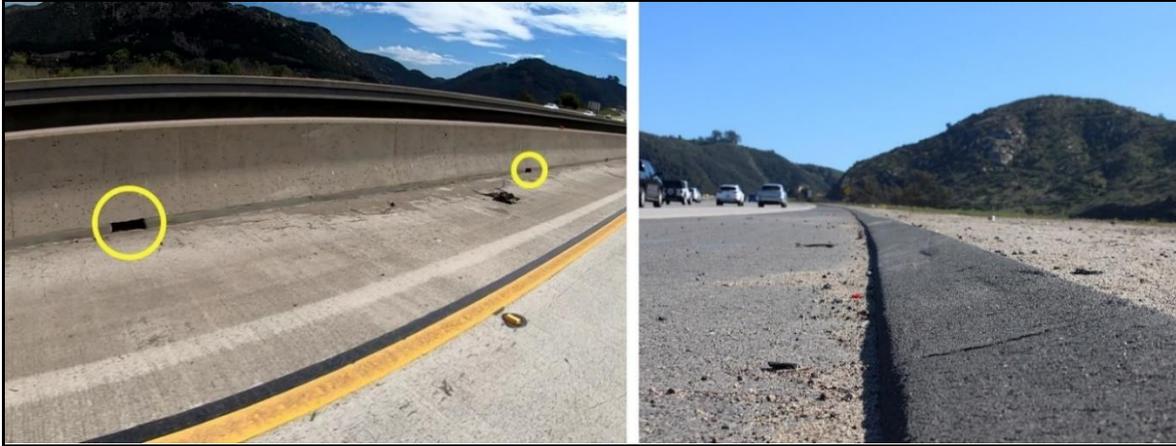
mountable drainage dikes border the edges of paved shoulders and channel stormwater to drainage inlets and catch basins along the roadway (see figure 6).²⁰ The median has concrete-lined drainage ditches that channel the stormwater to nine drains at the ditch bottoms. CHP and NTSB investigators visually inspected the drainage inlets, slots, and scupper and area drains, and found them to be clear of major debris.

Figure 6. Drainage devices along southbound lanes in area of crash. Depicted are (left image) scupper drains along the left shoulder on the bridge and (right image) a drainage dike along the right shoulder past the bridge.

The design of the highway and bridge drainage systems on and along southbound I-15 near the crash conformed to the general national guidance provided by the American Association of State Highway and Transportation Officials (AASHTO), as well as to guidance specific to the state of California (AASHTO 2018 [sections 4.7 and 4.8], Caltrans 2020 [chapters 800-890]).

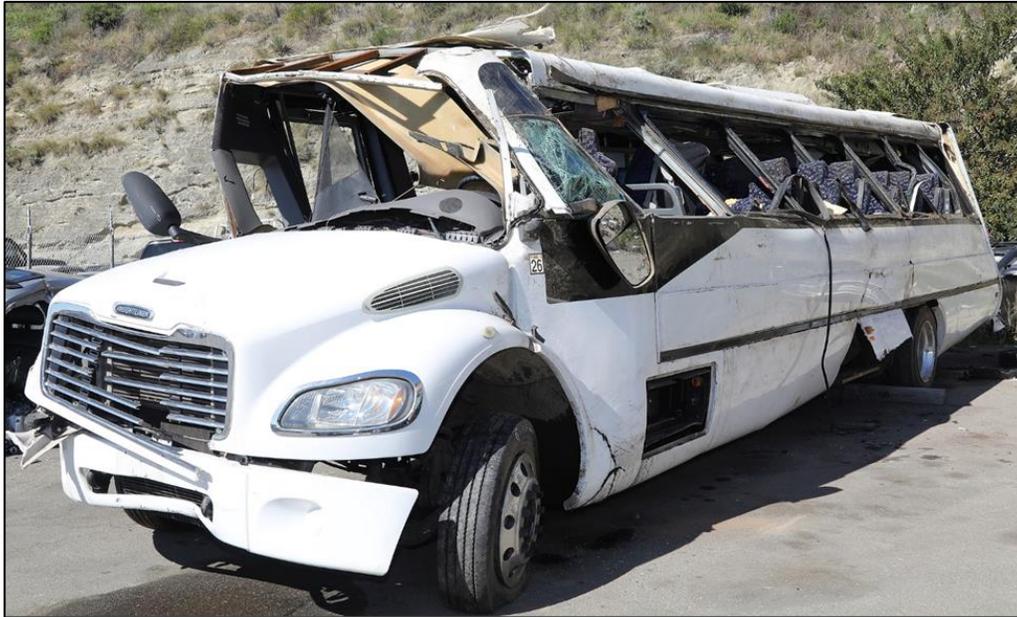
The bus sustained significant damage during the crash and rollover event, when it came to rest on its roof. The bus roof structure sustained extensive damage, and its structural support members were severely deformed (see figures 7 and 8). Several of the support members failed during the rollover, which created openings through which several passengers were ejected.²⁴ The roof hatch cover was torn away from the bus, creating an opening through which two passengers were able to self-extricate postcrash.²⁵ Substantial lateral roof displacement, in places measuring 24 inches to 30 inches, occurred at some sections of the bus. The most extensive damage occurred at the front of the bus. The lateral roof displacement substantially reduced the interior height, exposing the tops of passenger seatbacks and integrated headrests on the left side of the bus. At the point of maximum roof deformation,

located between seat rows 2 and 3, the bus's interior height decreased from 84 inches, as constructed, to 54 inches postcrash.

Figure 7. View of damage to front and left side of bus.

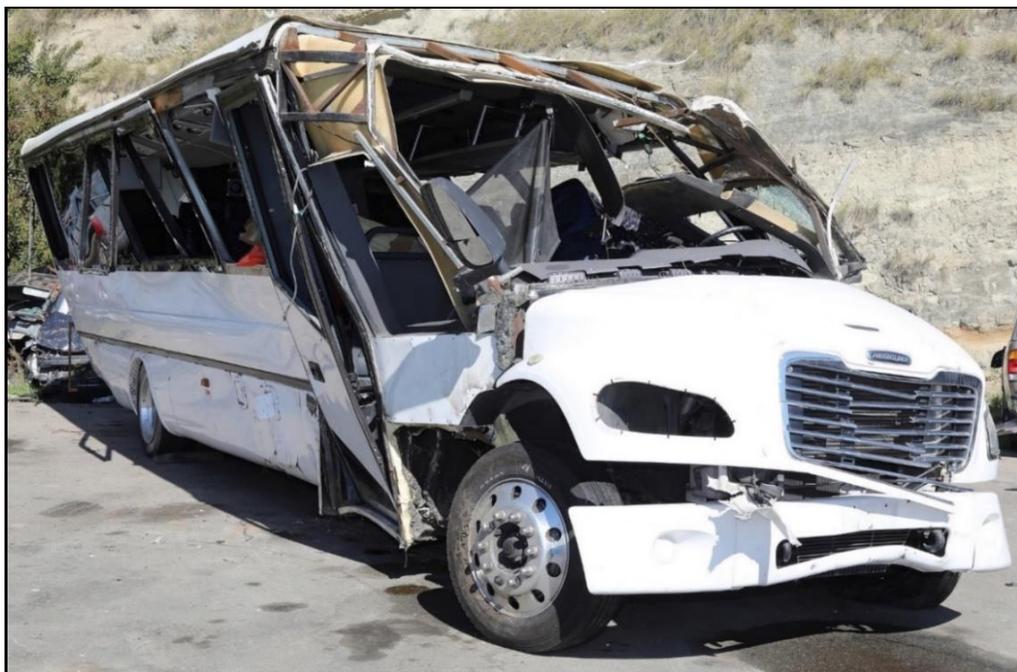
Figure 8. View of damage to front and right side of bus.

Damage to the front end of the bus included a displaced windshield, damage to the hood and the front bumper, and displacement of the right headlight from its mount. Damage to the left side included displaced covers for the battery and the spare wheel; additionally, the glazing from all seven windows on the left side of the bus was missing. Damage to the right side of the bus included a shifting of the support brackets forward and deformation to the front-loading door, which remained wedged against the frame and inoperative; the glazing from four of the six windows on the right side of the bus was missing.
