Multivehicle Crash

Near the Township of Arlington, Wisconsin
 June 12, 2020

On June 12, 2020, near the Township of Arlington, Wisconsin, a queue of slowed and stopped traffic formed on Interstate 39 because of two previous traffic collisions.¹ About 6:45 a.m., a 2013 Freightliner truck-tractor in combination with a 2017 Utility semitrailer struck the end vehicle in the queue, causing a crash involving eight vehicles. Four vehicle occupants died and three were seriously injured.

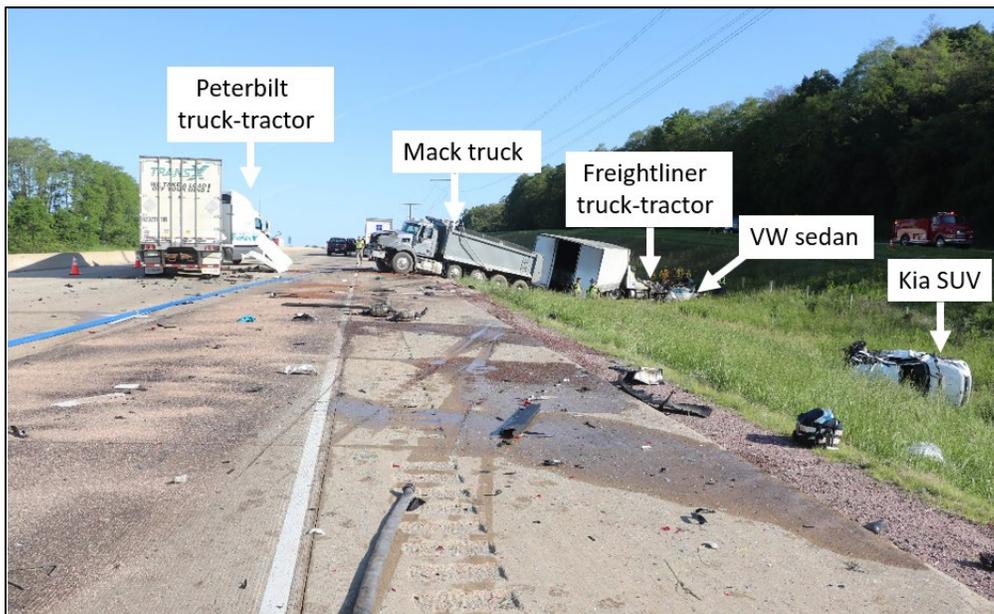
Figure 1. View to the north from the shoulder of northbound Interstate 39, showing the final rest positions of some of the involved vehicles. (Source: Wisconsin State Patrol, annotations added by NTSB).

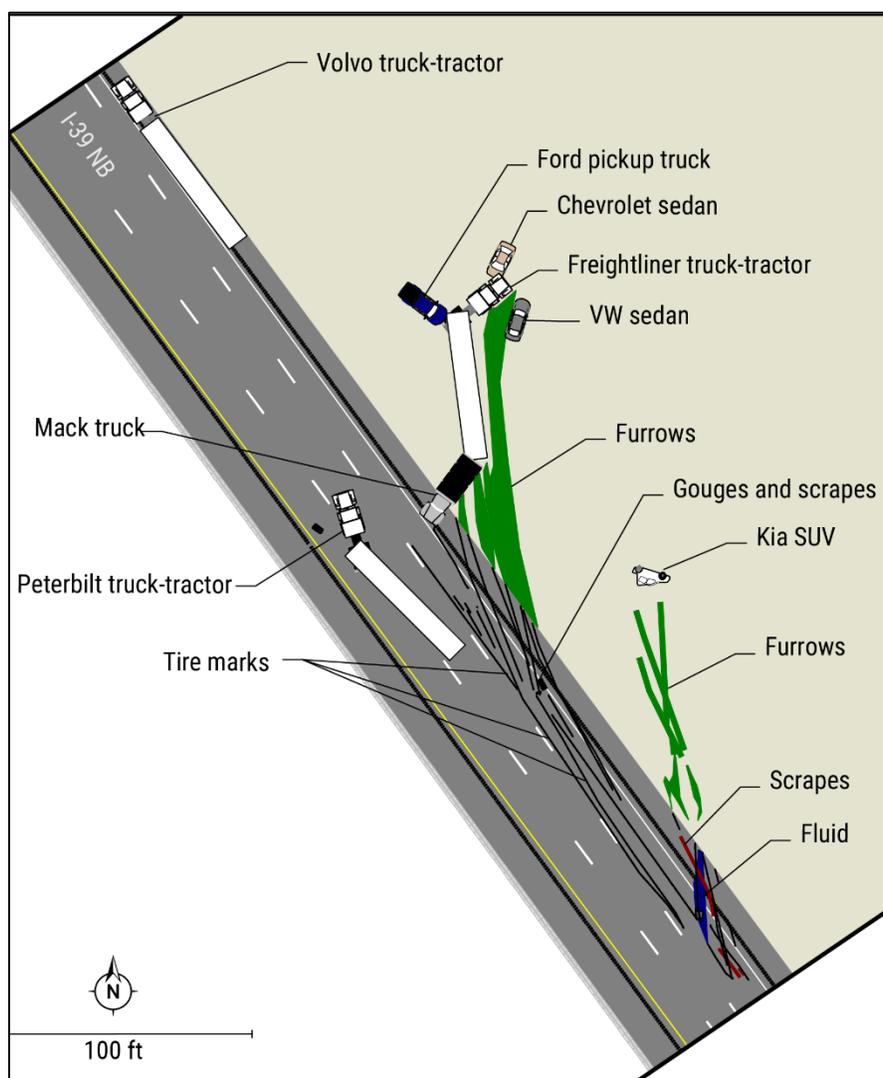
The Freightliner truck collided with the rear of a 2021 Kia Seltos sport utility vehicle (SUV) that had slowed at the back of the traffic queue. Following the collision with the Kia, the Freightliner truck continued forward, colliding with additional vehicles and forcing them into subsequent crashes. Six other vehicles were involved in this crash: a 2006 Volkswagen (VW) Passat sedan, a 1999 Chevrolet Malibu sedan, a 2018 Ford F-150 pickup truck, a 2018 Mack dump truck, a 2020 Peterbilt truck-tractor in combination with a 2014 Utility semitrailer, and a 2020 Volvo truck-tractor in combination with a 2007 Utility semitrailer.

Figure 3. Scene diagram showing physical evidence and final rest positions of the involved vehicles. (Source: Wisconsin State Patrol, annotations added by NTSB).
