May 3, 2023

HIR-23-07

Improving the Identification, Prioritization, and Completion of Follow-up Actions on Bridges with Uncoated Weathering Steel Components

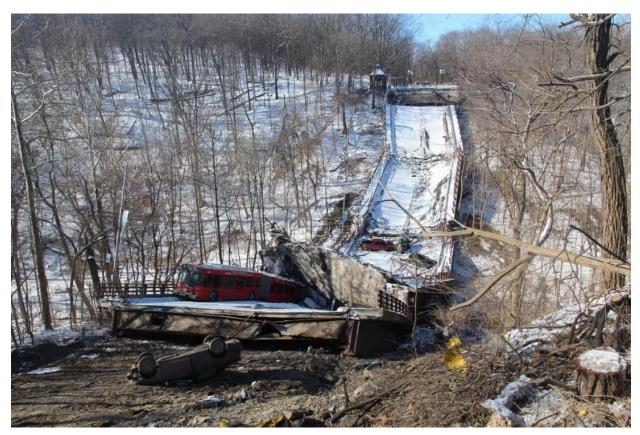
Figure 1. View of collapsed Fern Hollow Bridge from the east.

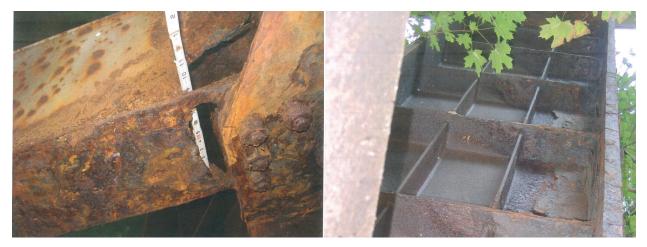
The NTSB found extensive corrosion damage and deterioration of the Fern Hollow Bridge legs during the on-scene examination of the collapsed bridge. We also reviewed the National Bridge Inspection Standards inspection reports for the 17 years before the collapse.⁸ Starting in 2005, each of these inspection reports documented corrosion damage and deterioration of the bridge legs (see figure 4), including the most recent inspection report in September 2021, 4 months before the collapse (see figure 5).

Figure 4. Section loss on lower bracing of northwest bridge leg (left image) and corrosion damage on southwest bridge leg below bracing (right image). (Source: September 2005 inspection report)

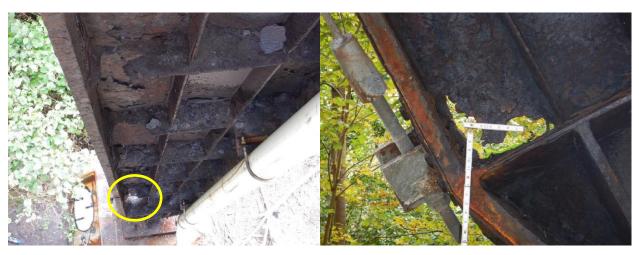
Figure 5. Corrosion damage including areas of 100% section loss on southwest bridge leg near connection to reinforced concrete thrust blocks (circled in yellow in photograph on left and shown in closer view in photograph on right). (Source: September 2021 inspection report)

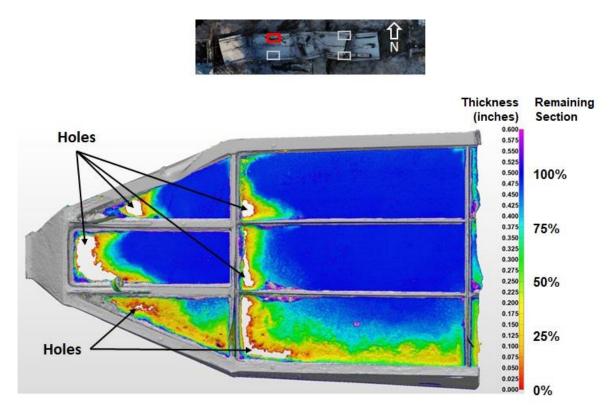
The NTSB Materials Laboratory conducted three-dimensional laser scanning of the lower portions of the bridge legs to examine the extent of the section loss on the structural elements due to corrosion damage. Figure 6 shows an image of the remaining section found on the bottom of the northwest leg postcollapse.⁹

Figure 6. Three-dimensional laser scan image showing remaining section on bottom of northwest leg postcollapse. Per the design plan, the nominal thickness of the leg web plate was 0.5 inches; the blue in the figure indicates areas of the leg web that met the design plan, and the yellow indicates areas that were about 25% of the nominal thickness. The red square in the image above the figure shows the northwest leg's position in the bridge structure.

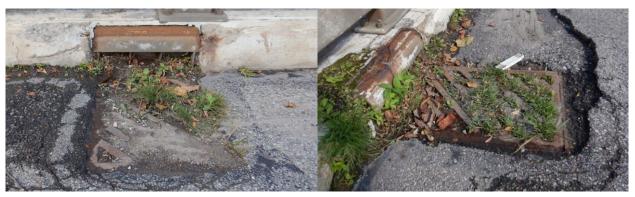
Further, drainage issues, including drains blocked by debris, dirt, and plant material, were documented in the inspection reports, both in writing and in photographs (see figure 7). The blocked drains led to improper drainage, allowing water and other contaminants, such as deicing salts, to drain onto areas of the bridge not designed for water flow, resulting in evidence of active leakage on steel surfaces such as the bridge legs. In 2009, a rehabilitation project was conducted to replace the downspouts, which required all bridge drains to be cleaned. The 2009 inspection report reflects that this work was completed and described the drains as being clear. However, the 2011 inspection report noted that some of the drains had become clogged again. Clogged drains and the need for associated maintenance work were continually identified in the inspection reports between 2011 and 2021.

Figure 7. Blocked drains on Fern Hollow Bridge. (Source: September 2021 inspection report)
