HIR-23-11

# Pickup Truck Centerline Crossover Collision with Transit Van and Postcrash Fire

Andrews, Texas  
March 15, 2022

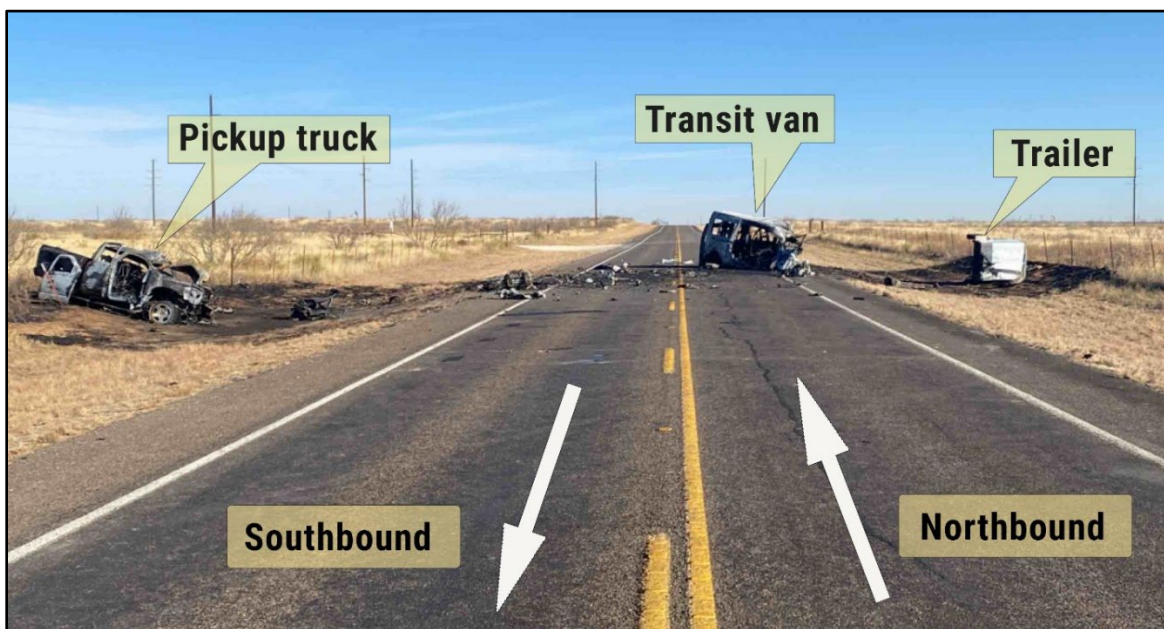
**Figure 1.** The north view of FM 1788, showing the final rest positions of the involved vehicles. (Source: Texas Department of Transportation, annotations added by NTSB)

The nearly head-on impact caused both vehicles to rotate counterclockwise. The van came to rest in the northbound lane—at the impact location but rotated—while the pickup truck came to rest off the roadway, southwest of the impact location. The trailer separated from the van at impact and came to rest off the roadway, east of the location of the van. Both the van and the pickup truck sustained catastrophic intrusion damage
