HIR-24/01

Intersection Crash Between Medium-Size Bus and Combination Vehicle

Dermott, Arkansas
June 6, 2022

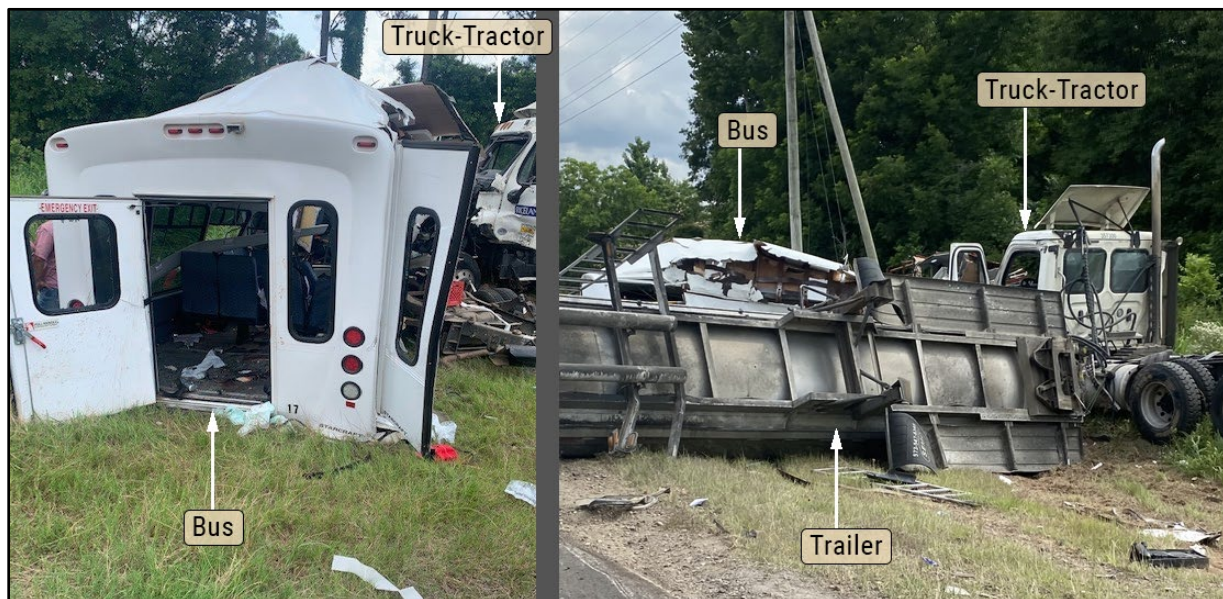
Figure 1. The two vehicles postcrash at the scene of the collision. (Source: Arkansas State Police, annotations added by NTSB)

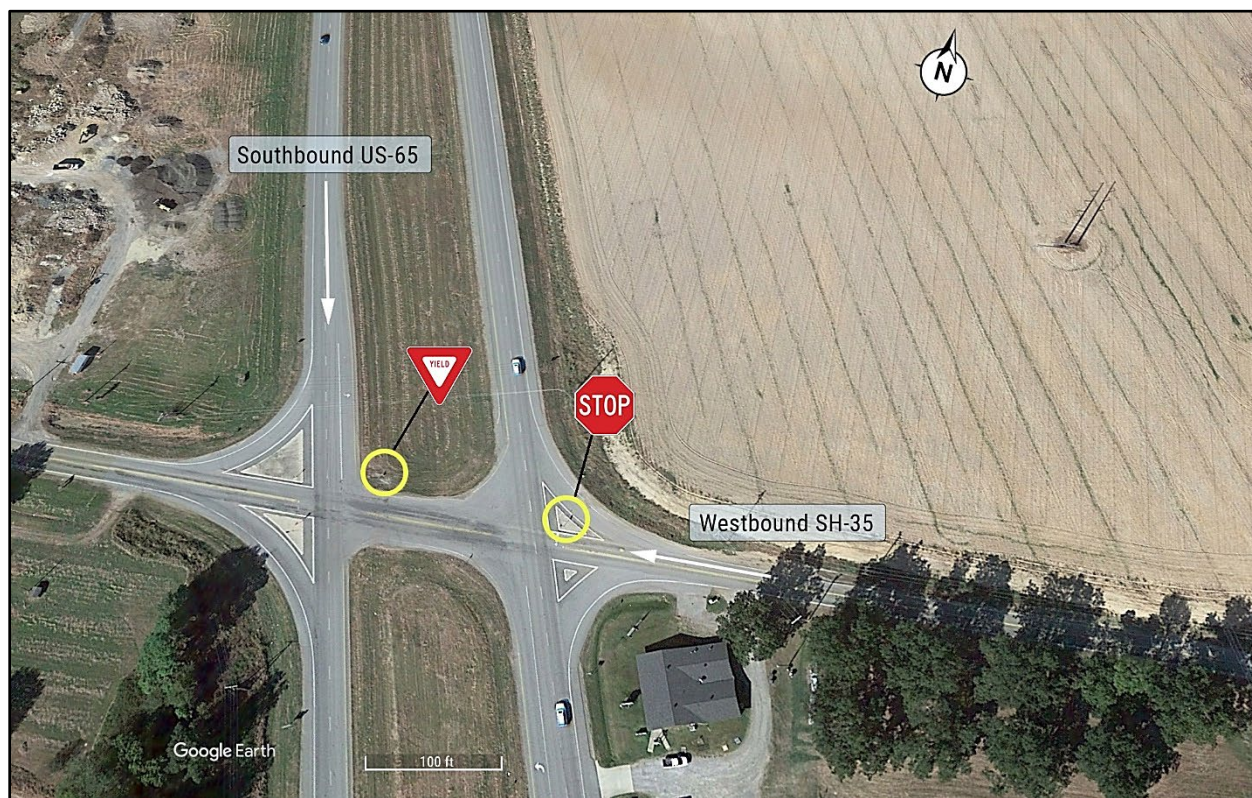
At the location of the crash, the northbound and southbound lanes of US-65 are separated by a 137-foot-wide earthen median (see figure 3). Both travel directions have two through-lanes and one left-turn lane, each lane 12 feet wide. Both directions of travel had left and right shoulders, which were delineated from the travel lanes by solid yellow and white lines, respectively. The through-lanes were delineated by dashed white lines.

Figure 3. Overhead view of the intersection of US-65 with SH-35.

SH-35 intersects US-65 at an 89.5-degree angle. At the intersection, SH-35 consists of a single 10-foot-wide travel lane in both the eastbound and westbound directions of travel. In the westbound approach to the intersection (direction of travel of the bus), SH-35 traffic was presented with the following signage: (1) a stop ahead sign, located about 750 feet before the intersection with the northbound US-65 lanes; (2) a stop sign, located on a concrete island before the northbound lanes of US-65; and (3) a yield sign, located in the median before the southbound lanes of US-65.

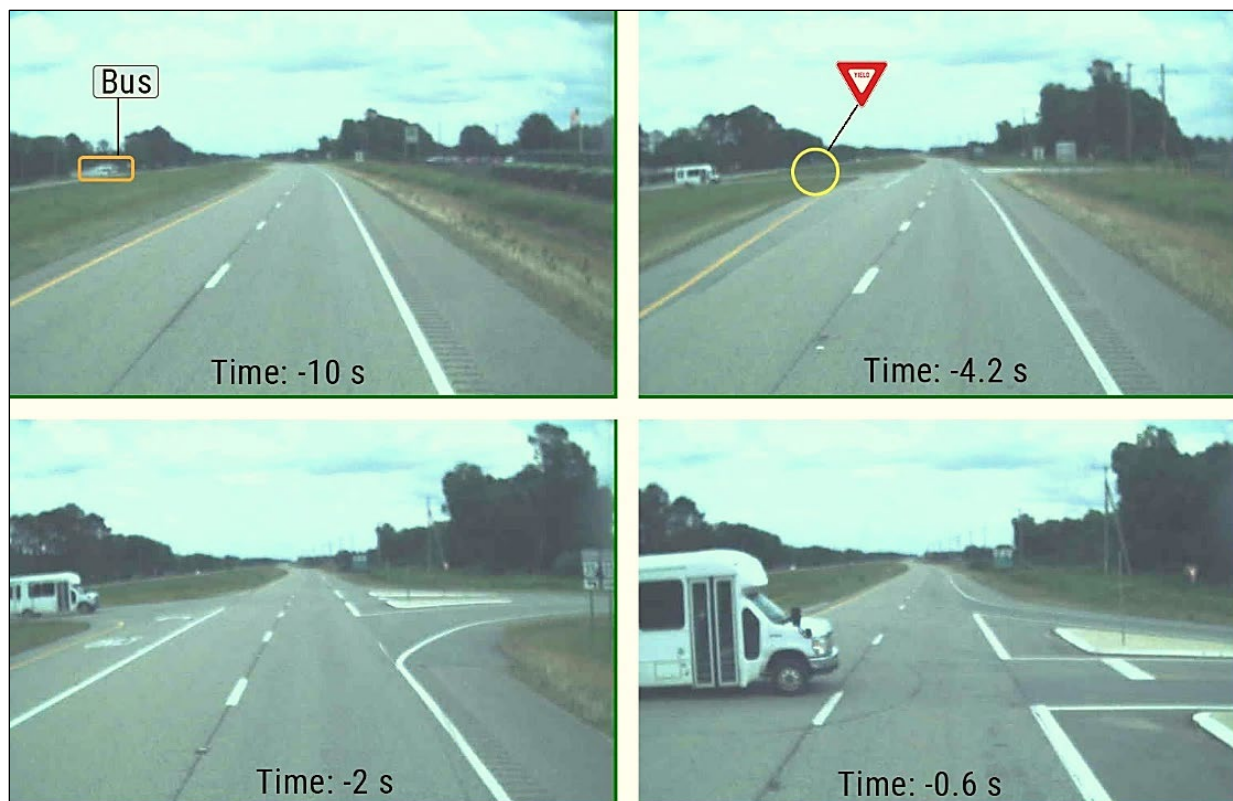
Figure 4. Screenshots of the video footage from the truck-tractor’s Bendix SafetyDirect forward-facing camera at 10 seconds (top left), 4.2 seconds (top right), 2 seconds (bottom left), and 0.6 seconds (bottom right) before impact. (Source: J.B. Hunt, annotations added by NTSB)

To determine the movement of the bus across the intersection and estimate its speed, the NTSB examined data from the airbag control module (ACM) recovered from the bus and the video footage from the truck-tractor’s forward-facing camera.⁴ The estimated speed of the bus had an uncertainty range of +/- 3.5 mph. This examination showed that:

- 10 seconds before the crash (estimated), the bus stopped at the stop sign before the northbound lanes of US-65,⁵
- 4.2 seconds before the crash, the bus completed crossing of the northbound lanes, traveling about 18 mph,

- 2 seconds before the crash, the bus reached the location of the yield sign, traveling about 18 mph,
- 0.6 seconds before the crash, the bus began to cross the right lane of southbound US-65, traveling about 21 mph.

The data showed that when the bus crossed the northbound lanes of US-65, it did not decelerate as it approached and passed the yield sign and then began crossing the southbound lanes of US-65. It was not possible, based on the video footage, to determine whether the bus driver turned to look in the direction of the combination vehicle before the collision. The front end of the truck-tractor struck the right side of the bus, just aft of the front passenger loading door. The bus sustained extensive intrusion damage on the right side and the bus body separated from its chassis (see figure 5). At impact, the truck-tractor jackknifed to the right and the tank-trailer rolled over while detaching from the truck-tractor.⁶

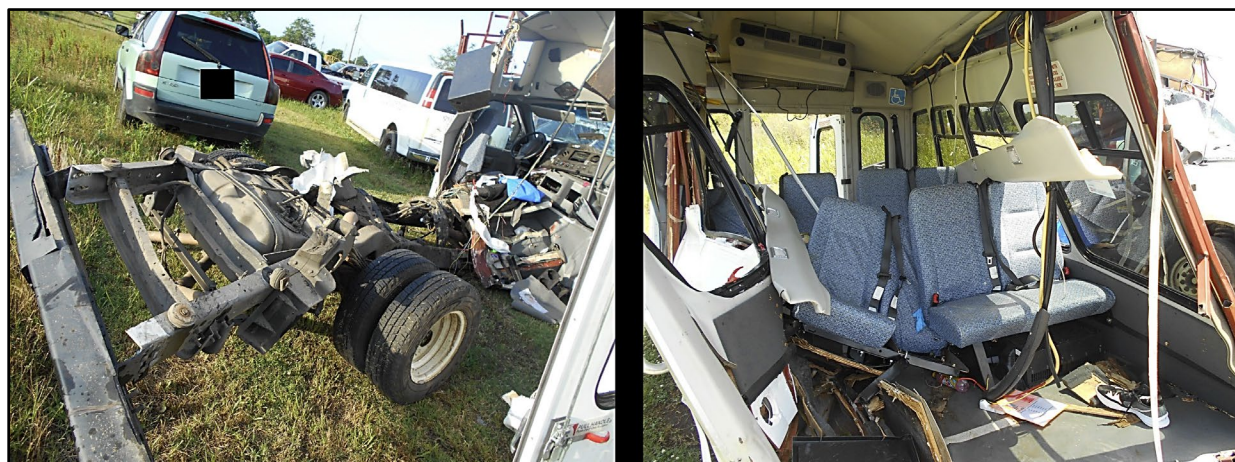
Figure 5. Damage to the bus, showing the detached chassis (left) and the interior intrusion (right).

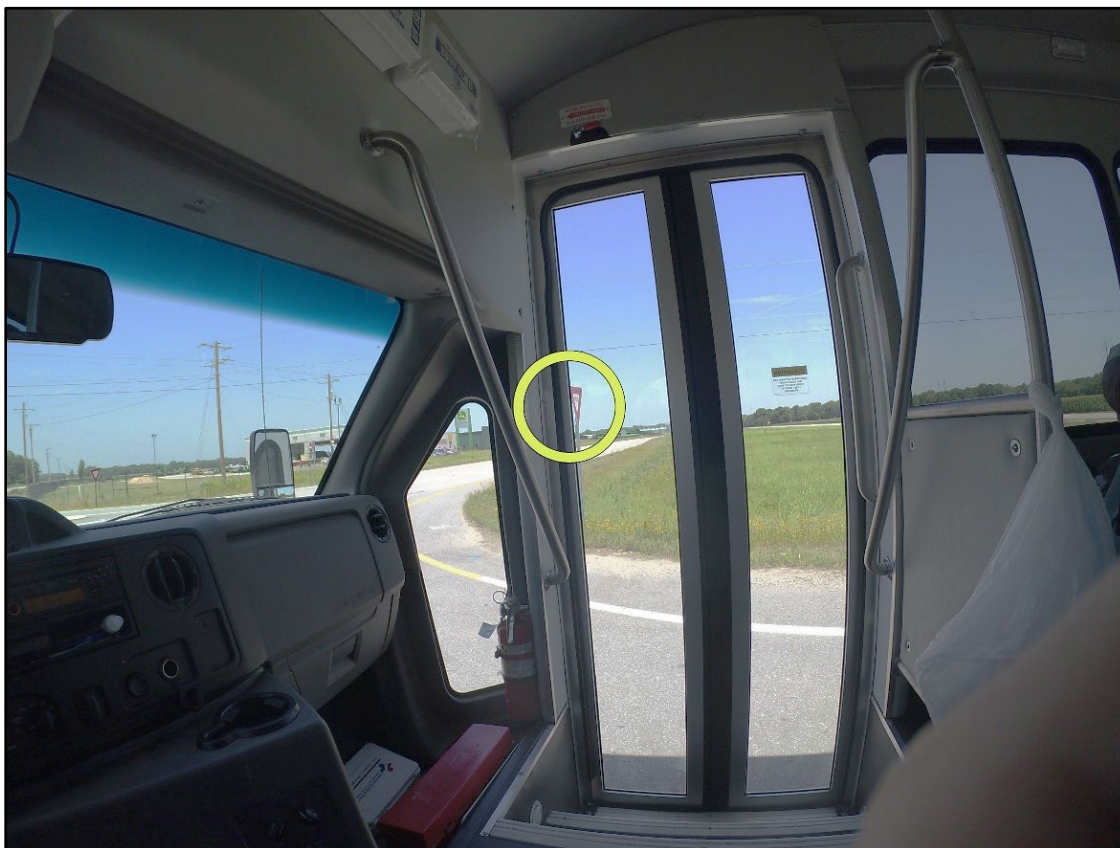
approached the intersection in a westbound direction, replicating the path of the crash-involved bus. When the exemplar bus was in the intersection, the A-pillar of the interior structure partially obscured the exemplar driver's view of southbound US-65 traffic, which necessitated the driver to move in the seat to obtain the complete view of the southbound lanes (see figure 6). There were no environmental obstacles, including the roadway geometry, that obscured the driver's view of the southbound US-65 lanes when the exemplar bus approached them.

Figure 6. View of the US-65 southbound lanes from the exemplar bus. The location of the yield sign is circled in yellow.
