HIR-25-01

Combination Vehicle Rollover, Fire, and Interstate 95 Overpass Collapse

Philadelphia, Pennsylvania

June 11, 2023

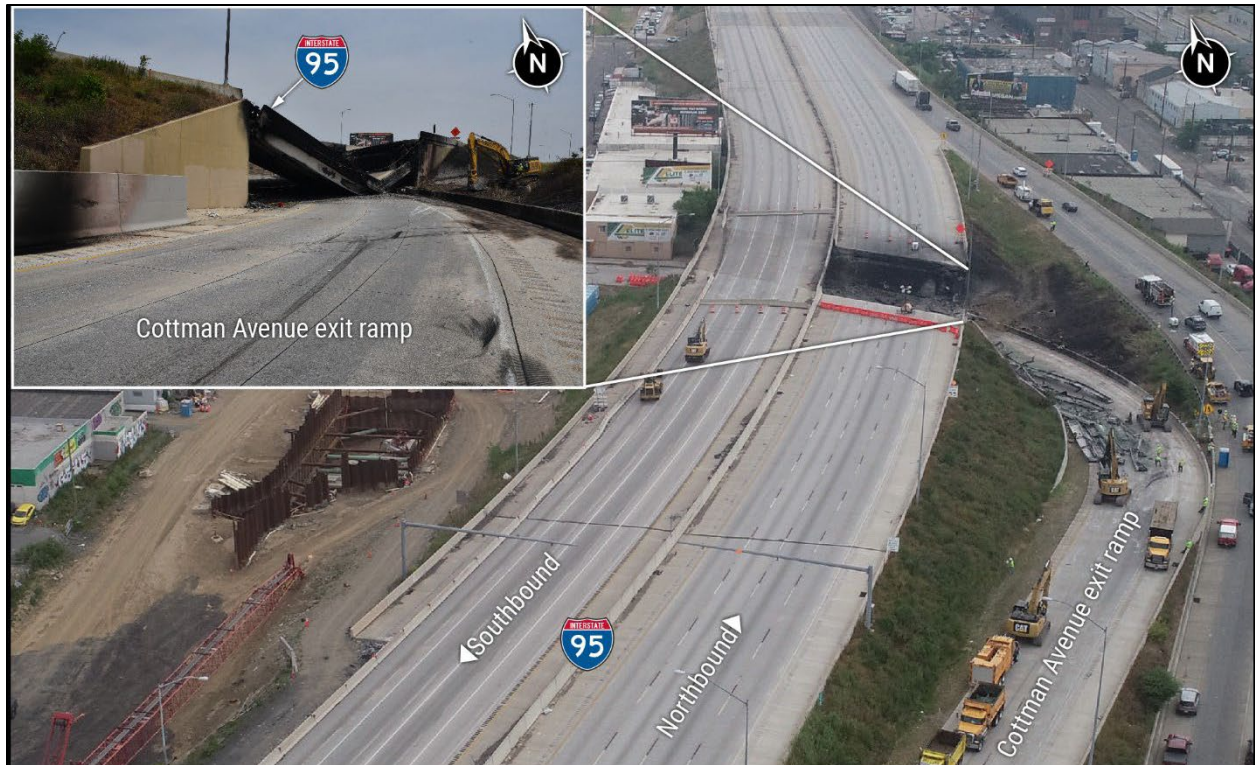
Figure 1. View of crash location on Cottman Avenue exit ramp and I-95 in vicinity of crash.

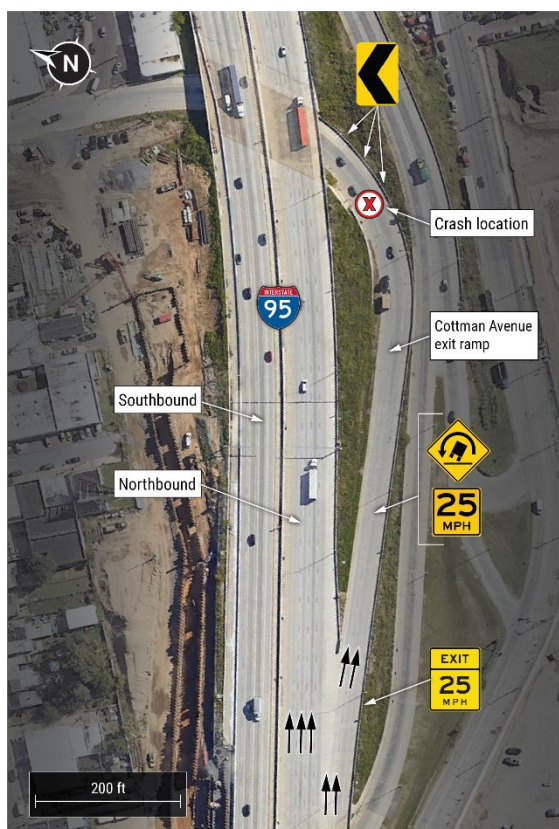
The speed limit on northbound I-95 just before the exit ramp was 55 mph. At the onset of the exit ramp on the right, approximately 733 feet south of the collision area, an exit speed sign was posted, advising motorists to travel no faster than 25 mph. About 500 feet south of the collision area was a truck rollover warning sign accompanied by an advisory speed plaque also indicating the recommended speed of 25 mph. Near the area where the rollover occurred, three chevron alignment signs were located along the outside of the horizontal curve, emphasizing the change in horizontal alignment.

Figure 3. Overhead view of I-95 and Cottman Avenue exit ramp with signage identified. (Source: Google Earth; annotated by NTSB)

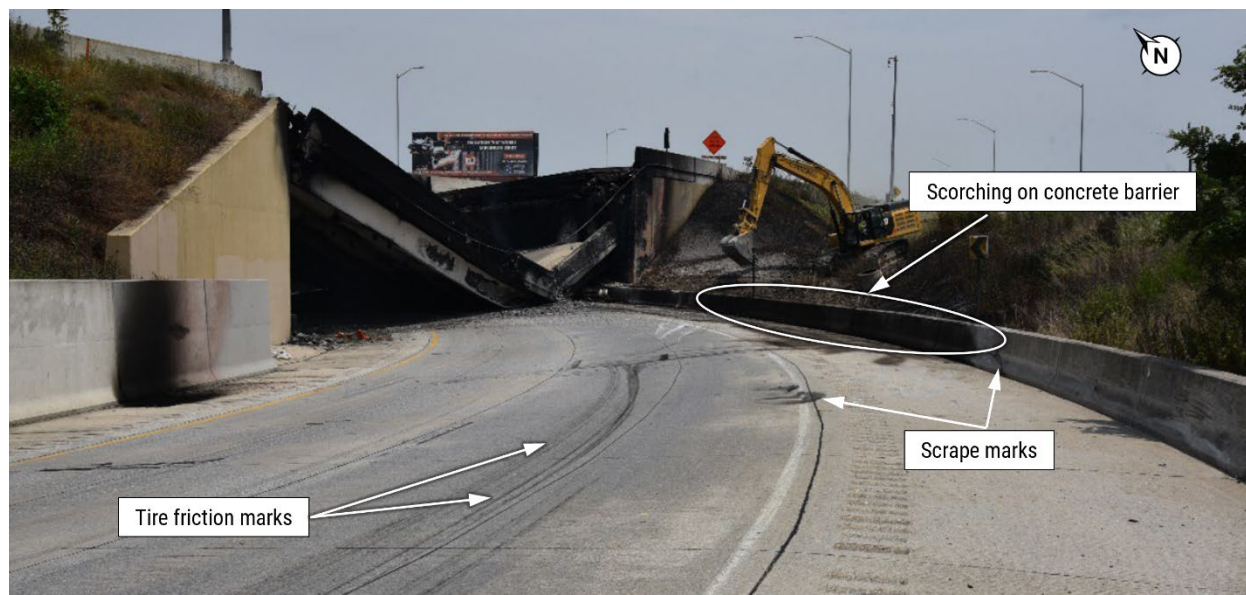
Based upon on-scene observations of the crash area as well as aerial photographs provided by the Pennsylvania State Police (PSP), the National Transportation Safety Board (NTSB) documented roadway evidence including two parallel tire friction marks that were lighter in color where they first appeared and became darker leading to the curve in the exit ramp. In total, the marks extended about 176 feet. At their termination, the marks were dark, and the right outer mark widened and angled toward the right shoulder of the roadway. About 4.5 feet south of the final friction mark were scrape marks on the roadway surface that extended to the right concrete barrier in the area where the exit ramp began to curve sharply before crossing under I-95. Black scorched areas were also observed on the roadway, concrete barrier, grassy area beyond the concrete barrier, and overpass bridge structure. Recovery operations were underway during the evidence documentation, and some roadway evidence had been covered up by debris or obscured by heavy equipment being used to clean up and remove the

collapsed bridge. Figure 4 shows the friction marks, scrape marks, and concrete barrier scorching.

Figure 4. Tire friction marks, scrape marks, and scorching on the Cottman Avenue exit ramp roadway and concrete barrier.

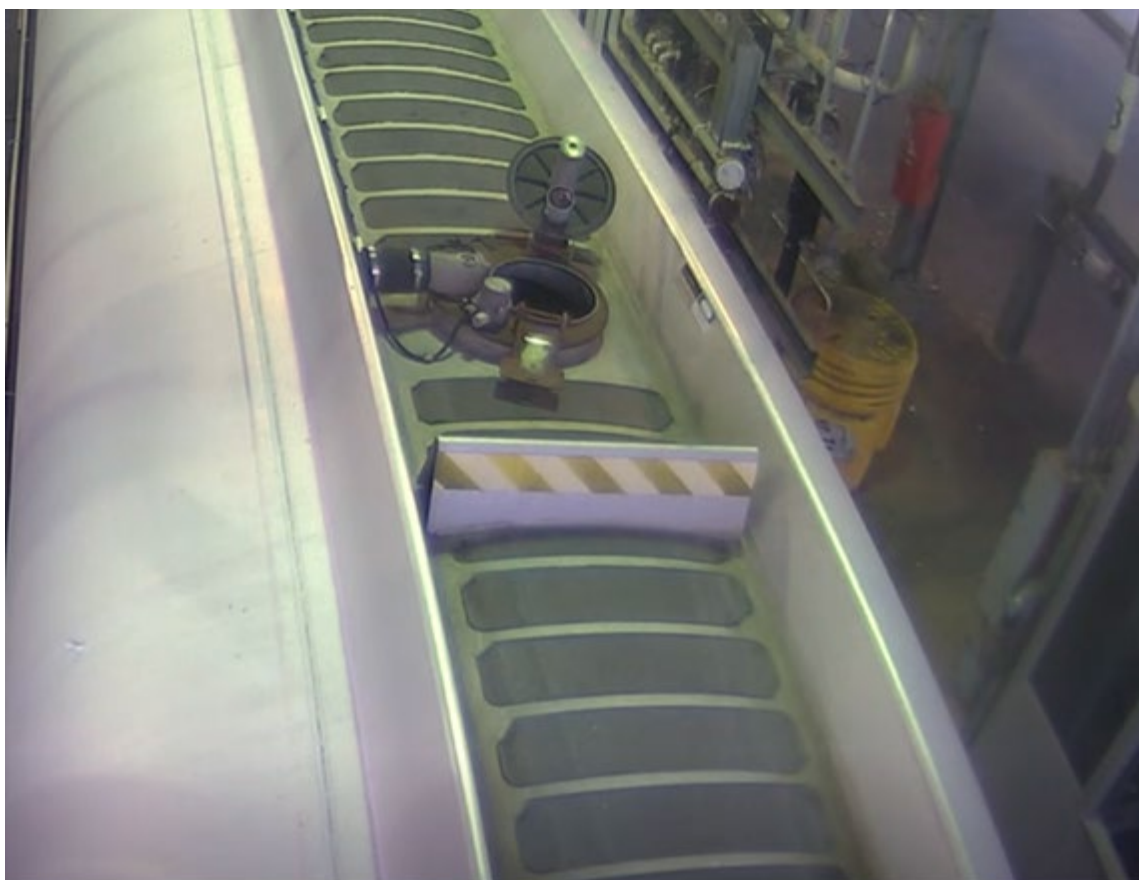
at the bottom of the tank.⁸ Figure 5 includes a still image from video footage at the Wilmington, Delaware, loading facility showing the tank's forwardmost manhole cover in an open position.

Figure 5. Loading facility video footage showing open manhole cover atop cargo tank.
(Source: Buckeye Terminal, Wilmington, Delaware)

Other surveillance video footage showed the driver walking back and forth and at times standing next to the cargo tank near the open manhole. In the footage that the NTSB reviewed, the driver did not appear to notice that it was open at any time. The NTSB also spoke with several company officials from Penn Tank Lines; each of them stated that the driver should have been able to hear air being displaced from the open compartment while he was filling it with gasoline from below, with one official stating that this displacement would have sounded like a “tornado.”

each of the truck driver's three trips before the crash showed that the manhole cover for the forwardmost compartment of the truck's cargo tank was open when he arrived to pick up or deliver gasoline and remained open when he departed.

After the crash occurred, Penn Tank Lines transitioned from a paper-based process to an electronic process for drivers to complete pretrip inspections. Although this updated process does not completely prevent a driver from skipping an inspection step, it requires the driver to make an entry signifying that all manhole covers are secured.

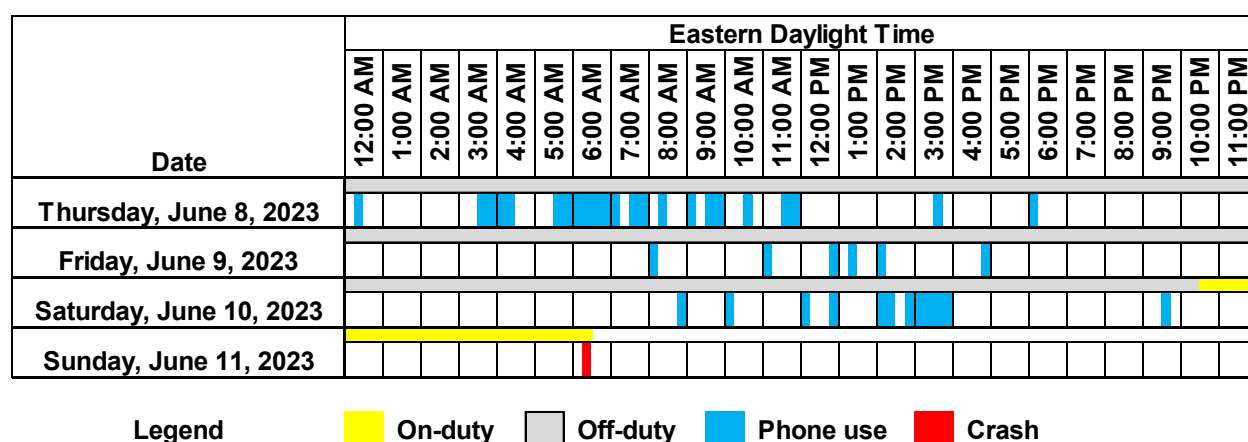
The truck driver's cell phone records showed that from June 8-10, his days off, he registered calls and text activity between the hours of 8:00 a.m. and 6:00 p.m. (see figure 6). This suggests that on his days off, the truck driver reverted to a daytime schedule.

Figure 6. Graphical representation of truck driver's phone use (calls/texts) and on-duty times during the 72 hours before the crash. Phone use is shown as a contiguous block if the time between outgoing texts or phone calls was less than 15 minutes.
