HIR-25-04

Tire Failure, Motorcoach Roadway Departure, and Rollover

Wawayanda, New York
September 21, 2023

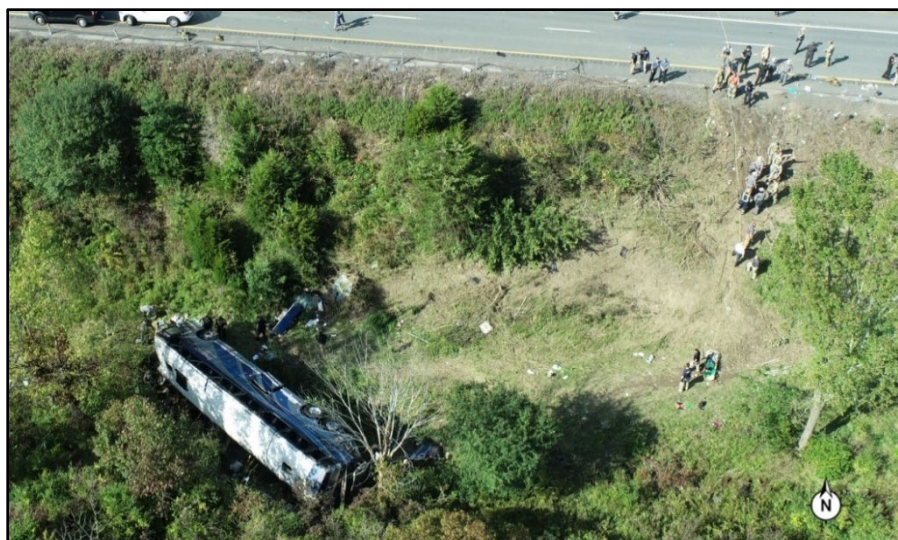
Figure 1. An aerial view of the motorcoach at final rest on its left side at the bottom of the median. (Source: New York State Police)

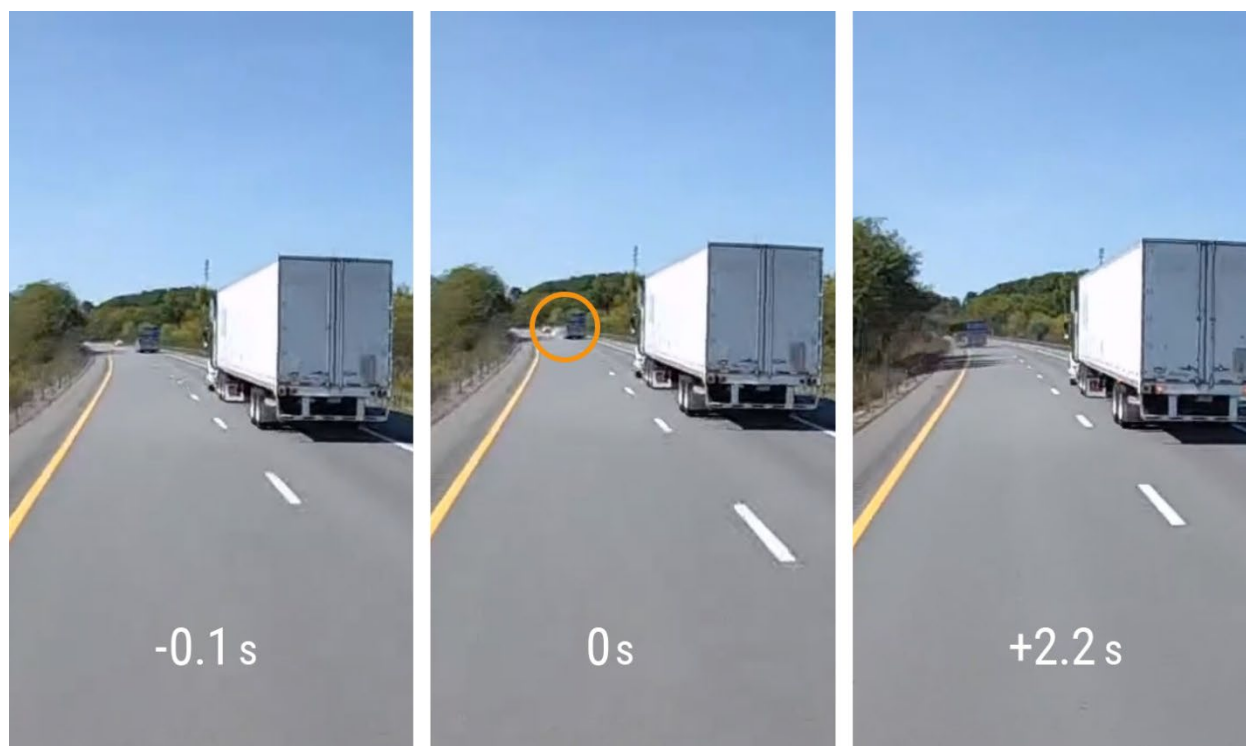
Just beyond mile marker 12, as the motorcoach was negotiating a gradual leftward horizontal curve, the left steer axle tire experienced a sudden and catastrophic deflation, or “blowout.”⁴ Video footage showed that immediately after the tire failure, the motorcoach veered leftward, and about 2 seconds later, it had crossed onto the left shoulder (see figure 3).⁵

Figure 3. Video sequence from the trailing motorcoach's forward-facing camera (with annotations by the NTSB) showing the moment before tire failure (left image), the moment of tire failure (center image), and the point of roadway departure (right image). The yellow circle highlights the point at which the tire burst, releasing air and depressurizing the tire.⁶

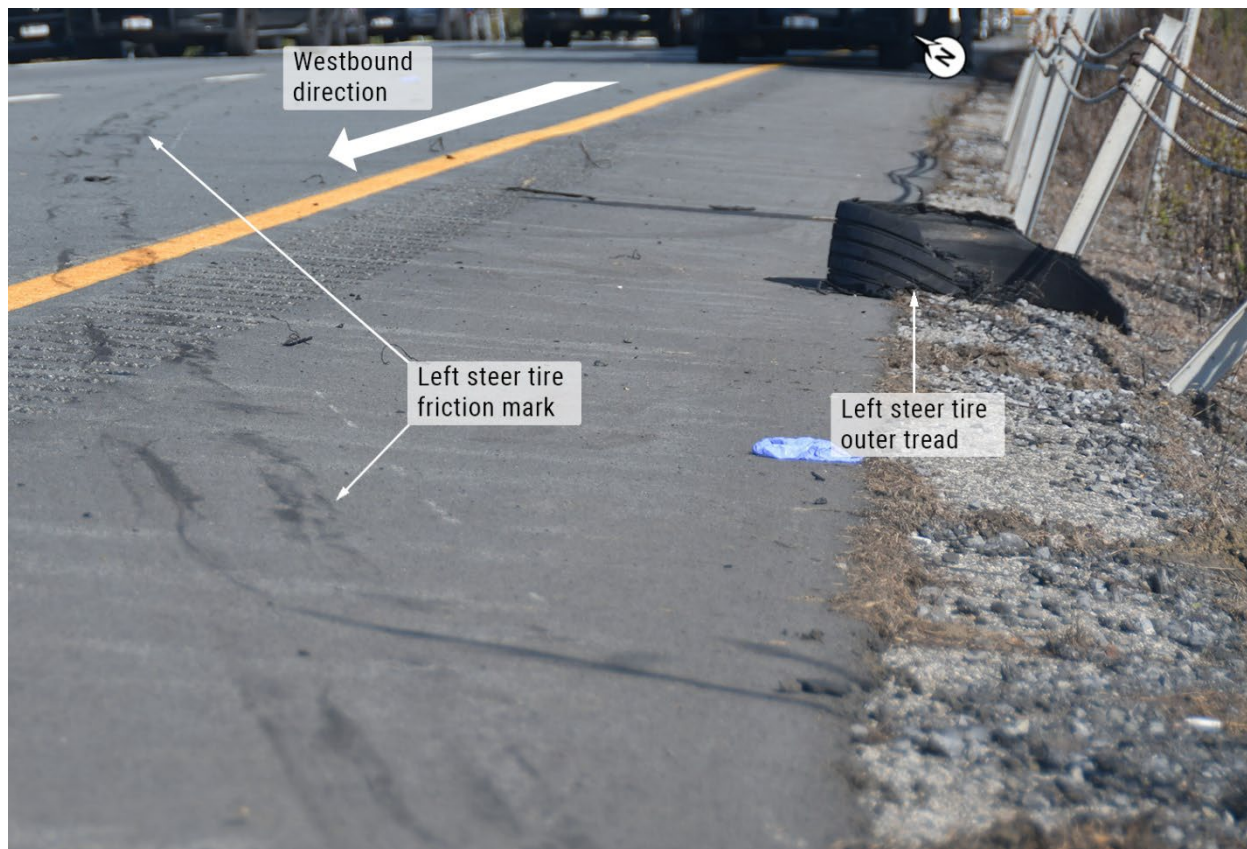
Physical evidence on the roadway revealed marks and scrapes originating in the right lane, extending across the left lane, and continuing into the shoulder (see figure 4). Investigators identified the onset of roadway evidence, a tire friction mark created by the deflated left steer axle tire, about 260 feet from the point where the motorcoach departed the roadway.⁷

Figure 4. Left steer axle tire friction mark showing the motorcoach's abrupt path of departure from the roadway. The view is from the departure location looking back along the vehicle's travel path toward where the tire failed. The tire's outer tread is shown on the shoulder. (Source: New York State Police; annotated by the NTSB)

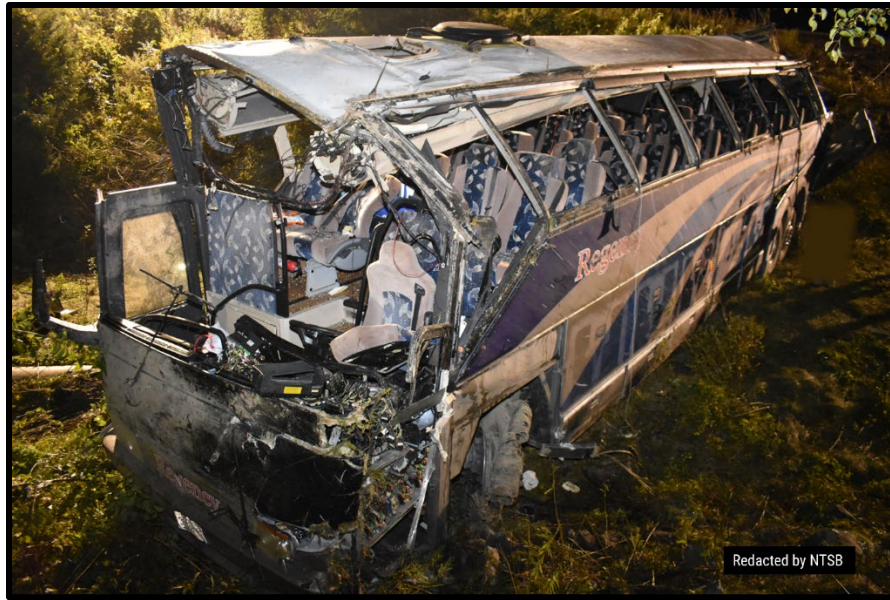
The rollover caused extensive damage to the motorcoach structure (see figure 5). The upper front section, including the windshield and side windows, separated from the vehicle body. All side windows lost their window glazing. The left-side roof rail was displaced inward toward the vehicle's centerline, and the supporting pillars were bent into the occupant space, resulting in lateral crush measurements between 21 and 29 inches. The roof rail on the right side was displaced outward from the vehicle's centerline during the roll.

Figure 5. Left-front view of the motorcoach after the motorcoach was righted.

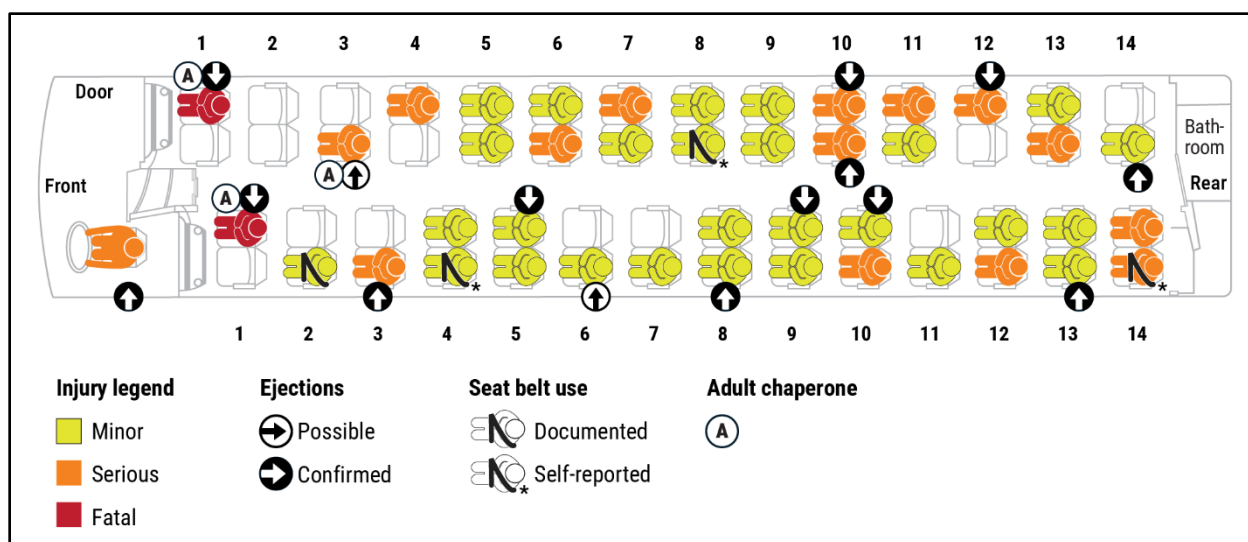
Physical evidence—stretching of the belt webbing—indicated that only one passenger (row 2, left-side window seat) was wearing a lap/shoulder belt when the crash occurred. The occupant of this seat, a student who sustained minor injuries, also reported being belted during the crash.

Figure 6. Motorcoach occupant seating chart showing injury severity and seat belt use.

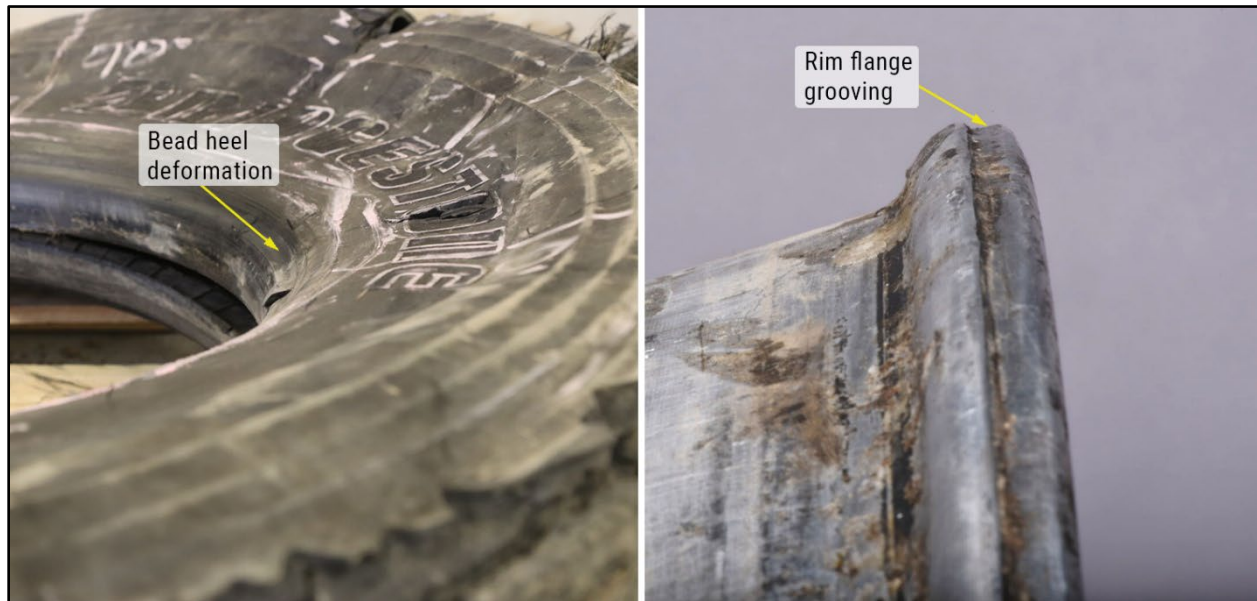
Following the crash, the NTSB requested that Bridgestone, the manufacturer of the steer axle tires, examine both steer axle tires.²⁷ The examination showed that the failed steer axle tire exhibited signs of prolonged underinflation during operation, including a compression groove at the rim flange, incipient cutting of the rubber by the rim adjacent to the compression groove, and bead heel deformation with chafing along the base (see figure 7). Most of these indicators were also observed on the right steer axle tire.

Figure 7. Images of the failed left steer axle tire showing indicators of underinflation.

The postcrash tire examination by Bridgestone, the tire manufacturer, revealed that both steer axle tires showed evidence of prolonged operation in an underinflated condition, including compression grooves at rim flanges and rubber cutting adjacent to these grooves. The failed left steer axle tire exhibited more severe underinflation indicators: recovered tread fragments had a blue tint on fracture surfaces, which is evidence of elevated operating temperatures. The left steer axle tire also showed evidence of precrash impact damage along its outboard shoulder with notable radial splits through the tire body and liner and signs of a developing tread separation. The Bridgestone examination, observed by the NTSB, showed that the left steer axle tire blowout resulted from a combination of underinflation and previous impact damage.

In addition, this crash demonstrates that proper tire pressure maintenance is critical. A properly configured tire pressure monitoring system can alert vehicle operators to under- or overinflated tires. Periodic tire pressure gauge checks—beyond visual inspection—should be undertaken as a part of a vehicle inspection in the event that a tire pressure monitoring system is not configured or functioning properly. The NTSB has previously recommended both manual tire pressure checks and tire pressure monitoring systems.

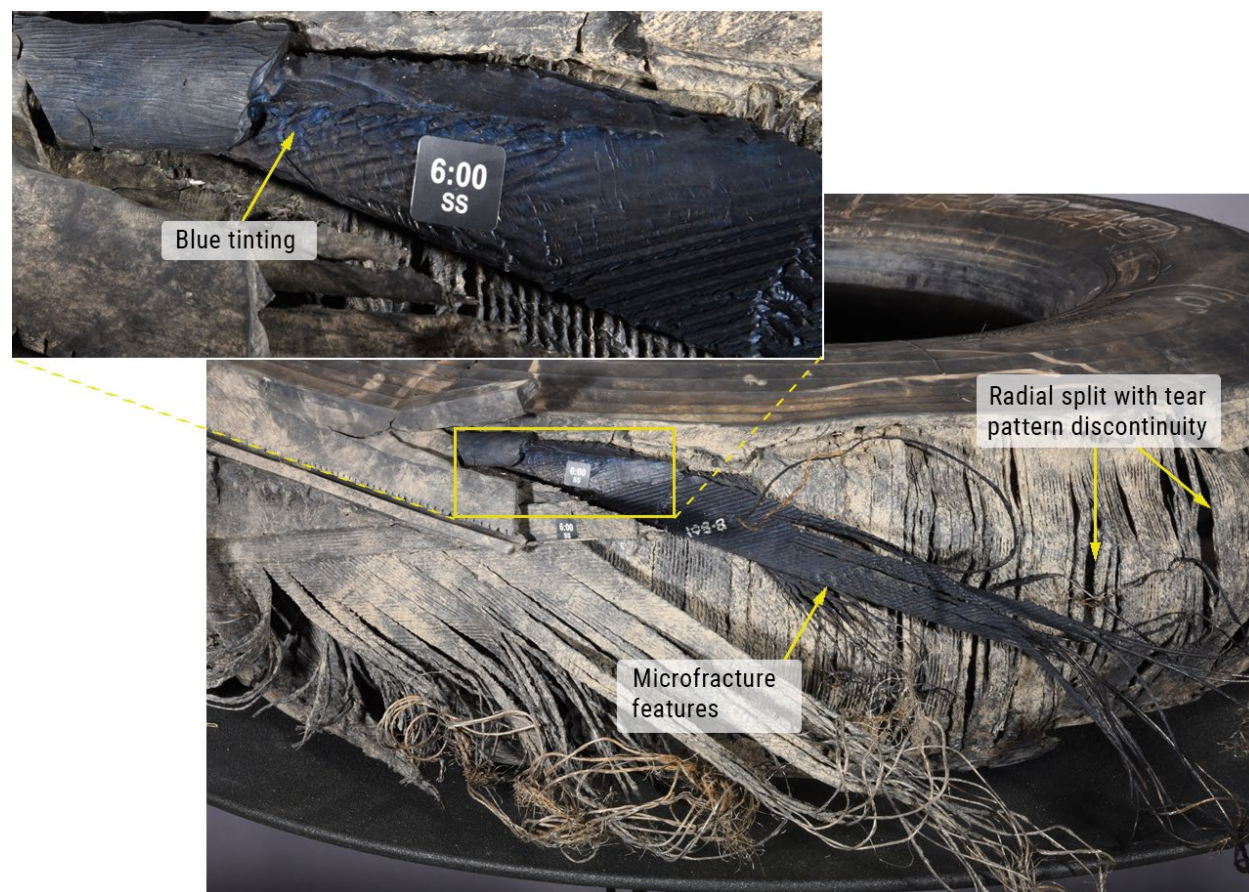
Furthermore, multiple tread fragments recovered from the crash scene displayed a blue tint on the tread fragment edges (see figure 8), indicating elevated tire temperature from extended underinflation at the time of tire failure. The left steer axle tire showed features in the rubber adjacent to the rim flange consistent with underinflation during extended operation. This tire also had evidence of precrash impact damage along the outboard-facing shoulder, covering about 21% of the tire circumference. The examination revealed notable radial splits through the tire body and liner across the tread and down the external sidewall at multiple points (see figure 8).²⁸

Small fractures or cracks consistent with a preexisting and progressing internal belt separation were found in the vicinity of the impact damage between the second and third tire belts. During the tire failure, a large tread piece separated from the tire, separating between the second and third belts.

Figure 8. Images of the failed left steer axle tire showing indicators of underinflation and impact damage.
