Highway Investigation Report HIR-25-05

Multivehicle Collision and Postcrash Fire on Interstate 70

Etna, Ohio

November 14, 2023

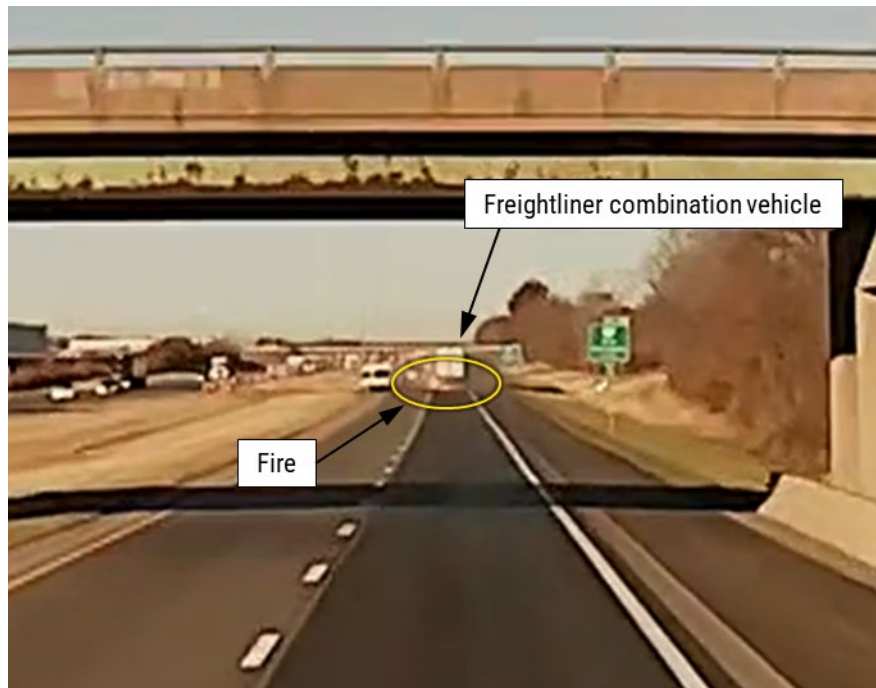
Figure 2. Video still from the witness vehicle's forward-facing camera (annotated by NTSB), showing the fire under the Freightliner combination vehicle.

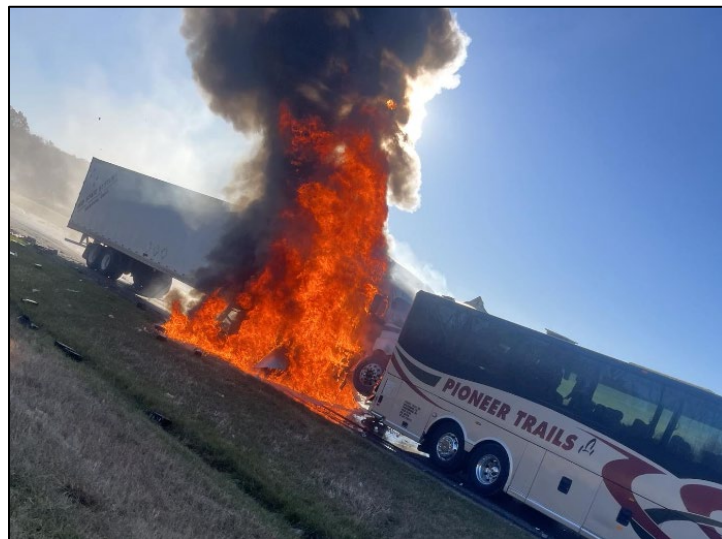
The fire began shortly after the Freightliner struck the Nissan and before the vehicles came to final rest. The fire progressed postcrash and engulfed the Nissan and Freightliner. It then spread to the rear of the motorcoach. Figure 5 shows the postcrash fire shortly after the crash; at the time the photograph was taken, the fire had not yet spread to the motorcoach.

Figure 5. Postcrash fire initially involving Nissan and Freightliner combination vehicle before spreading to motorcoach. (Source: motorcoach occupant)

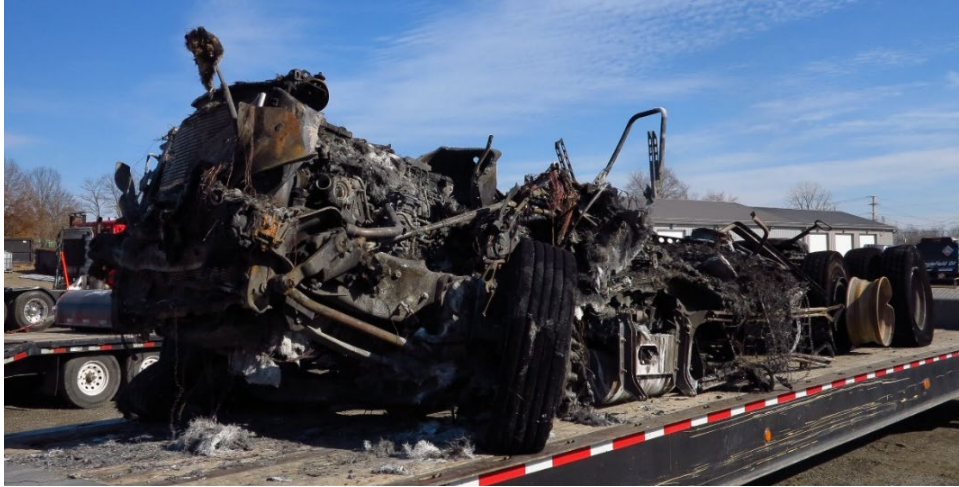
The NTSB examined the Freightliner truck-tractor and documented that it was completely burned in the postcrash fire (see figure 10). All combustible materials from the front bumper to rear of the last drive axle—such as the electrical wiring,

rubber and plastic air hoses and lines, all driver controls, and vehicle body parts—were damaged.

Figure 10. Damage to Freightliner truck-tractor.

Despite the extensive fire damage, crash-induced damage was apparent as well. The front frame horns and rails were bowed upward and rearward. The right-side frame rail was bowed outward above the steering axle, and the left-side frame rail was buckled outward and bowed upward above the steering axle. The right-side frame rail was bowed upward beneath the sleeper berth. The cab was separated from the front and rear mounts. The two fuel tanks, which were no longer mounted to the truck-tractor, were found with the crash debris. The fuel tanks had been torn open and crushed.

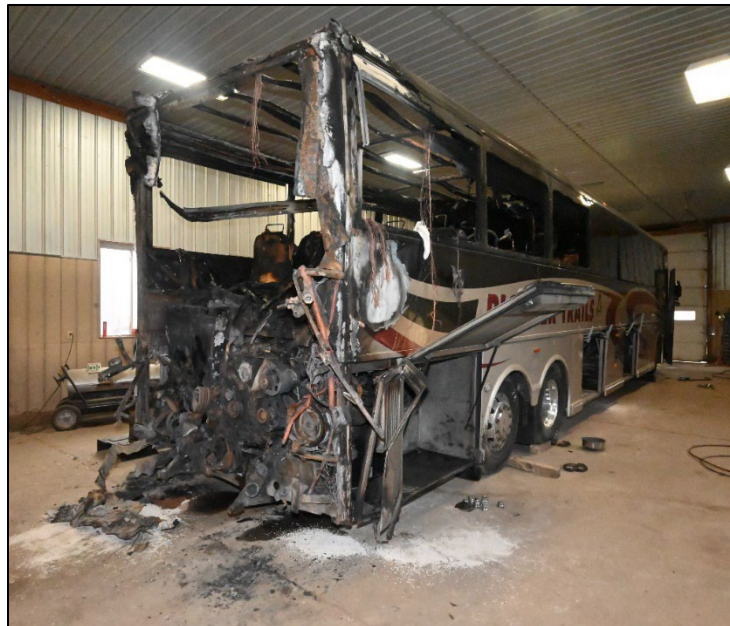
The motorcoach exhibited impact damage at both the front and rear, in addition to fire damage in the rear half of the vehicle and its interior passenger compartment. At the rear, all exterior panels (including the engine cover, upper panel, and lights) were displaced during the crash, though the rear body framing appeared to remain in place (see figure 11). The engine, located in the rear, exhibited evidence of both impact and fire damage. The rear of the motorcoach sustained intrusion from the Freightliner truck-tractor, and the seats in row 15 were displaced upwards and pushed toward the front of the motorcoach.

Figure 11. Damage to right rear of motorcoach.

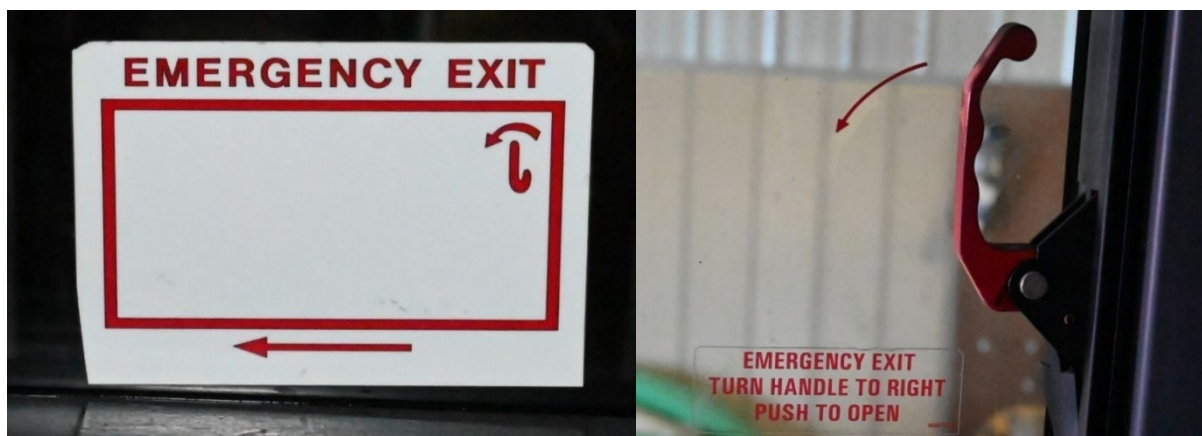
Therefore, the emergency exit signage on the non-emergency windows constituted an out-of-service condition for the motorcoach, per 49 *Code of Federal Regulations (CFR)* 393.62. Although Public Utilities Commission of Ohio (PUCO) safety investigators inspected the motorcoach multiple times between 2017 and 2022, no violations had been documented.³¹ When PUCO safety investigators

inspected the motorcoach after the crash on November 16, 2023, it was cited for improper exit markings.

The examination of the motorcoach's windows also revealed that the emergency exit window latch instructions were inaccurate (see figure 12, right image). The instructions directed passengers to turn the handle to the right, but in fact, the handles on the emergency windows needed to be turned to the left for the windows to then be pushed open.

Figure 12. Emergency exit signage located on all emergency window exits as well as all non-emergency windows (left) and emergency exit window latch instructions (right).

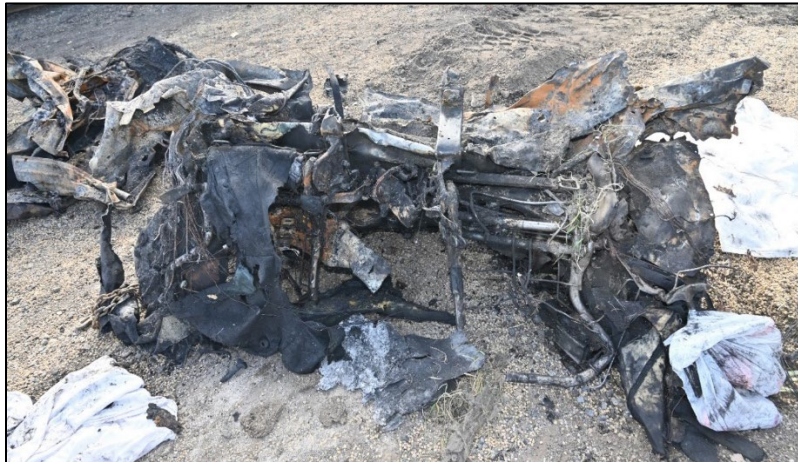
Three other vehicles were involved in the crash. The 2015 Nissan Murano passenger vehicle sustained catastrophic impact damage and comprehensive fire damage.³³ It was crushed between the front of the Freightliner combination vehicle and the rear of the motorcoach and was found in multiple pieces (see figure 13).

Figure 13. Postcrash view of Nissan, which sustained catastrophic crash damage and comprehensive fire damage.

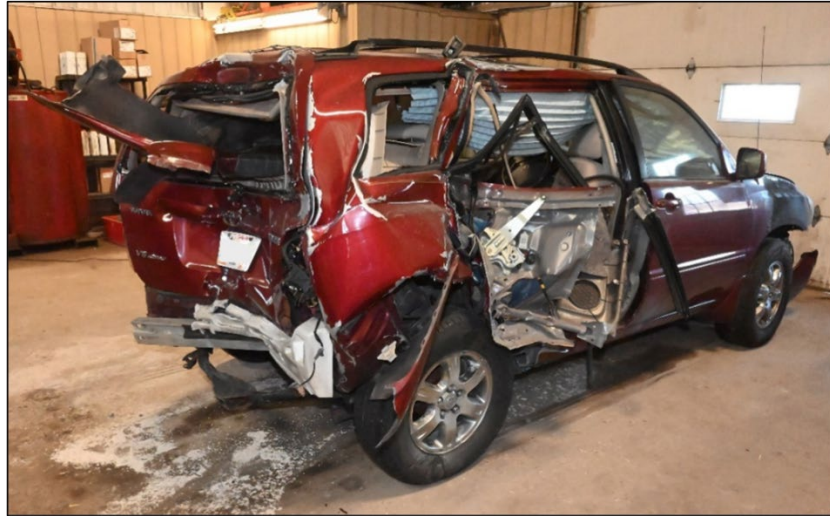
The 2006 Toyota Highlander passenger vehicle, which was traveling in front of the motorcoach, was struck at its right-rear corner by the left front of the motorcoach. The rear lift gate, bumper, and right-rear corner panel were crushed forward (see figure 14). The exterior door panel for the right-side rear passenger door was missing and the door was crushed. The Toyota also sustained minor fire damage.

Figure 14. Damage to rear of Toyota.

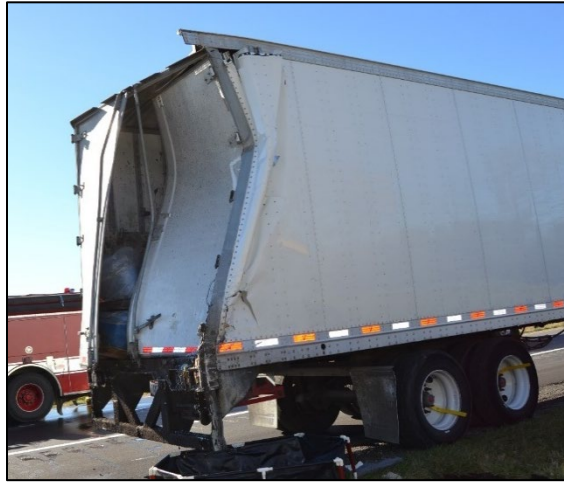
The Volvo combination vehicle—consisting of a 2014 Volvo truck-tractor coupled with a 2022 Vanguard semitrailer—sustained minor damage to the rear of the semitrailer from the front of the motorcoach but was not involved in the postcrash fire (see figure 15).³⁴ The OSHP released the Volvo combination vehicle from the crash scene, and the NTSB did not examine it.

Figure 15. Damage to rear of Volvo combination vehicle Vanguard semitrailer. (Source: OSHP)
