HIR-26/04

Sport Utility Vehicle Roadway Departure, Overturn, and Submersion

Belle Glade, Florida
August 5, 2024

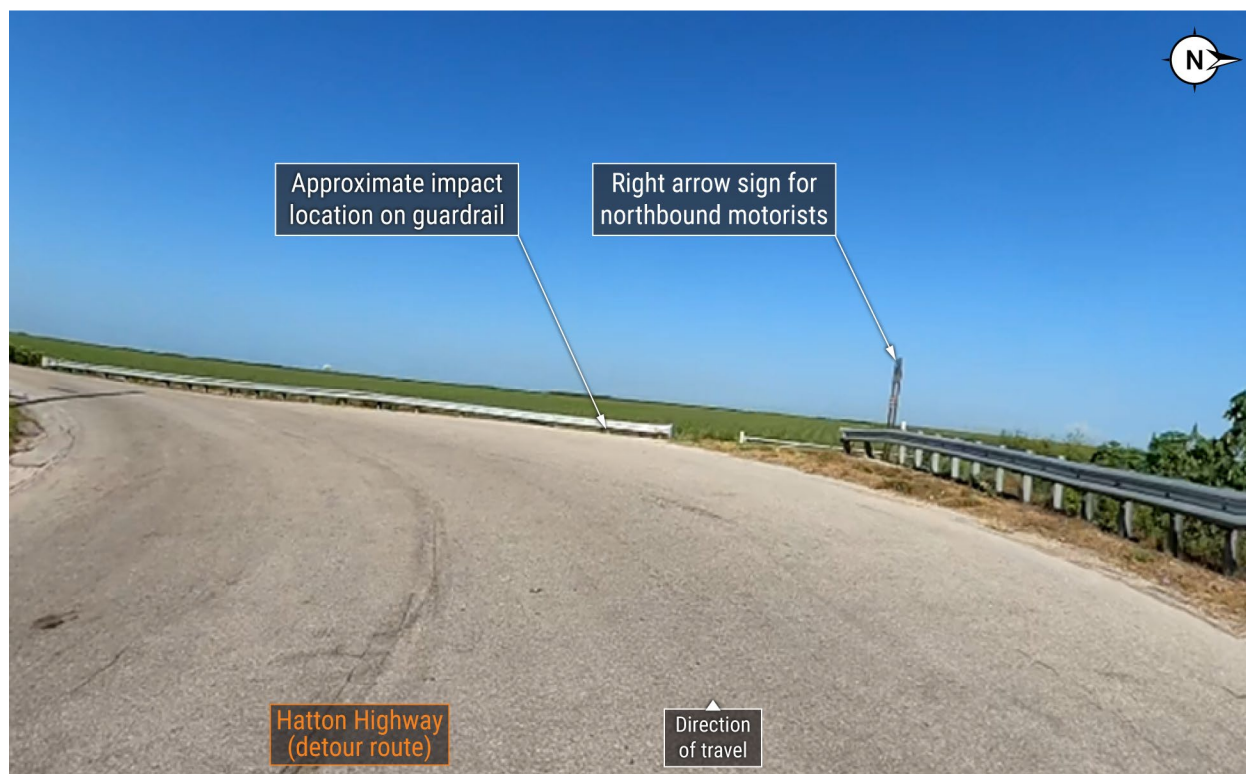
Figure 1. Still image of the crash location taken by Palm Beach County dashboard camera footage on May 2024, 3 months before the crash occurred. A right-arrow sign for northbound motorists is installed (perpendicular to westbound motorists) at the end of a guardrail. (Source: Palm Beach County; annotated by NTSB)

guardrail measured about 15 inches (1.3 feet) above the roadway edge (refer to figure 1).⁷

To accommodate the unpermitted road entrance, the guardrail deviated from the shoulder edge and beyond the slope break. Although the rail height was about 31 inches relative to the ground surface at the post line, its placement downslope resulted in a reduced effective height relative to the roadway—about 1.3 feet above the roadway edge and about 1 foot below the SUV's center of gravity. This reduced effective height is insufficient for proper vehicle-barrier interaction and increases the potential for vehicle override, thereby diminishing the guardrail's ability to redirect an errant vehicle. Placement beyond the slope break and on a side slope steeper than 1V:10H further compromises post support and system performance. In addition, a portion of the guardrail face was oriented nearly perpendicular to the westbound direction of travel, a configuration that may increase impact severity and reduce the guardrail's redirection capability.¹⁹

These conditions—including excessive lateral offset, reduced effective rail height, installation beyond the slope break, and placement on a nonrecoverable slope—are inconsistent with guidance contained in the FDOT *Design Manual* and can adversely affect guardrail performance during a crash.

According to planned improvements by Palm Beach County, reconstruction of the west curve on Hatton Highway will include installation of a new, stronger, and contiguous guardrail system along the curve. The proposed guardrail will be installed on a reconstructed shoulder, which will bring the guardrail height and orientation into compliance with the current design standards. The improvement plan also includes enhanced signage, installation of rumble strips, and restriping the lane markings throughout the curve.

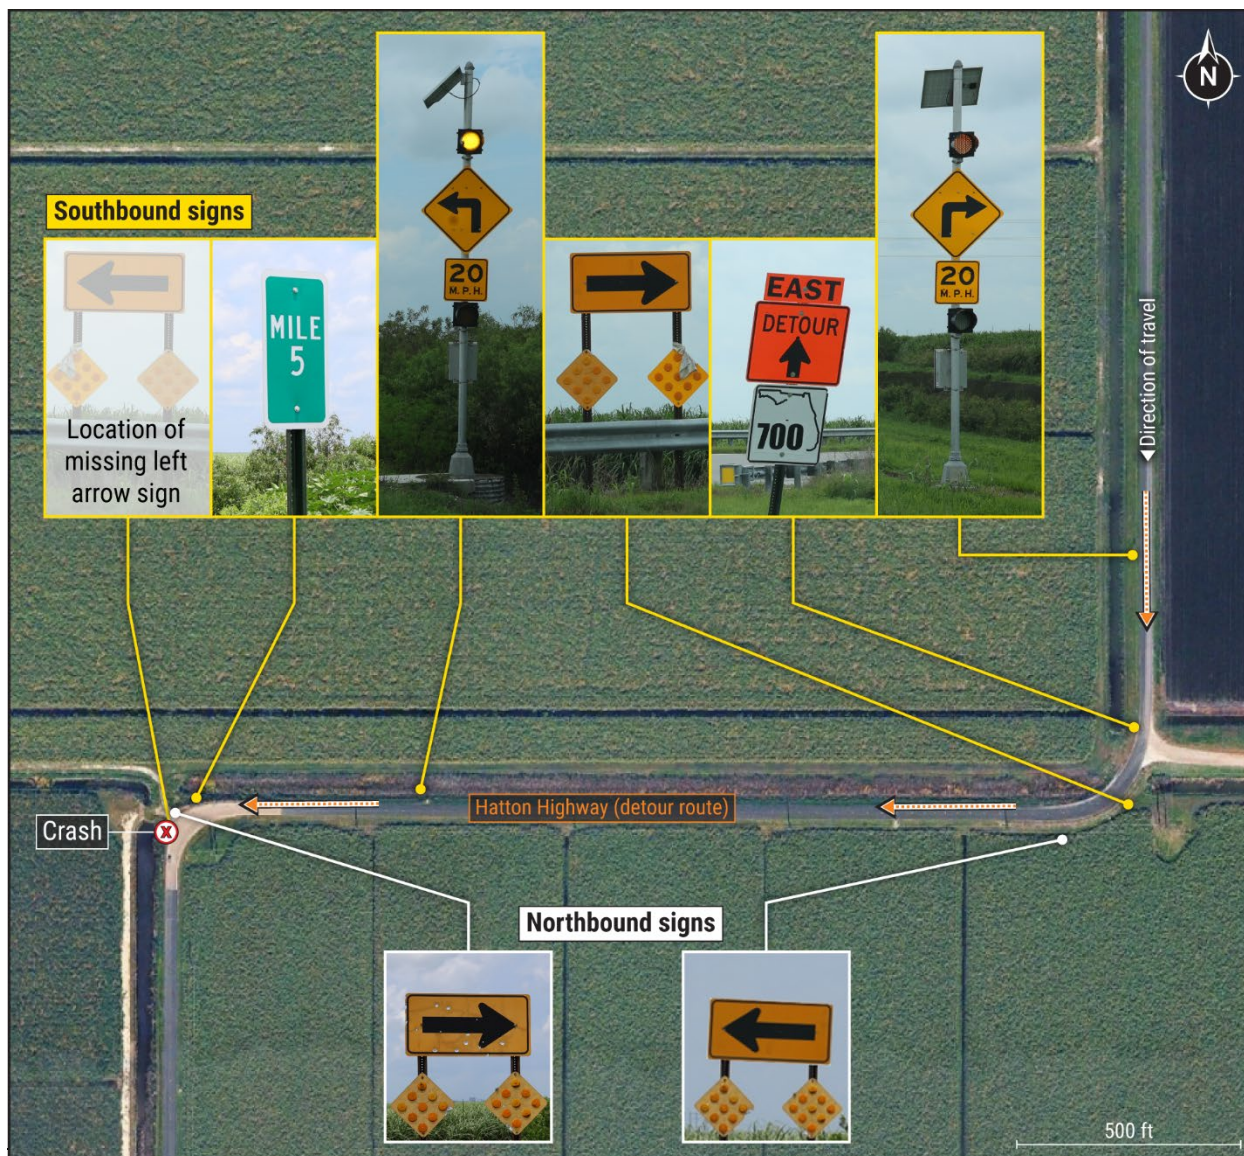
Hatton Highway was mostly straight but featured two curves in the area of the crash.³ The right-hand curve had an inside radius of about 245 feet. The left-hand curve, where the crash occurred, had an inside radius of about 120 feet. Approaches to both curves were marked by two flashing beacons, an arrow warning sign, and a 20-mph advisory speed plaque mounted on a pole. At the outside of both curves, in line with a driver's path, one-direction large arrow signs combined with object markers had been installed side by side (one for westbound motorists, one for northbound motorists) to indicate where the roadway changed direction (see figure 3).⁴ However, at the crash location, and at the time of the crash, the large arrow sign intended for westbound motorists was missing after having been damaged and displaced in a previous crash.⁵

Figure 3. Signage along the driver's route on Hatton Highway up to the crash location. (Source: Google Earth; inset images and annotations by NTSB)

A large arrow sign intended to alert westbound motorists of the left-hand curve was missing at the time of the crash. It had been damaged and displaced during a previous crash (occurring between June 2021 and May 2023) and had not been replaced by Palm Beach County. The absence of this sign likely reduced advance warning and visual guidance for motorists approaching and entering the curve.

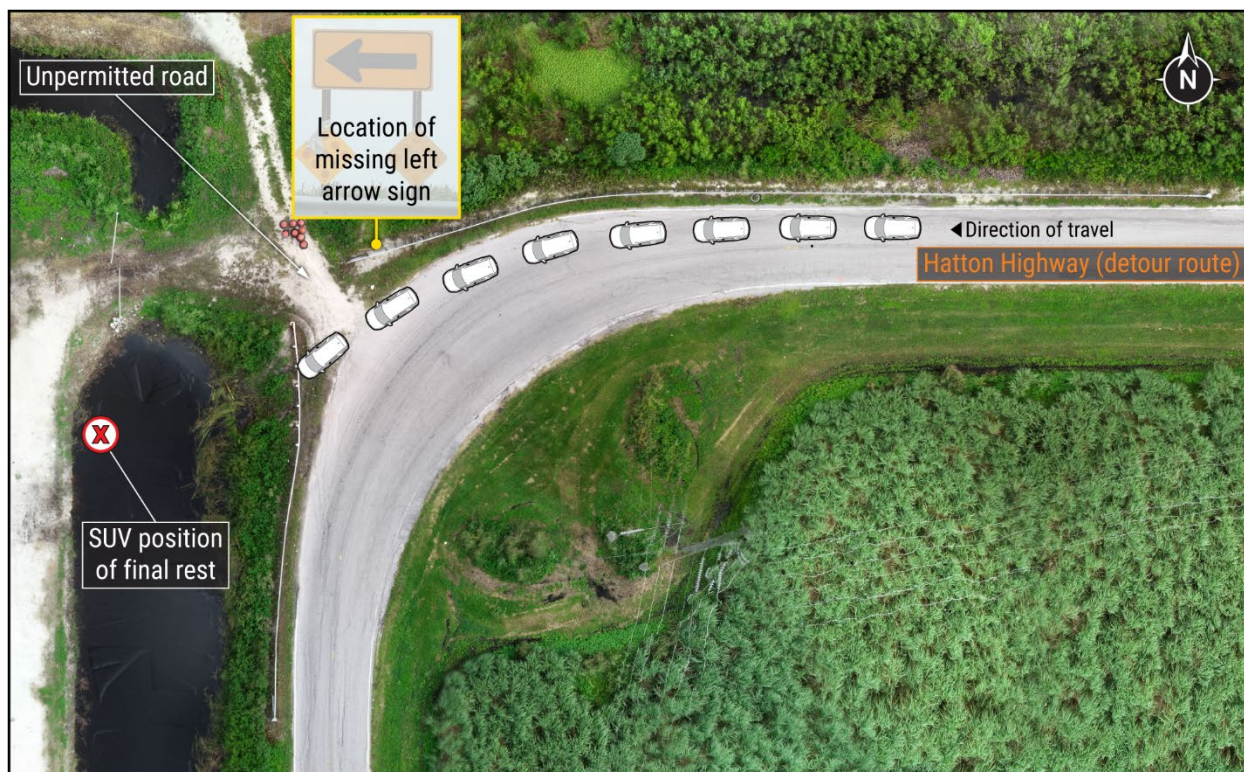
Two tire-friction marks were identified in the westbound travel lane. The marks were approximately parallel to each other and measured about 29 and 32 feet long. Both marks terminated at the white edge line where the SUV exited the roadway.

The SUV struck the guardrail at an angle and at a recorded speed of 44 mph (see figure 4). It continued west over the guardrail, overturned, and landed on its roof in the canal that bordered the roadway. The canal was about 5 feet deep, 48 feet wide, and 20 feet from the roadway edge. After the SUV came to rest in the canal, one passenger was able to extricate himself from the vehicle.

Figure 4. Reconstructed overhead image of the SUV's travel path to impact location. (Source: Google Earth; inset image and annotations by NTSB)
