HIR-26-05

# Multivehicle Work Zone Collision and Postcrash Fire on Interstate 95

Kenly, North Carolina  
July 24, 2024

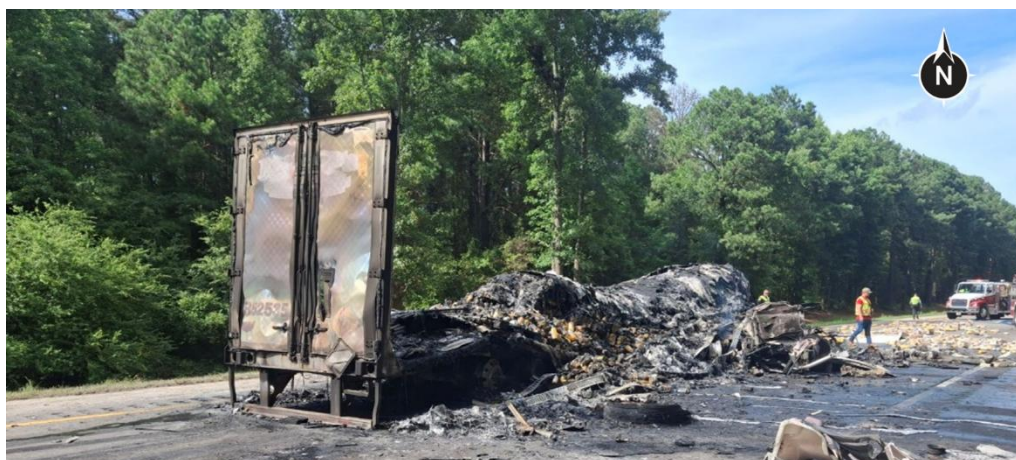
**Figure 1.** Final rest position of Freightliner combination vehicle. (Source: Mangum Towing and Road Services)

final rest. The postcrash fire, which had begun after the Freightliner sideswiped the Kenworth, consumed the Freightliner. The International departed the roadway to the right, where it came to final rest. Figure 4 shows the initial impact point where the Freightliner first struck the Chevrolet as well as the final rest positions of all five vehicles.

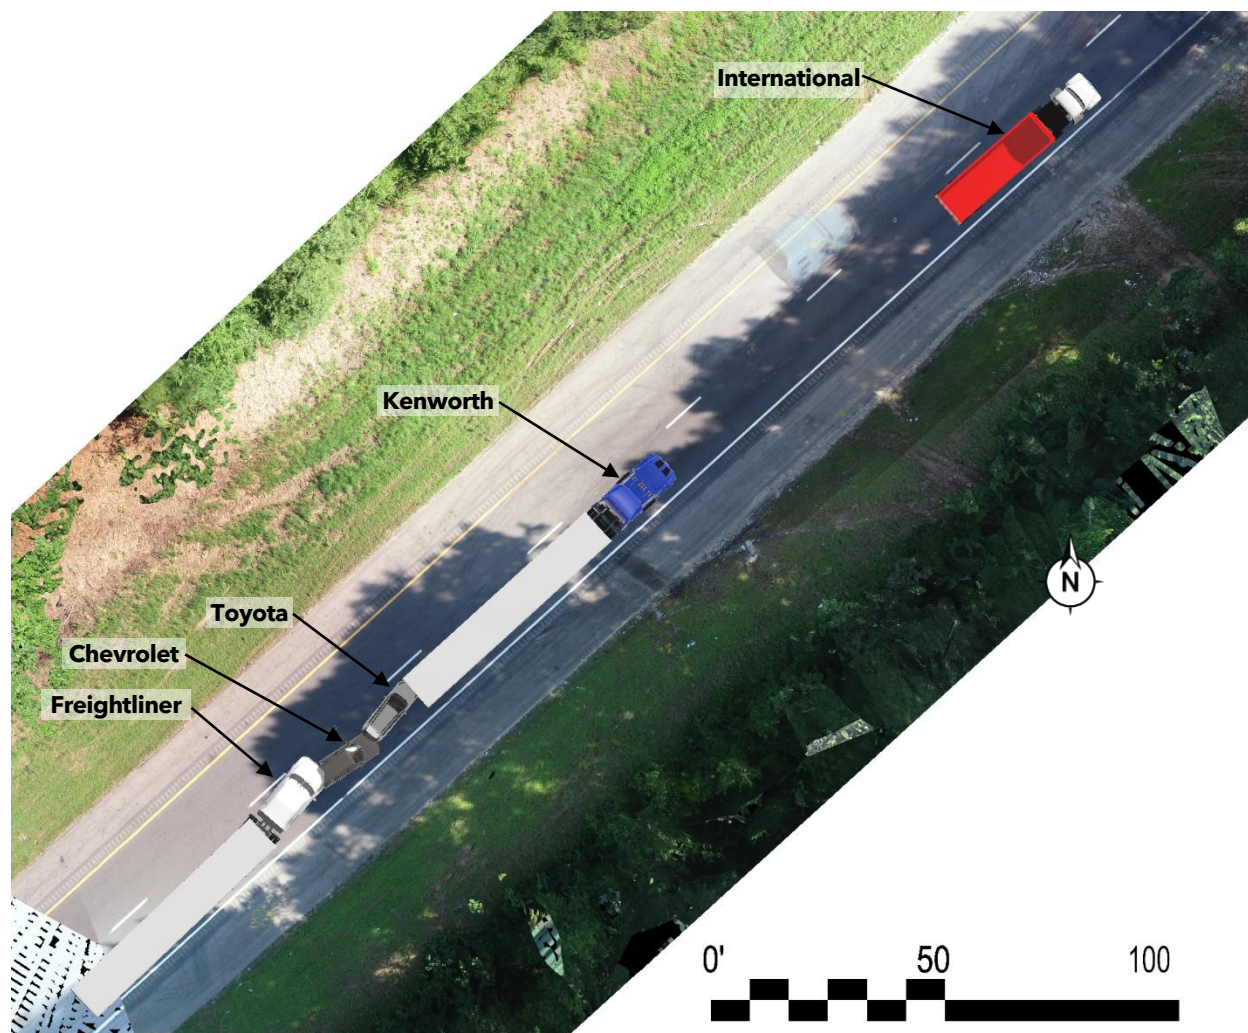
As the Chevrolet continued to be pushed forward by the Freightliner, it started rotating to the right and collided with the right rear of the Toyota. The Toyota was traveling at a recorded speed of 6.2 mph at impact.<sup>4</sup> The impact occurred about 36.5 feet north of the initial crash. The Toyota was pushed forward, started rotating to the left (counterclockwise), and collided with the rear of the Kenworth, displacing the rear underride guard of the Kenworth's semitrailer forward. The Kenworth was traveling at a recorded speed of 5 mph when it was struck.<sup>5</sup> Figure 3 shows the approximate positions of the vehicles after this initial crash sequence. At this time, the first four vehicles (the Freightliner, Chevrolet, Toyota, and Kenworth) had been involved in the crash and the International had not yet been struck.

**Figure 3.** Illustration of initial impact involving Freightliner, Chevrolet, Toyota, and Kenworth. Vehicle separation distances are approximate.

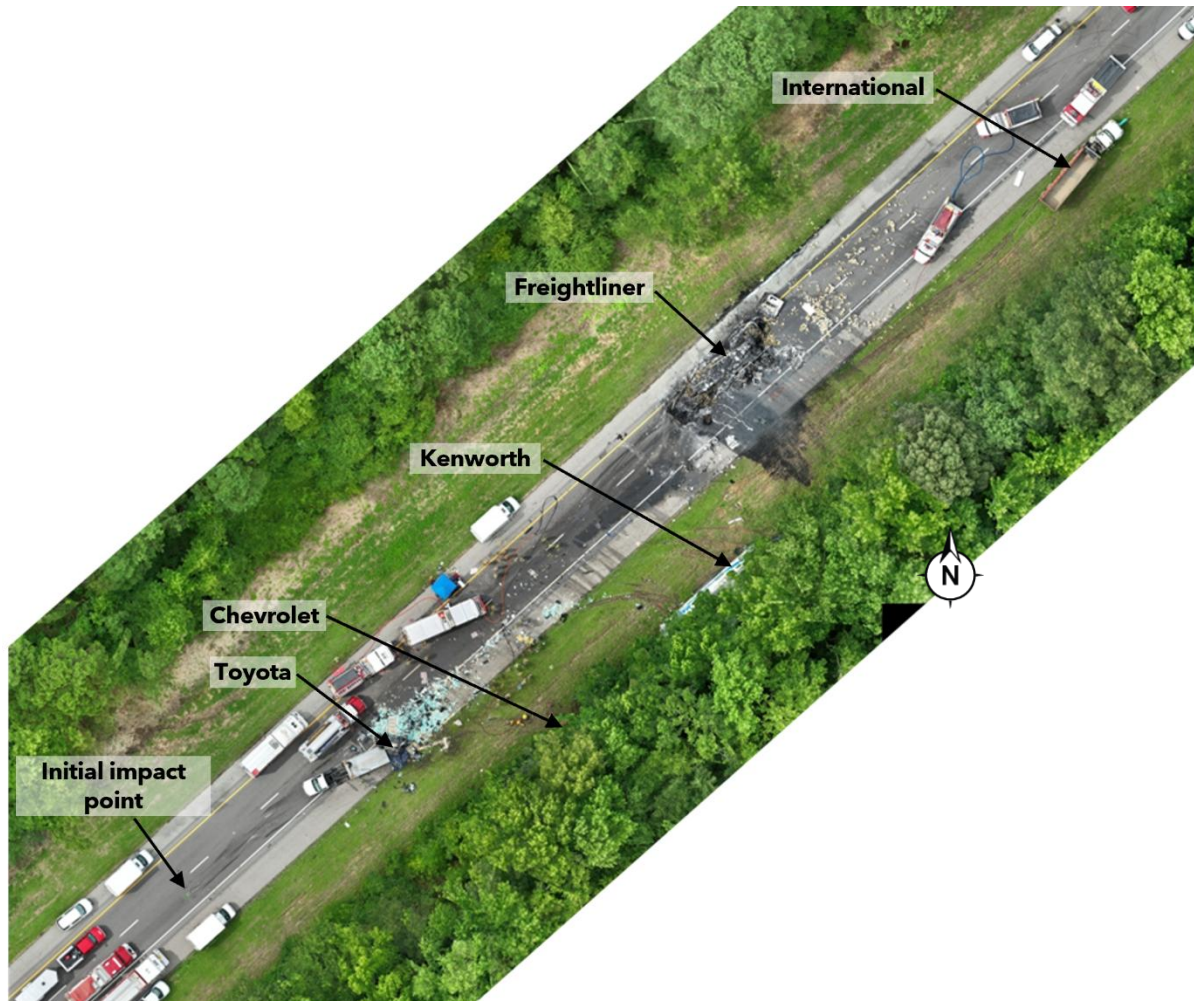
The Chevrolet separated from the Freightliner and the Toyota, veered to the right, traveled about 148 feet, and came to rest beyond the right shoulder of the highway. The front right of the Freightliner struck the Toyota, which continued rotating counterclockwise and being forced farther underneath the Kenworth. The Toyota became entangled with the right side of the Freightliner. The Freightliner then struck the left-rear corner of the Kenworth. After this impact, the Freightliner was redirected leftward, sideswiping the left side of the Kenworth. The Kenworth was redirected off the roadway to the right. The Toyota overturned and traveled on its roof about 60 feet from its point of impact with the Kenworth to its final position of rest on the right shoulder of I-95. A postcrash fire initiated on the Freightliner near the rear of its truck-tractor and beneath the forward portion of its semitrailer.

The final impact occurred when the Freightliner continued forward and collided with the rear of the International. This impact caused the Freightliner to jackknife, with its truck-tractor rotating to the right while crossing into the left travel lane, where it came to

**Figure 4.** Two-dimensional orthomosaic image from crash site, generated from North Carolina State Highway Patrol aerial photographs, showing point of initial impact and positions of vehicles at final rest.

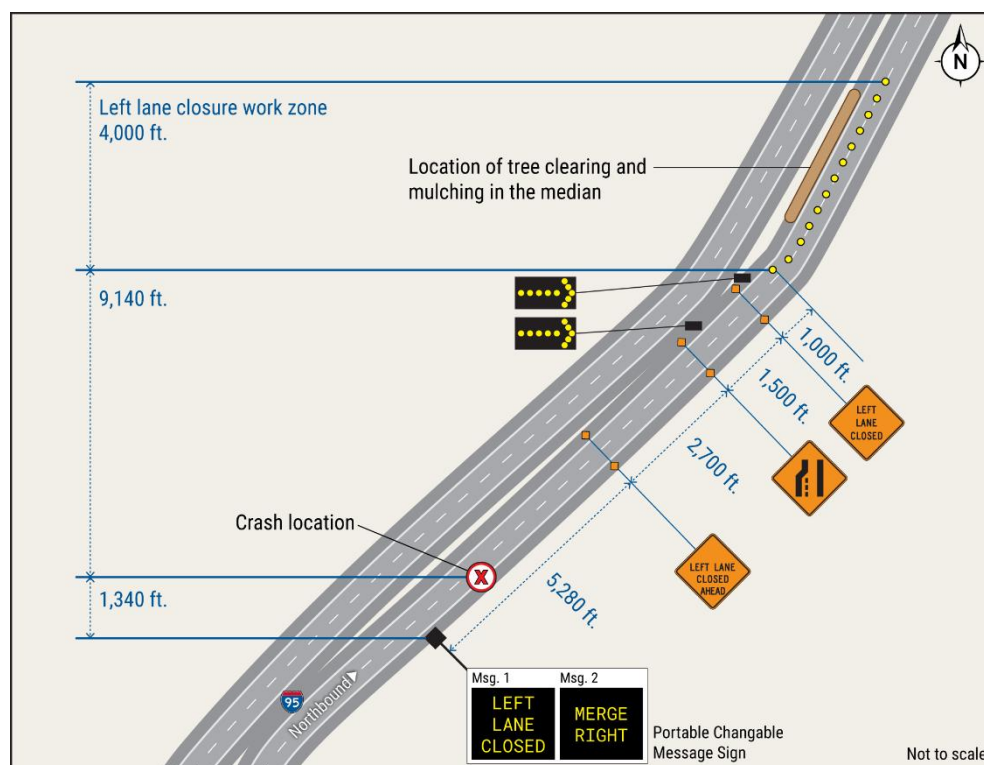
**Temporary Traffic Control.** The North Carolina Department of Transportation (NCDOT) contracted with a company to place temporary traffic control signage ahead of the temporary work zone to warn drivers of the lane closure. The contract required the company to use the 2018 NCDOT *Standard Specifications for Roads and Structures* to determine the appropriate temporary traffic control plan, including roadway signs placed ahead of the work zone (NCDOT 2018).<sup>10</sup> On the day of the crash, the signage consisted of two arrow board signs on the left shoulder (one at the start of the lane closure and the other about 2,000 feet in advance of the closure); two “Left Lane Closed” signs (one on each side of the northbound lanes, about 1,000 feet in advance of the lane closure); two merge-right signs (one on each side of the northbound lanes, about 2,500 feet in advance of the lane closure); two “Left Lane Closed Ahead” signs (one on each side of the northbound lanes, about 5,280 feet or 1 mile in advance of the lane closure); and a portable changeable message sign (PCMS; located about 10,480 feet or about 2 miles from the start of the lane closure) with the alternating messages “Left Lane Closed” and “Merge Right” (see figure 5). The only sign that the Freightliner driver encountered before the crash was the PCMS, located about 1,340 feet or about 0.25 miles in advance of the crash location. The other signs were north of the crash location. A truck-mounted attenuator, not depicted in figure 5, was located north of the temporary traffic control signage and within the closed lane.

**Figure 5.** Temporary traffic control signs in advance of lane closure on day of crash.

Traffic control in advance of the crash location included a PCMS on the right shoulder alternating the messages "Left Lane Closed" and "Merge Right." The traffic control strategy followed the 2018 NCDOT Standard Specifications for Lane Closures, which included additional signage leading up to the lane closure that the Freightliner driver had not yet encountered when the crash occurred. The driver passed the PCMS approximately 1,340 feet south of the crash site. Although he may have developed the expectation of encountering free-flow traffic conditions on I-95, the PCMS notified approaching motorists about the changing conditions ahead. Further, data indicated that the Chevrolet, the rearmost vehicle in the traffic queue, had its brake lights activated for at least 5 seconds before the crash, providing additional visual cues about the speed reduction that the Freightliner driver was encountering.

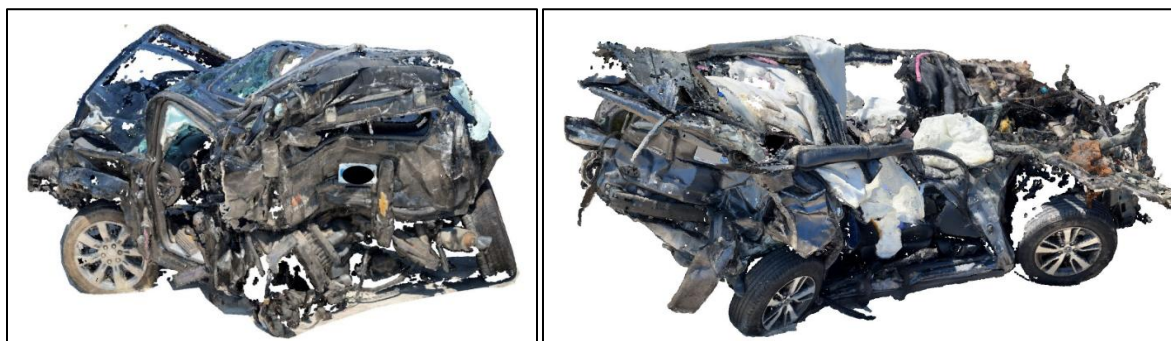
All five fatally injured individuals were occupants of the two struck passenger vehicles in the traffic queue. The first struck vehicle in the queue, the Chevrolet, had two primary areas of impact, one in the rear and one in the front. The vehicle body structure was displaced forward into the occupant compartment. The second-row seating was displaced forward on the driver's side, resulting in some forward deformation of the driver's seatback. The front side of the vehicle exhibited rearward displacement of the fender, hood, and underlying components at the left-front corner. The vehicle exhibited lateral counterclockwise bowing (see figure 6, left). According to data recorded by the vehicle's airbag control module, the Chevrolet was decreasing speed, slowing from 19 mph to 7 mph during the 5 seconds before the crash. The data indicated no throttle application and constant brake switch activation during this time.

The second struck vehicle in the queue, the Toyota, had multiple areas of impact, including evidence of having overturned onto its roof. Significant damage occurred in the front of the vehicle, where there was evidence of underride. The A-pillar was displaced rearward and downward. Damage extended over a substantial portion of the vehicle's vertical height. The hood was displaced rearward. The vehicle also exhibited lateral counterclockwise bowing (see figure 6, right). According to data recorded by the

**Figure 6.** 3D laser scan images showing postcrash damage to Chevrolet (left) and Toyota (right) at time of examination by NTSB.

impact. Both sport utility vehicles sustained significant crush damage during the crash sequence due to vehicle incompatibility. Vehicle incompatibility refers to design differences—such as speed, bumper height, and weight differences—between vehicle types that result in disproportionate damage patterns stemming from crashes (Acierno and others 2004). Due to significant crash forces and a reduction of survival space, it is unlikely that the injuries to the Chevrolet’s occupants could have been mitigated. Similarly, it is unlikely that seat belt use would have changed the injury outcome for the unrestrained occupant in the Toyota.
