HIR-26-06

# Multivehicle Collision with Combination Vehicle Parked on Shoulder, I-485

Charlotte, North Carolina  
July 26, 2025

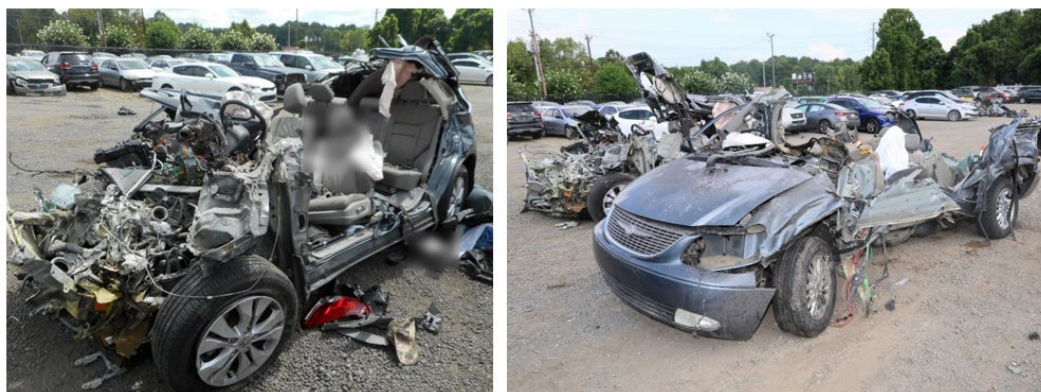
**Figure 1.** Postcrash photographs of the SUV (left) and minivan (right) after occupant extrications and vehicle recoveries. (Redactions by NTSB)

**SUV Damage.** As shown in figure 1, the SUV sustained significant crush damage that extended beyond the front roof line and intruded into the occupant compartment (refer to figure 1, left photo). According to the National Highway Traffic Safety Administration (NHTSA) recall database, there were no open recalls for the SUV.<sup>16</sup> The most recent state safety inspection of this vehicle was completed in April 2025. The investigation did not discover any pre-collision issues with the vehicle.

**Minivan Damage.** The minivan sustained significant rearward and rightward crush damage. The roof was displaced rearward and downward and the left side of the vehicle collapsed into the occupant compartment (refer to figure 1, right photo). According to the NHTSA recall database, there were no open recalls for the minivan. The most recent state safety inspection of this vehicle was completed in December 2021. The damage to the minivan was consistent with collision damage. The investigation did not discover any pre-collision issues with the vehicle.

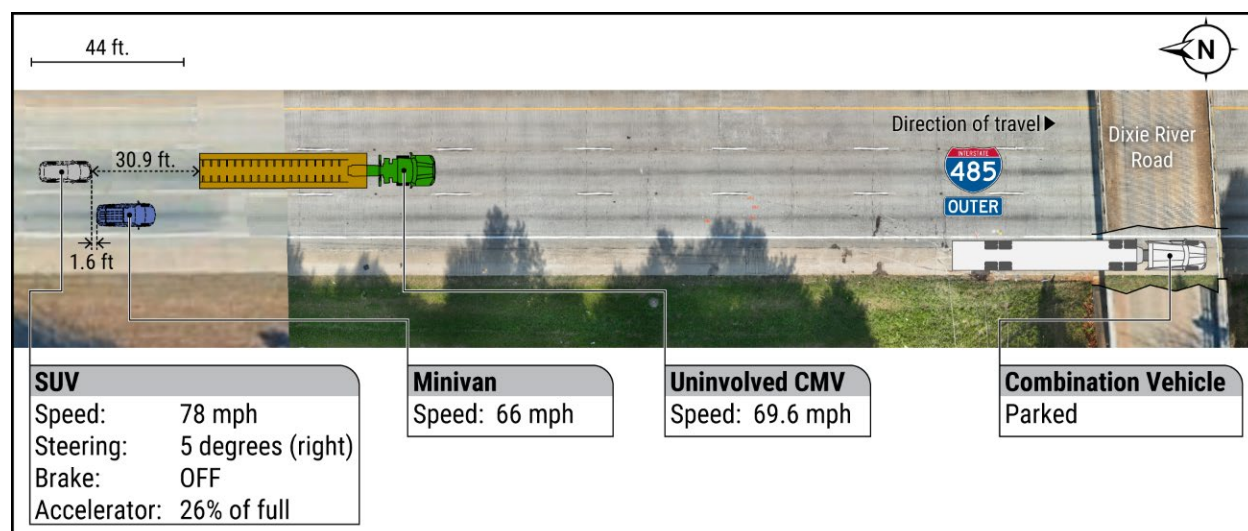
About 1.5 seconds before impact, when the SUV driver was 30.9 feet behind the uninvolved CMV, he had increased his speed to 78 mph and briefly turned the steering wheel to the right 5 degrees and then back to neutral (see figure 3).<sup>3</sup>

**Figure 3.** Position of the vehicles 1.5 seconds before the impact between SUV and minivan. (Source: Google Earth and North Carolina State Highway Patrol; annotations by NTSB)

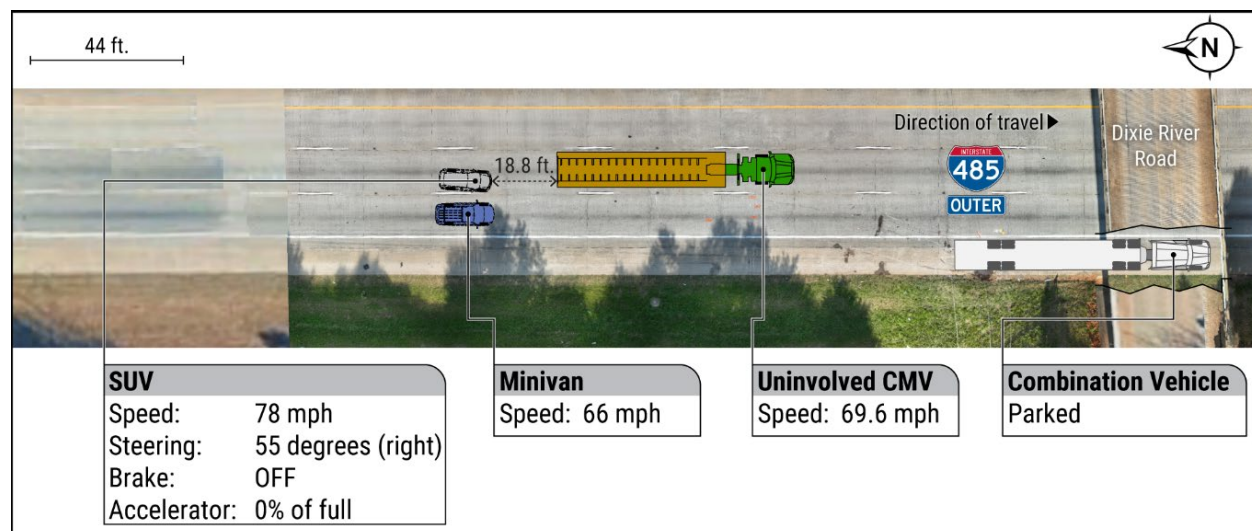
vehicle's airbag control module (ACM), which had an event data recording capability, showed that the vehicle's electronic stability control became engaged. The minivan's speed was obtained from Life360 application data, which was recorded near the crash location by a minivan passenger's cell phone. The SUV was positioned adjacent to the minivan and 18.8 feet behind the uninvolved CMV. Both passenger vehicles were about 134 feet from the parked combination vehicle (see figure 4).

**Figure 4.** Position of the vehicles 0.5 seconds before impact between SUV and minivan. (Source: Google Earth and North Carolina State Highway Patrol; annotations by NTSB)

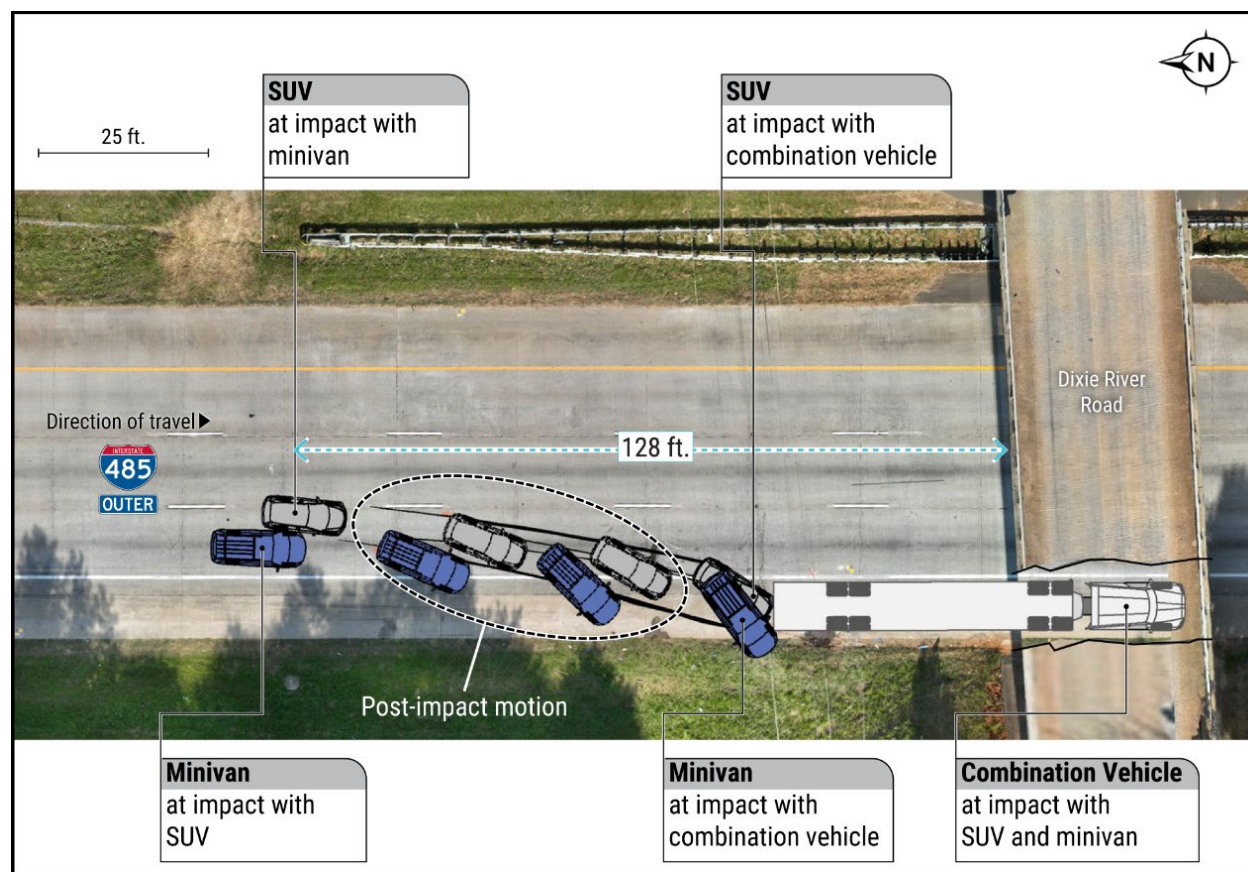
Subsequently, the SUV moved from the middle lane into the right travel lane where its right-rear door struck the left-front tire of the minivan when both vehicles were 128 feet north of the overpass (see figure 5). At or immediately before impact with the minivan, the SUV driver turned the steering wheel 90 degrees to the left and applied the accelerator to 58% of full. The impact caused the SUV's right-side curtain airbag to deploy. At the time of impact, the SUV's right-side tires were in the right travel lane and its left-side tires were in the middle travel lane. The minivan was fully in the right travel lane.

**Figure 5.** Post-impact motion of the crash-involved vehicles. (Source: North Carolina State Highway Patrol; annotations by NTSB)

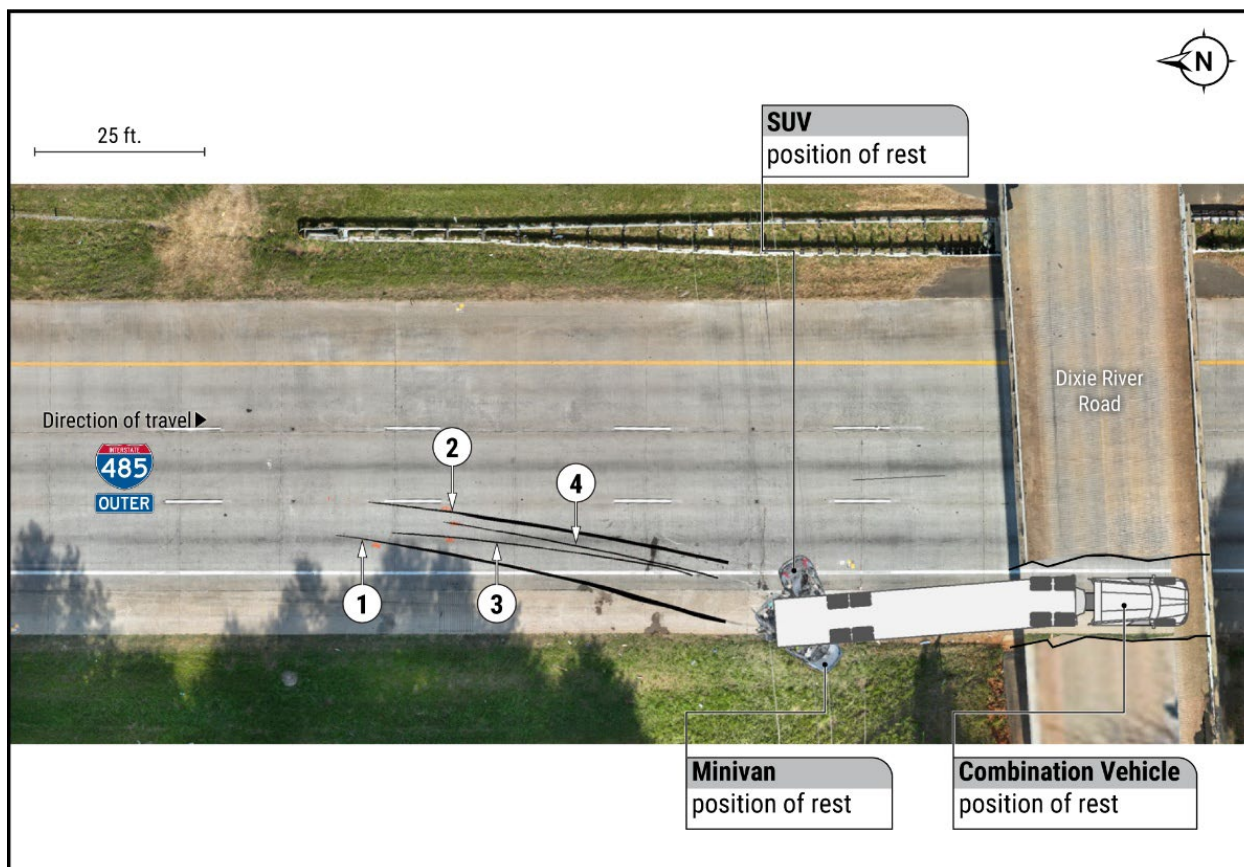
The vehicles' impact with the semitrailer slightly displaced it, rotating it about 4 degrees counterclockwise from its original parked position (see figure 6). The SUV came to rest facing southwest on the right shoulder with its rear partially in the right travel lane, 37.7 feet north of the overpass. The front half of the SUV was lodged beneath the left side of the semitrailer. The SUV's speed was 75 mph when it struck the semitrailer's rear-impact guard, commonly referred to as rear-underride guard.<sup>4</sup>

**Figure 6.** Diagram showing the vehicles' position of rest; also shown are curvilinear tire friction marks (labeled 1 through 4) located in the right lane and shoulder. (Source: North Carolina State Highway Patrol, Collision Reconstruction Unit; annotations by NTSB)

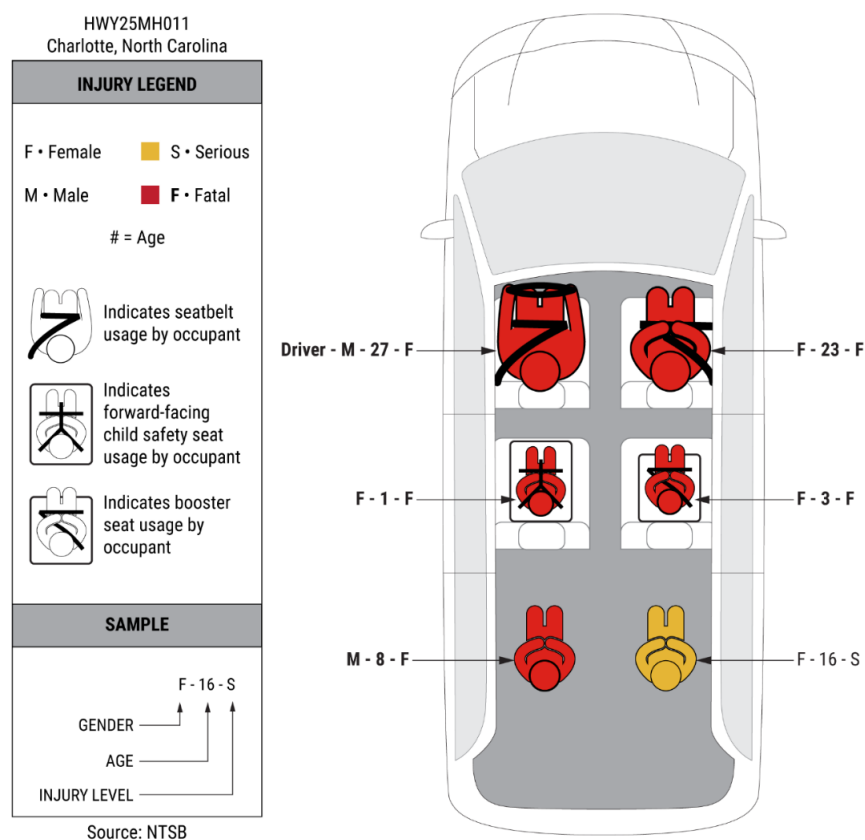
(ages 23, 8, 3, and 1) died.<sup>6</sup> One passenger in the minivan, positioned behind the second-row seating positions, survived but was seriously injured. The minivan had four seats installed: two seats in each of the first and second rows. Occupants in the second row were seated in child safety seats. The two rearmost occupants were positioned behind the second-row seating positions, where the third-row seats would have been positioned if installed. Figure 7 shows the seating positions, restraint use, and injury outcome of the minivan occupants.

**Figure 7.** Minivan seating diagram with gender, age, and injury severity.
