HIR-26-07

# Motorcoach Tire Failure, Roadway Departure, and Overturn

Vicksburg, Mississippi  
August 31, 2024

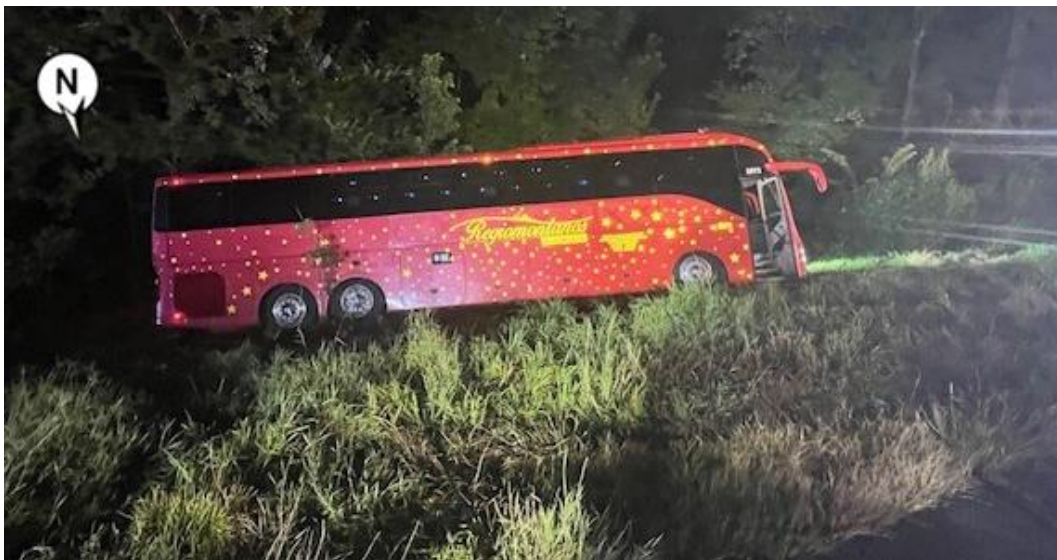
On August 31, 2024, about 12:33 a.m. central daylight time, a motorcoach operated by Transportes Regiomontanos was traveling west on Interstate 20 (I-20) near Vicksburg, Mississippi, when its front-left steer axle tire failed.<sup>1</sup> The motorcoach departed the roadway to the left, entered the median, and overturned onto its left side. The motorcoach was occupied by a 54-year-old driver, a co-driver, and 42 passengers. Seven passengers died, 8 sustained serious injuries, and 13 sustained minor injuries. The driver sustained minor injuries, and the co-driver sustained serious injuries (see figure 1).

**Figure 1.** Side view of motorcoach during postcrash recovery phase. (Source: Mississippi Highway Patrol)

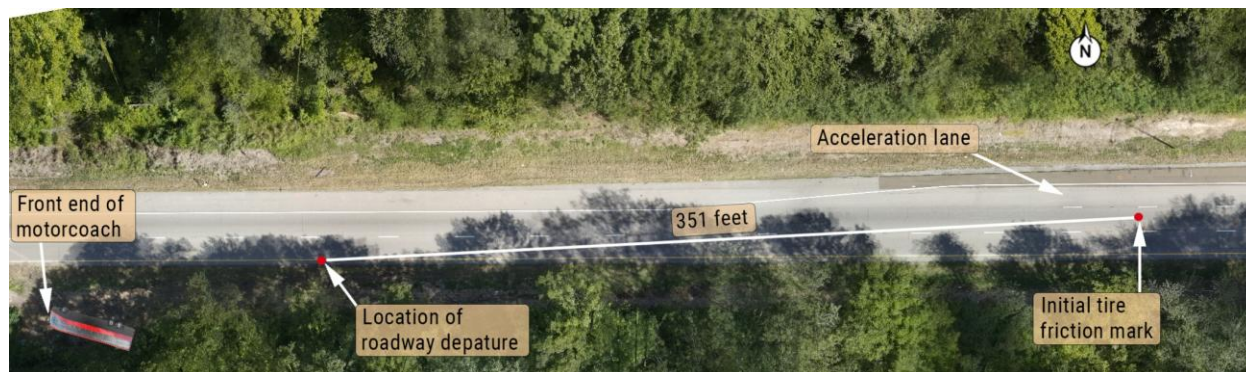
Video footage from the cameras on the motorcoach and physical evidence on the roadway showed that the motorcoach departed the roadway about 3.1 seconds after the tire failure (see figure 2).<sup>5</sup>

**Figure 2.** Orthomosaic image of crash area.

The onset of physical roadway evidence—a tire friction mark created by the deflated left steer axle tire originating in the right lane—was located about 351 feet from the point where the motorcoach departed the roadway. The mark extended west across the left lane and continued onto the shoulder.

Upon crossing onto the grassy median, the tire friction mark transitioned to a soil furrow that arced leftward, following the median's downward foreslope. The furrow extended about 237 feet into the median, where it terminated. At this point, the motorcoach tipped onto its left (driver) side and then slid a short distance down the slope before coming to rest about 26 feet south of the westbound roadway edge.

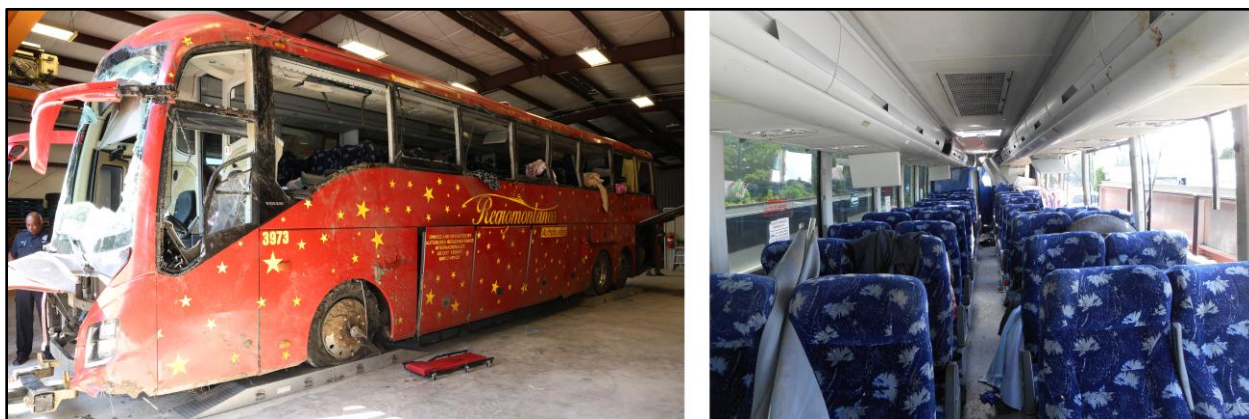
**Damage.** The overturn caused damage to the entire left side of the motorcoach, including scrapes and deformation to the exterior panels and an inward bend of about 18 inches to two roof-support pillars. All eight main windows on the left side were displaced and missing; the windows on the right side remained intact (see figure 3). The interior sustained minor damage with no measurable structural intrusion from the overturn. All passenger seats and the overhead luggage compartments remained in place.

**Figure 3.** Front-left view of damage to motorcoach (left image) and view of motorcoach interior, looking from front to rear (right image).

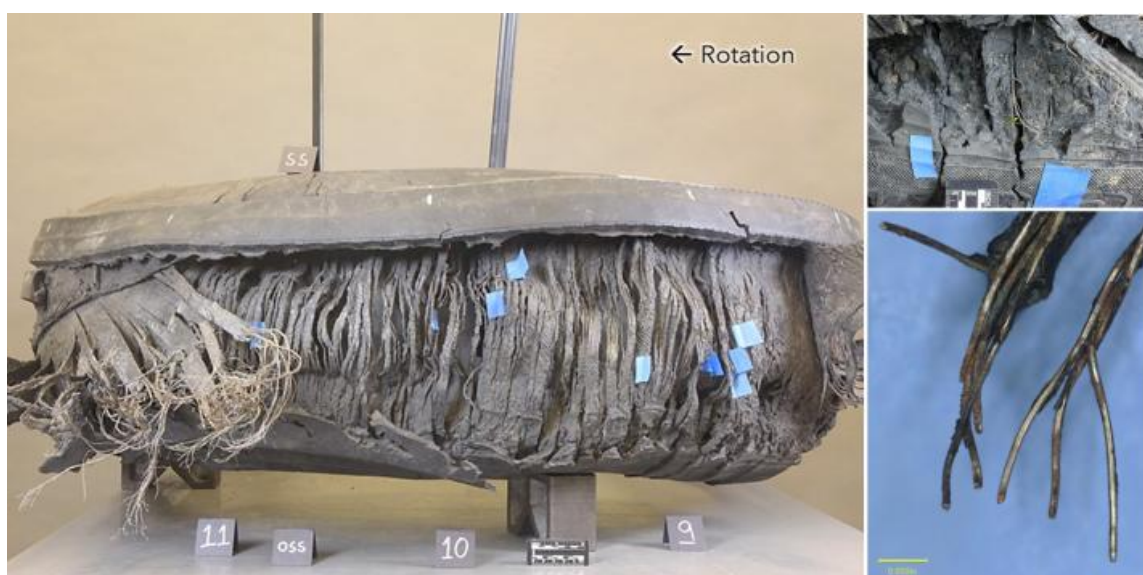
The failed left steer axle tire was further examined at the NTSB laboratory. The examination revealed damage consistent with a tread/belt separation and multiple indicators of previous impact damage to the tire's internal structure.<sup>27</sup> The radial ply was exposed over about 25% of the tire's circumference, showing numerous separations between radial steel cords and areas where steel cord wires had broken (see figure 4). Examination of the fractured wire ends revealed necking consistent with tensile overstress fracture. The inner liner exhibited numerous splits in this area and appeared loosened from the radial ply.<sup>28</sup>

**Figure 4.** Images of failed steer axle tire showing exposed radial ply and indicators of impact damage. Blue markers in the left image indicate locations of broken radial cord wires, shown more closely in the right images.

The NTSB's postcrash examination revealed that the left steer axle tire suffered tread/belt separation, as evidenced by a region of progressive tearing between the belt plies that was initiated at the belt edges. Once the belt had detached, the radial ply could no longer contain the internal tire pressure, resulting in a blowout and rapid air loss. The most likely cause of the tread separation was previous impact damage to the

tire's internal structure, evidenced by broken radial cord wires and discontinuous tear patterns across radial splits through the inner liner, radial ply, shoulder, and sidewall near the separation origin. The examination could not determine when or how the impact damage occurred, and carrier maintenance records contained no documentation of such damage.

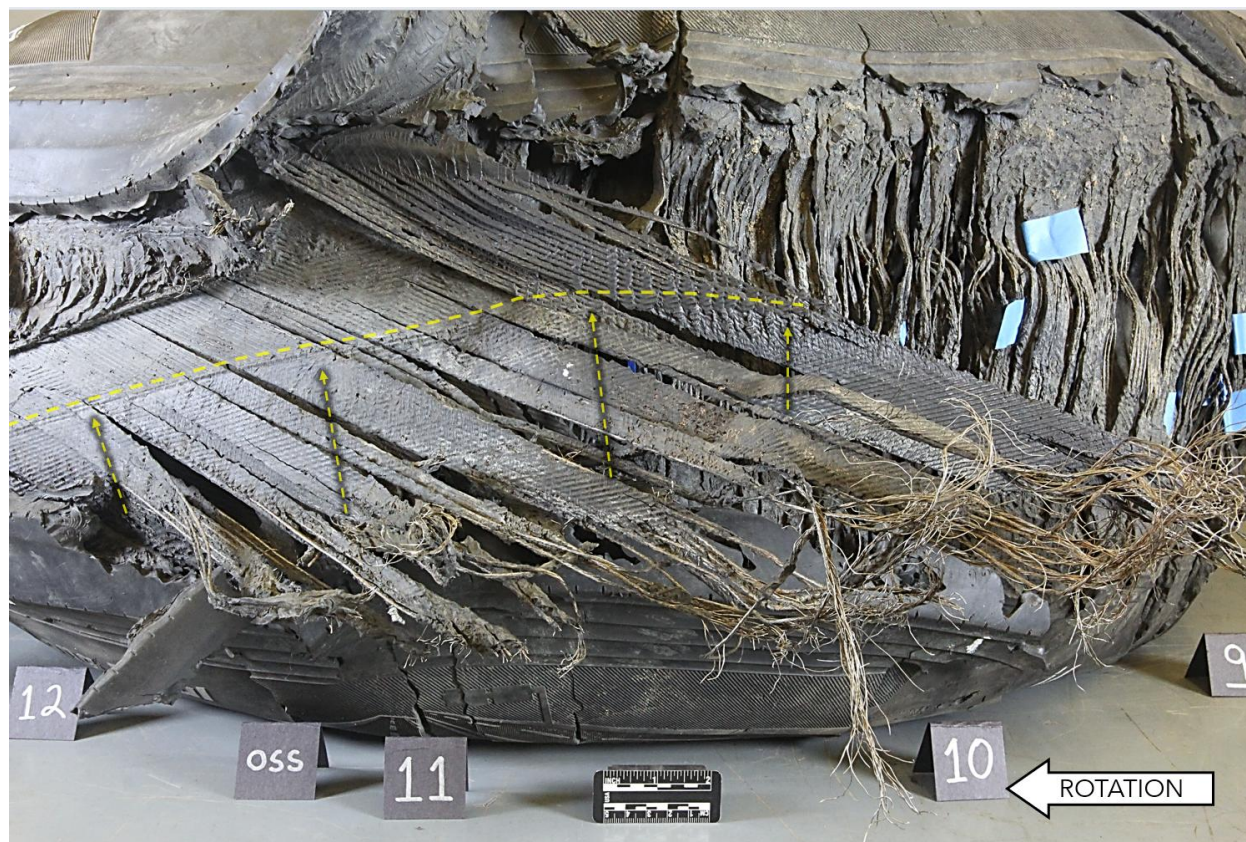
A curvilinear feature was observed on the outer surface of ply 3, showing progressive fracture patterns between plies 3 and 4 (see figure 5). These fractures originated from the belt edges at the tire shoulder and propagated circumferentially (around the tire, parallel to the tread) and across the tire until the tread and portions of the belt rapidly detached. Near the origin area of the curvilinear region at the shoulder opposite the side of the tire marked with the serial number, continuous radial splits were observed through the inner liner, radial ply cords, tire sidewall, and mating side of the shoulder.

**Figure 5.** Image of failed left steer axle tire showing a portion of the tread/belt separation initiation region on the top side of ply 3, bounded by a dashed yellow line. Progressive fracture propagated from the tire shoulder region toward a curvilinear demarcation, as indicated by yellow arrows, leading to the final separation.

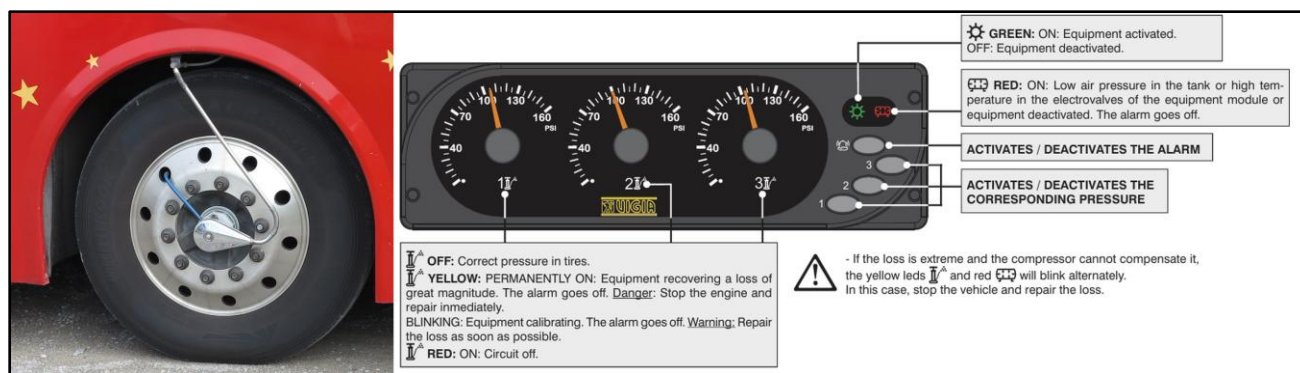
**Figure 6.** Outer component of CTIS as installed on exemplar motorcoach (left image) and graphic of control panel (right image). (Source of right image: Vigia manual)

At the time of the on-scene examination, all axle control buttons and the auditory alert button were in the deactivated position. NTSB laboratory examination of the supply line to the left steer axle tire revealed small leaks in the line and around the coupling, with a leak rate of about 4 psi per second; it could not be determined whether these leaks were a preexisting condition or resulted from the crash. Examination and testing of the control unit showed that the auditory alert was programmed to deactivate once pressure reached 100 to 105 psi for the steer axle, 100 to 105 psi for axle 2, and 105 to 110 psi for axle 3. Because the CTIS displays equalized pressure for each axle rather than individual tire readings and does not store data, the examination could not determine the tire pressures at the time of the crash or when the buttons were placed in the deactivated position.
