Highway Investigation Report HIR-26-08

# Rear-End Collision Between Combination Vehicle and Sport Utility Vehicle on Interstate 80 — Swanton Township Toll Plaza

Swanton, Ohio  
August 15, 2024

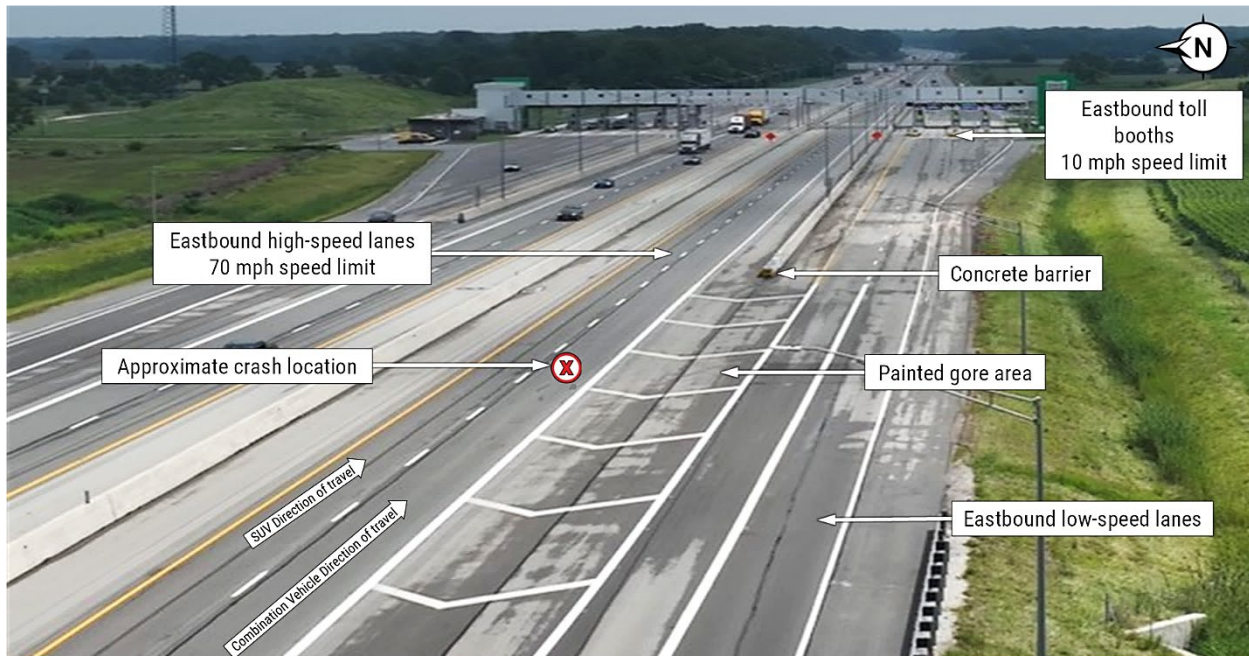
**Figure 1.** View of the crash scene with the crash location, high- and low-speed lanes, direction of travel, gore area, and concrete barrier annotated. (Source: Ohio State Highway Patrol; annotations by NTSB)

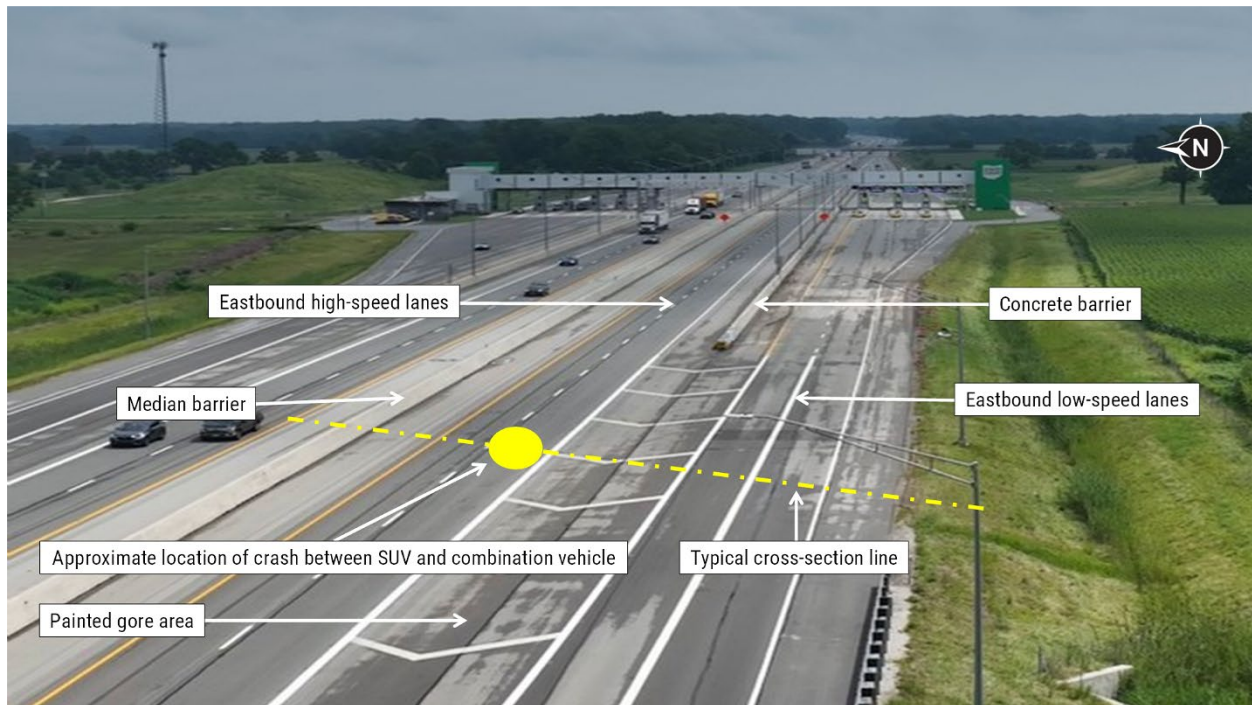
**Figure 5.** Annotated image of the roadway configuration at the Swanton Toll Plaza, with the approximate location of the SUV and combination vehicle crash noted.

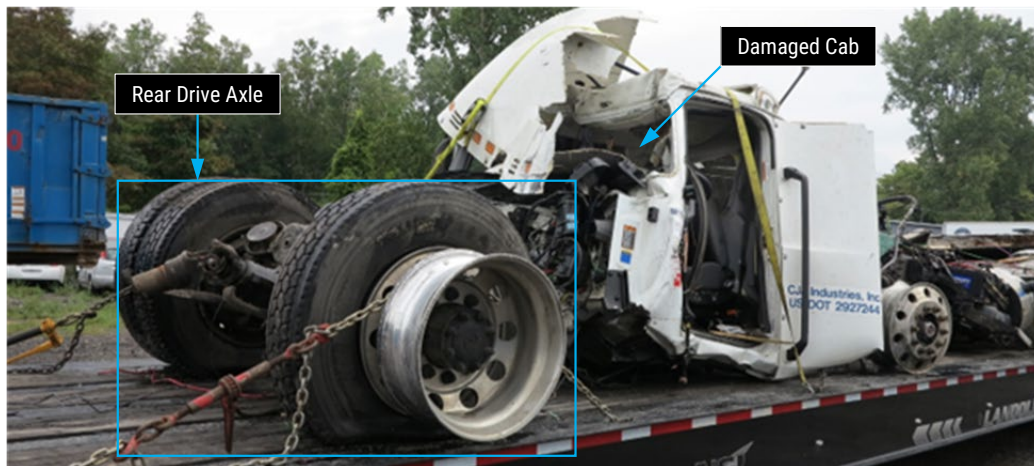
As shown in figure 8, the truck-tractor sustained severe crash damage. Both drive axles were torn from the vehicle mounts and separated from the vehicle. The vehicle cooling system, engine, batteries, and electrical cables all sustained crash damage. The truck cab was completely separated from the vehicle’s frame rails and sustained extensive crash damage. All electrical wiring and air lines to the cab were severed. The steering column, dashboard, instrument cluster, and center stack were all displaced rearward into the cab area. The NTSB postcrash examination did not show any out-of-service indicators or other non-crash deficiencies in the truck-tractor.

**Figure 8.** Photo of the crash-damaged Mack truck-tractor, viewed from the front left. During recovery, the truck-tractor’s separated rear drive axle was located and secured in front of the damaged cab.

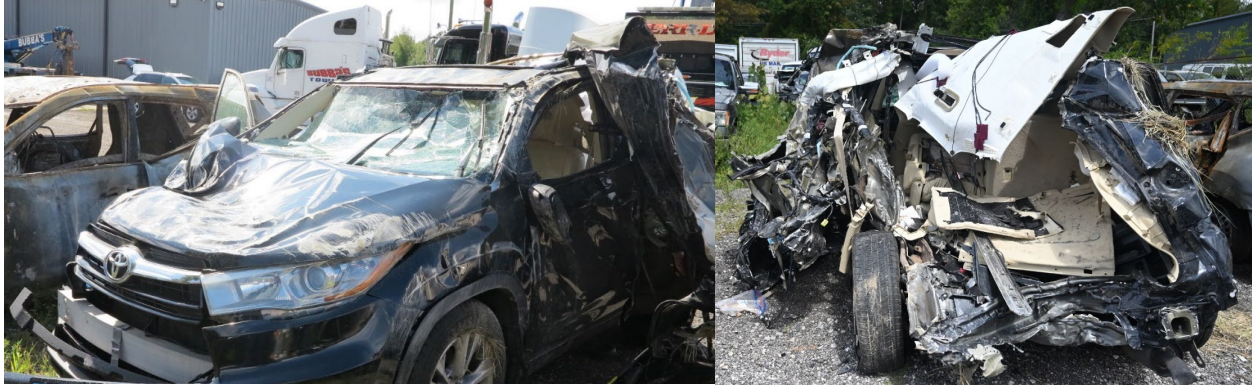
As shown in figure 9, the SUV was significantly damaged in the crash. The rear cargo hatch and roof were displaced forward, and the roof was peeled along the top, up to the sunroof, and then folded forward over the driver's door. The left rear was crushed forward past the left-rear second row passenger seat. The left-rear passenger door was crushed, and the exterior sheet metal skin was missing. The left B-pillar was displaced to the left. The right-front tire was deflated, and the outboard wheel flange was broken in one location. The front bumper cover was dislodged from its mounted position and was partially on the ground. The hood, fenders, roof, and driver's door

had numerous scratches. The hood was crushed downward, and the windshield was shattered.

**Figure 9.** Photo of the front (left image) and rear (right image) of the crash-damaged SUV.

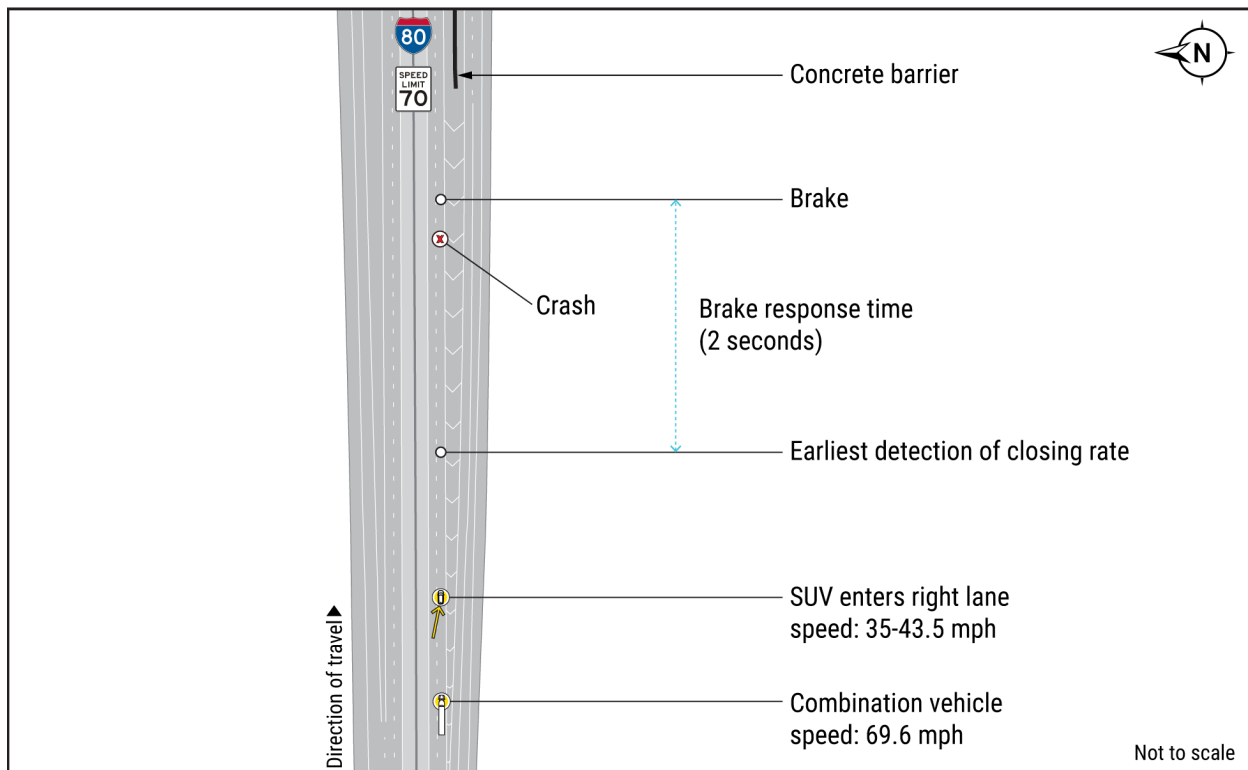
The recorded time for the combination vehicle brake application was about 2 seconds after the earliest opportunity for the driver to visually detect the closing rate. Brake response time (BRT) is the total time it takes for a driver to perceive a hazard and move their foot to the brake, and the time for the brakes to begin activating. BRT values vary based on many factors and can be difficult to standardize, although the National Highway Traffic Safety Administration (NHTSA) reports that an average driver takes about 1.5 seconds to perceive, react, and initiate brake pedal

**Figure 10.** Locations of critical points in the crash sequence, from the SUV entering the lane, when the closing rate would first be perceptible to the truck driver, the brake reaction time, and when braking was recorded in the combination vehicle EDR.

Considering the closing rate, detection times, and actions of both drivers, the NTSB concludes that although the truck driver was traveling at the posted speed limit, he did not have enough time to react to the imminent hazard created by the SUV's sudden lane incursion and deceleration to avoid or mitigate the crash.

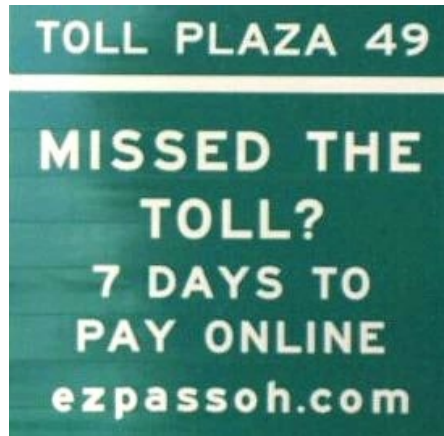
for drivers to use the high-speed lanes and pay their toll online if their vehicles were not equipped with a toll transponder. The overhead signage for the high-speed lanes stated that they were “E-ZPass Only” lanes and did not indicate the option to pay online; instead, they emphasized the need to use the low-speed lanes. Figure 11 shows a sign 1.3 miles *after* the toll plaza stating that drivers who missed the toll could pay online.

**Figure 11.** Signage 1.3 miles east (after) the Swanton Toll Plaza.

This lack of information about how to pay a missing toll may further encourage drivers to make last-minute lane changes to enter the low-speed lanes. OTIC could encourage use of the high-speed lanes by adding signage before the toll plaza, including modifying overhead signage to state that the tolls can be paid online and/or by mail. Informing drivers that they are not explicitly required to use the low-speed lanes might help reduce the number of last-minute lane changes (along with significant speed reduction in the high-speed lanes) and potentially reduce the overall number of conflicts and crashes near toll plazas. Other locations that use hybrid designs have adopted this type of signage, informing motorists of the payment options before reaching the toll plaza and using license plate readers to facilitate payment collection. Figure 12 shows overhead signage on the Central Florida Expressway that includes a “pay-by-plate” option in addition to the logo for the electronic tolling option. Based on documentation provided by OTIC and in discussions with the NTSB, no additional equipment is required to be installed at the Swanton Toll Plaza to accomplish this; open-road or high-speed tolling technology and equipment was installed at the turnpike plazas along the Ohio Turnpike in all lanes, including Swanton, during the recent upgrade completed in 2024.<sup>52</sup>
