PRELIMINARY REPORT

HAZARDOUS MATERIALS

High-Pressure Hydrogen Gas Cylinder Fire During Transportation

**Diamond Bar, California
February 11, 2018
HMD18FR001**

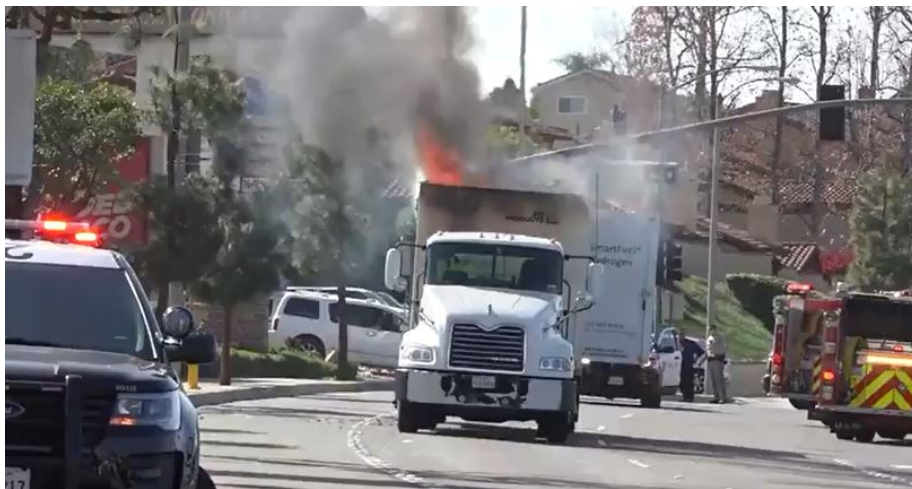
Figure 1. Accident scene. (Photo from YouTube.)

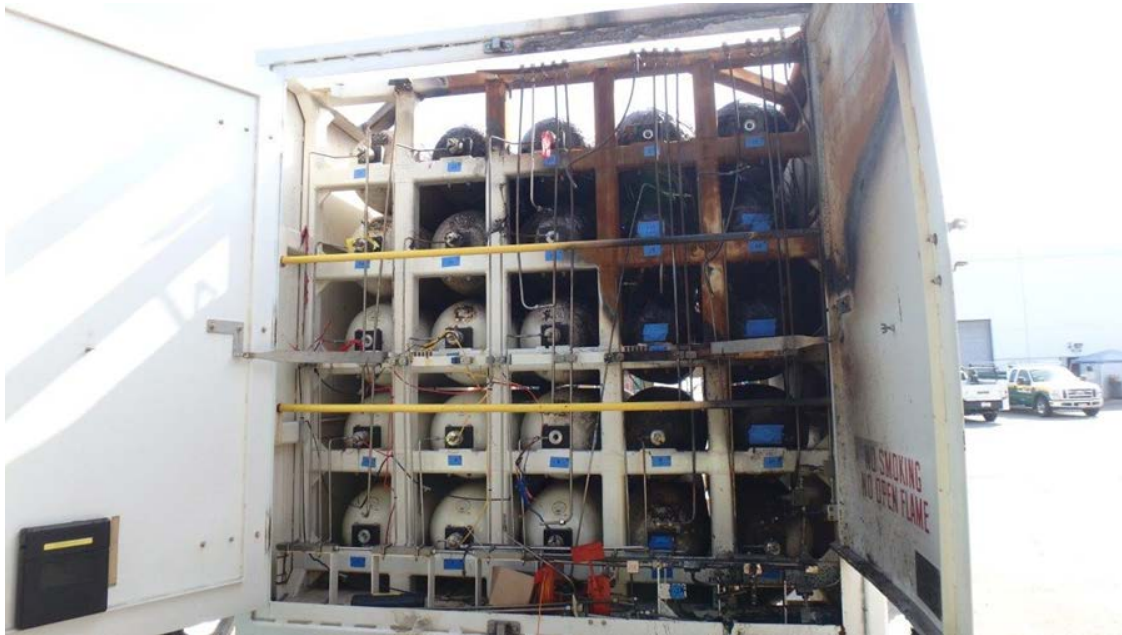
- Cylinder damage was limited to fire exposure. Twenty of the cylinders exhibited varying degrees of fire exposure, but none of them were breached (see Figure 2).

- Pressure relief devices activated on 12 of the cylinders.
- The cylinder manufacturer specifications call for type CG-5 pressure relief devices set at 10,000 psig.¹ However, NTSB investigators and investigation party members found pressure relief devices set at an incorrect pressure rating of 5,833 psig installed in three of the cylinders. Two of these under-rated pressure relief devices had activated. The source of the incorrect pressure relief devices is under investigation.

- The trailer included tubing attached to each pressure relief device outlet to safely vent relieved gases upward to the outside top of the cylinder module. Seven of the vent tubes became detached from the pressure relief device assemblies and vented gas to the interior of the trailer, which fueled the fire. The separated tubing had not been tightly secured by the compression fittings.

Figure 2. Postaccident view of the hydrogen cylinder module.

- Responding to initial findings, Air Products inspected its remaining fleet of 13 hydrogen cylinder modules. One trailer undergoing qualification inspection was found to have a cylinder with an underrated pressure relief device. Improperly secured vent tubing was found in about half of all the lines inspected.
- Air Products and FIBA have revised the requalification inspection procedures to address fittings securement and pressure relief device compatibility.
