PRELIMINARY REPORT

Accident Performance of DOT-117R Tank Cars

Doon, Iowa
June 22, 2018
HMD18LR002

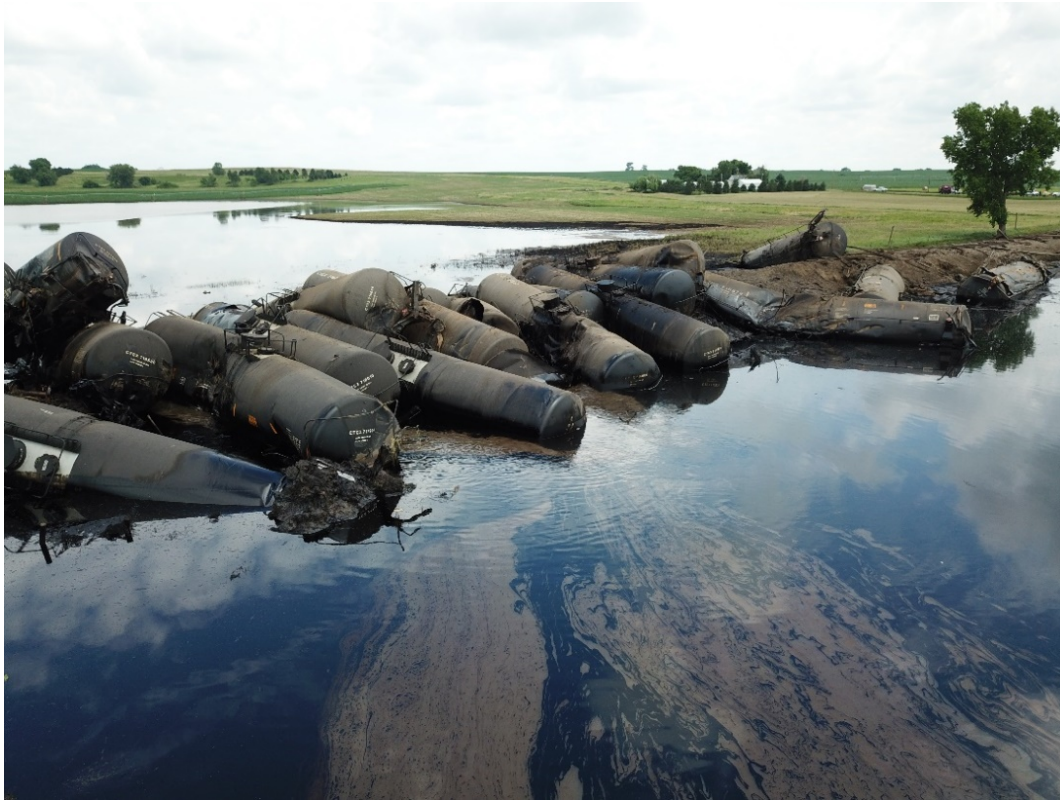
Figure 1. Accident scene. (Photo courtesy of BNSF Railway)
