# PRELIMINARY REPORT

## HIGHWAY

### HWY15MH006

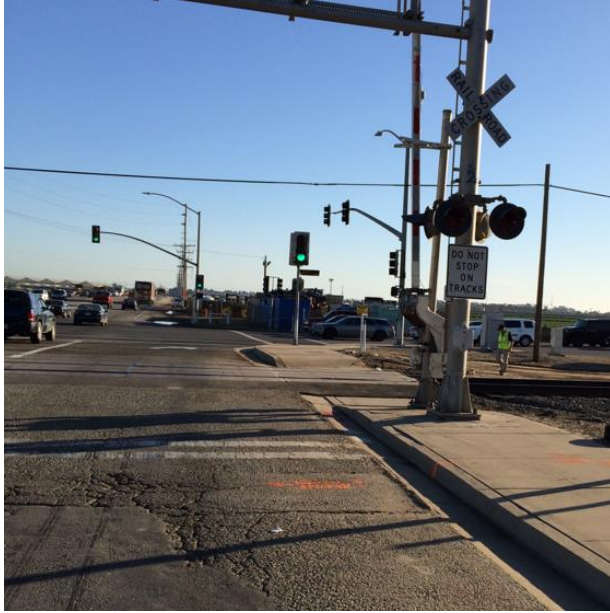
Driver's forward view of crossing.

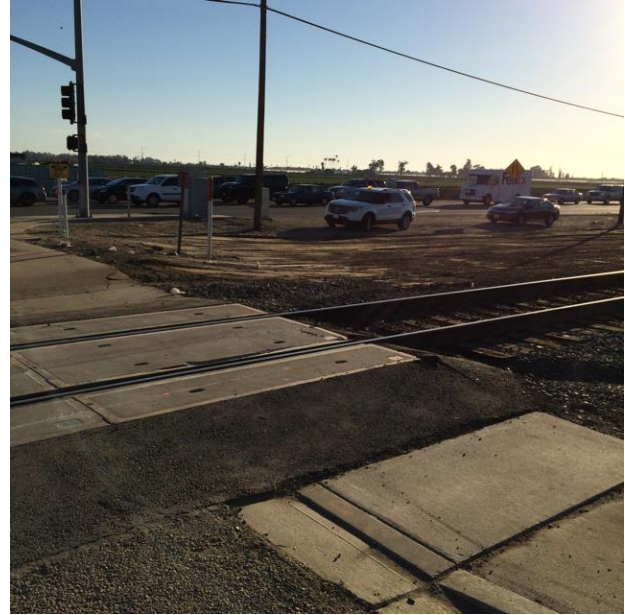
Driver's view to the right, looking at tracks.

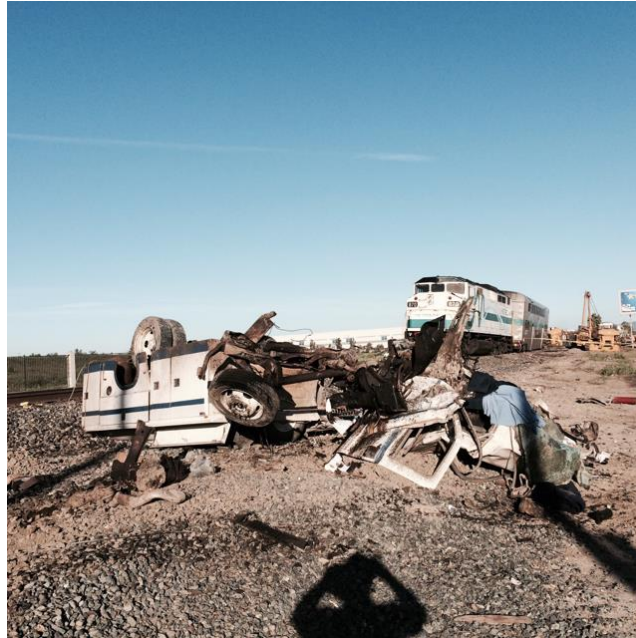
Ford F-450 truck at final rest.
