## PRELIMINARY REPORT

### HIGHWAY

### HWY16MH020

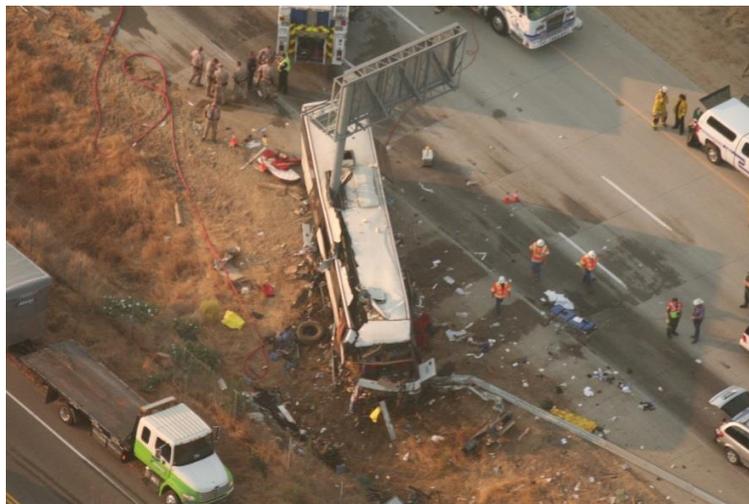
The motorcoach overrode the guardrail and subsequently collided with the signpost. The impact resulted in the passenger side being separated from the bus body for nearly the entire length of the bus (see figure 1). As a result of this crash, four passengers died, 18 passengers received serious-to-minor injuries, and four passengers were not injured. The bus driver was seriously injured.

**Figure 1.** Aerial view of motorcoach at final rest and impact damage caused by penetration of the 14-inch diameter signpost, (Source: California Highway Patrol).

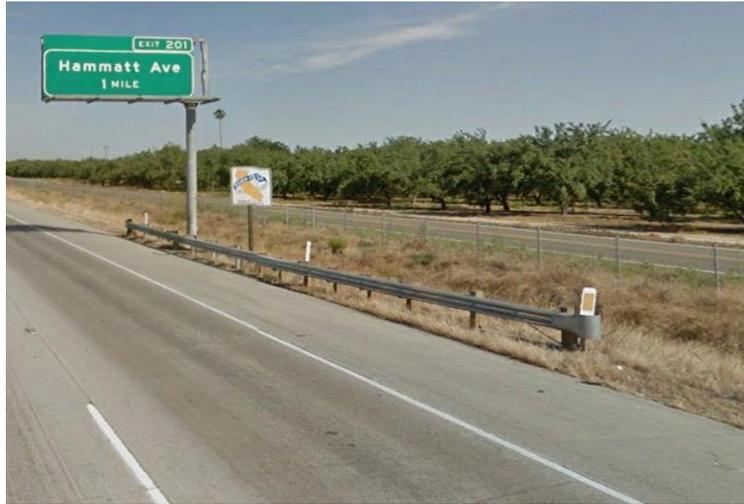
The signpost consisted of one vertical 14-inch-diameter steel tubular pole with the exit sign mounted at the top of the pole. The centerline of the signpost was separated by a lateral distance of 64.3-inches from the end of the guardrail. The total height from the paved shoulder surface to the top of the w-beam rail element was approximately 29 inches. The posts supporting the guardrail were embedded in the ground approximately 3.5 to 4 feet. (See figure 2.)

**Figure 2.** Northbound view of the sign, signpost, and guardrail (Source: Google Maps, July 2016).
