PRELIMINARY REPORT

HIGHWAY

HWY18FH006

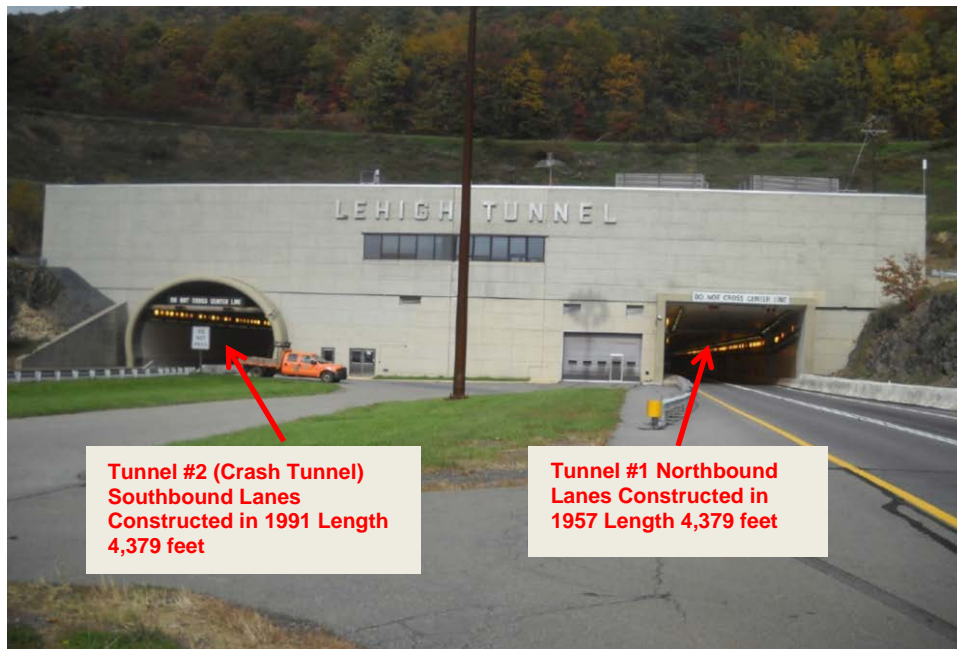
Figure 1. Photograph of the Lehigh Tunnel south portal entrance. The crash occurred in the southbound (left) tunnel.

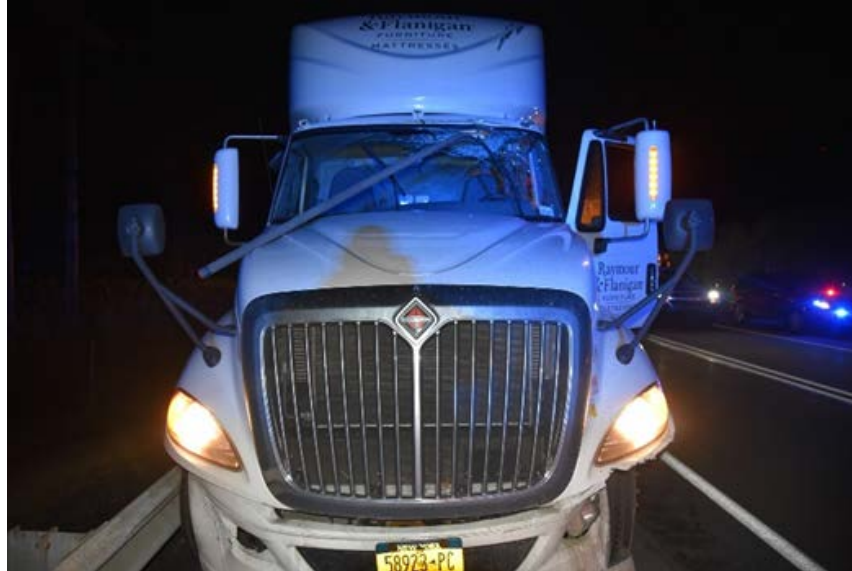
Figure 2. Front view of the combination vehicle at its final rest position. The displaced section of electrical conduit can be seen resting on the corner of the hood, with the end protruding through the upper part of the windshield. (Source: Pennsylvania State Police)

The tunnel, including the fans and electrical conduit, had last been inspected in 2016. The inspection found evidence of corrosion on multiple steel support straps used to affix the electrical conduit to the tunnel ceiling. On the day of the crash, a failure occurred in the support system, causing a section of electrical conduit to fall into the path of the southbound combination vehicle.

Before the crash, the Pennsylvania Turnpike Commission was in the process of awarding a contract to replace the lighting and electrical system in Tunnel #2¹. In part, the contract specifies relocating the electrical system from directly above the two travel lanes of the roadway to the outside edges of the tunnel walls. The estimated completion date for the new electrical system in Tunnel #2 is October 2018.

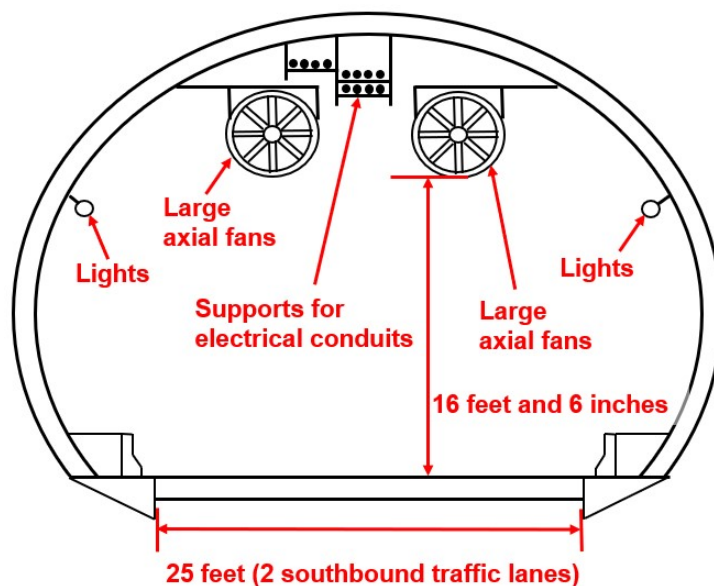
Lehigh Tunnel #2 was equipped with 10 sets of large axial fans suspended from the apex of the tunnel arch. The fans were controlled from the portal buildings on the north and south ends, enabling fresh air to be forced in either direction through the tunnel. Also suspended from the apex of the tunnel arch were supports for the electrical conduit system supplying power to the lights, fans, cameras, and substations inside the tunnel (figure 3). The fans and electrical system were directly above the roadway's two travel lanes. The clearance from the roadway to the bottom of the large axial fans was about 16 feet, 6 inches.

Figure 3. Diagram showing interior details of Tunnel #2. (Not to scale)
