PRELIMINARY REPORT HIGHWAY HWY18FH013

About 6:46 p.m. on Tuesday, May 8, 2018, a 2014 Tesla Model S electric-powered car was traveling south in the 1300 block of Seabreeze Boulevard, in Fort Lauderdale, Florida. The car was occupied by the 18-year-old driver, a front seat passenger, and a second passenger seated in the right rear. Seabreeze Boulevard consists of two northbound and two southbound lanes divided by a center turn lane, with a posted speed limit of 30 mph. At the crash location, the roadway curves to the left. The approach to the curve has an advance warning sign denoting a left-hand curve, augmented by a flashing beacon and a posted advisory speed of 25 mph (Figure 1).

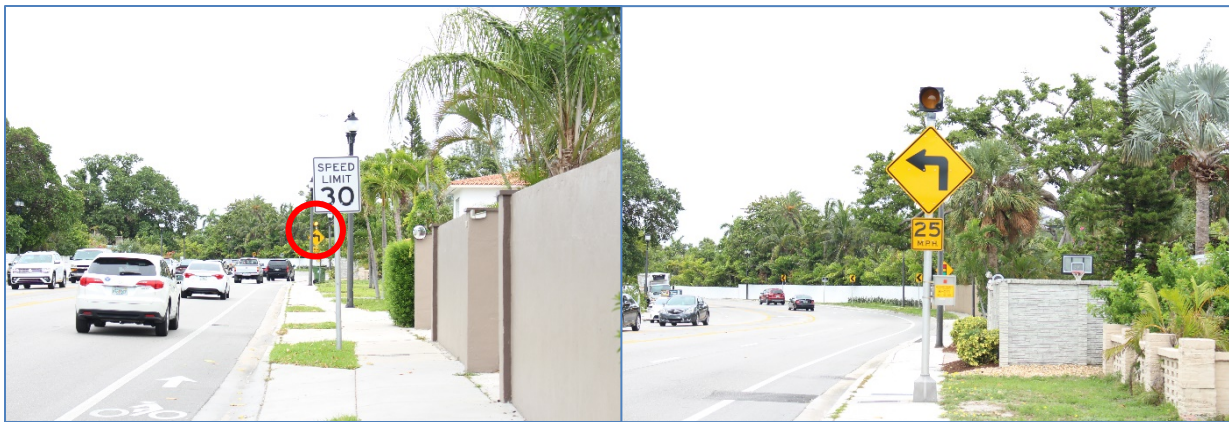
Figure 1. Seabreeze Boulevard with advance warning sign circled in red; and closeup view of approach to curve with advance warning sign, flashing beacon, and 25-mph advisory speed limit.

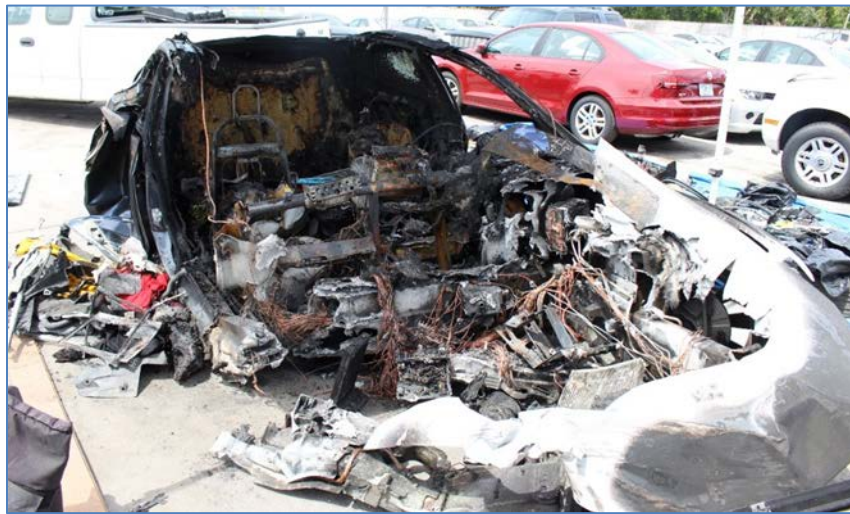
The Fort Lauderdale Fire and Rescue Department arrived at the crash scene and found the Tesla fully engulfed in flames. They extinguished the vehicle fire using 200–300 gallons of water and foam. Small portions of the lithium-ion high-voltage battery had separated from the vehicle, and—though there was no visible fire—they applied water and foam to the debris. During the loading of the car for removal from the scene, the battery reignited and was quickly extinguished. Upon arrival at the storage yard, the battery reignited again. A local fire department responded to the storage yard and extinguished the fire. Figure 2 shows the Tesla postcrash.

Figure 2. Remains of Tesla Model S at storage yard.
