PRELIMINARY REPORT

HIGHWAY

HWY18FH014

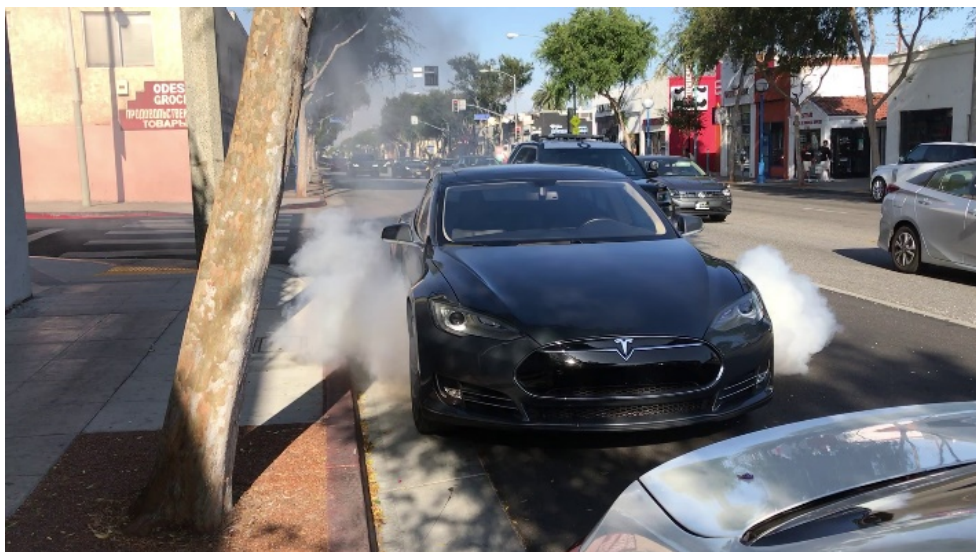
The NTSB obtained a video of the event taken by the driver after he exited the vehicle. The NTSB also obtained a video taken by a bystander. A preliminary examination of the driver's video showed smoke coming from the underside of the Tesla after the driver had stopped it at the curb (see figure 1).

Figure 1. View of the Tesla looking east from the north side of Santa Monica Boulevard. (Source: driver video)

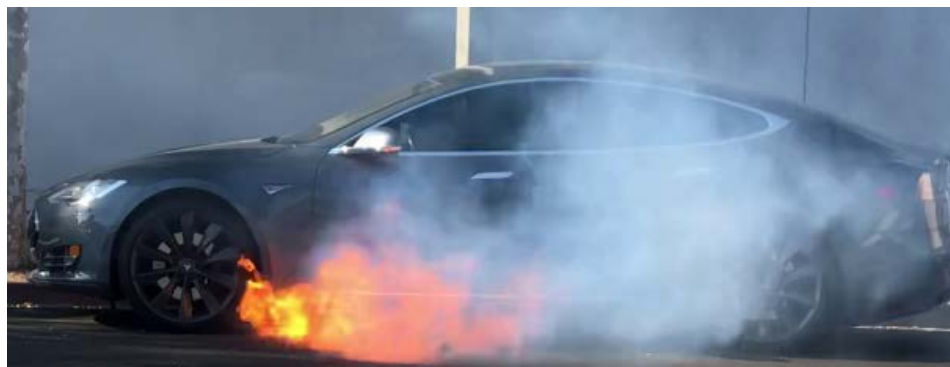
The bystander video recorded that, a few minutes later, flames were coming from under the Tesla on both the left and right sides, aft of the front wheels and extending under the front doors (see figure 2). The video also showed police and fire department personnel, as well as bystanders walking by the vehicle near the smoke during the incident.

Figure 2. View of the left side of the Tesla, showing flames coming from the vehicle's underside. (Source: bystander video)

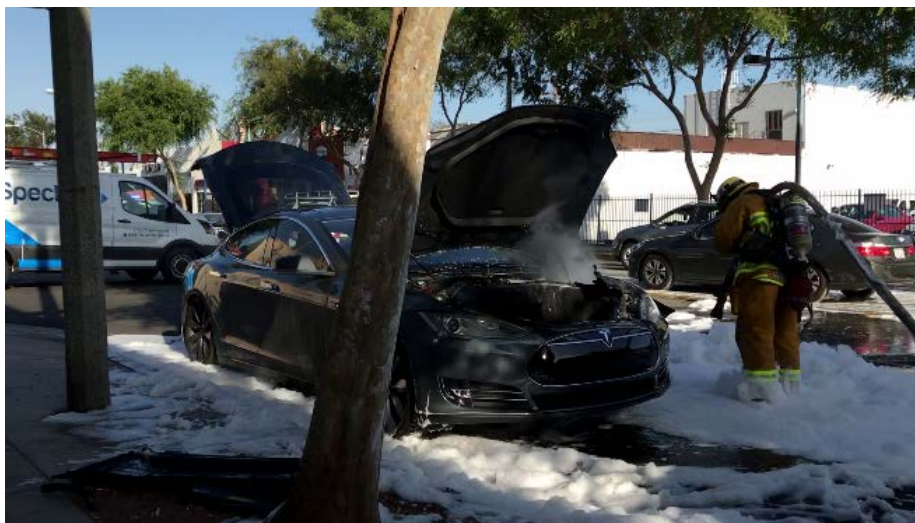
Smoke and flames were still coming from the vehicle as the fire engine arrived on the scene about 5:40 p.m. Los Angeles County firefighters wearing self-contained breathing apparatus responded to the fire and applied both water and foam. The flames were quickly extinguished, but smoke continued to come from the vehicle. Firefighters removed portions of the vehicle's left front fender and under-hood trim, severed the high voltage cut loop, and applied additional water and foam under the hood and behind the front wheels. The fire captain estimated that less than 300 gallons of water and foam were applied during the event.

Figure 3. View of the Tesla and a firefighter after water and foam had been applied to the vehicle. (Source: Tesla Inc.)
