INVESTIGATIVE UPDATE

Collapse of Pedestrian Bridge Under Construction Miami, Florida (HWY18MH009)

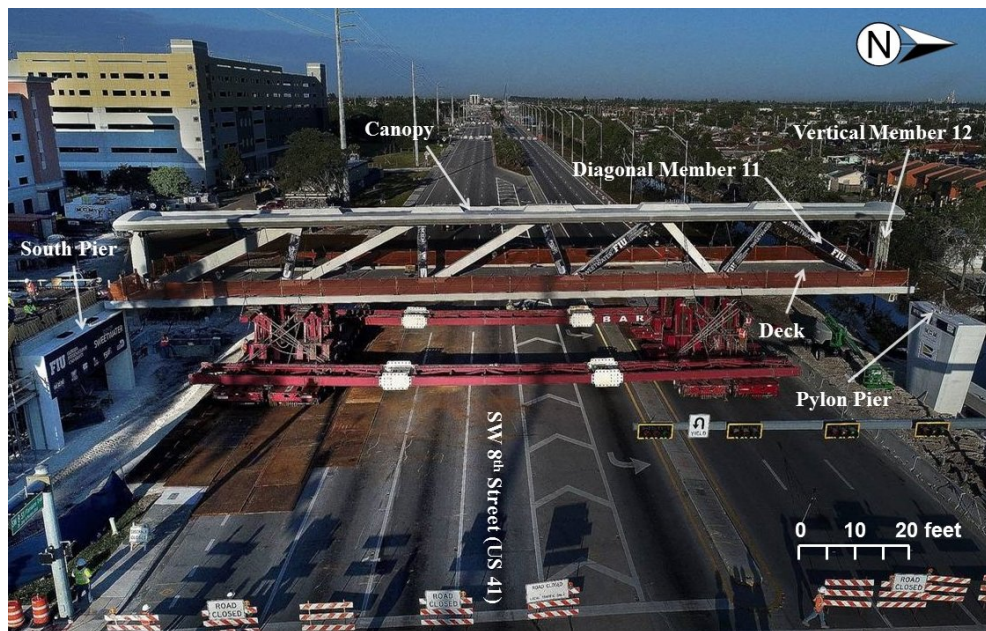
Photograph of 174-foot-long main span on March 10, 2018, prior to placement on south pier and north pylon pier, looking west. Labels showing diagonal member 11 and vertical member 12 added by NTSB. (Source: Internet)

Although the evaluation is ongoing, the assessment has determined that errors were made in design of the northernmost nodal region of the 174-foot-long span, where two truss members were connected to the bridge deck. These design errors resulted in (1) overestimation of the capacity (resistance) of a critical section through the node comprised of diagonal member 11 and vertical member 12; and (2) apparent underestimation of the demand (load) on that same critical section. Additionally, the FHWA evaluation determined that the cracking observed in the node prior to the collapse is consistent with the identified errors.
