# **PRELIMINARY REPORT**

## **HIGHWAY**

### **HWY20FH003**

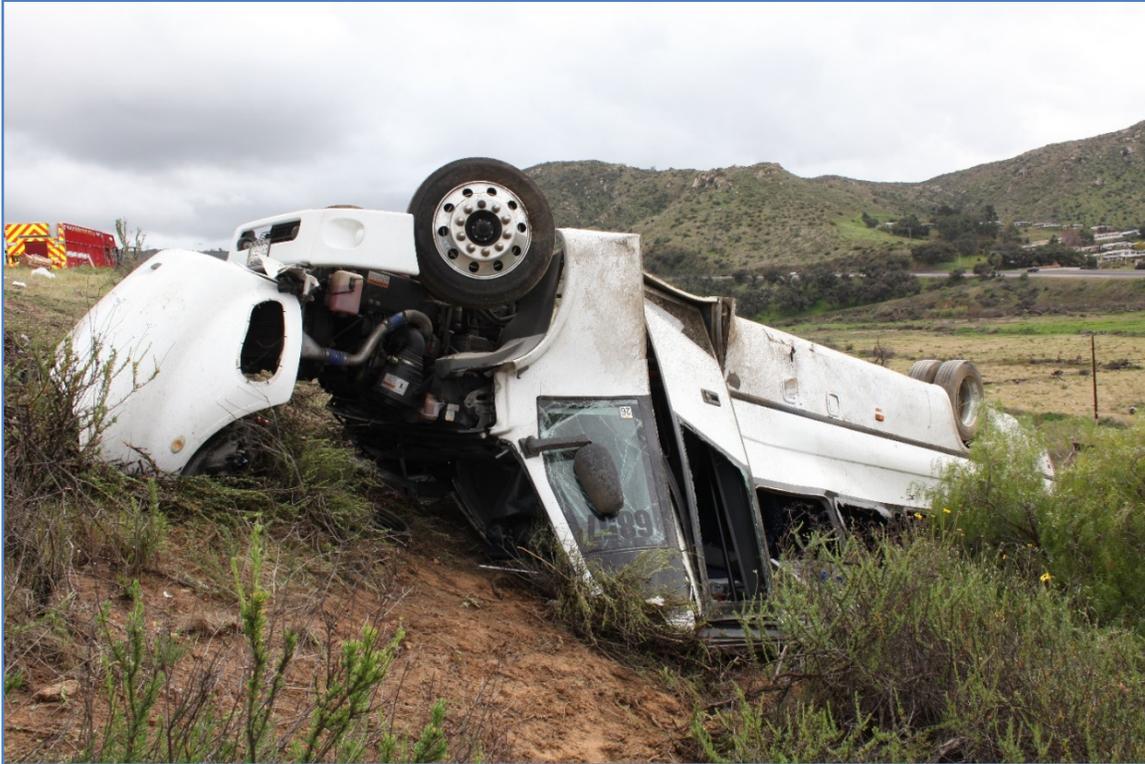
About 10:23 a.m. Pacific standard time (PST) on Saturday, February 22, 2020, a 2014 Freightliner chassis configured with a General Coach America 30-passenger coach body (hereafter “the bus”) was southbound on Interstate Highway 15 (I-15) in Pala Mesa, San Diego County, California. The bus was operated by Executive Lines, Inc. and was occupied by the driver and 20 passengers.<sup>1</sup> The bus was en route from El Monte, California, to San Ysidro, California, with stops in Baldwin Park, Pomona, Riverside, and Temecula. As the bus crossed the bridge over the San Luis Rey River and Dulin Road, it departed the roadway to the west, overturned, and slid down an embankment, coming to rest on its roof.

**Figure 1.** The bus at final rest (Source: California Highway Patrol).

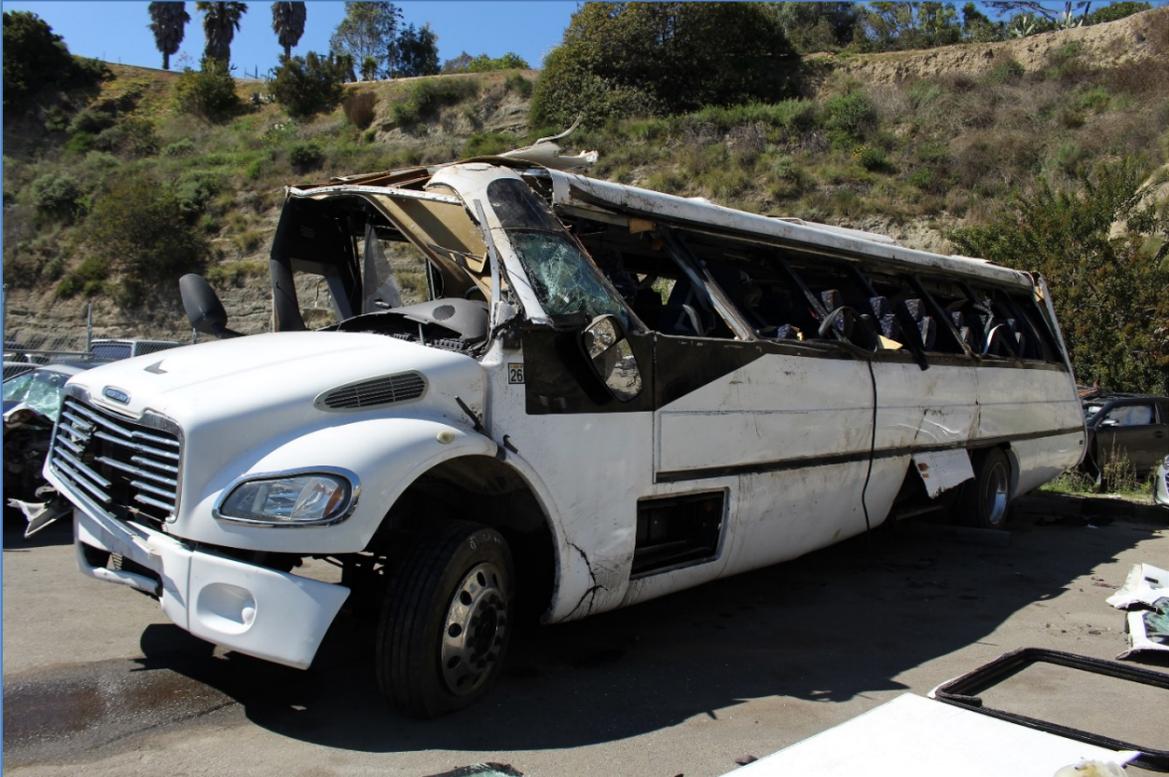
**Figure 2.** Front/left view of the bus in the tow yard.
