National Transportation Safety Board Washington, D.C. 20594

Hazardous Materials Accident Brief

Accident No: DCA02MZ001
Location: South Charleston, West Virginia
Date of Accident: January 5, 2002
Time: 11:36 a.m. eastern standard time
Carrier: Dana Transport, Inc.
Vehicle: MC-307 Cargo Tank
Injured: No injuries
Evacuated: None
Property Damage: In excess of \$18,000
Materials Involved: 5,152 gallons of polypropylene glycol
Type of Accident: Catastrophic structural failure of cargo tank

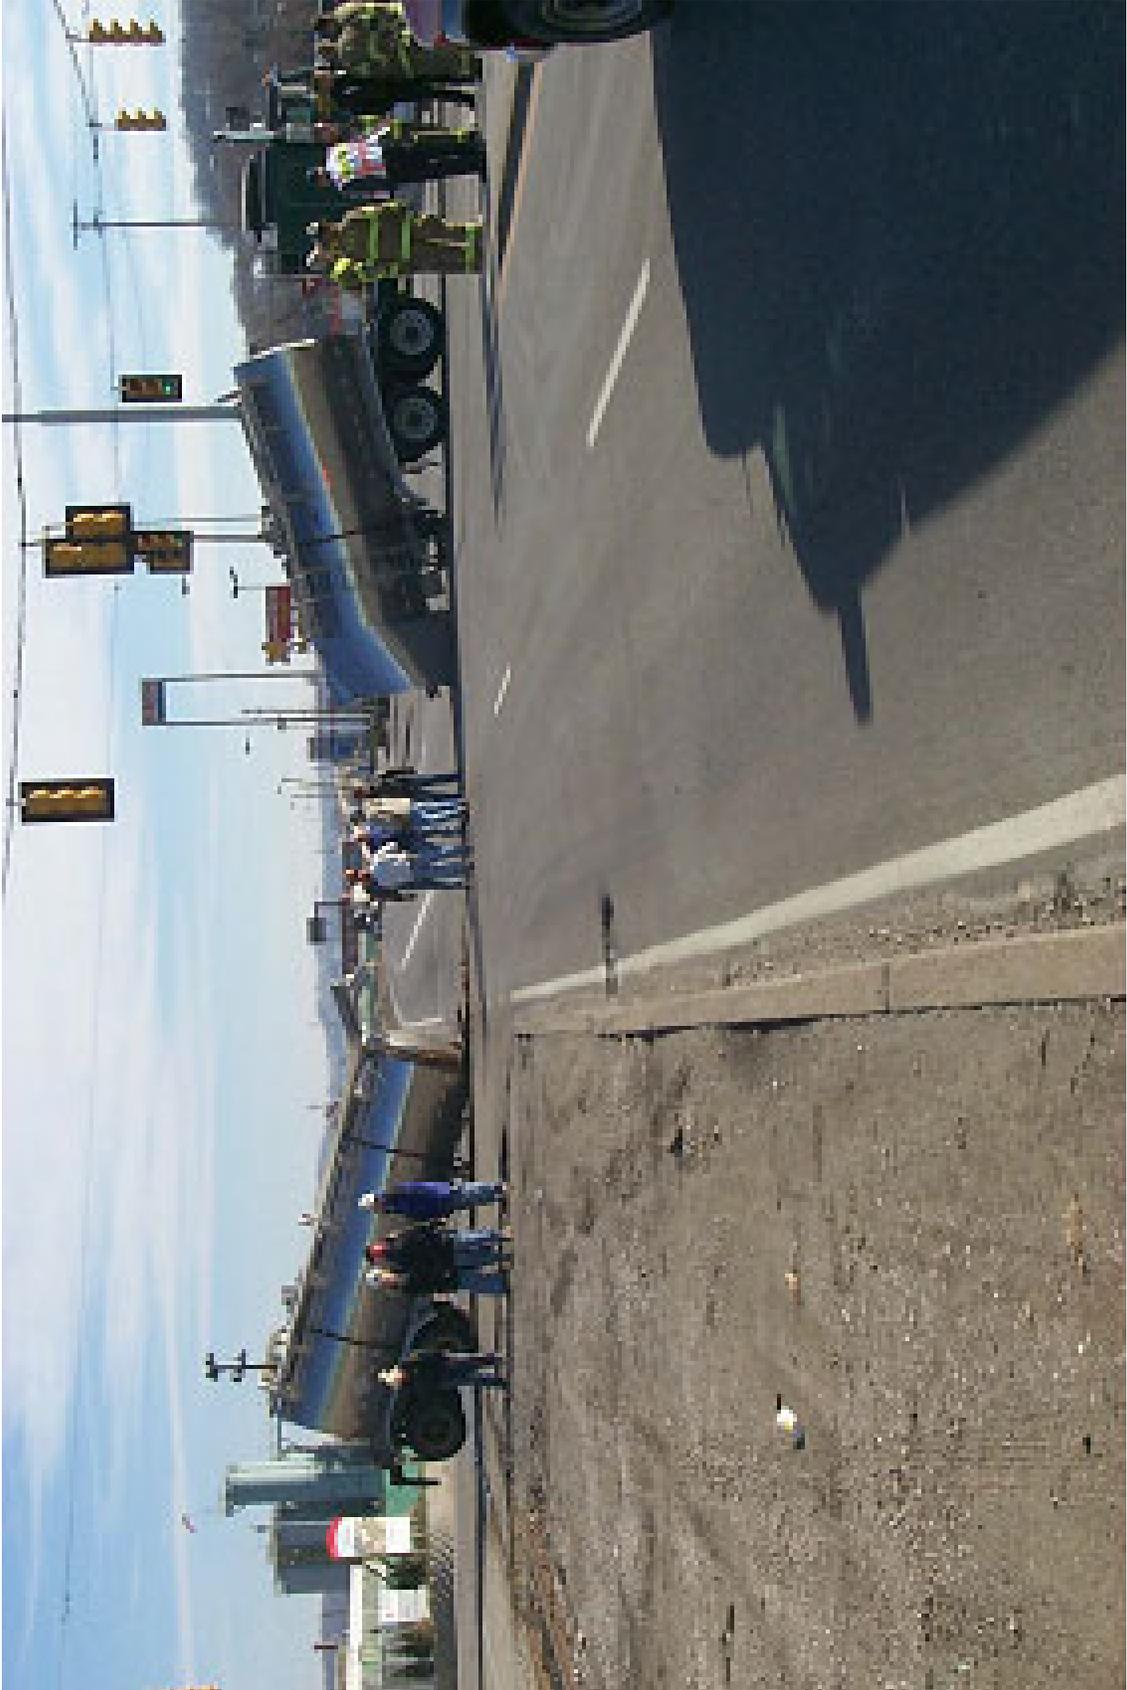
Figure 1. Accident.

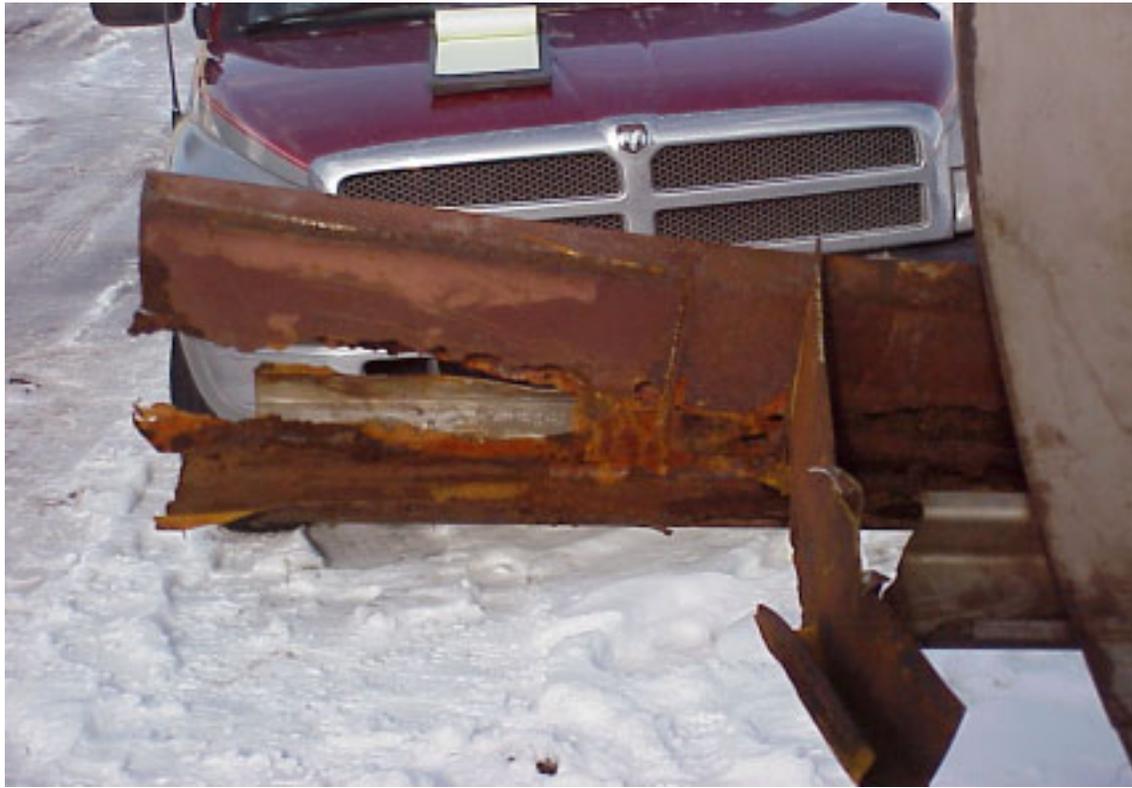
On-scene Safety Board investigators found that the portion of the frame that had been uncovered by the failure was extensively corroded. The corrosion had penetrated the full thickness of the metal in some areas. (See figure 4.) The investigators removed the jacket to reveal the frame in an area under the tie band between the rear and center tanks. That part of the frame was also extensively corroded.

Figure 4. Corrosion of frame.
