# National Transportation Safety Board

## Hazardous Materials Accident Brief

Accident No.:	DCA04MZ001
Transportation Mode	Air
Location:	Memphis, Tennessee
Date:	August 7, 2004
Time:	3:51 a.m. central daylight time
Carrier:	Federal Express Corporation
Shipper	AC Propulsion, Inc.
Vehicle:	Boeing MD-11
Injuries:	None
Property Damage:	About \$20,000
Hazardous Material:	Lithium-ion batteries
Type of Accident:	Cargo fire

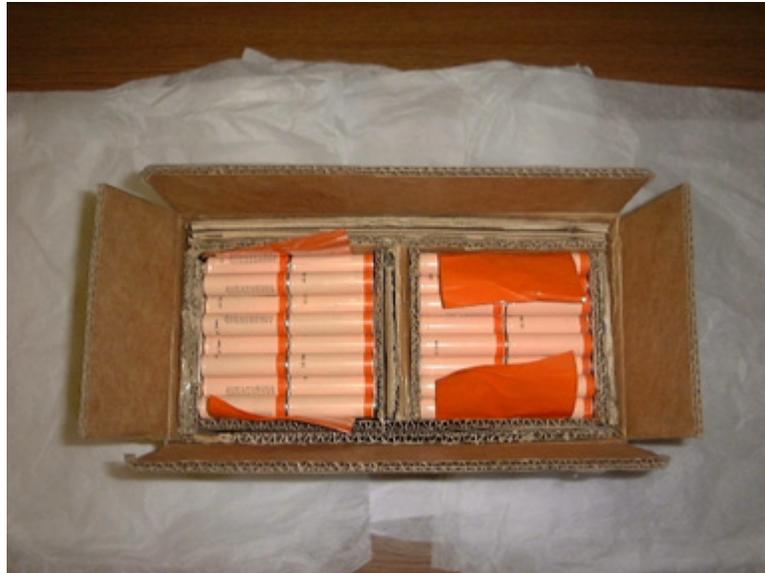
In contrast to the packaging requirements for the battery pack, the accident package consisted of a 4G fiberboard<sup>3</sup> box that held two rechargeable lithium-ion battery modules. The accident modules were not secured within a fiberglass case and then mounted in a wooden box. (See figures 3 and 4.)

**Figure 3.** Sample modules in a 4G fiberboard box, as were the accident modules.

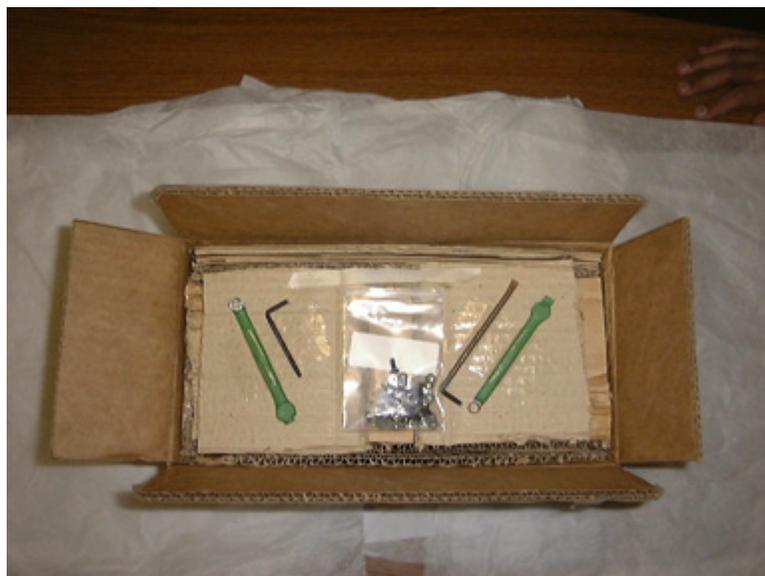
The box used to transport the accident modules had two compartments, one for each module. The box, including the space between the compartments, was lined with a double layer of fiberboard. The equipment to install the modules in the automobile battery was taped to the top of the fiberboard lining over the modules. The equipment consisted of two 2-inch-long metal Allen wrenches, two shrink-wrapped metal combination wrenches, and a bag of nuts and bolts. The total package weighed 30 pounds. (The modules were meant to replace faulty modules in a prototype lithium battery pack. The modules of the prototype lithium battery can be removed and replaced separately.)

**Figure 4.** Tools taped to the top of the fiberboard lining covering the sample battery modules in figure 3, as was done with the accident package.

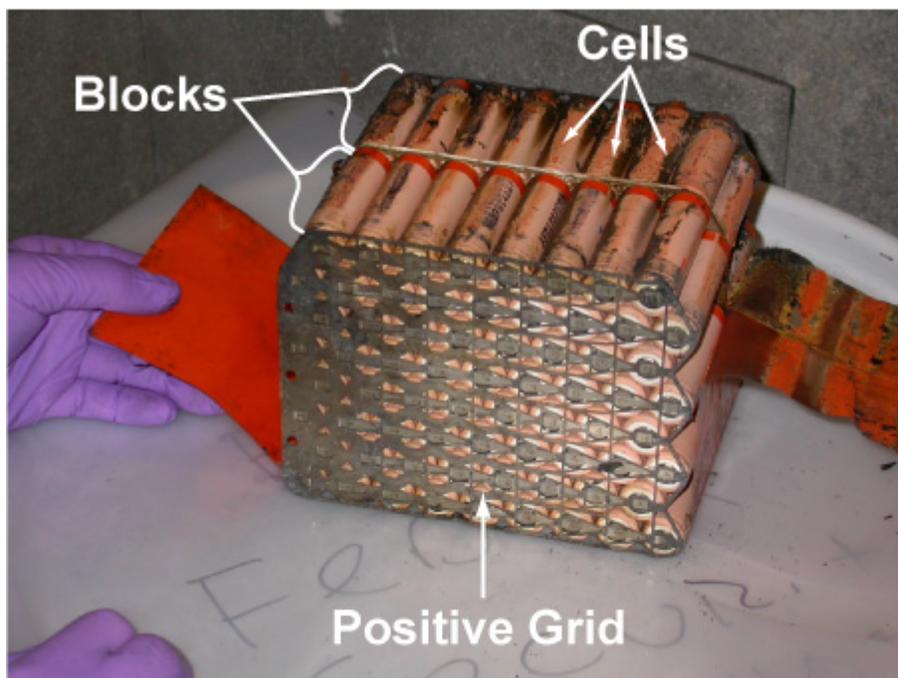
Each module was shipped with a measured voltage of 7.6 volts and consisted of two blocks. The positive terminal grid of one block was bolted to the negative terminal grid of the other block. Each block consisted of 68 lithium-ion cells that were spot-welded to the terminal grids, which were exposed. (See figure 5.)

**Figure 5.** Sooted module after incident. (The handler is wearing gloves.)

With the help of personnel from the Navy's Carderock Facility, National Transportation Safety Board investigators visually examined the burned modules in order to assess their condition and to identify any damage or failures that were present before the fire. The shrink-wrap on the outside of the cells in the damaged module had either melted or been consumed by fire, and the majority of those cells had uniform sooting. The walls and caps of most of the cells showed no evidence of punctures, tears, breaches, or any other type of damage. Three cells had rounded bottoms, indicating overpressure, and copper or aluminum foil exuded from the top vent holes, indicating exposure to heat. However, one cell with no evidence of overpressurization had a longitudinal opening in its sidewall, and some of its internal material had exuded through the opening. An adjacent cell had a longitudinal scrape on its sidewall that closely matched the opening on the first.
