National Transportation Safety Board

Hazardous Materials Accident Brief

Lithium-Ion Battery Truck Fire Following Aerial Transport

Brampton, Ontario, Canada

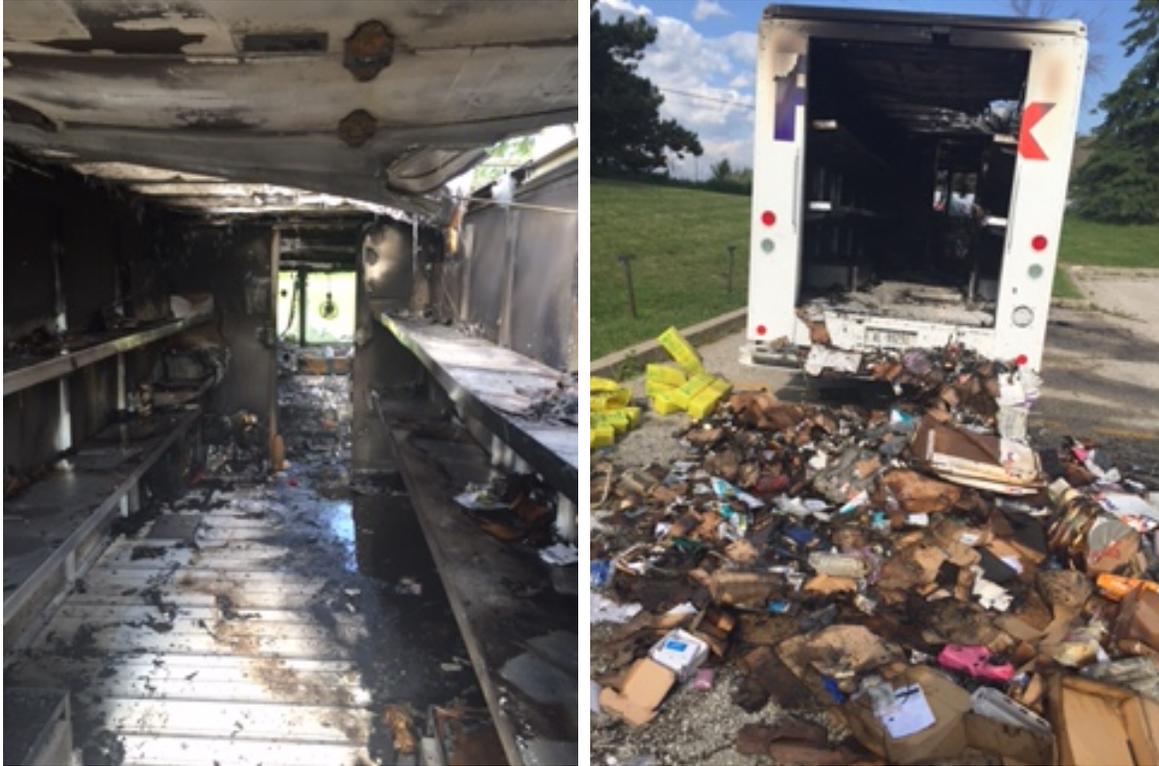
Figure 1. The fire damage to the FedEx truck and its contents. The contents of the truck were removed by firefighters following the fire. (Courtesy of FedEx.)

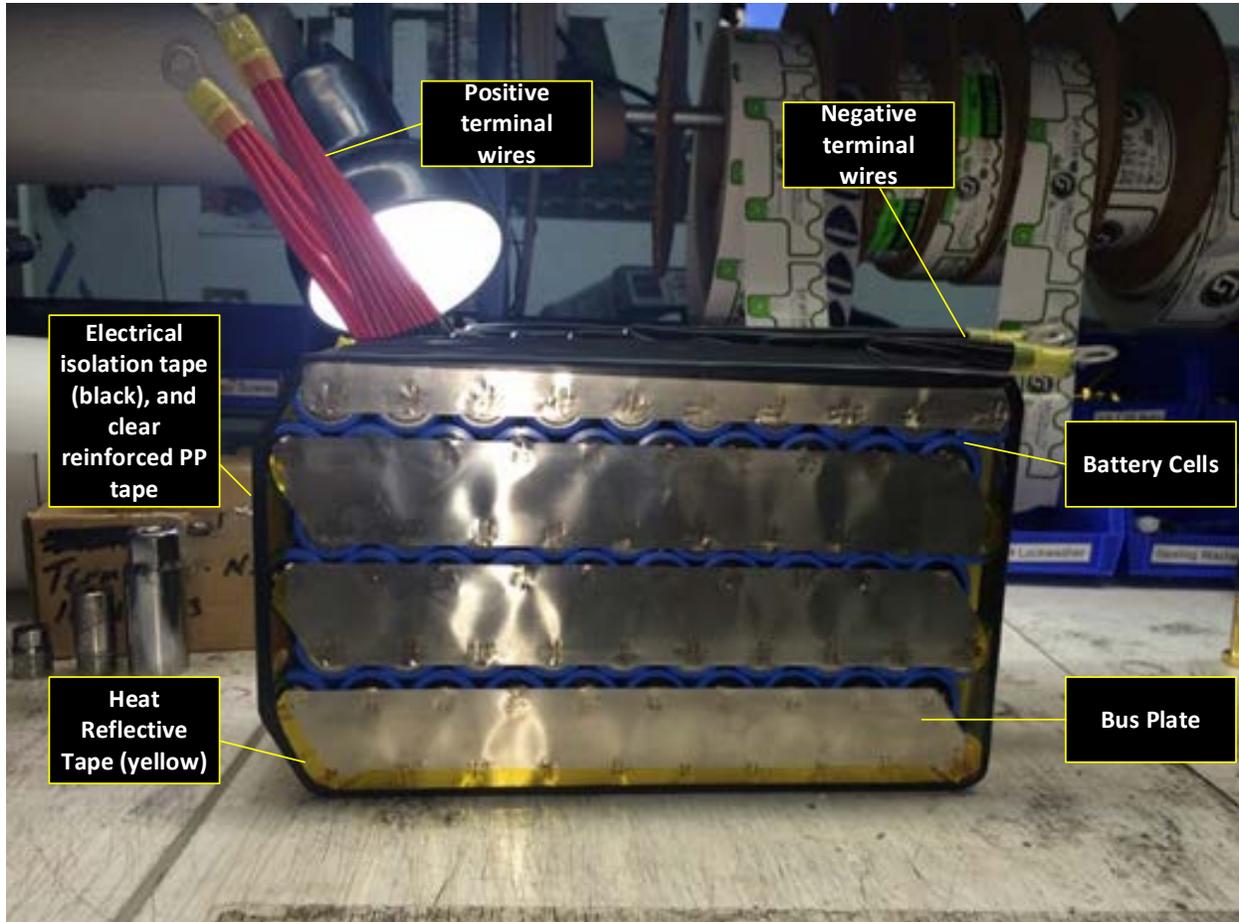
Each module consisted of cylindrical cells that were encased in a stainless steel case with a blue polyethylene terephthalate (PET) outer wrap.⁸ Braille assembled each module by electrically connecting the cells by spot welded metal tabbing in a configuration of seven cells-in-series, 10 cells-in-parallel. The edges of each module were wrapped with black polyvinylchloride electrical-isolation tape and 2-inch fiber-reinforced clear polypropylene tape. Then, yellow polyamide-imide (heat-reflective) tape was used to cover the sides of the module (edges and positive bus).⁹ An exemplar battery module is shown in figure 2.

Figure 2. Battery module identical to the one involved in the accident. (Courtesy of FAA.)

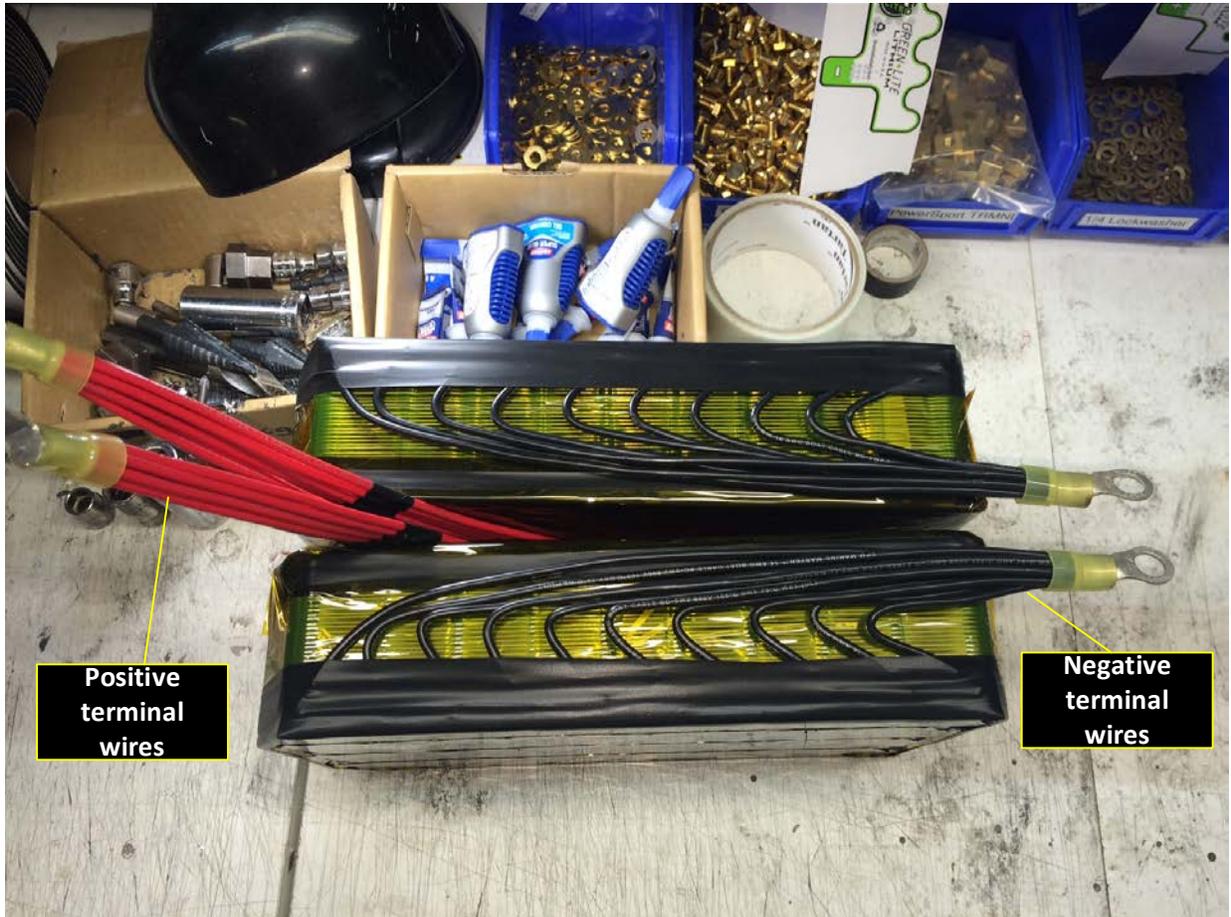
The two modules in each battery were placed inside a Battery Council International Group 31 car battery case made of polypropylene, fitted with positive and negative terminal wires connected to the battery modules.¹⁰ The modules were placed within the case with the terminal wires facing the top of the case as shown in figure 3.

Figure 3. Exemplar battery modules configuration inside the battery case. (Photograph courtesy of FAA.)

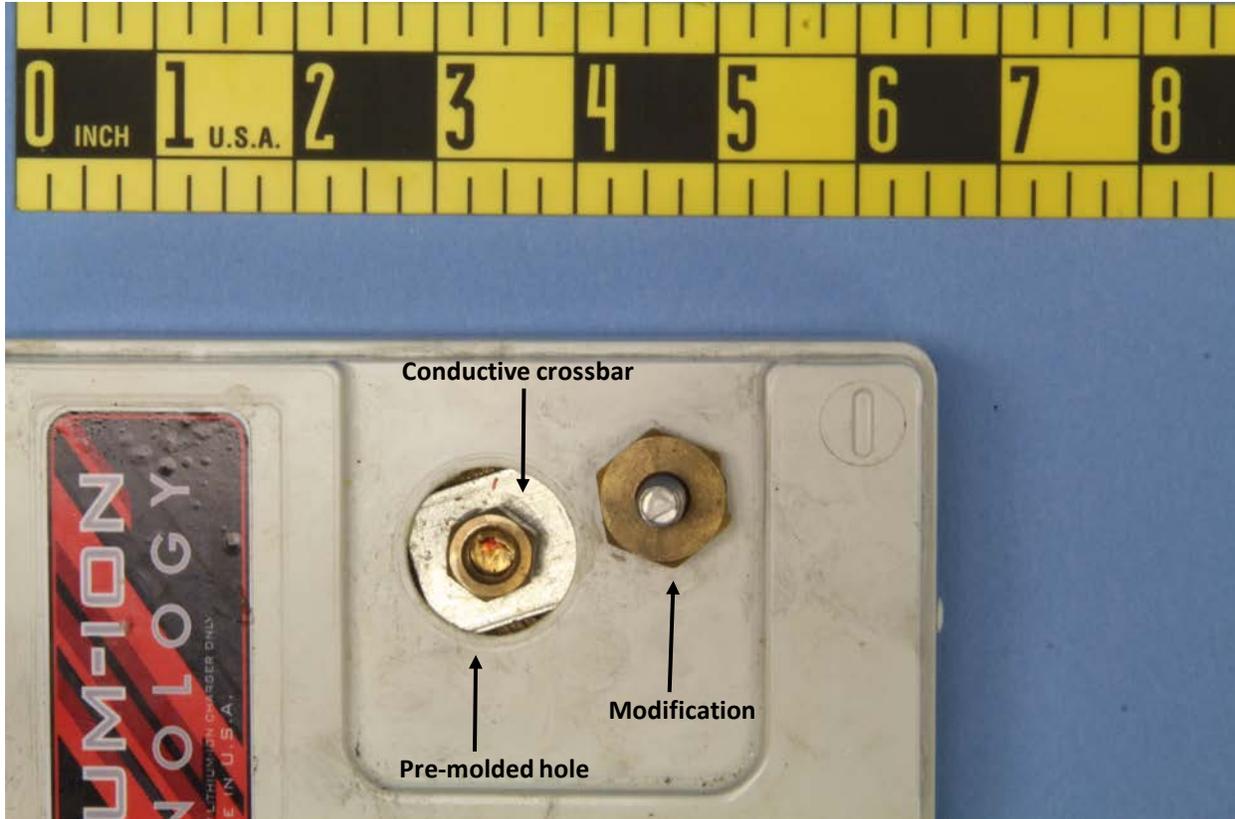
The lid of the case was modified for its intended use. The internal terminal post was located in a premolded opening in the lid. The internal terminal consisted of a 9/16-inch diameter bolt that went through one end of a conductive crossbar with the opposite end of the crossbar connected to the external terminal post located in a modified opening in the lid. (See figures 4 and 5.)

Figure 4. Photograph of modified terminal placement in case lid.

NTSB determined from its examination and testing that the modules were not secured and could move within the case. Furthermore, the modification made to the lid for the terminal posts did not provide enough clearance between the bolts and the modules. During transport, the shifting modules rubbed against the terminal bolt causing the bolt to tear through the tape layers and the cell wrap, damaging the cell casing, eventually resulting in a localized short circuit.¹² The short circuit caused the damaged cell to go into thermal runaway, producing excessive heat that caused surrounding cells to go into thermal runaway, resulting in a cascading failure of the battery.

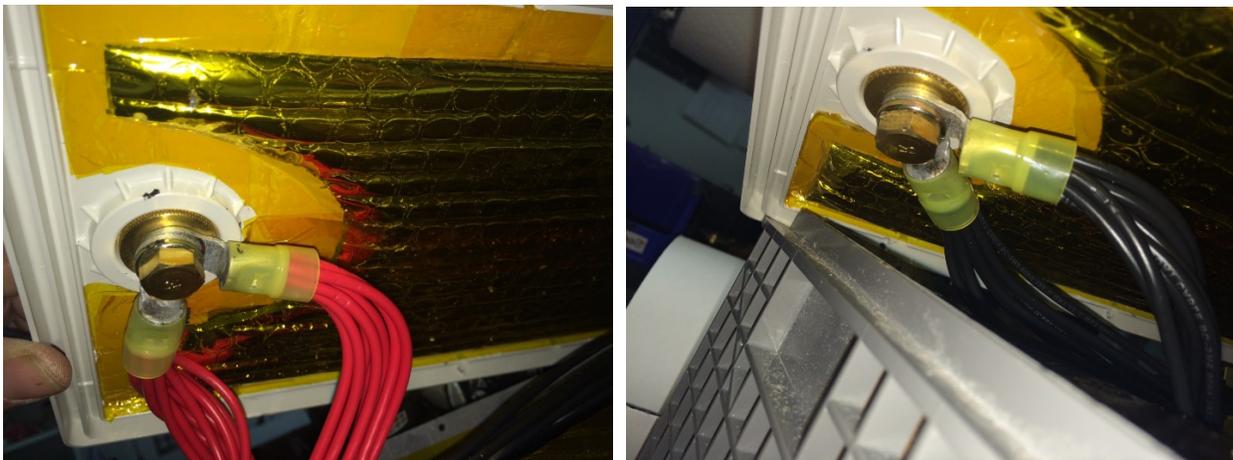
Figure 5. Exemplar positive and negative terminals on Braille battery lid. (Courtesy of FAA.)

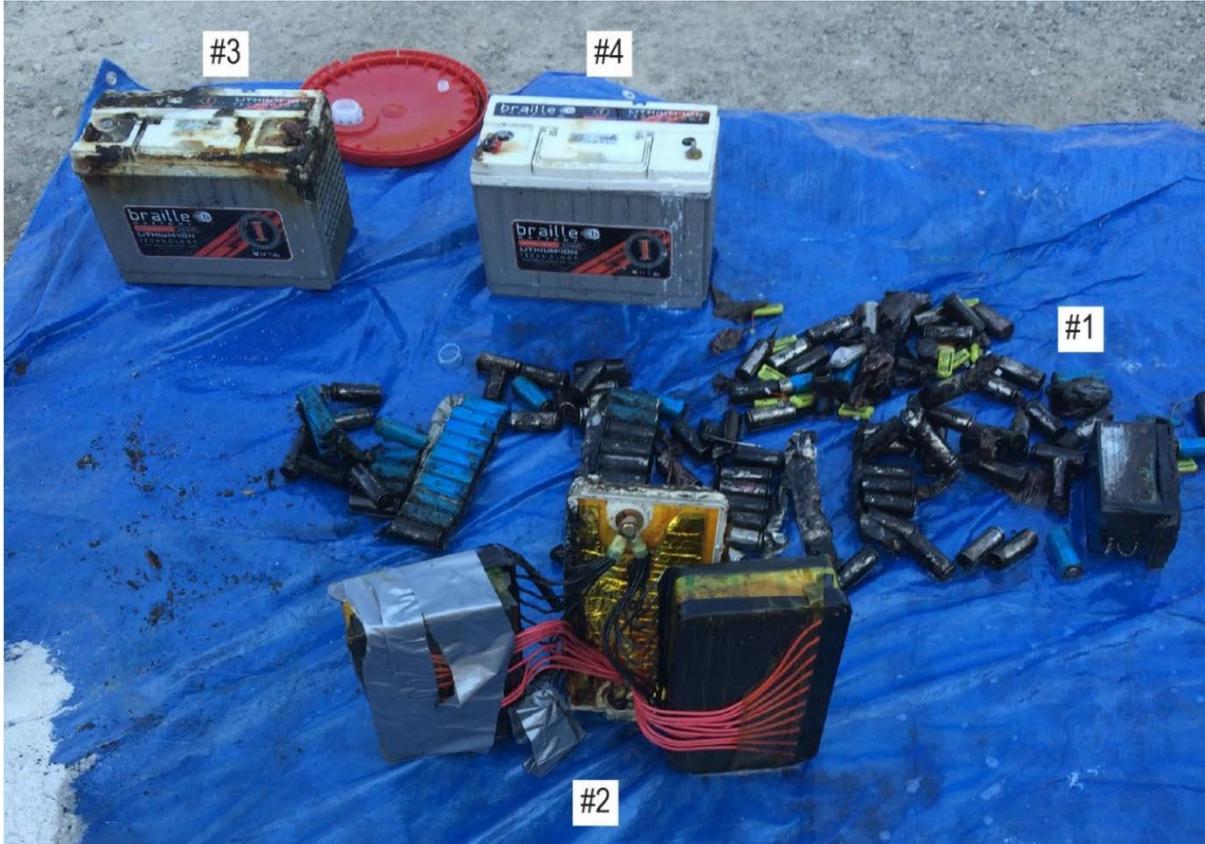
Following the accident, the damage to the batteries was documented and the batteries were labeled sequentially with the battery with the most damage labeled #1. (See figure 6.) The Brampton Fire Department determined battery #1 started the fire; its battery case and lid were destroyed, and the modules and associated hardware separated into individual cells and partial

strings of cells. The individual cells and string fragments that were recovered from this battery had heavy-to-moderate sooting on their surfaces and had heavy-to-moderate bulging at the top vents. One of the cell cases exhibited melting consistent with electrical contact. Electrolyte salt residue was present on the surface of several of the cells, suggesting electrolyte vented from these cells. The top vent bulging and presence of electrolyte salt residue was consistent with the cells overheating and going into thermal runaway.¹¹

Figure 6. Four Braille batteries involved in the fire.

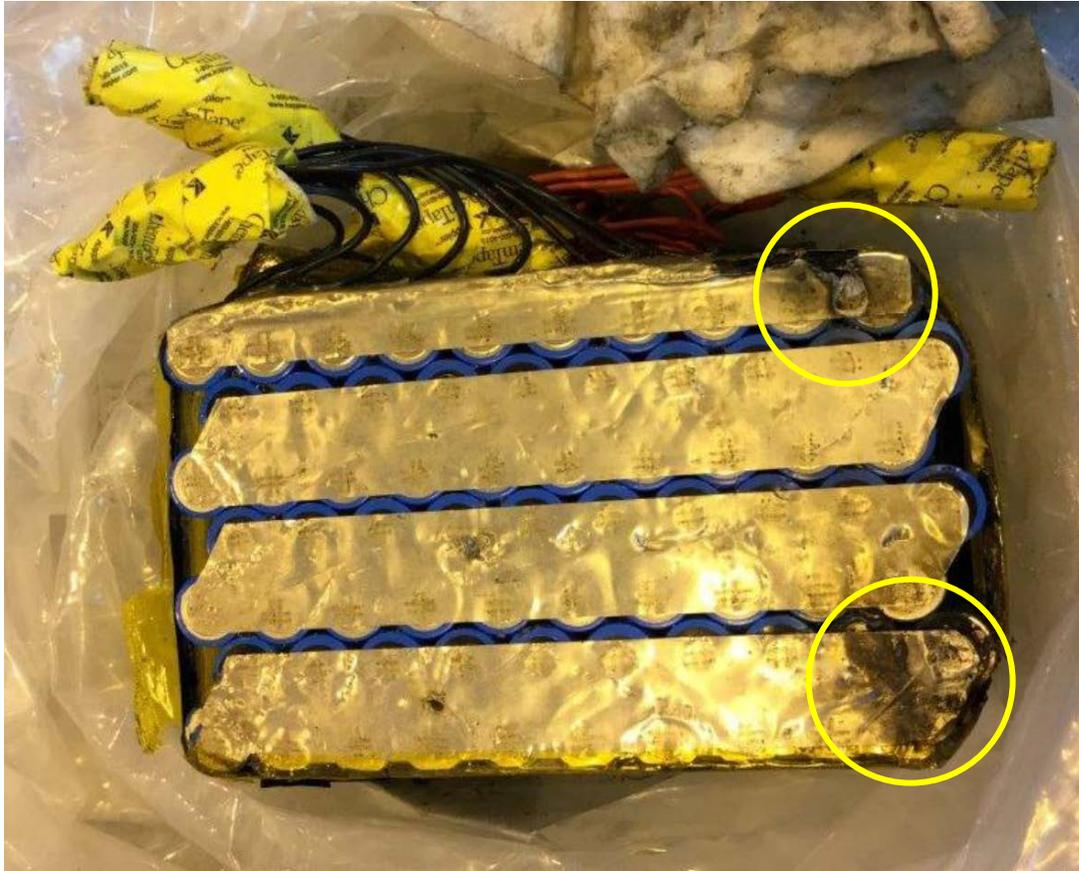
The outer case for battery #2 separated from the rest of the battery and only the case lid and two battery modules with associated wiring were recovered from the scene. Batteries #3 and #4 were intact; however, their battery case lids exhibited charring and melting. When opened, the modules for batteries #3 and #4 were found loosely packed in the battery cases. After removing the modules from the cases, module #2 showed evidence of electrical arcing from one cell on top of the module, as seen in figure 7. Similar damage was found on the adjacent terminal bolt.

Figure 7. Burn patterns observed on the top string showing electrical arcing on one of the modules of battery #2.

Investigators noted deformed and discolored tape layers and missing material from the bus plates on the corners of the intact modules, revealing evidence of rubbing and scraping between the modules and the terminal bolts. The cells within the modules displayed visible evidence of contact between the blue PET cell wrap and the battery terminal bolt on the inside lid of the battery case. Electrolyte salt residues, consistent with electrolyte venting, were present on the top surface of several of the cells.

The National Transportation Safety Board determines that the probable cause of the fire on a FedEx delivery truck in Brampton, Ontario, Canada, on June 3, 2016, was an electrical short circuit between the battery terminal bolt and the upper cells of the lithium-ion battery module, causing a thermal runaway within the battery, igniting the battery and its packaging. Contributing to the electrical short circuit was Braille Battery, Inc.'s design that did not protect against short circuiting. Also contributing to the consequences of the accident was Braille Battery, Inc.'s use of combustible packing materials.
