Hazardous Materials Accident Report

**Hazardous Materials Release
From Railroad Tank Car With
Subsequent Fire at
Riverview, Michigan
July 14, 2001**

**NTSB/HZM-02/01
PB2002-917002
Notation 7400A
Adopted June 26, 2002**

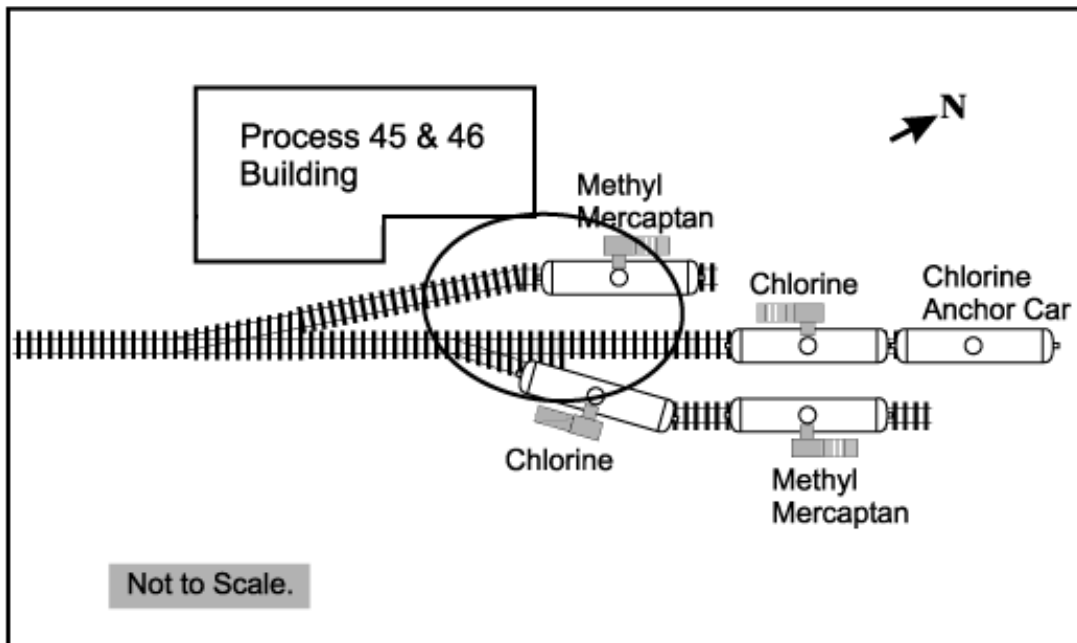
Figure 2. Accident site. (The circled area is the area of greatest fire damage.)

Damage to the plant was limited to fire exposure on the methyl mercaptan unloading station, which resulted in melting or damaging most of the non-ferrous fittings, gauges, and other apparatus; fire exposure and warping of the track under the methyl mercaptan tank car; and scorching of track ties and nearby wooden planking.

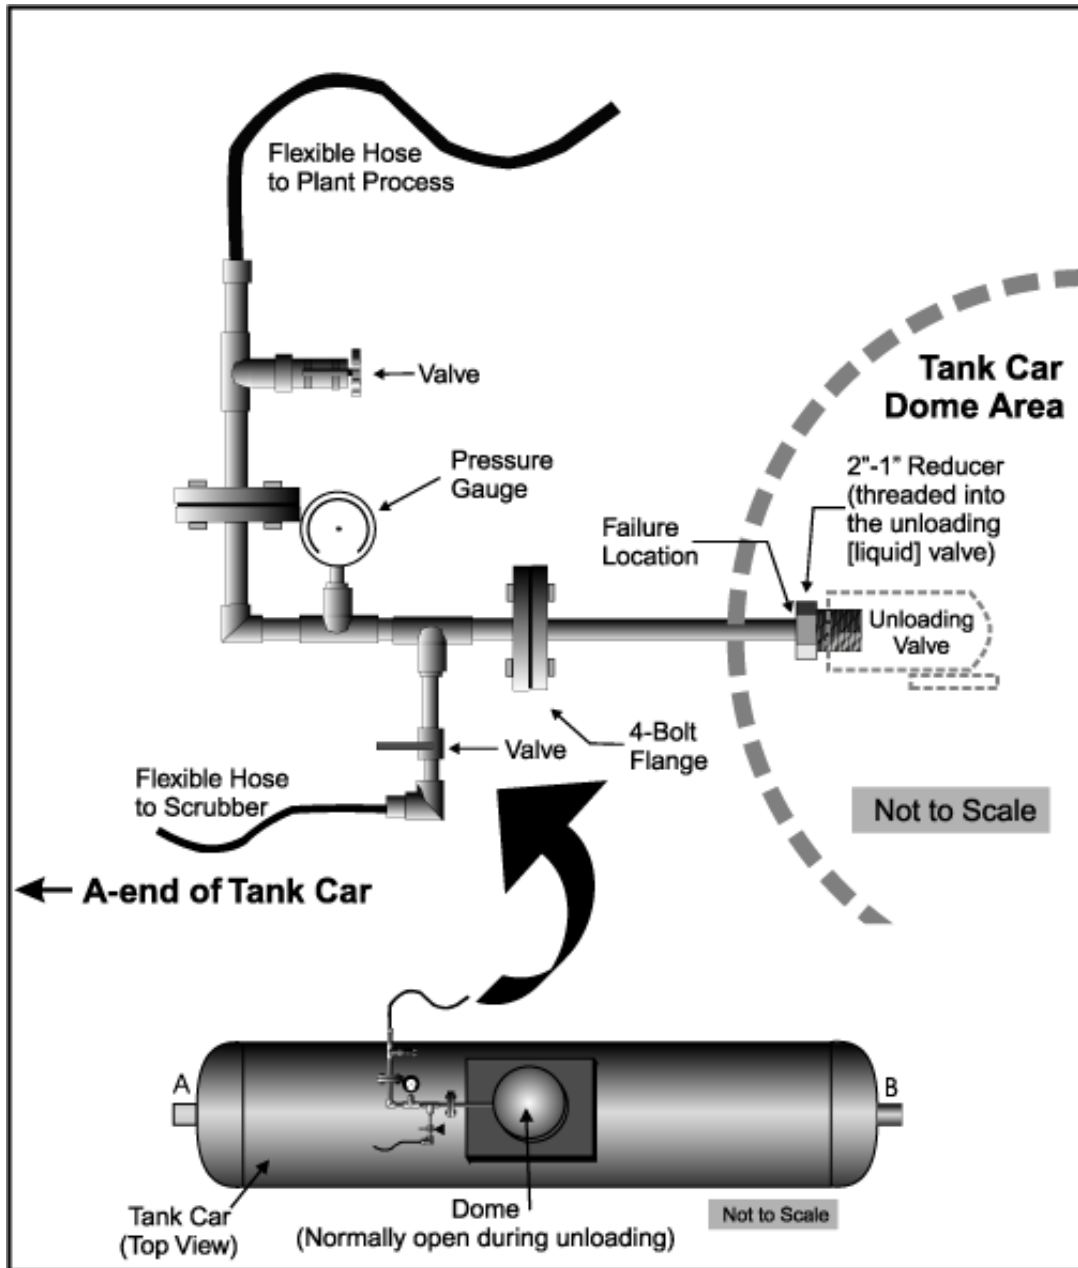
Figure 4. Overhead view of unloading apparatus. (For clarity, the pressure gauge, valves, and scrubber line have been rotated into the horizontal plane.)

The first component of ATOFINA’s unloading apparatus consisted of a 1-foot-long, 1-inch-diameter steel pipe with a 2- to 1-inch reducer threaded onto one end and a four-bolt flange threaded onto the other. In preparation for product transfer, the reducer end of the pipe was passed through an access hole on the side of a tank car dome, and the reducer was threaded onto the tank car’s unloading valve. The 1-inch pipe was the one that, in this accident, failed and separated, releasing the methyl mercaptan.

As noted earlier, a 1-inch-diameter steel pipe in the unloading apparatus of UTLX 900558 was separated at the point the pipe threads exited a 2- to 1-inch reducer installed in the tank car's unloading valve. The flexible hoses attached to the unloading apparatus on both tank cars were melted and partially consumed by the fire.

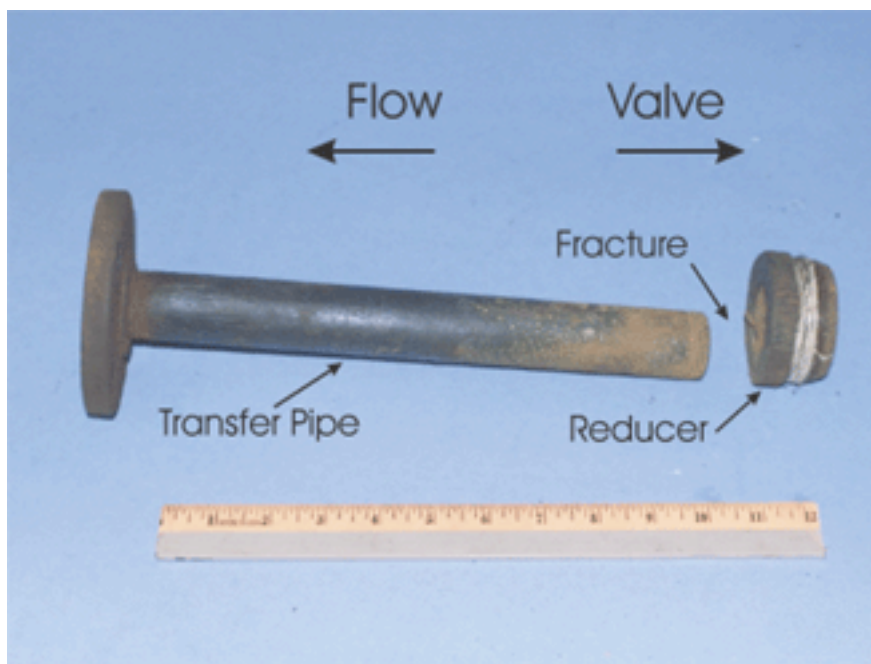
Figure 5. Separated transfer pipe.

The Safety Board's metallurgical examination of the separated steel pipe in the unloading apparatus (figure 5) did not identify any evidence of preexisting cracks on the fracture surface; the fracture features were typical of an overstress separation. Examination of the pipe revealed evidence of corrosion, including deposits of iron oxide (rust) and pitting on both interior and exterior surfaces. (The interior surfaces of the pipe were exposed to the weather whenever the unloading apparatus was not in place on a tank car.)

Measurements of the interior and exterior diameters at several locations on the length of the pipe were compared with interior and exterior diameters for new pipe. These comparisons revealed that the outside diameter was comparatively the same as that of new pipe; however, the inside diameter near the end of the pipe where the failure occurred showed evidence of erosion-corrosion damage (discussed in the next section) that reduced the wall thickness near the fracture by about 23 percent as compared to the inside diameter of new pipe.

Calculations made using the weight of each of the unloading apparatus components, their distances from the pipe separation, the standard (as manufactured) wall thickness of 1-inch pipe, and standard piping design and engineering formulas indicate that bending stresses on a new pipe at the point the pipe entered the reducer would have been 20,800 pounds per square inch (psi). The wall thickness reduction of the accident pipe that resulted from erosion-corrosion resulted in a 20-percent increase in the calculated bending stress on the pipe, to 25,100 psi at the point of fracture. Comparing the bending stress to the strength of the material, Safety Board metallurgists estimated that an additional force of about 175 pounds (added to the existing force represented by the weight of the unloading apparatus), if applied at the outer end of the unloading apparatus, would cause an overstress failure (fracture) of the pipe.
